# Site Investigation Report

129282.1.USI

Auger were commissioned by Crawford & Co to undertake a site investigation and CCTV inspection of the underground drainage within the area of concern at the property.

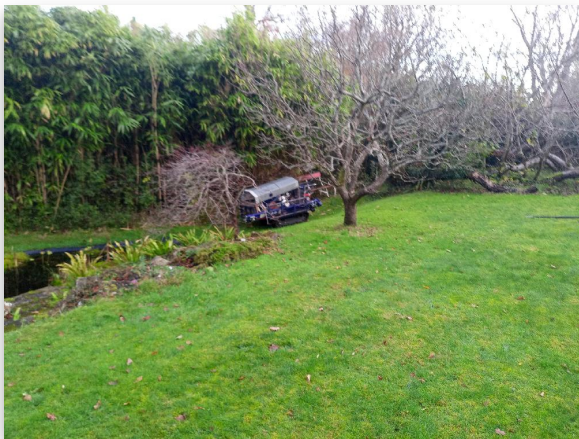
Fig 2.1: Installation of the datum

The datum was installed at the rear of the property. It was reported by the mechanical auger operator that refusal was met at 5.5m below ground level, at a depth of 5m the SPT reading (N value) was 55.

As a result of the above, the datum was not installed at 6m it was in fact installed at 5m.

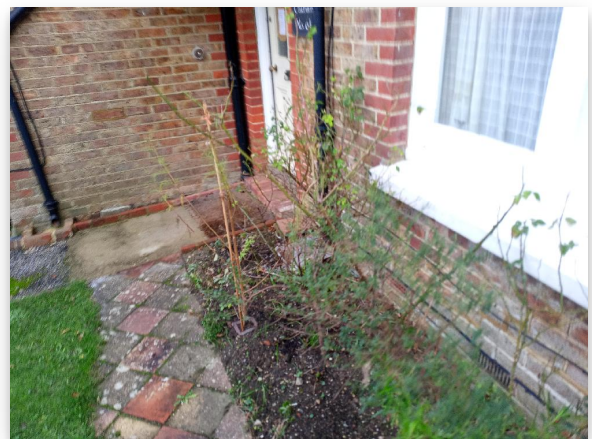
Fig 2.2: Location of excavation

Our CCTV survey revealed that this drain has previously been lined. Furthermore the end of the liner on the restbend is not flush to the pipe. As a result this has caused a 'lip' on the drain which may cause blockages.

On line 2, excavate and replace SVP and 1m of 100 mm pipework at a depth no greater than 1m through concrete. This will involve removing a section of defective liner.

The above excavation may involve excavating through the brick step, if we complete such action the attached quote will be varied and this may incur further costs.
