**TECHNICAL REPORT ON A SUBSIDENCE CLAIM**

**Crawford Reference: SU2103539**

**Miss Anna Bryant  
61 Lodge Lane, Hassocks  
West Sussex, BN6 8LX**

**SUBSIDENCE CLAIM**

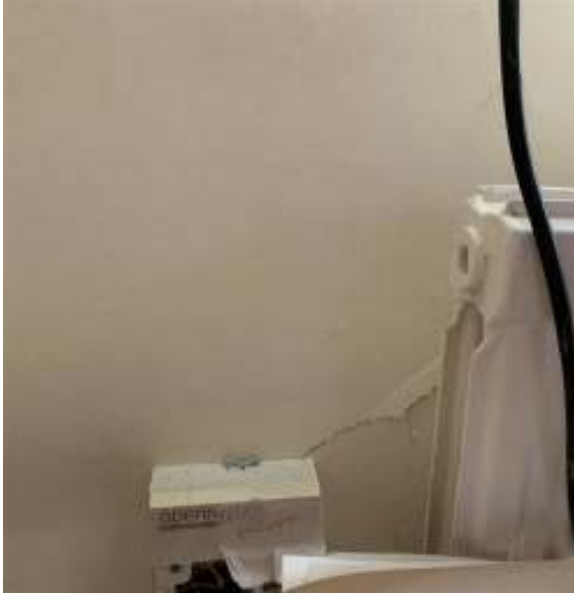
Left reception - below right of window

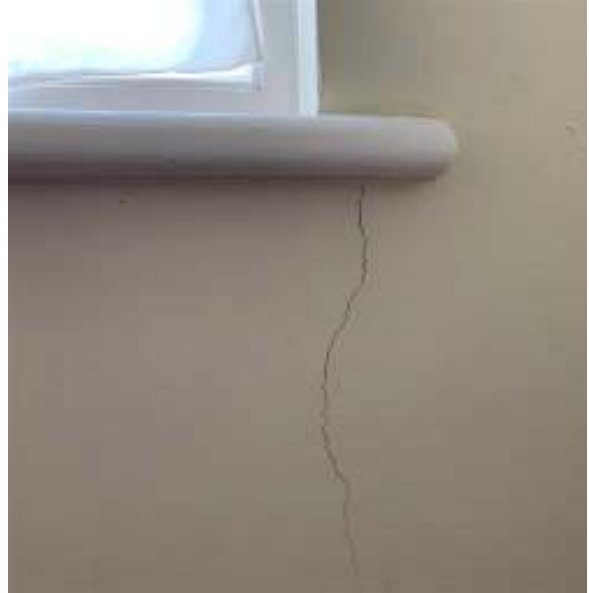
Half-landing - below window on rear wall

Vertical crack below right side and diagonal crack above left side of half-landing rear window

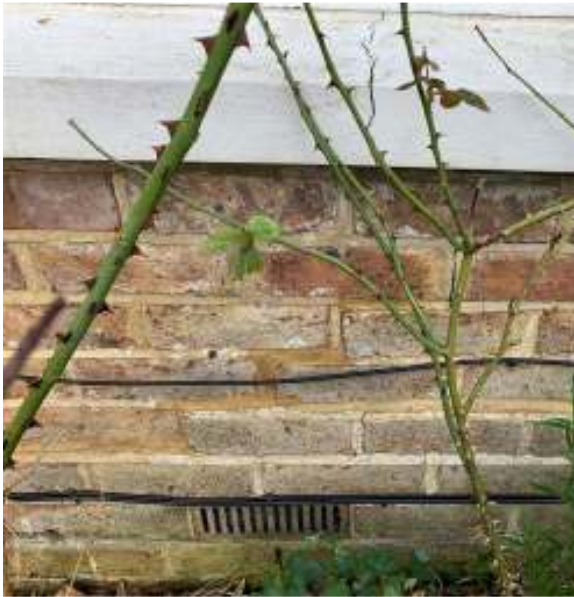
Below GF right reception window

Laser level shows bed joints tilt down by 20mm to right on GF front right window

Stepped crack below GF front right window, extending as stepped & vertical cracks to bedroom window above

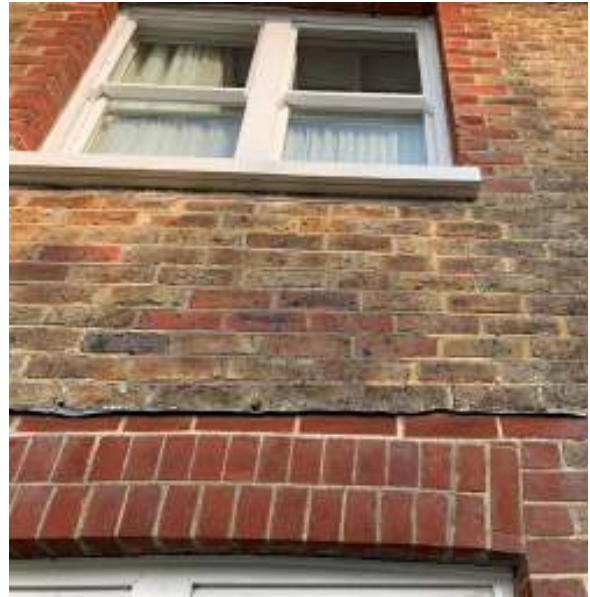
Above GF right reception window

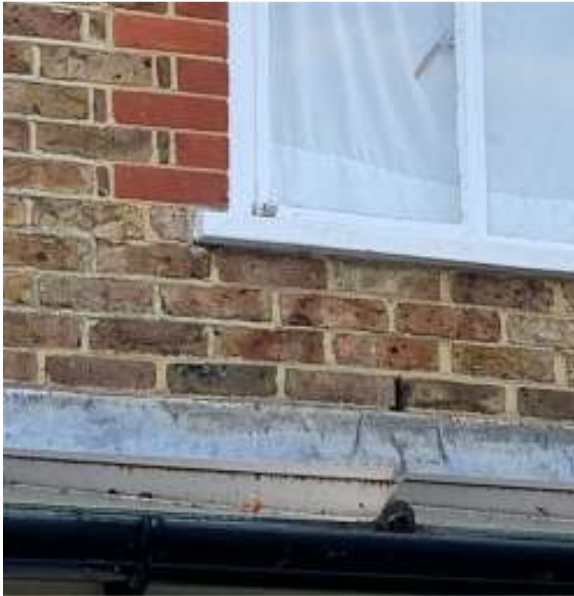
Stepped crack above patio doors extending up to half-landing window and above.

Below half-landing window on rear

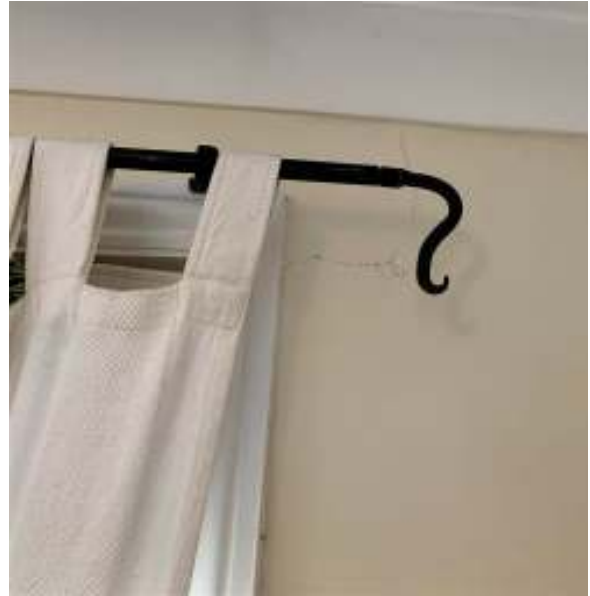
Cracking around lintel above left side of front window

Right reception - above left side of window

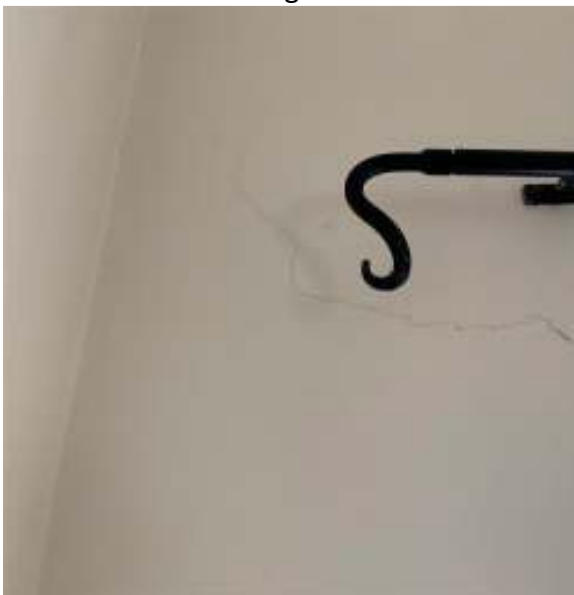
Half landing - above window on rear wall

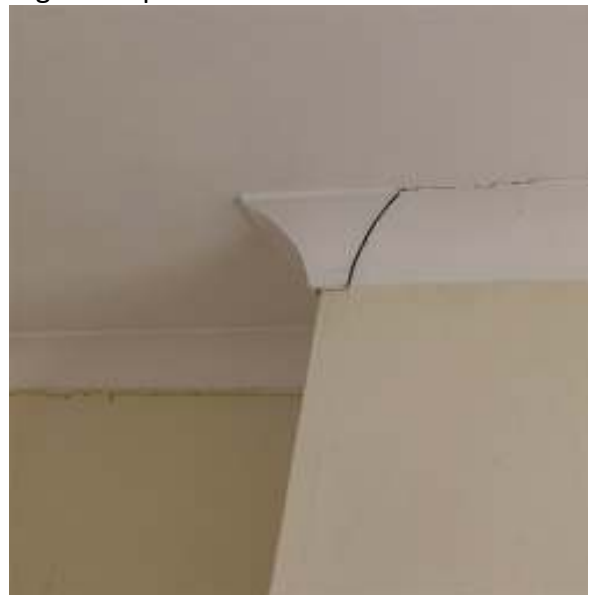
Right bedroom

Cracking along right gable wall/ceiling junction and extending through coving joint

Feint cracking above and below corners of front window

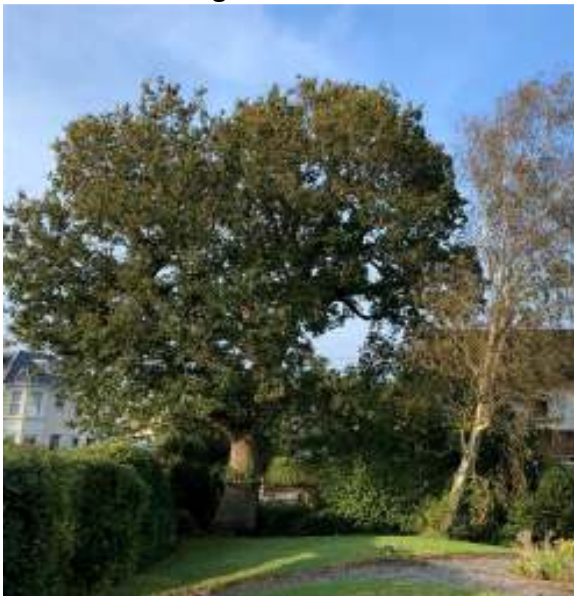
Oak T1

| Type | Height | Distance | Ownership |
|---|---|---|---|
| T1 Oak | 14 m | 11 m | Owners |

Further recommendations will be dependent on the results of these initial investigations but this may involve some further vegetation management, subject to the recommendations of a specialist arboricultural report. Level monitoring will need to continue at least over the next summer period.

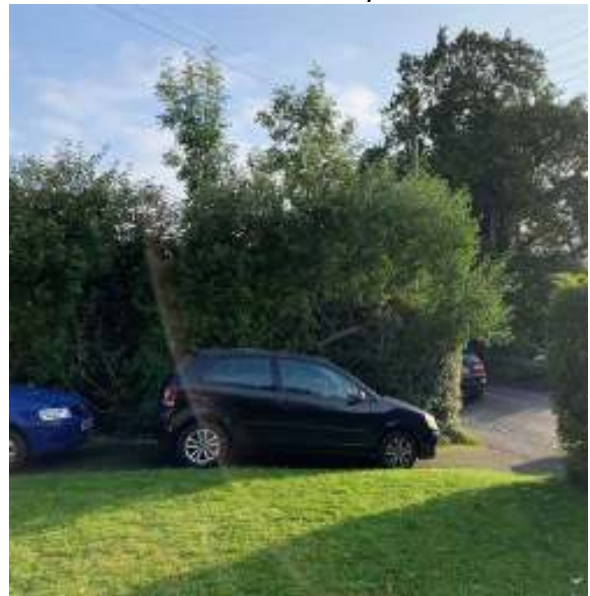
| Type | Height | Distance | Ownership |
|---|---|---|---|
| S1 Shrubs (inc Olive) | 5 m | 4 m | Owners |
| T2 Oak | 22 m | 28 m | Council |

Shrubs S1 inc Olive with Oak T2 in background
