Project Name: Penland Farm

Project Description: CCTV Survey, Trace & Plot

Inspection Standard: MSCC5 Sewers & Drainage GB (SRM5 Scoring)

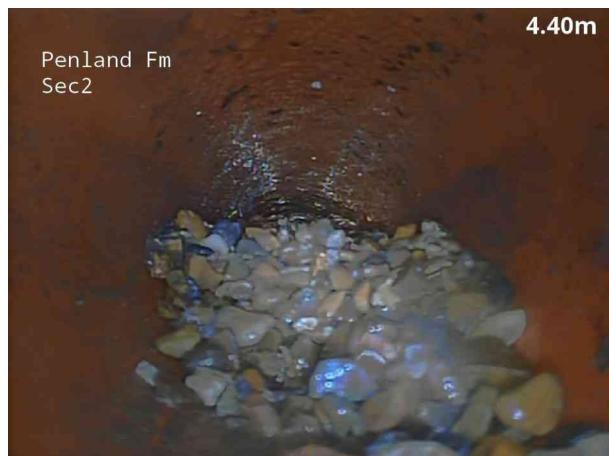
3, 00:00:21, 4.20 m
Settled deposits, coarse, 10% cross-sectional area loss, start

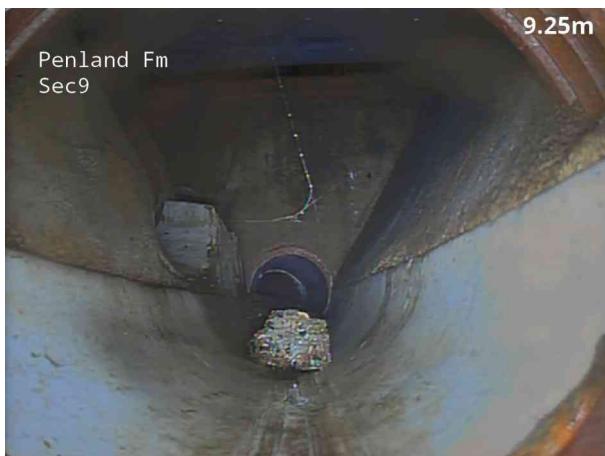
2, 00:01:04, 9.10 m
Fracture, circumferential from 12 o'clock to 12 o'clock

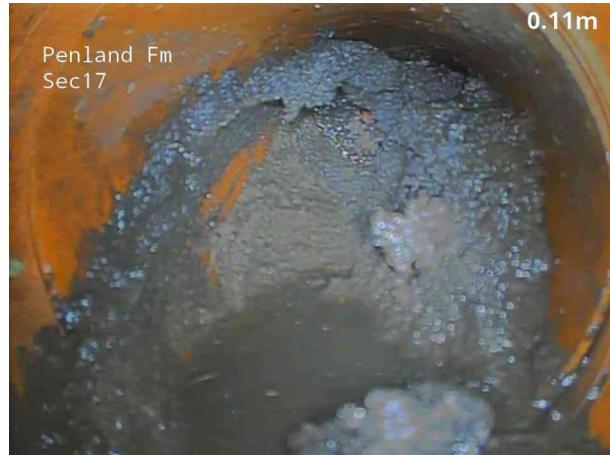
2, 00:00:13, 0.20 m
Settled deposits, fine, 90% cross-sectional area loss

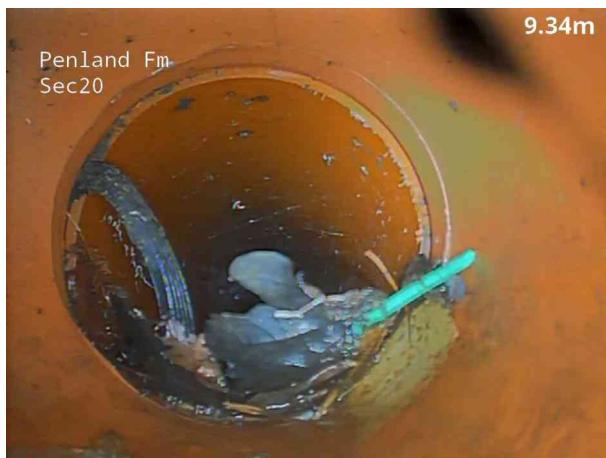
3, 00:00:32, 9.40 m
Sealing ring intruding, loop hanging below centre from 7 o'clock to 10 o'clock

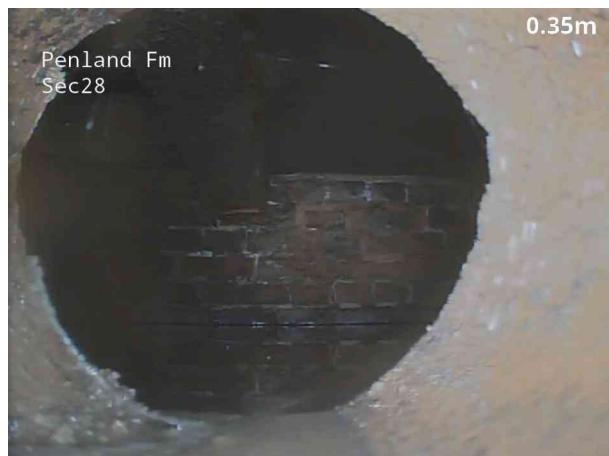
4, 00:00:11, 0.50 m
General remark, Dipper pipe missing

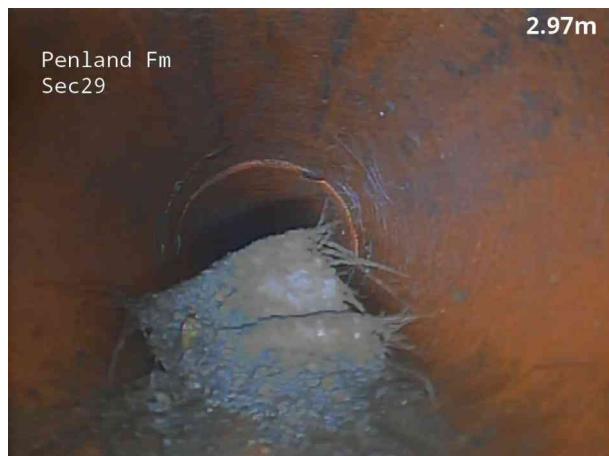
4, 00:00:21, 3.00 m
Roots, mass, 10% cross-sectional area loss

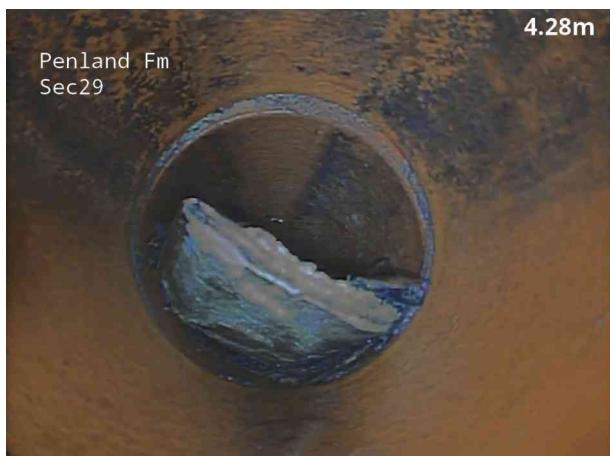
5, 00:00:28, 4.50 m
Settled deposits, coarse, 45% cross-sectional area loss

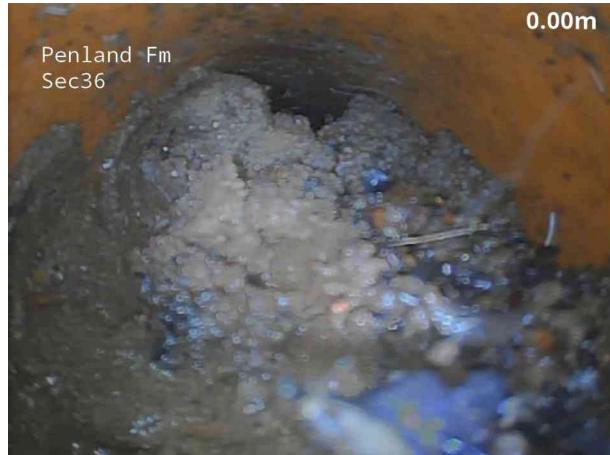
2, 00:00:34, 0.10 m
Settled deposits, fine, 95% cross-sectional area loss
