## **7 Appendices**

**Project Name:** Prince Albert Pub RH10 3QX  
**Project Description:** General CCTV - Condition Check  
**Project Number:** JSD7518  
**Project Status:** Complete  
**Project Date:** 25/07/2024  
**Inspection Standard:** MSCC4 Sewers & Drainage GB (SRM4 Scoring)

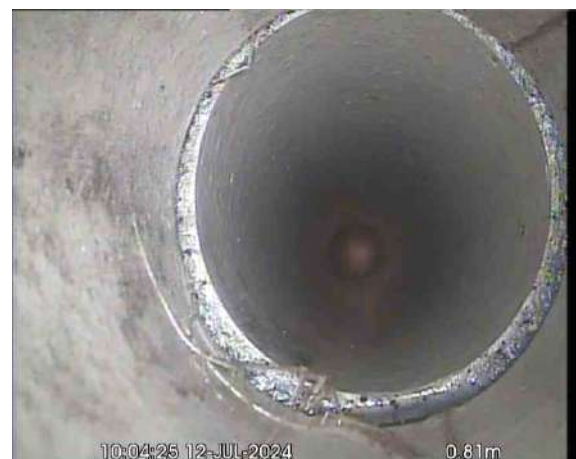
| Scale: | 1:50 | Position [m] | Code | Observation | MPEG | Photo | Grade |
|---|---|---|---|---|---|---|---|
| | 0.81 | CCJ | Crack, circumferential at joint from 6 o'clock to 9 o'clock | 00:01:01 | GULLYX_b10122b8-1f1f-4b61-53ee-44b1 | | 2 |

GULLYX\_b10122b8-1f1f-4b61-85ad-1d1dd839dd63\_20240725\_090208\_797.jpg, 00:01:01, 0.81 m  
Crack, circumferential at joint from 6 o'clock to 9 o'clock

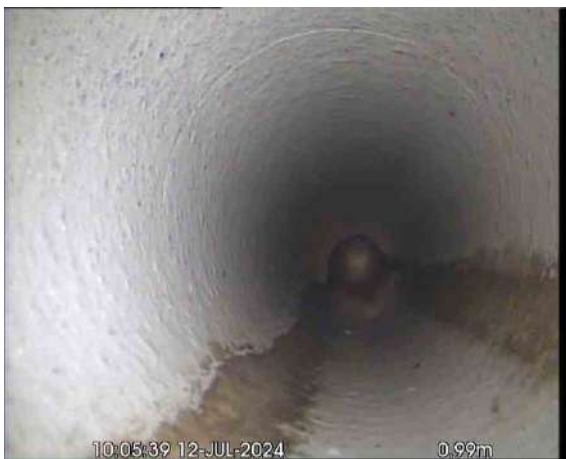
| Scale: | 1:50 | Position [m] | Code | Observation | MPEG | Photo | Grade |
|---|---|---|---|---|---|---|---|
| | | 0.99 | CC | Crack, circumferential from 9 o'clock to 3 o'clock | 00:00:37 | W_CX_b0<br>b5a396-c8<br>7b-44df-b5 | 2 |

W\_CX\_b0b5a396-c87b-44df-b524-f6ae86763abc\_20240725\_090413\_863.jpg, 00:00:37, 0.99 m  
 Crack, circumferential from 9 o'clock to 3 o'clock

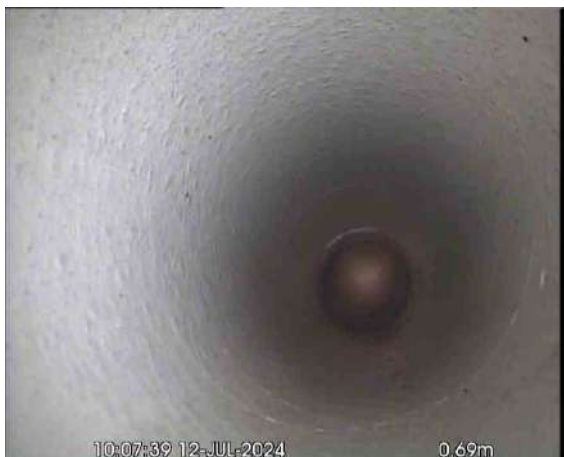
| Scale: | 1:50 | Position [m] | Code | Observation | MPEG | Photo | Grade |
|---|---|---|---|---|---|---|---|
| | | 0.69 | CC | Crack, circumferential from 3 o'clock to 8 o'clock | 00:00:31 | W_CX_6d<br>e99cdf-b4<br>13-404c-b | 2 |

W\_CX\_6de99cdf-b413-404c-b955-bd55d3022d42\_20240725\_090601\_206.jpg, 00:00:31, 0.69 m  
 Crack, circumferential from 3 o'clock to 8 o'clock

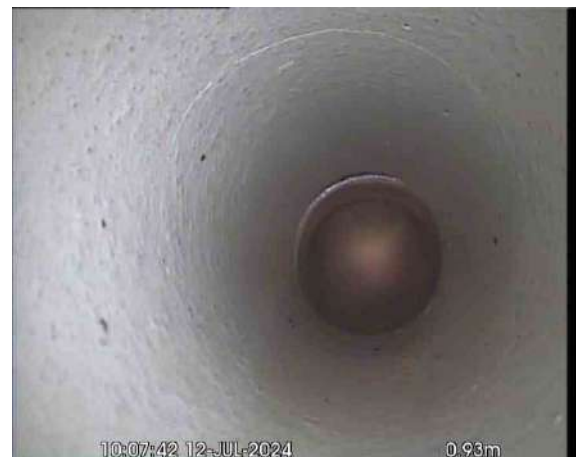
| Scale: | 1:50 | Position [m] | Code | Observation | MPEG | Photo | Grade |
|---|---|---|---|---|---|---|---|
| | | 0.93 | CC | Crack, circumferential from 9 o'clock to 3 o'clock | 00:00:34 | W_CX_9fa<br>16cc0-059<br>8-4ab2-b0 | 2 |

W\_CX\_9fa16cc0-0598-4ab2-b04a-1bd0e0447c7d\_20240725\_090647\_708.jpg, 00:00:34, 0.93 m  
 Crack, circumferential from 9 o'clock to 3 o'clock

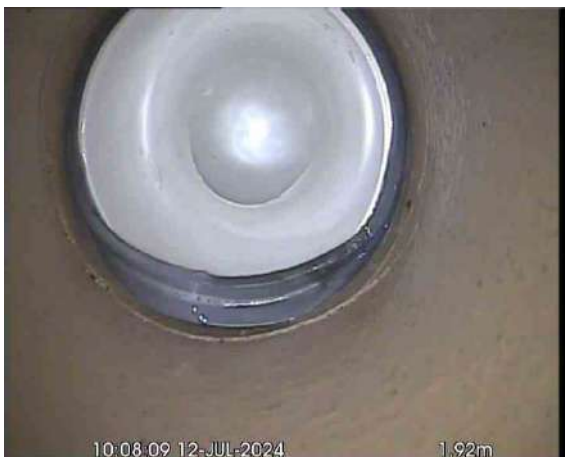
| Scale: | 1:50 | Position [m] | Code | Observation | MPEG | Photo | Grade |
|---|---|---|---|---|---|---|---|
| | | 1.92 | CCJ | Crack, circumferential at joint from 12 o'clock to 12 o'clock | 00:01:01 | W_CX_14<br>0950e0-f4<br>b9-4fa9-b1 | 2 |

W\_CX\_140950e0-f4b9-4fa9-b1b6-8f3dc2314eb6\_20240725\_090748\_590.jpg, 00:01:01, 1.92 m  
 Crack, circumferential at joint from 12 o'clock to 12 o'clock

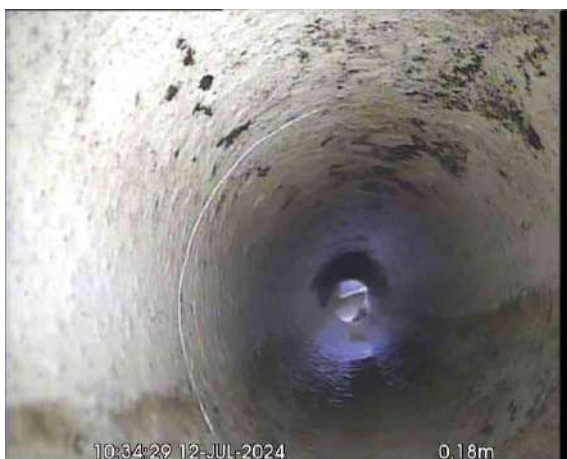
| Scale: | 1:50 | Position [m] | Code | Observation | MPEG | Photo | Grade |
|---|---|---|---|---|---|---|---|
| | | 0.18 | CC | Crack, circumferential from 6 o'clock to 12 o'clock | 00:00:28 | MH1X_97<br>e7b7b8-20<br>ed-4a65-9 | 2 |

MH1X\_97e7b7b8-20ed-4a65-9726-8e0e94167fbc\_20240725\_090948\_059.jpg, 00:00:28, 0.18 m  
 Crack, circumferential from 6 o'clock to 12 o'clock

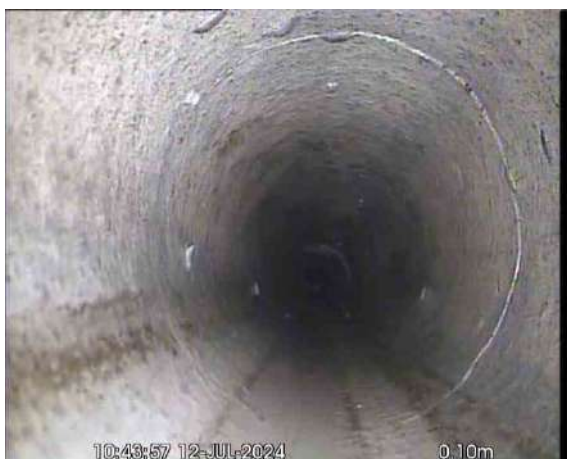
| Scale: | 1:50 | Position [m] | Code | Observation | MPEG | Photo | Grade |
|---|---|---|---|---|---|---|---|
| | | 0.10 | FC | Fracture, circumferential from 11 o'clock to 5 o'clock | 00:00:23 | MH6X_d2f<br>e370d-baf<br>2-4429-b3 | 3 |

MH6X\_d2fe370d-baf2-4429-b37e-bc117d0a8e8e\_20240725\_091559\_829.jpg, 00:00:23, 0.10 m  
 Fracture, circumferential from 11 o'clock to 5 o'clock

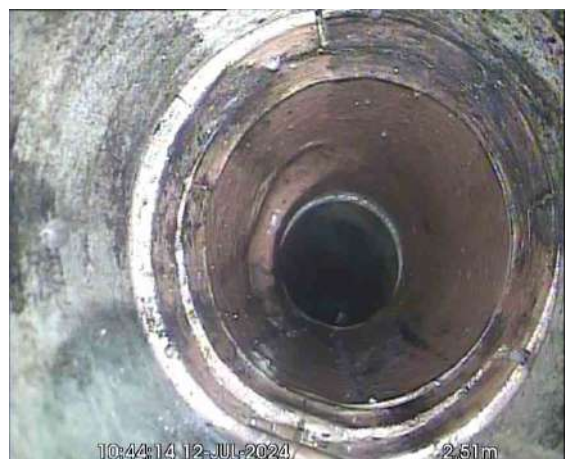
| Section | PLR | Grade | Description |
|---|---|---|---|
| 6 | MH6X | 4 | Fracture, multiple at joint from 12 o'clock to 12 o'clock |

| Scale: | 1:50 | Position [m] | Code | Observation | MPEG | Photo | Grade |
|---|---|---|---|---|---|---|---|
| | | 2.51 | FMJ | Fracture, multiple at joint from 12 o'clock to 12 o'clock | 00:00:41 | MH6X_5b<br>7b7237-2b<br>a3-4cba-8 | 4 |

MH6X\_5b7b7237-2ba3-4cba-86aa-fcb1f22d1ecc\_20240725\_092232\_813.jpg, 00:00:41, 2.51 m  
 Fracture, multiple at joint from 12 o'clock to 12 o'clock

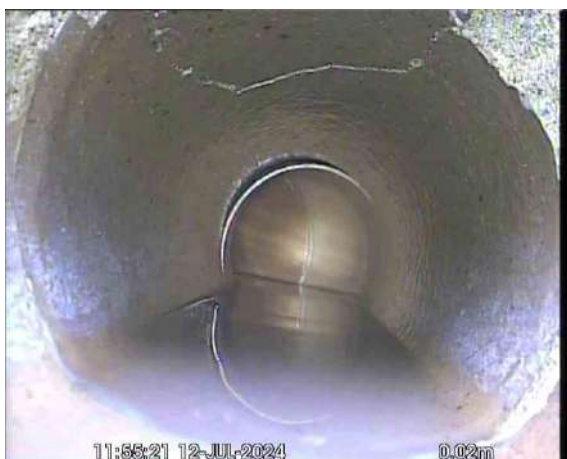
| Scale: | 1:156 | Position [m] | Code | Observation | MPEG | Photo | Grade |
|---|---|---|---|---|---|---|---|
| | 0.02 | CC | Crack, circumferential from 10 o'clock to 2 o'clock | 00:00:35 | MH2X_71<br>538d31-16<br>45-4ac7-b | 2 | |

MH2X\_71538d31-1645-4ac7-b3ba-3a632e838191\_20240725\_092525\_584.jpg, 00:00:35, 0.02 m  
 Crack, circumferential from 10 o'clock to 2 o'clock

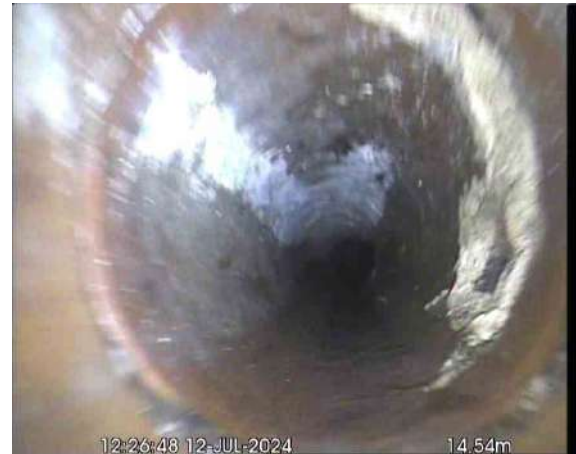
MH5X\_b9529b71-08d6-4df3-a0ef-83327201d51f\_20240725\_094926\_931.jpg, 00:02:15, 14.54 m  
 Hole in drain or sewer at 4 o'clock

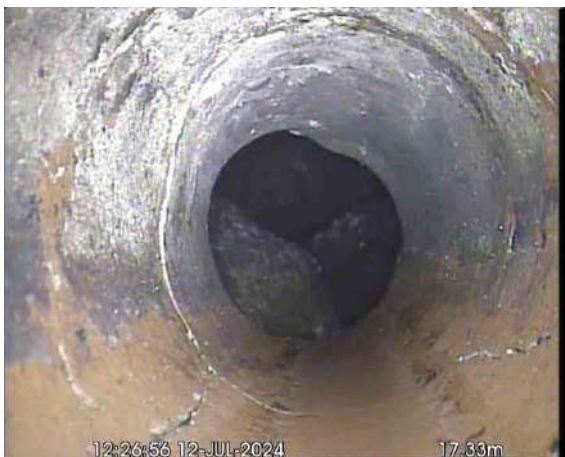
| Scale: | 1:153 | Position [m] | Code | Observation | MPEG | Photo | Grade |
|---|---|---|---|---|---|---|---|
| | | 17.33 | FM | Fracture, multiple from 12 o'clock to 12 o'clock | 00:02:23 | MH5X_24<br>5e56e0-af<br>60-4cc5-9 | 4 |

MH5X\_245e56e0-af60-4cc5-9251-72fe8d11e2b2\_20240725\_094946\_179.jpg, 00:02:23, 17.33 m  
 Fracture, multiple from 12 o'clock to 12 o'clock

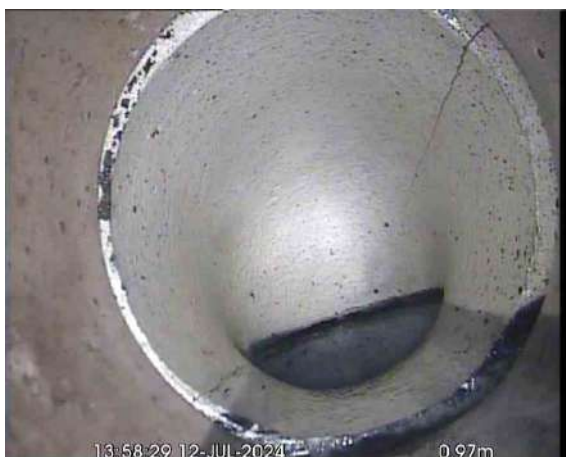
| Scale: | 1:50 | Position [m] | Code | Observation | MPEG | Photo | Grade |
|---|---|---|---|---|---|---|---|
| | | 0.97 | CLJ | Crack, longitudinal at joint at 2 o'clock | 00:00:24 | GULLYX_36dc49d5-3dc1-4da4 | 2 |

GULLYX\_36dc49d5-3dc1-4da4-862e-24eaa0b586df\_20240725\_100014\_047.jpg, 00:00:24, 0.97 m  
Crack, longitudinal at joint at 2 o'clock
