## **Tree Risk Assessment 2022**

### **St Paul's Catholic College**

**Jane Murray Way  
Burgess Hill  
RH15 8GA**

**Tree risk assessment undertaken:** 5<sup>th</sup> November 2024

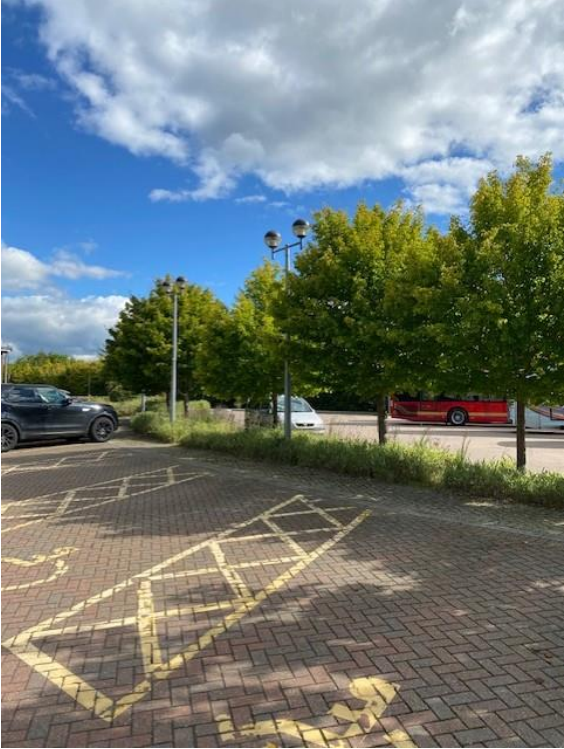
| Photograph | Description |
|---|---|
| | <p><b>Item 1.</b></p> <p>Group of 6 Field maples in car park (image from 2022 survey)</p> |

| Tree Ref | Species | H (m) | Spr (m) | Maturity | Condition | Action Recommendations | Priority | Done | Inspected |
|---|---|---|---|---|---|---|---|---|---|
| Comment: 6 x trees. Remove secondary branches only | | | | | | | | | |

| Tree Ref | Species | H (m) | Spr (m) | Maturity | Condition | Action Recommendations | Priority | Done | Inspected |
|---|---|---|---|---|---|---|---|---|---|
| 1 | Field Maple | 5 | 2 | SM | Good | Raise low canopy :: To 2.0m | 6 Months | No | 05-Nov-24 |

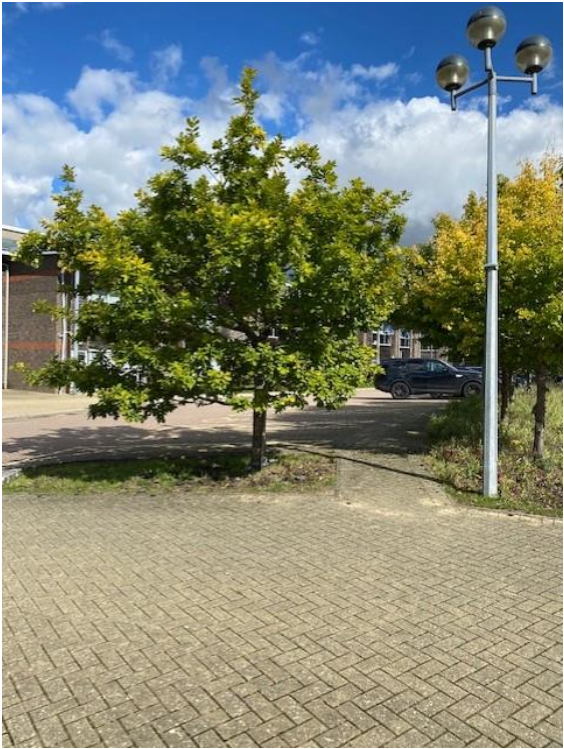
| Photograph | Description |
|---|---|
| | <p><b>Tree 2.</b></p> <p>Oak tree (image from 2022 survey)</p> |

| Tree Ref | Species | H (m) | Spr (m) | Maturity | Condition | Action Recommendations | Priority | Done | Inspected |
|---|---|---|---|---|---|---|---|---|---|
| Comment: Remove 4 x primary branches on stem | | | | | | | | | |

| Tree Ref | Species | H (m) | Spr (m) | Maturity | Condition | Action Recommendations | Priority | Done | Inspected |
|---|---|---|---|---|---|---|---|---|---|
| 2 | Common Oak | 4.5 | 2 | Y | Good | Raise low canopy :: To 2.0m | 6 Months | No | 05-Nov-24 |

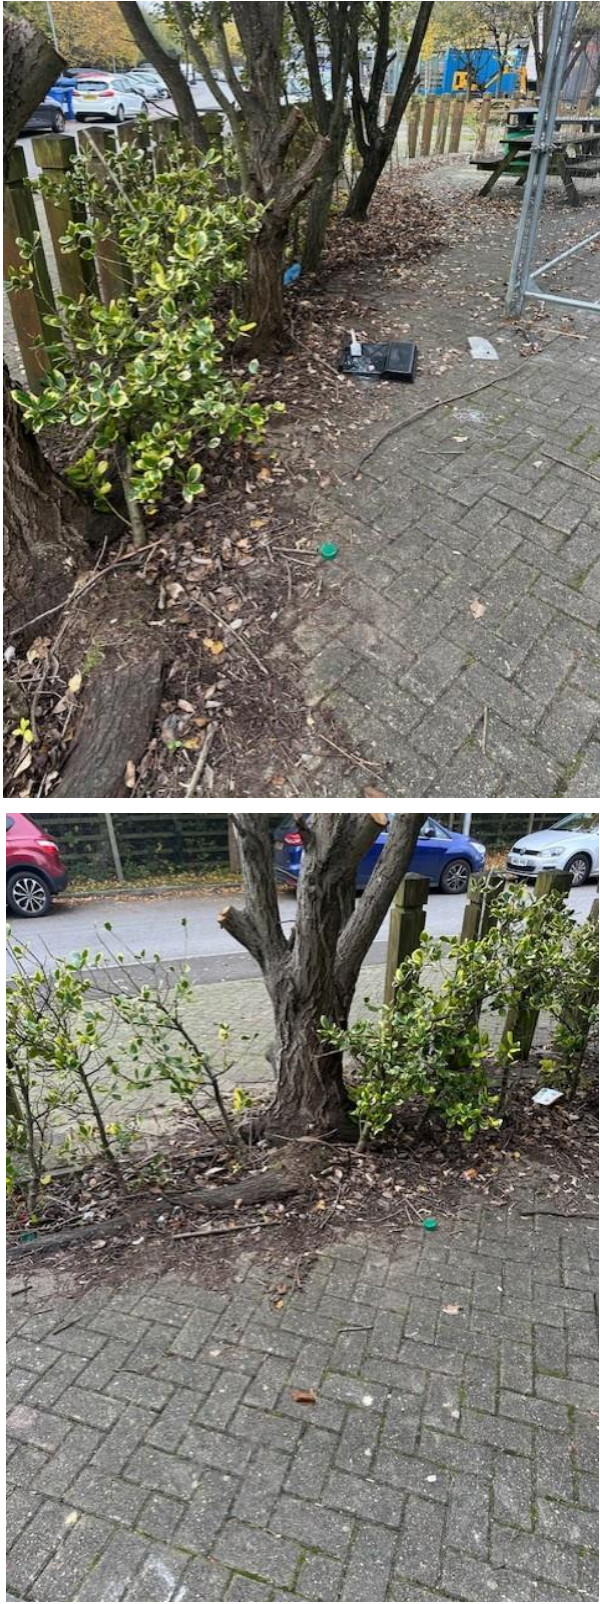
| Photograph | Description |
|---|---|
| <p>The top photograph shows a paved path made of grey bricks. On the left side of the path, there is a dense group of Goat willows with green and yellow variegated leaves. The roots of the trees are visible, growing over the paving stones and causing damage. A black bag and some other debris are scattered on the path. In the background, there are parked cars and a wooden fence.</p> <p>The bottom photograph shows a similar scene from a different angle. A large, gnarled tree trunk is visible on the left side of the path. The Goat willows are growing along the path, and their roots are causing damage to the paving stones. A red car is visible in the background.</p> | <p><b>Item 5.</b></p> <p>Group of Goat willows, causing damage to paving</p> |

| Tree Ref | Species | H (m) | Spr (m) | Maturity | Condition | Action Recommendations | Priority | Done | Inspected |
|---|---|---|---|---|---|---|---|---|---|
| Comment: Trees are causing damage to paving. | | | | | | | | | |

| Tree Ref | Species | H (m) | Spr (m) | Maturity | Condition | Action Recommendations | Priority | Done | Inspected |
|---|---|---|---|---|---|---|---|---|---|
| 5 | Goat Willow | 7 | 3 | SM | Good | Fell :: Fell and treat stump(s) | 6 Months | No | 05-Nov-24 |

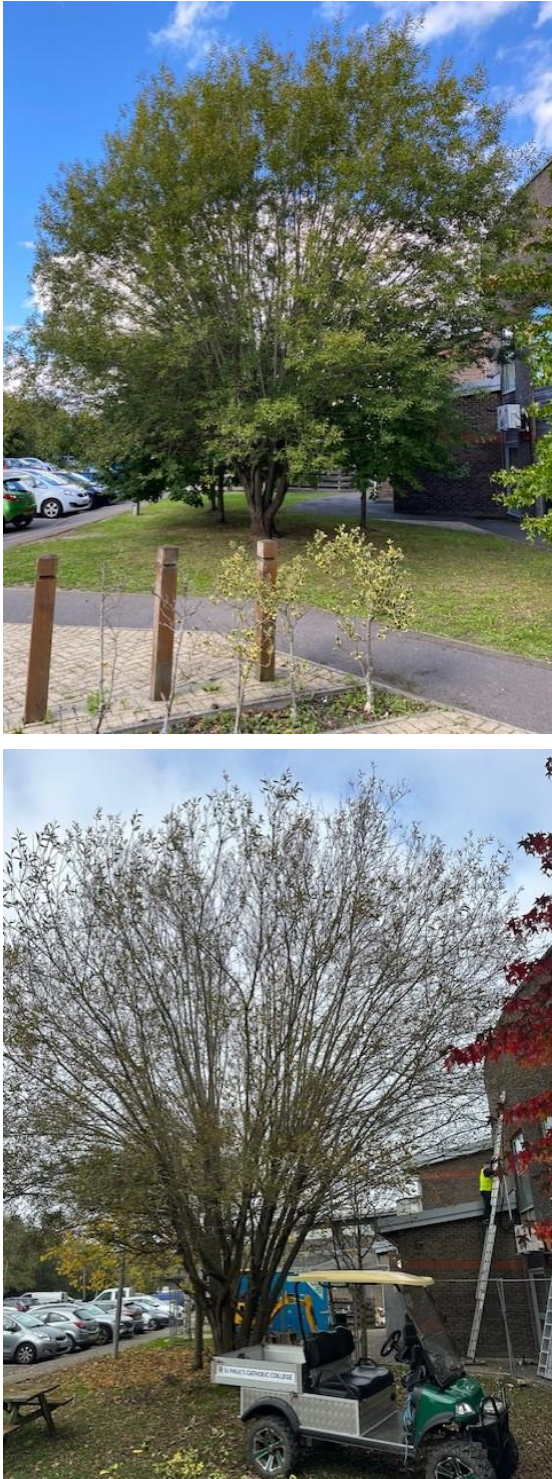
| Photograph | Description |
|---|---|
| | <p><b>Tree 6.</b></p> <p>Goat willow requiring re-pollarding</p> <p>(image from 2022 survey)</p> <p>(2024)</p> |

| Tree Ref | Species | H (m) | Spr (m) | Maturity | Condition | Action Recommendations | Priority | Done | Inspected |
|---|---|---|---|---|---|---|---|---|---|
| 6 | Goat Willow | 11 | 5 | SM | Good | Pollard :: Re-pollard | 6 Months | No | 05-Nov-24 |

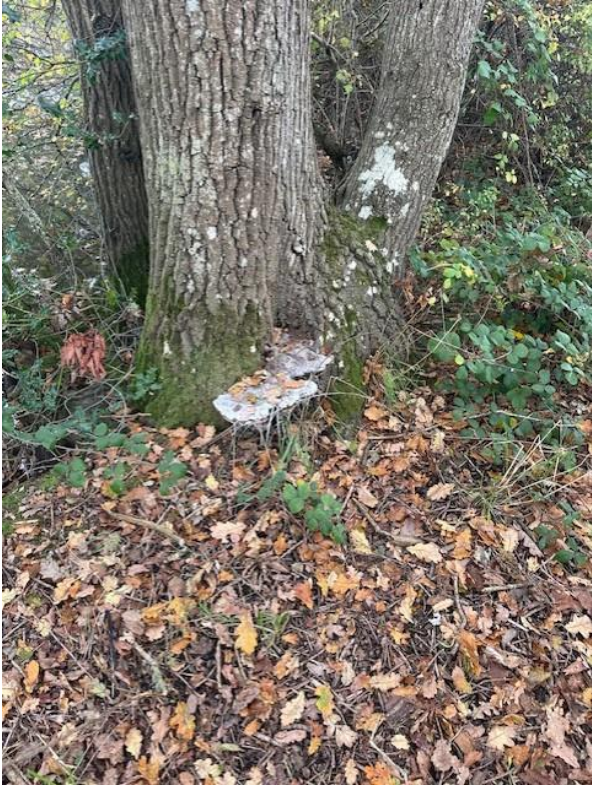
| Photograph | Description |
|---|---|
| | <p><b>Tree 28.</b></p> <p>Oak with Ganoderma fungal bracket</p> |

| Tree Ref | Species | H (m) | Spr (m) | Maturity | Condition | Action Recommendations | Priority | Done | Inspected |
|---|---|---|---|---|---|---|---|---|---|
| 28 | Common Oak | 4 | 0 | Dead | Poor | See Comment :: Unspecified | 6 Months | No | 05-Nov-24 |
| Comment: Retain for habitat benefit | | | | | | | | | |

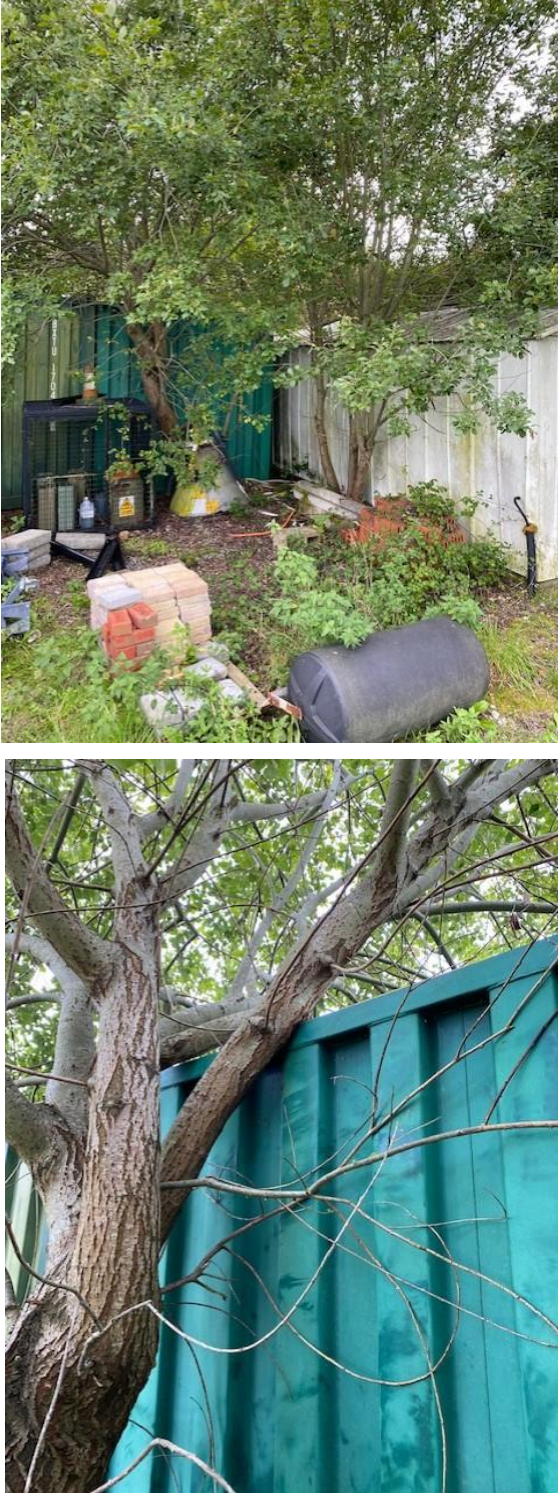
| Photograph | Description |
|---|---|
| The first photograph shows a cluster of green, leafy trees (goat willows) growing in a yard. In the foreground, there are stacks of bricks, a black barrel, and other debris. In the background, there are green and white storage containers. The second photograph is a close-up of a tree trunk and branches, showing the rough bark and some bare branches, with a green storage container visible in the background. | <p><b>Item 22.</b></p> <p>2 x goat willows in close proximity to storage containers</p> <p>(images from 2022)</p> |

| Tree Ref | Species | H (m) | Spr (m) | Maturity | Condition | Action Recommendations | Priority | Done | Inspected |
|---|---|---|---|---|---|---|---|---|---|
| Comment: 2 x Trees growing against container and shed | | | | | | | | | |

| Tree Ref | Species | H (m) | Spr (m) | Maturity | Condition | Action Recommendations | Priority | Done | Inspected |
|---|---|---|---|---|---|---|---|---|---|
| 22 | Goat Willow | 6 | 3 | SM | Good | Fell :: Fell and treat stump(s) | 6 Months | No | 05-Nov-24 |
