Inspection report

Date : 16/05/2021	Job number :	Weather : rain	Operator : Jason	Section number : 1	PLR SUFFIX: parking area
Weather rain	Vehicle :	Camera :	Preset :	Cleaned : yes	Operator : Jason

Place : Road : Location Inspection	Hassocks Keymer Rd Property with buildings IC1 (U/S) IC2	Location details: Catchment: Tape number : Pipe Length	U/S MH : U/S Depth : D/S MH : D/S Depth :
Use: Year laid : Purpose : Total length :	Foul 1950 Sample survey to determine asset condition 12.70 m	Pipe shape : Pipe size : Pipe material : Lining :	Circular 150 mm Vitrified clay Vitrified clay

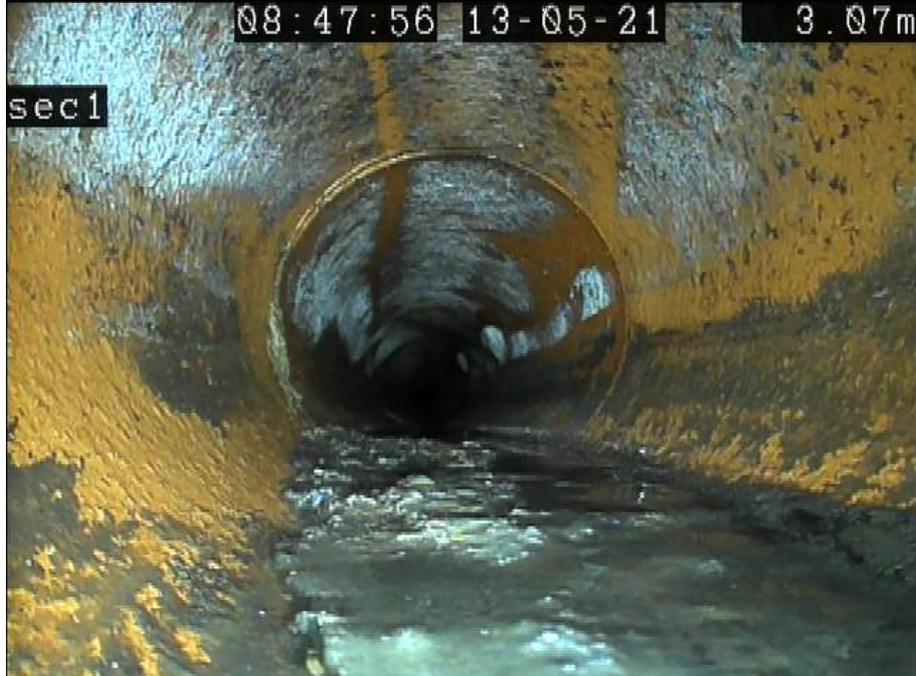
Photo: 1_1_6_A.jpg

3.1m, Attached deposits, other, from 5 to 7 o'clock, 15% cross-sectional area loss

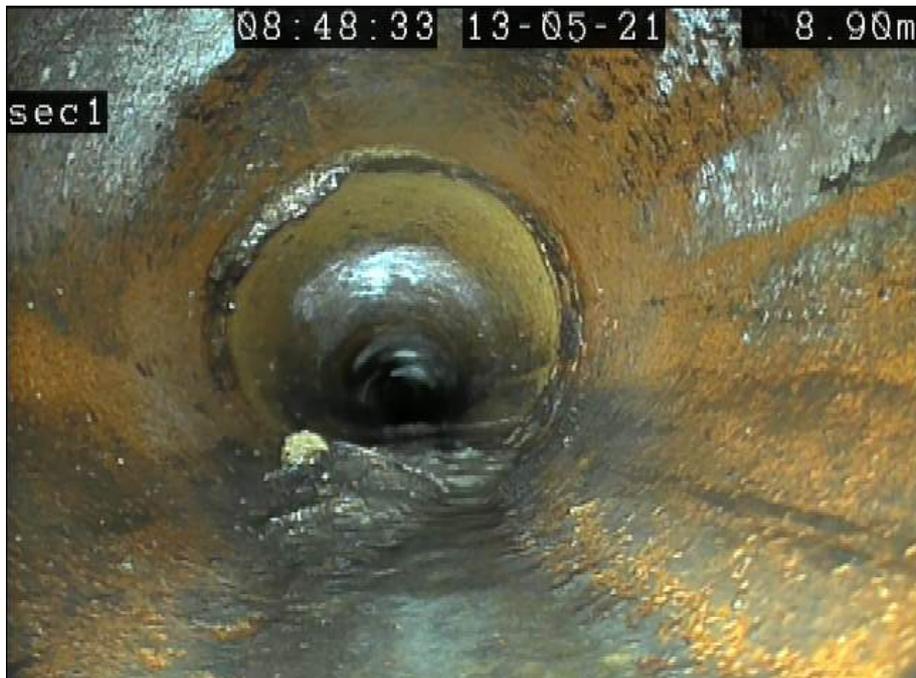
Photo: 1_1_7_A.jpg

9m, Attached deposits, other at joint, from 5 to 7 o'clock, 20% cross-sectional area loss

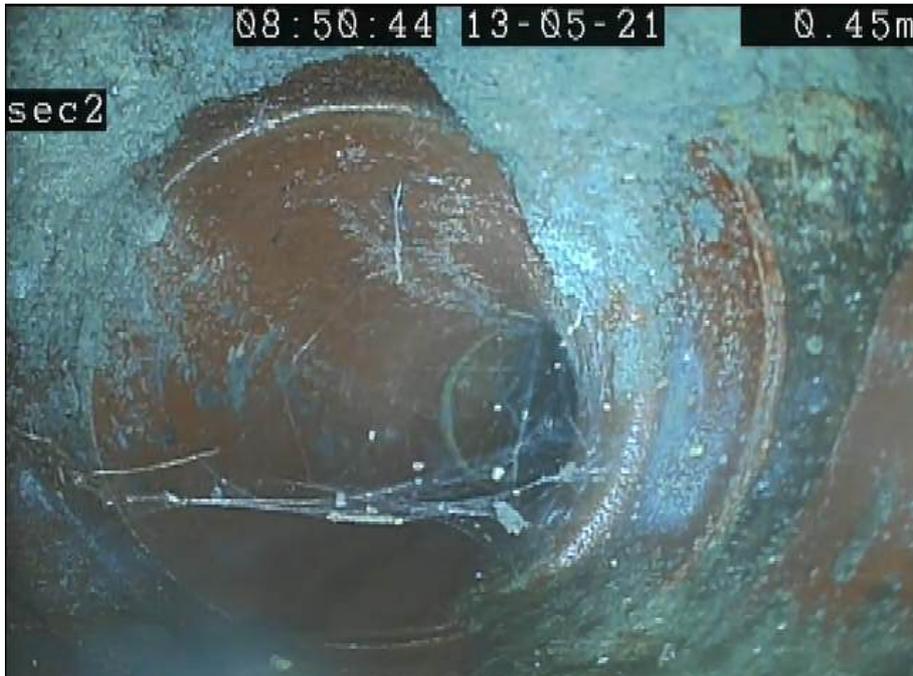
Photo: 3_3_12_A.jpg
0.5m, Line deviates right

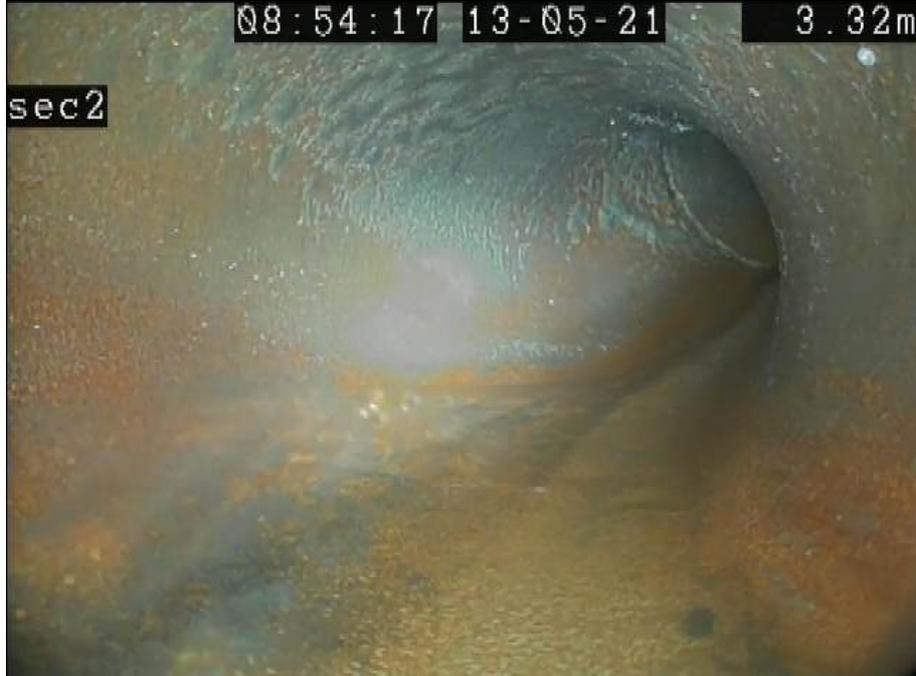
Photo: 3_3_13_A.jpg
3.3m, Line deviates right

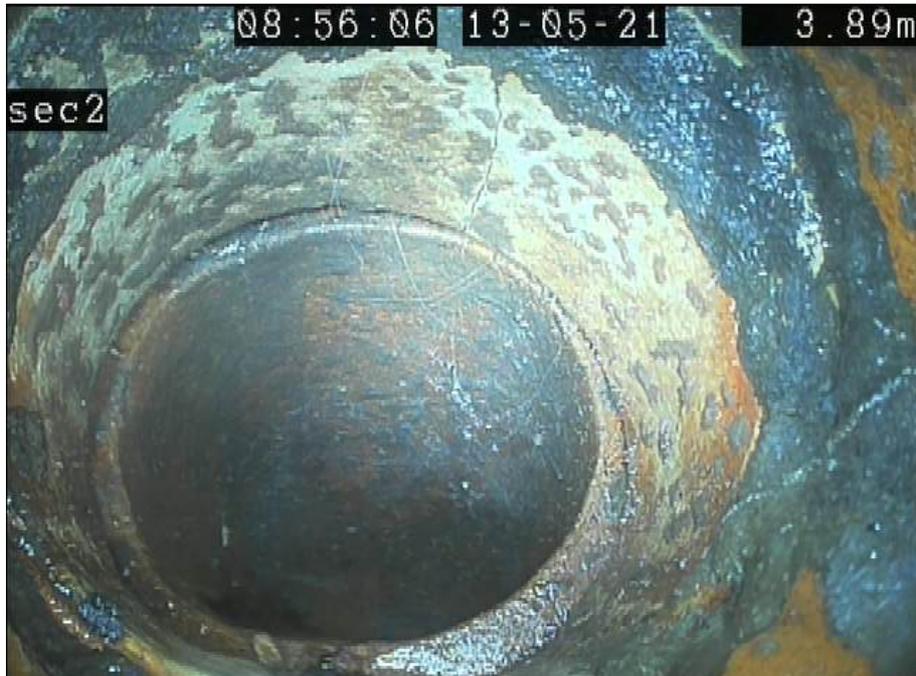
Photo: 3_3_15_A.jpg
3.9m, Joint displaced, medium

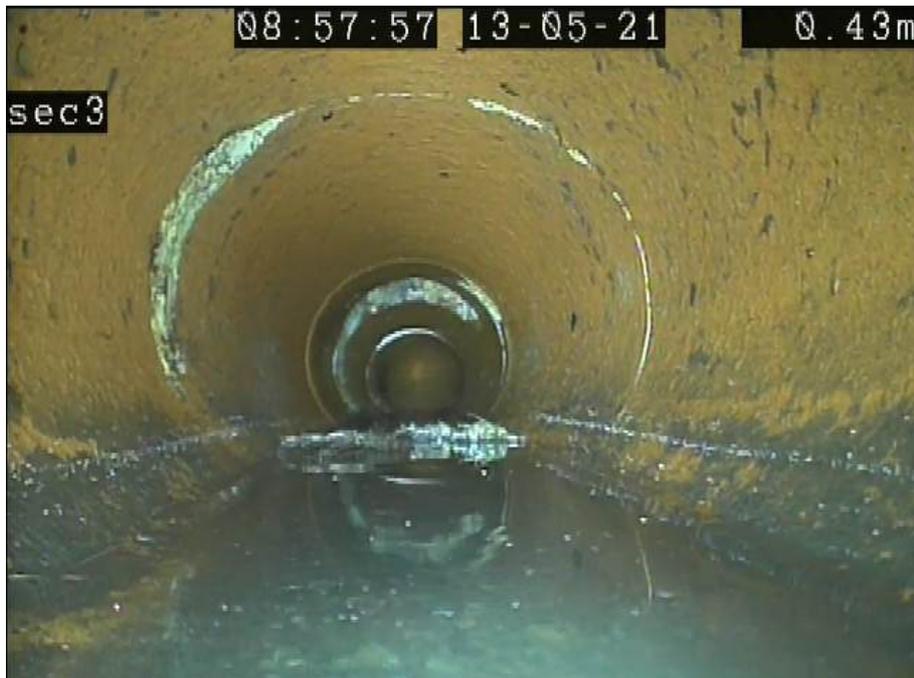
Photo: 4_4_21_A.jpg
0.4m, Fracture, circumferential, from 12 to 12 o'clock

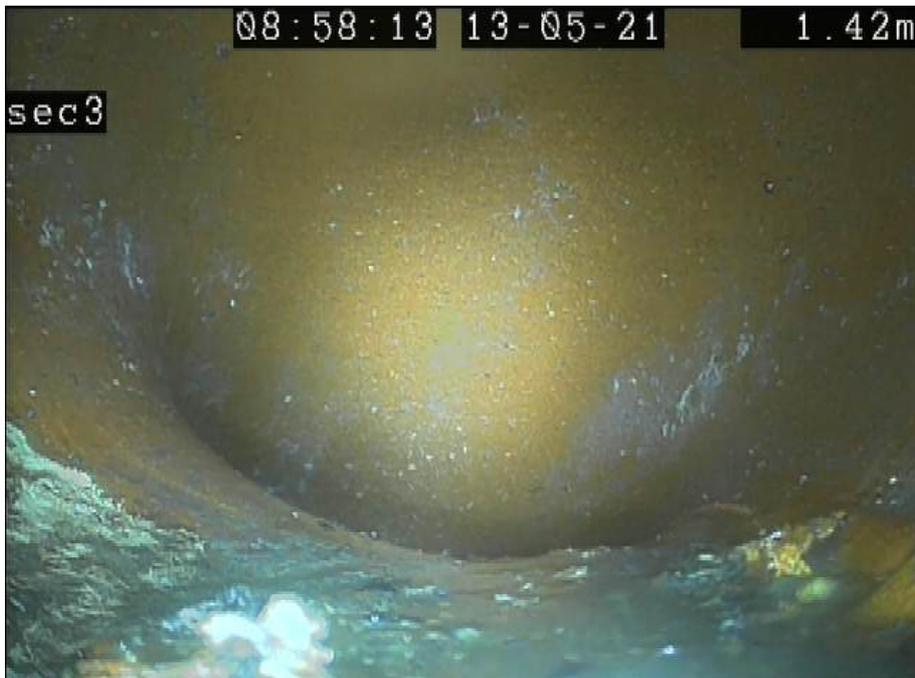
Photo: 4_4_18_A.jpg
1.4m, Line deviates down

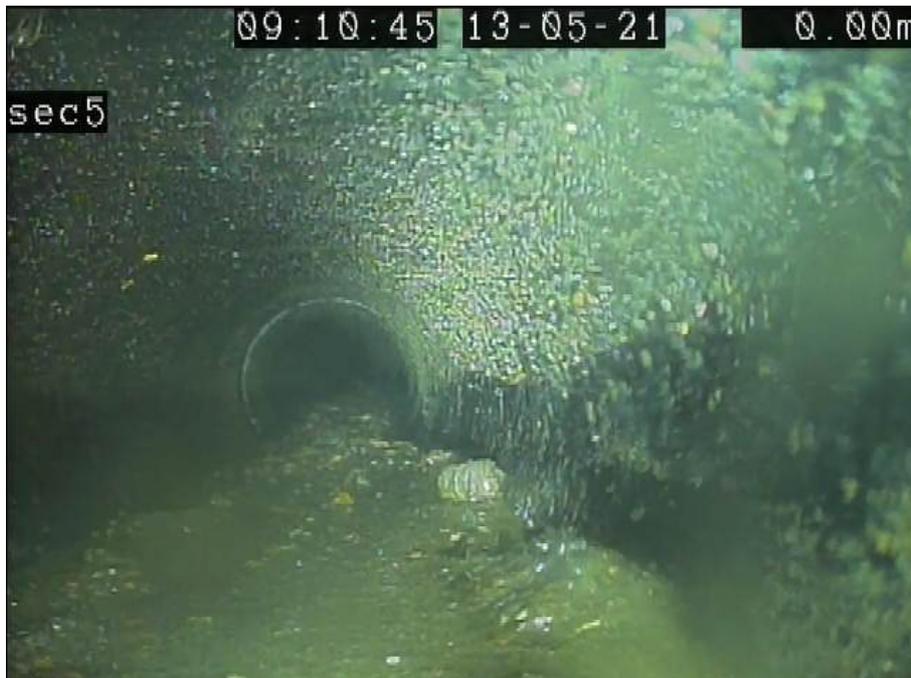
Photo: 6_6_31_A.jpg
0.3m, Settled deposits, fine, 25% cross-sectional area loss

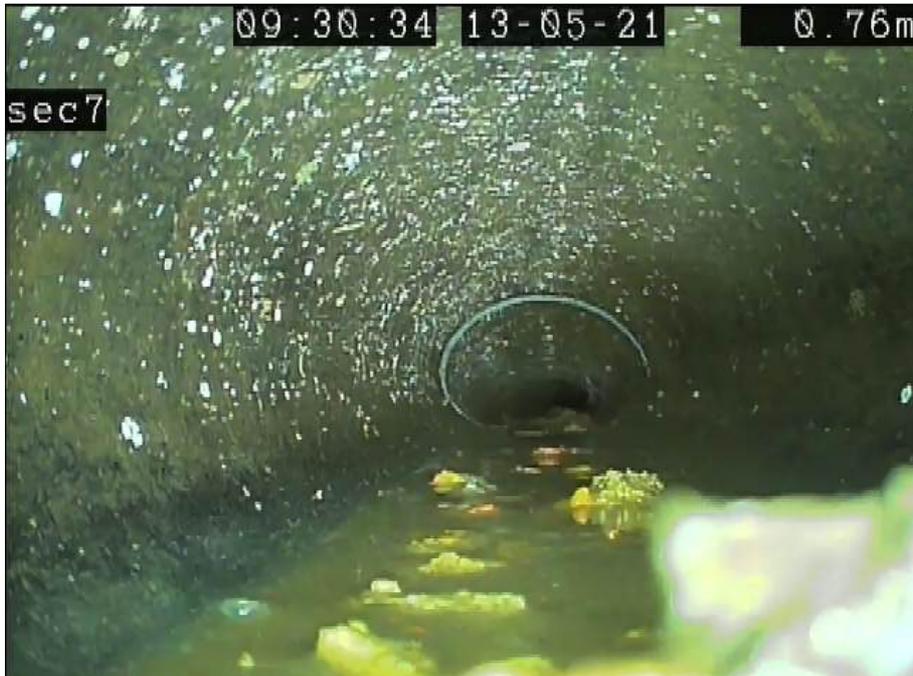
Photo: 8_8_46_A.jpg
0.8m, Deformed sewer/drain, 20%

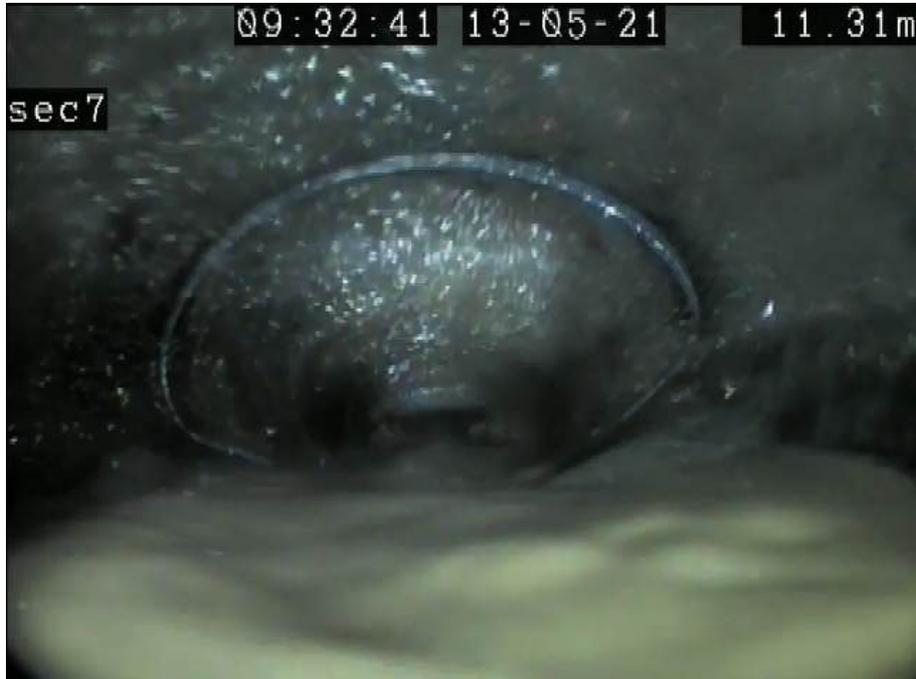
Photo: 8_8_48_A.jpg
11.2m, Deformed sewer/drain, 30%

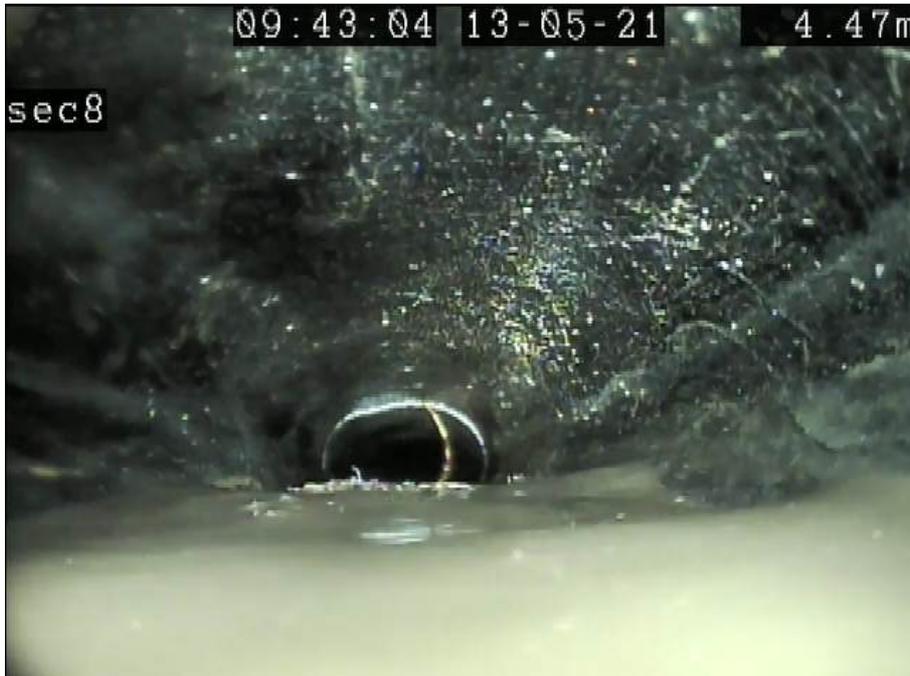
Photo: 9_9_55_A.jpg
4.4m, Deformed sewer/drain, 30%

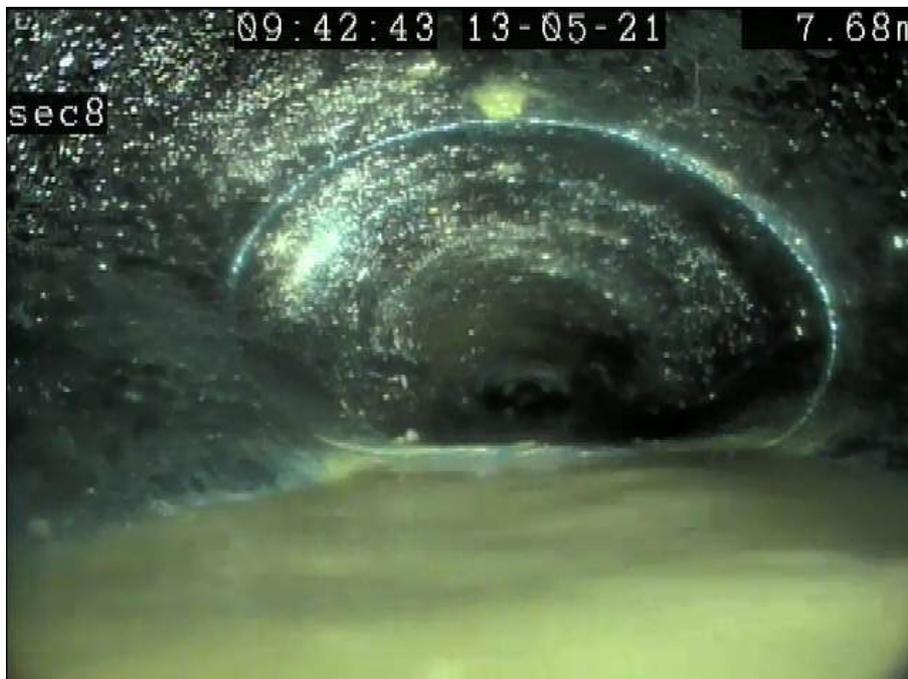
Photo: 9_9_54_A.jpg
7.6m, Deformed sewer/drain, 30%

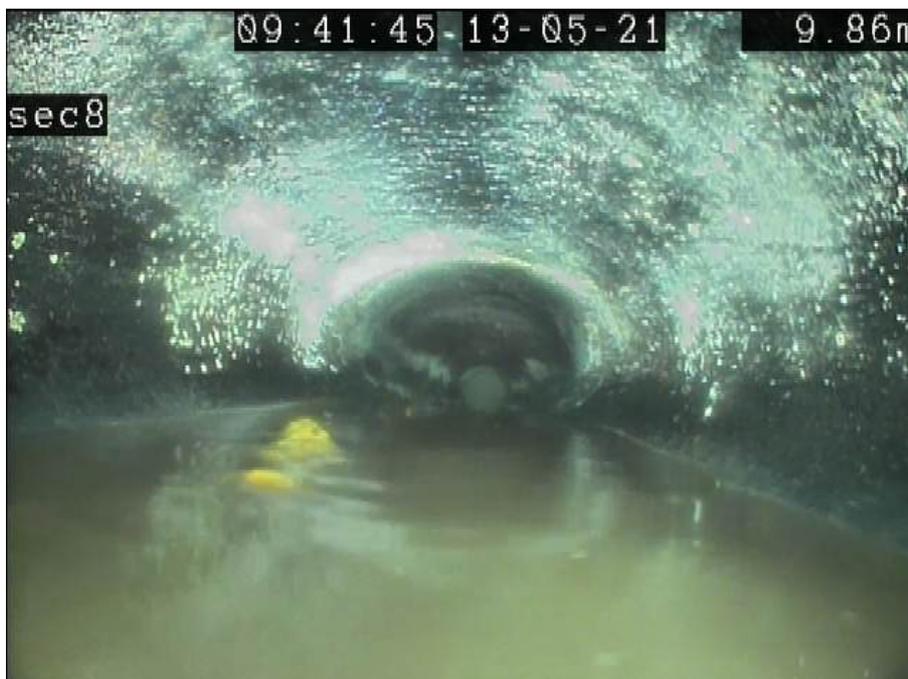
Photo: 9_9_53_A.jpg
10.1m, Deformed sewer/drain, 20%

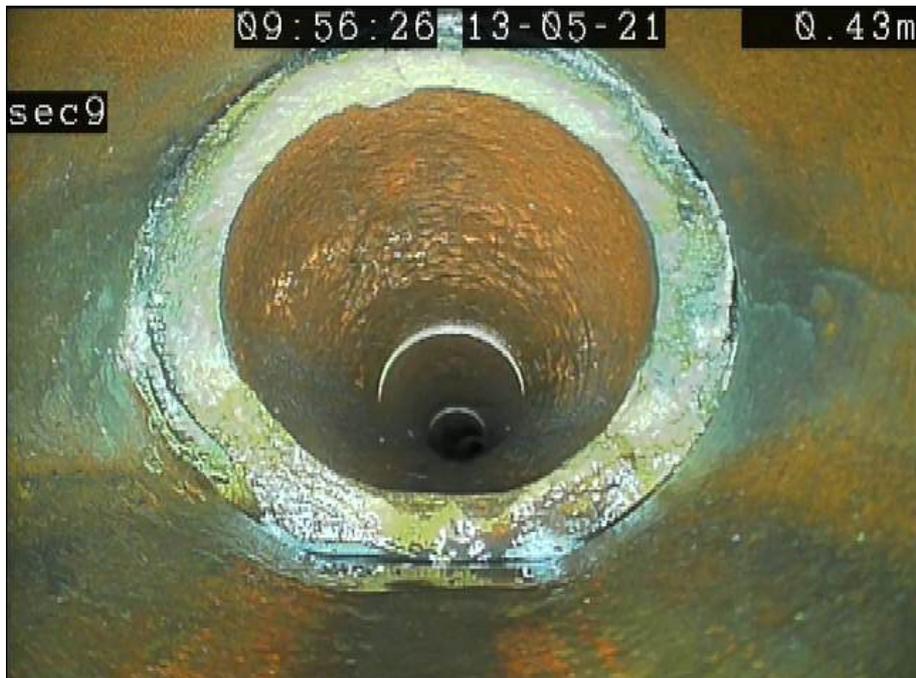
Photo: 10_10_60_A.jpg
0.5m, Dimension changes, 100mm high, 100mm wide

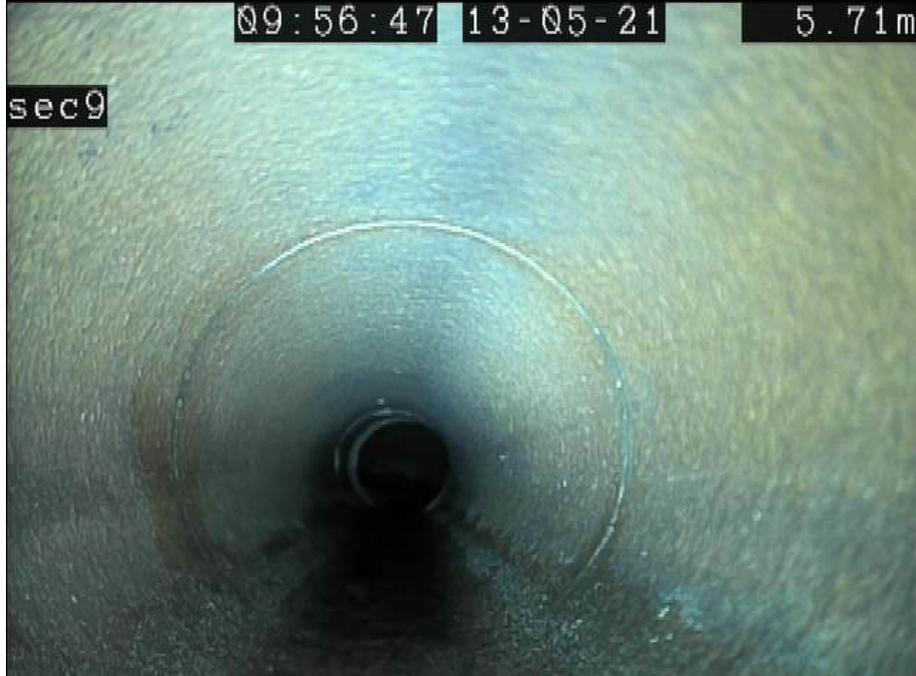
Photo: 10_10_61_A.jpg
5.7m, Crack, circumferential, from 12 to 12 o'clock

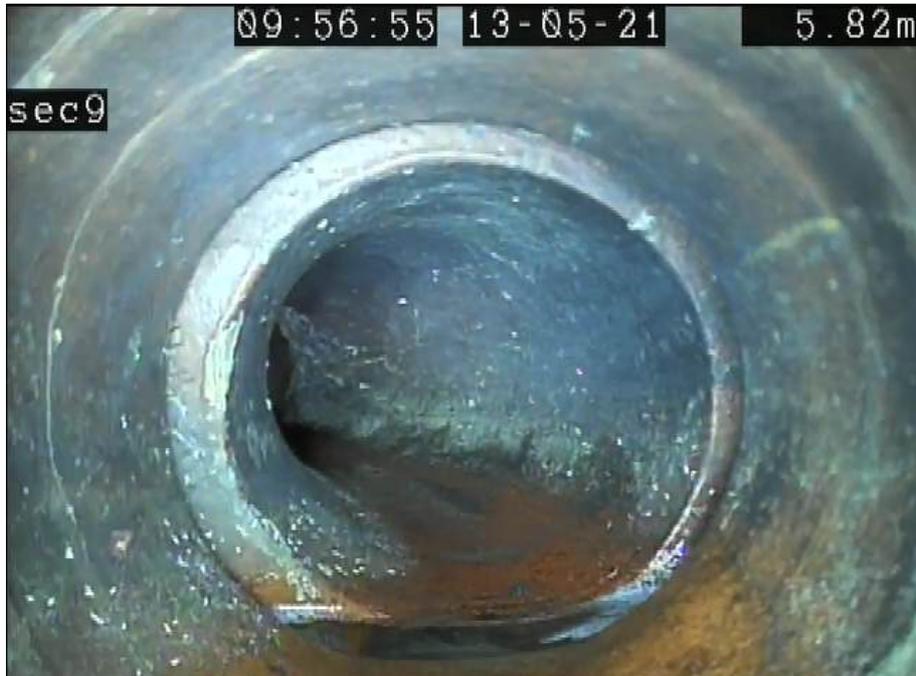
Photo: 10_10_62_A.jpg
5.8m, Line deviates left

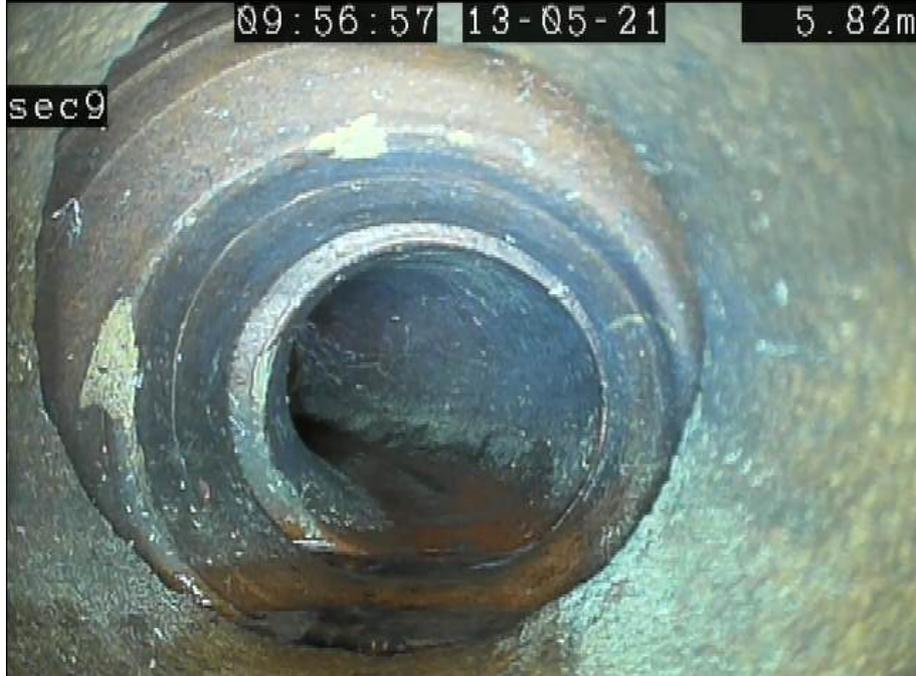
Photo: 10_10_63_A.jpg
5.8m, Open joint, medium

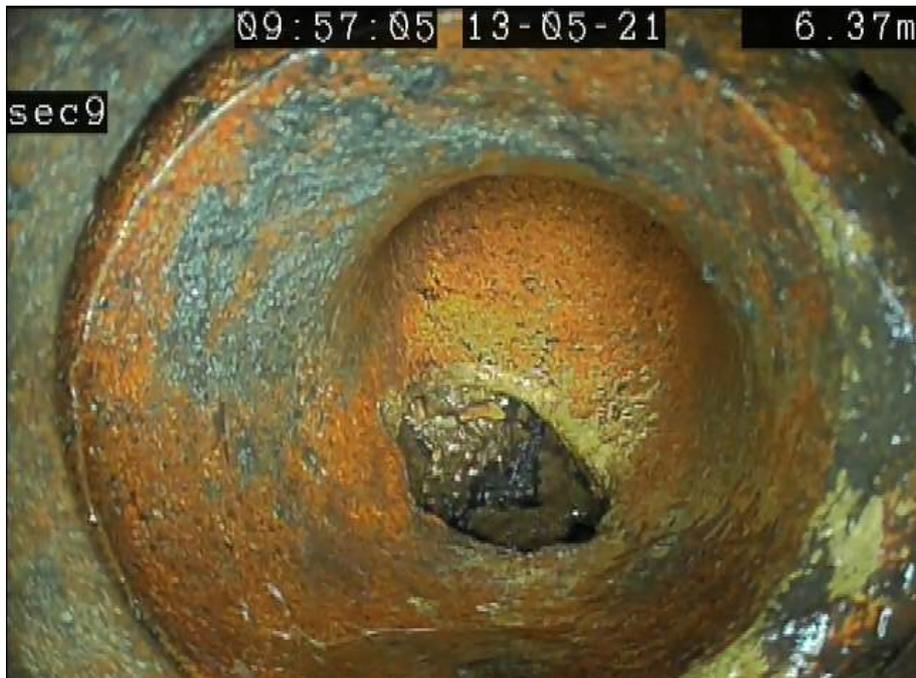
Photo: 10_10_65_A.jpg
6.4m, Hole in drain/sewer, from 5 to 9 o'clock
