COMPANY: Mactrees,  
www.mactrees.co.uk

REF; KM01

LOCATION: 77 Dunstall Avenue, Burgess Hill, West Sussex RH15 8PJ

INSPECTION DATE: 2nd April 2026

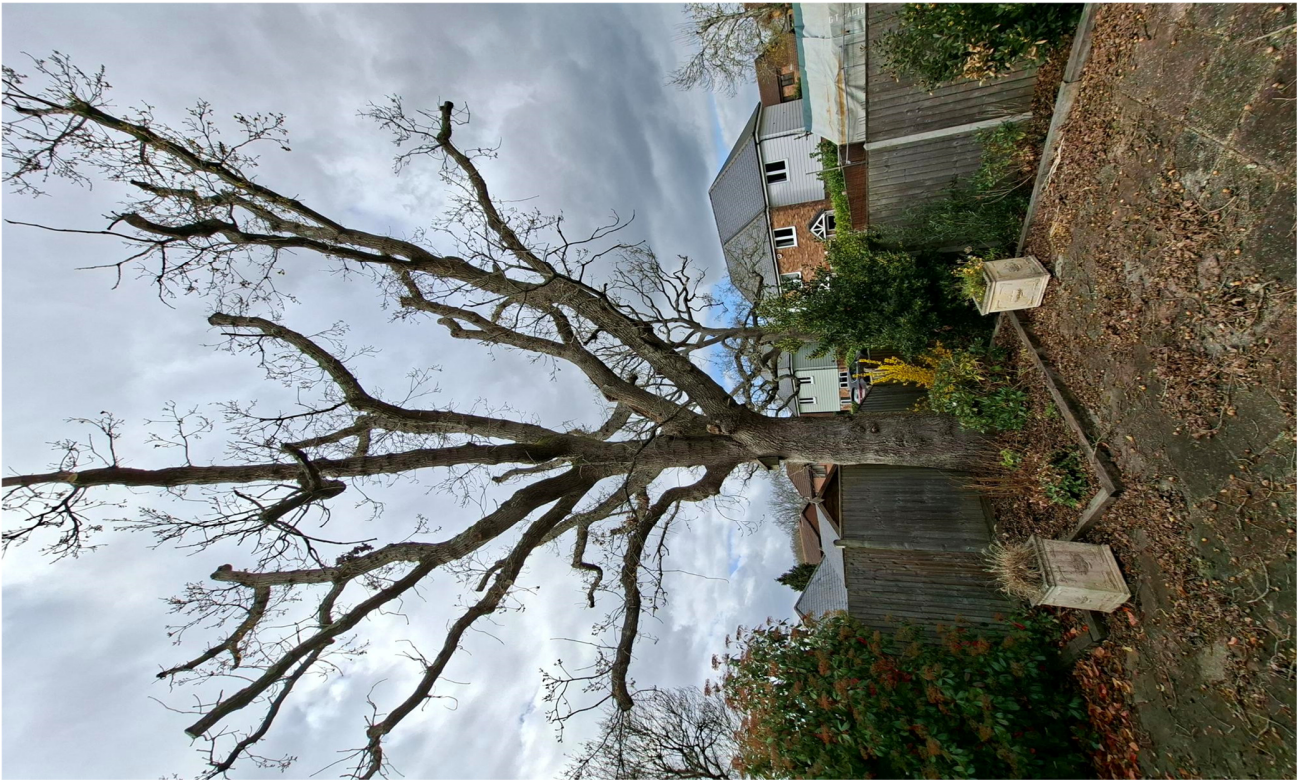
The tree's position at 77 Dunstall Avenue. This also shows the previous dead wood removal and what will be required latter this year.

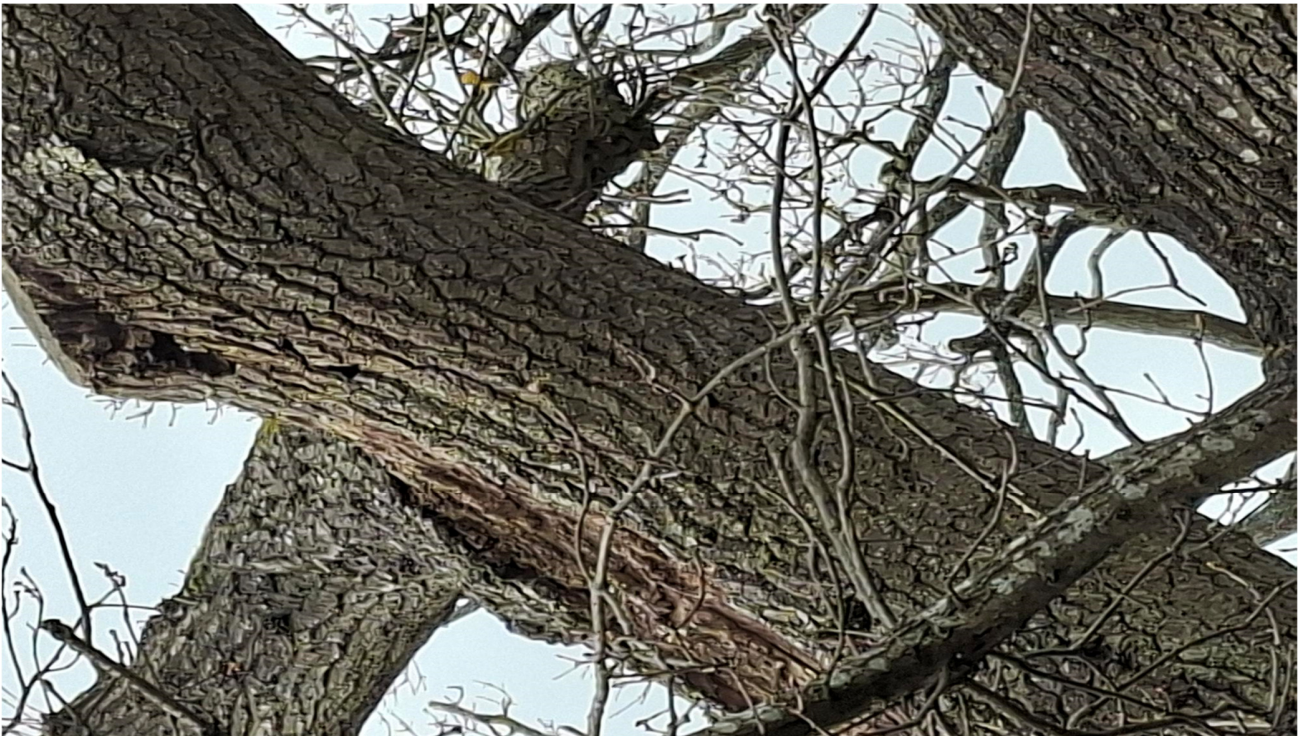
The branches need cutting back again and there is signs of decay and bark peeling off on one of the main limbs (Pictures included).

This is the main branch decaying area.
