DS/DS/MS05127

17<sup>th</sup> October 2024

**Structural Inspection of balcony balustrades on Chaucer & Byron Court buildings,  
Winnals Park, Haywards Heath**

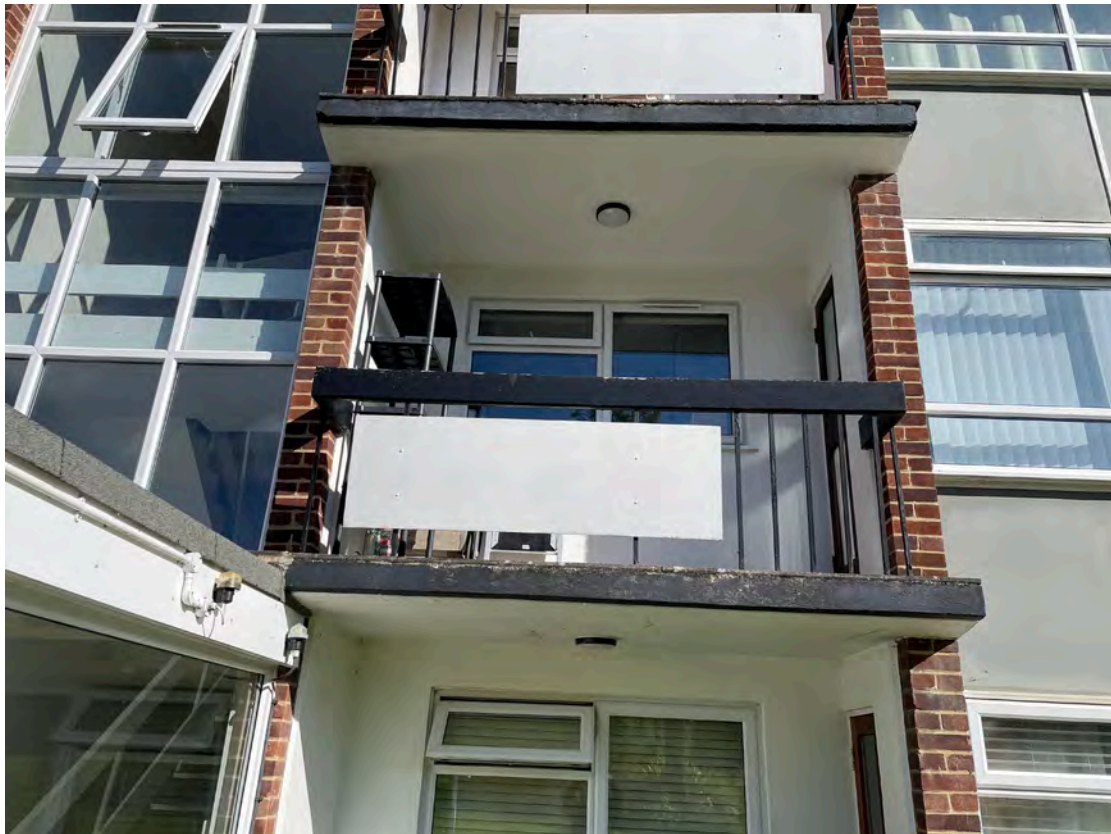
- 4.5 This was a first floor apartment and on this balcony the infill boarding panel appeared to be some form of fibre cement boarding approximately 6mm thick fixed with screws running into the 20 x 20mm steel posts.
- 4.6 The bottom rail of the balcony could be laterally moved and appeared to have lost it's fixing along the bottom edge.
- 4.7 There was some slight corrosion noted on the ends of the bottom rail and some flaking paint to the upright bars.
- 4.8 Height from floor to the top of the handrail was approximately 885mm.

***5 – Closer view of No.4 Chaucer Court Balcony***

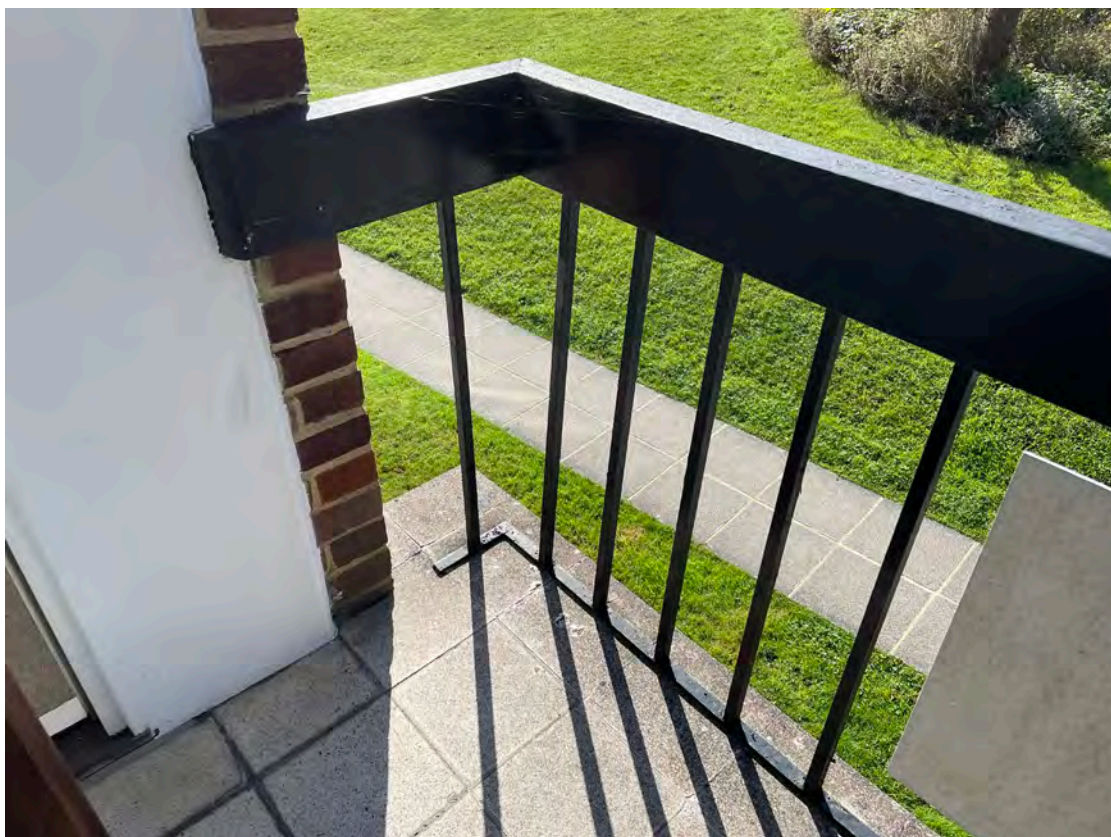
***6 – No. 4 Chaucer Court Balcony east side***

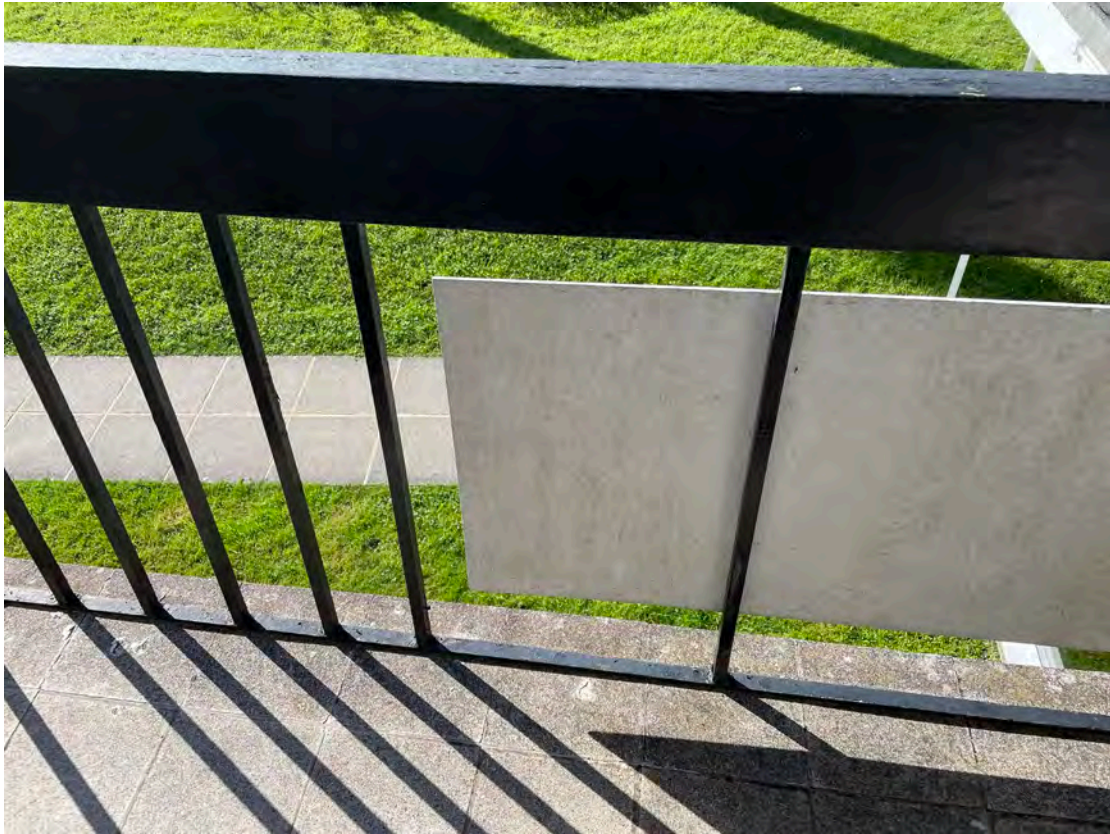
the past. All of the boards, both plyboard and cement board, significantly flex when leaning on the end sections, which cantilever past the fixing locations by around 300mm. **We would not be able to justify these boards for the required British Standard lateral load to infill panels of 1kN/m<sup>2</sup> spread load or 0.5kN point load.**

***7 - No. 4 Chaucer Court Balcony front section with infill panel***

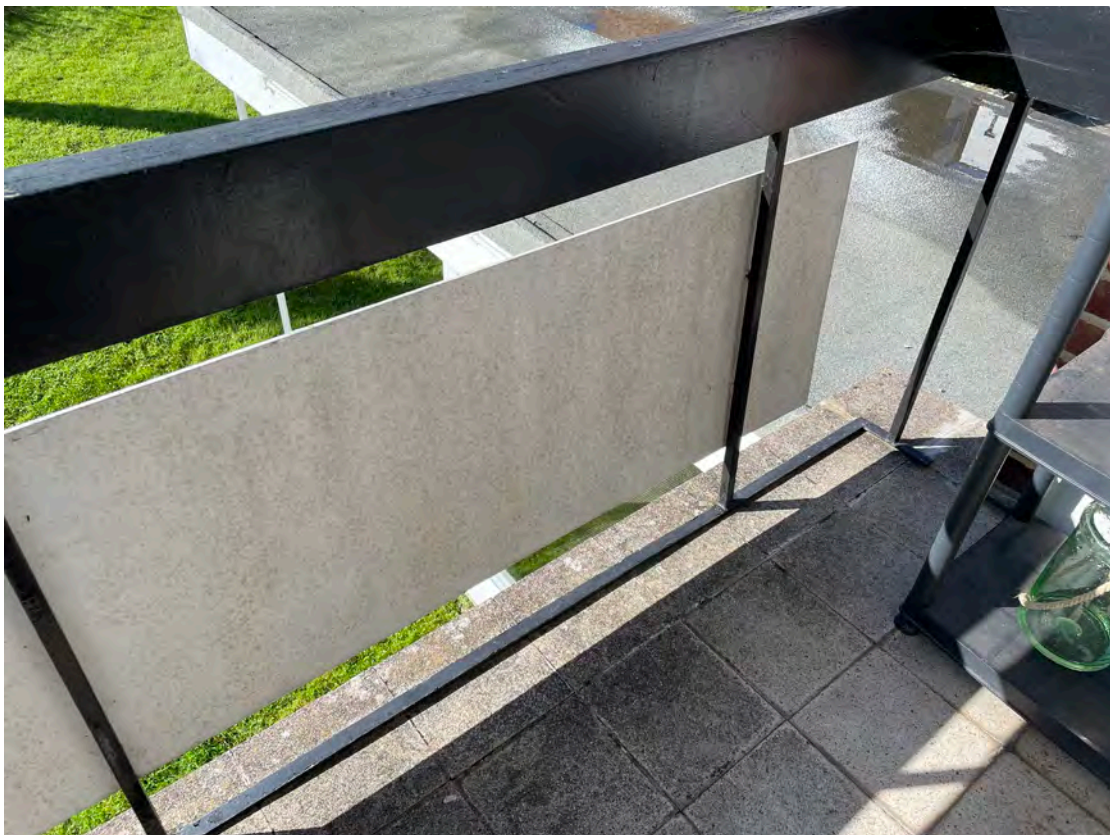
***8 - No. 4 Chaucer Court Balcony west side***

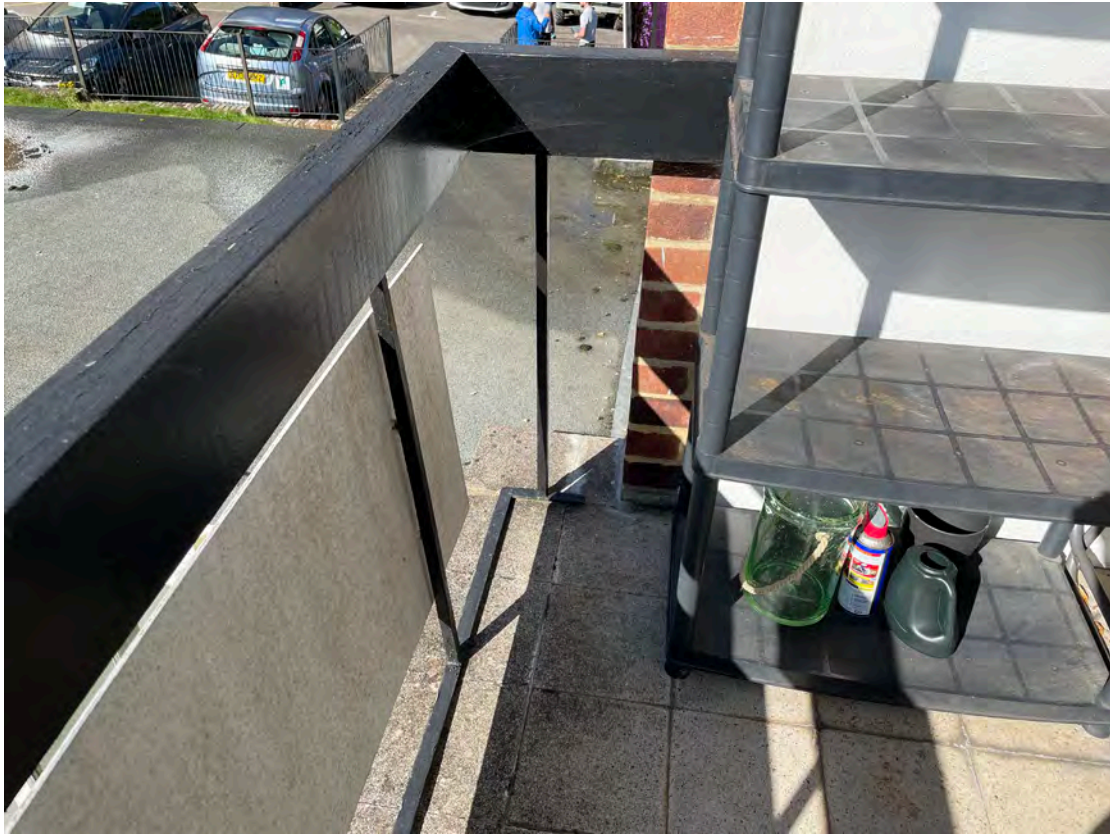
**9 - No. 4 Chaucer Court Balcony west side return**

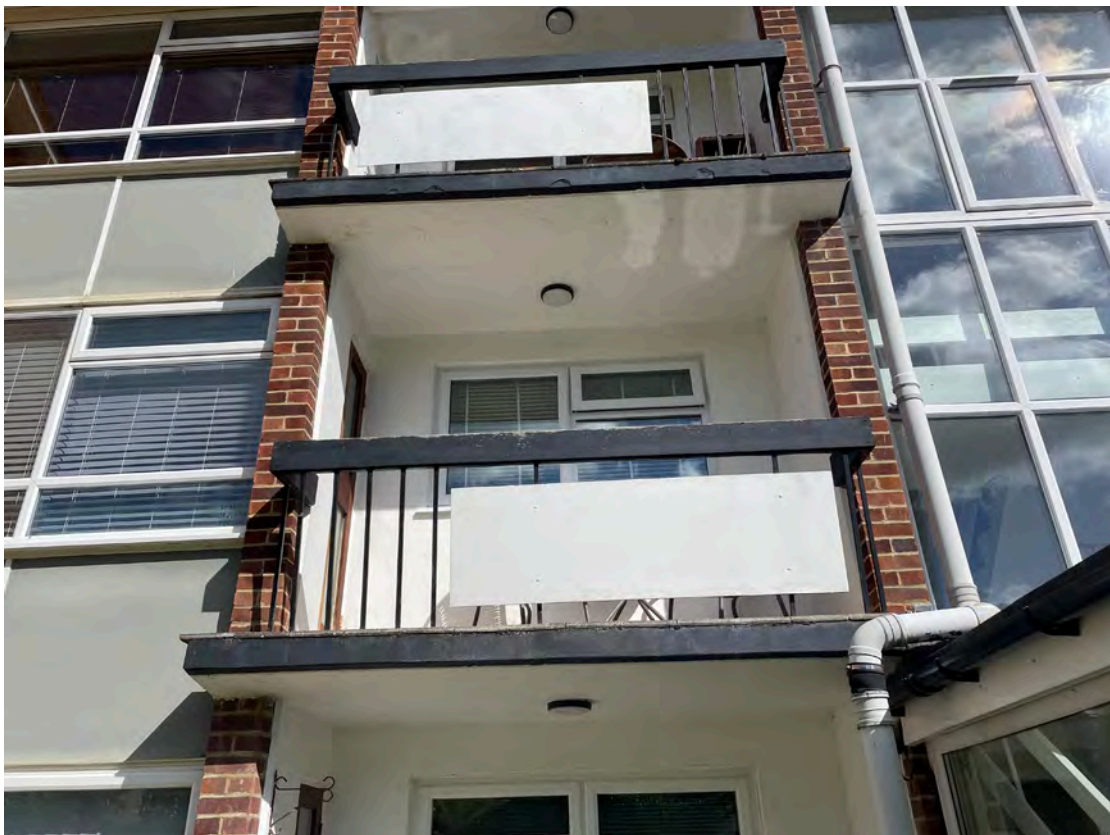
- 4.9 This was a first floor level apartment and the infill boarding was approximately 12mm thick plywood. The plywood boarding was fixed with approximately 5mm diameter bolts through the 20 x 20 steel posts.
- 4.10 An extra 20 x 20mm steel vertical post had been welded between the upper and low rails to the east side of the infill boarding.
- 4.11 The timber handrail had a steel bracket fixed on the inside face between the front face and east side return.
- 4.12 There was some slight corrosion noted on the ends of the bottom rail and some flaking paint to the upright bars.
- 4.13 Height from floor to the top of the handrail was approximately 880mm.

**10 - Closer view of No.9 Chaucer Court Balcony**

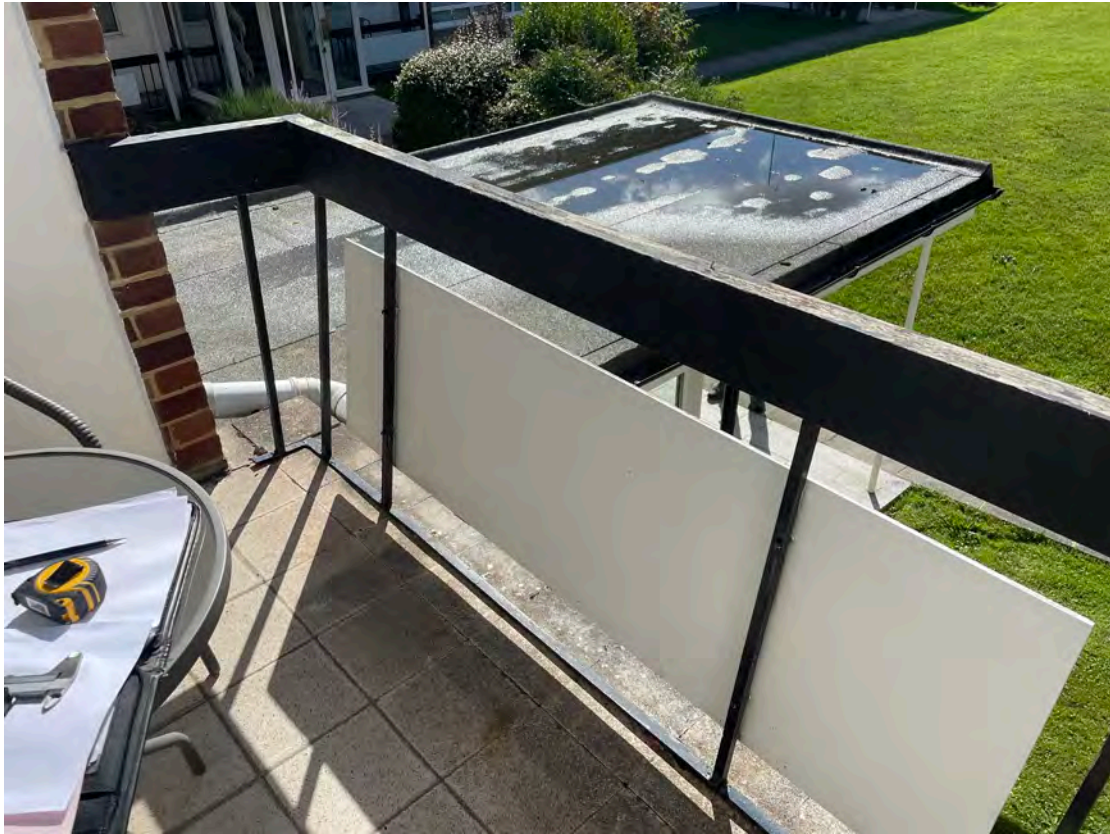
***11 - No. 9 Chaucer Court Balcony east side with extra post to the front corner***

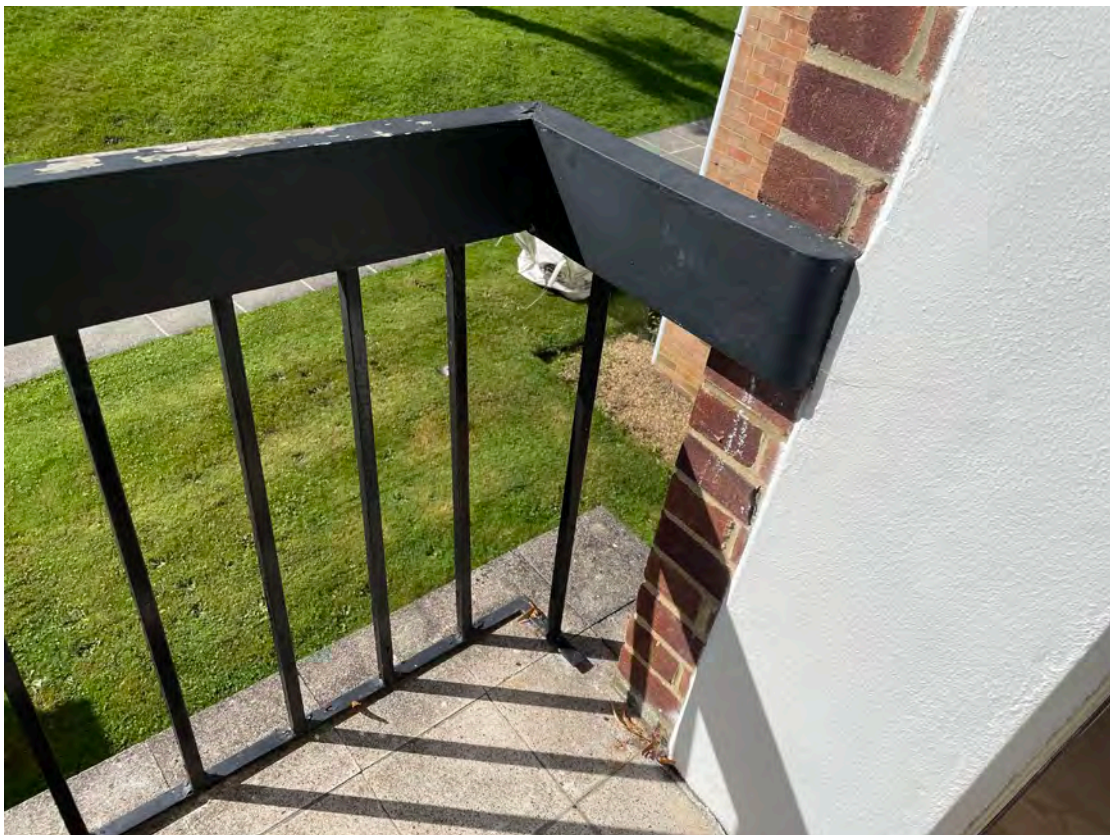
***12 - No. 9 Chaucer Court Balcony west side***

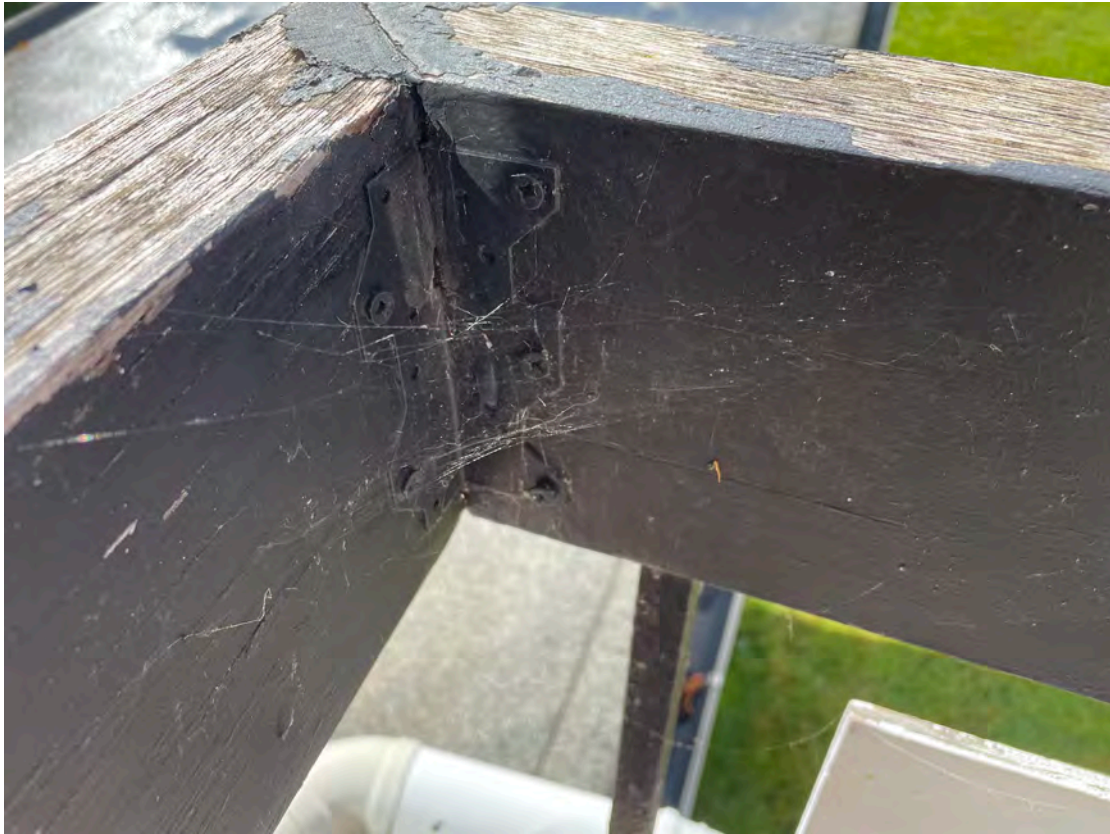
**13 - No. 9 Chaucer Court Balcony east side corner handrail bracket**

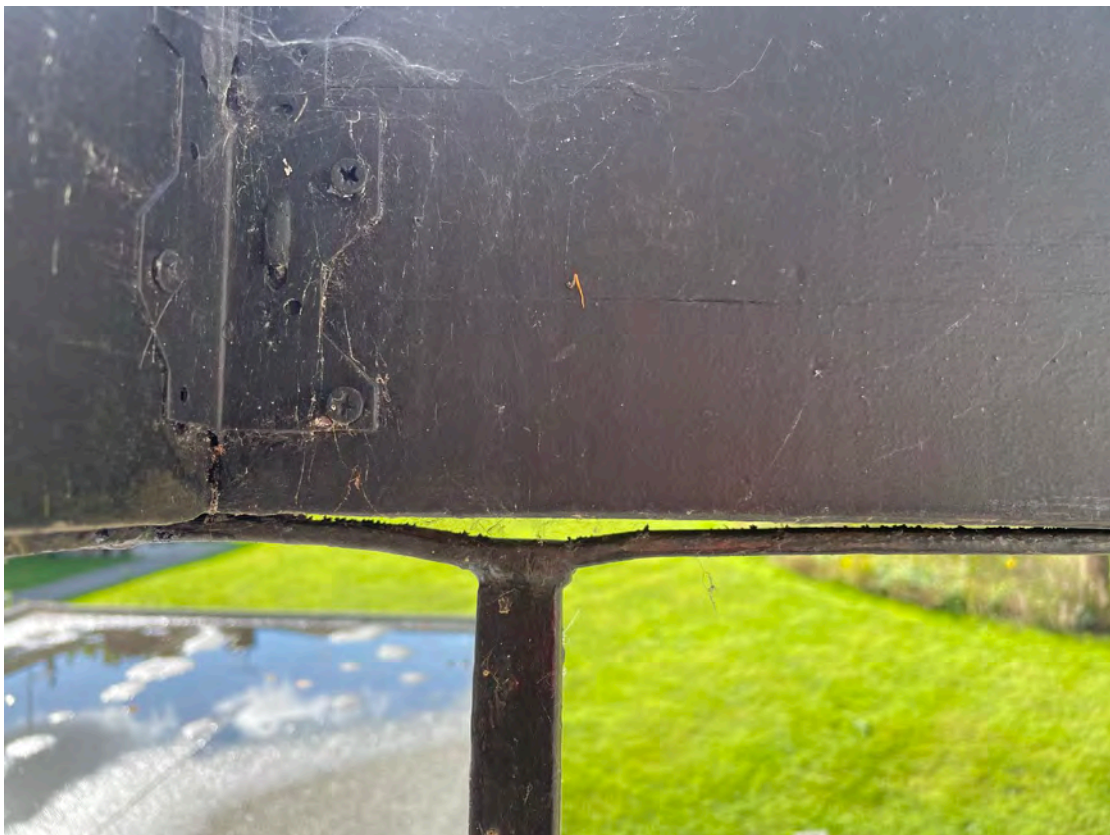
**14 - No. 9 Chaucer Court Balcony east side extra post top welded connection**

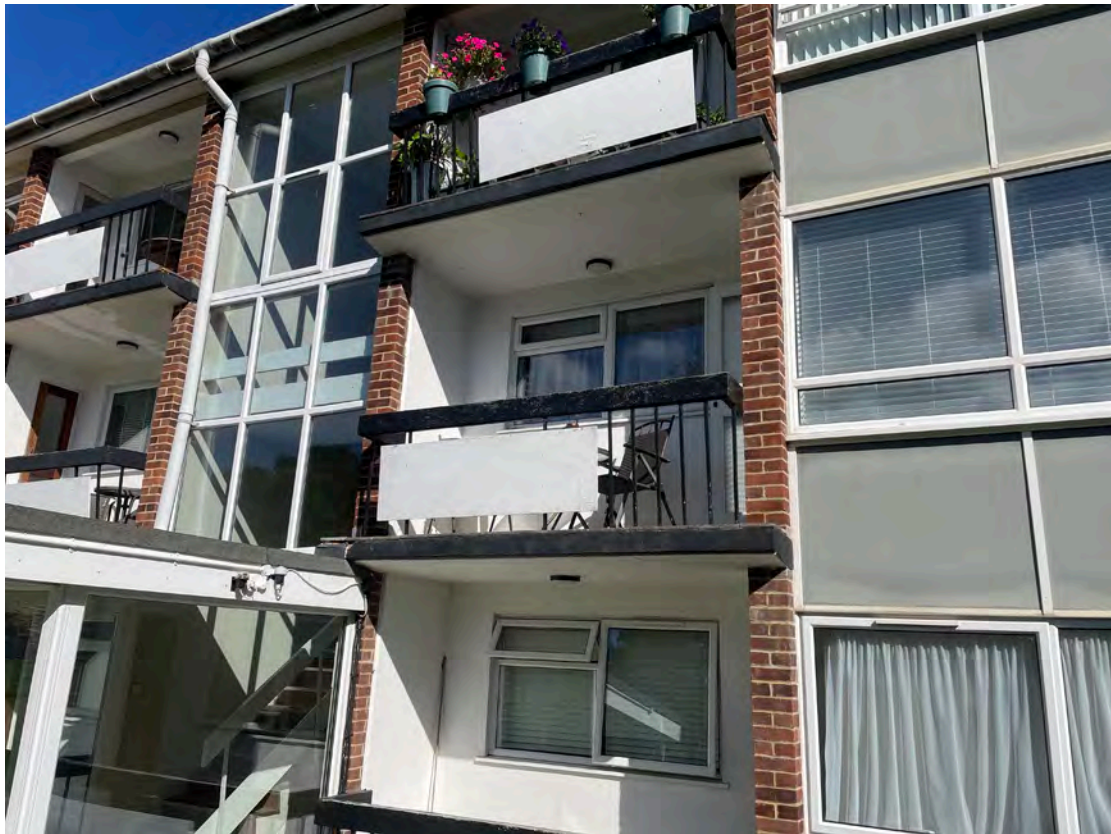
4.15 There was some slight corrosion noted on the ends of the bottom rail and some flaking paint to the upright bars.

4.16 Height from floor to the top of the handrail was approximately 885mm.

**15 - Closer view of No.10 Chaucer Court Balcony**

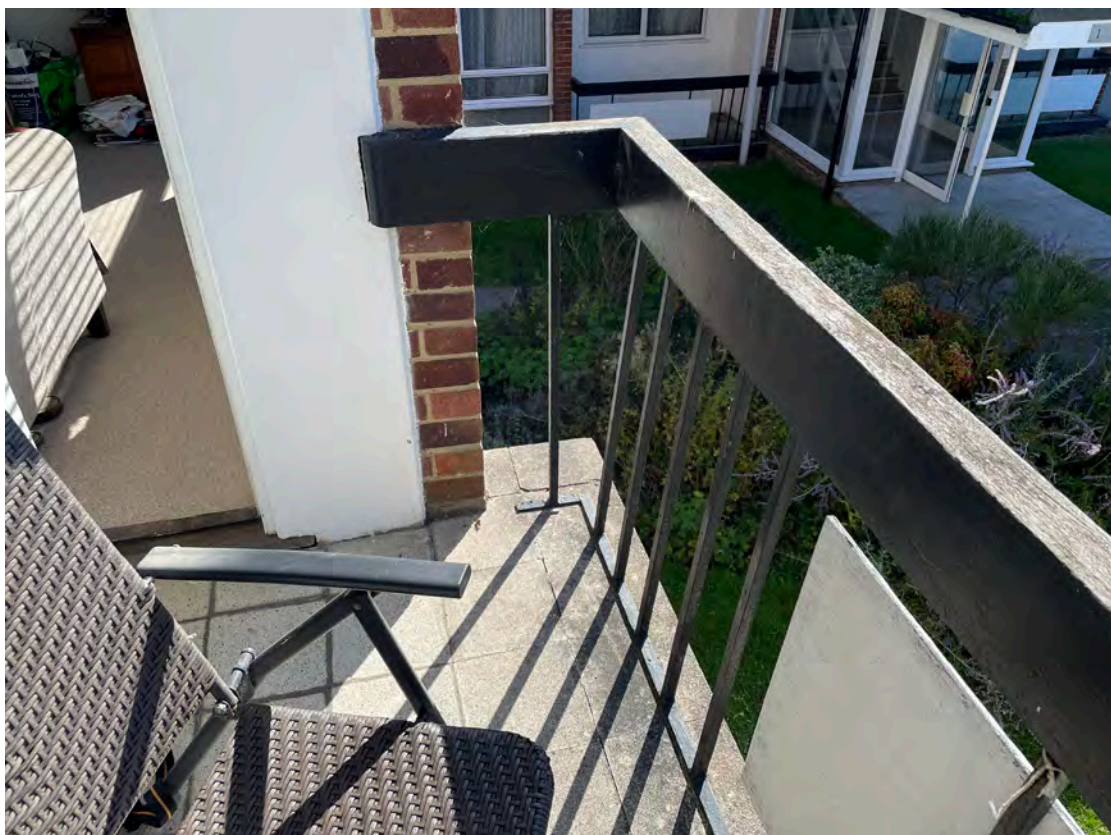
**16 - No. 10 Chaucer Court Balcony east side**

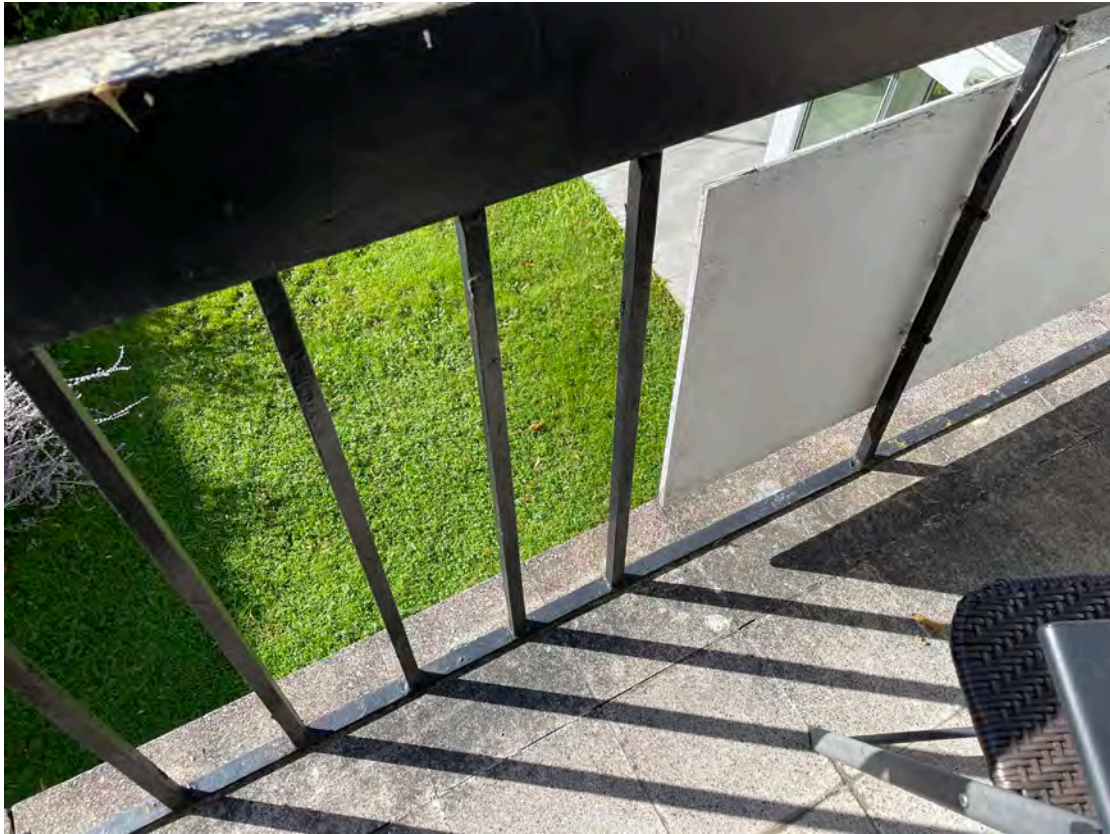
***17 – No. 10 Chaucer Court Balcony front section with plyboard infill panel***

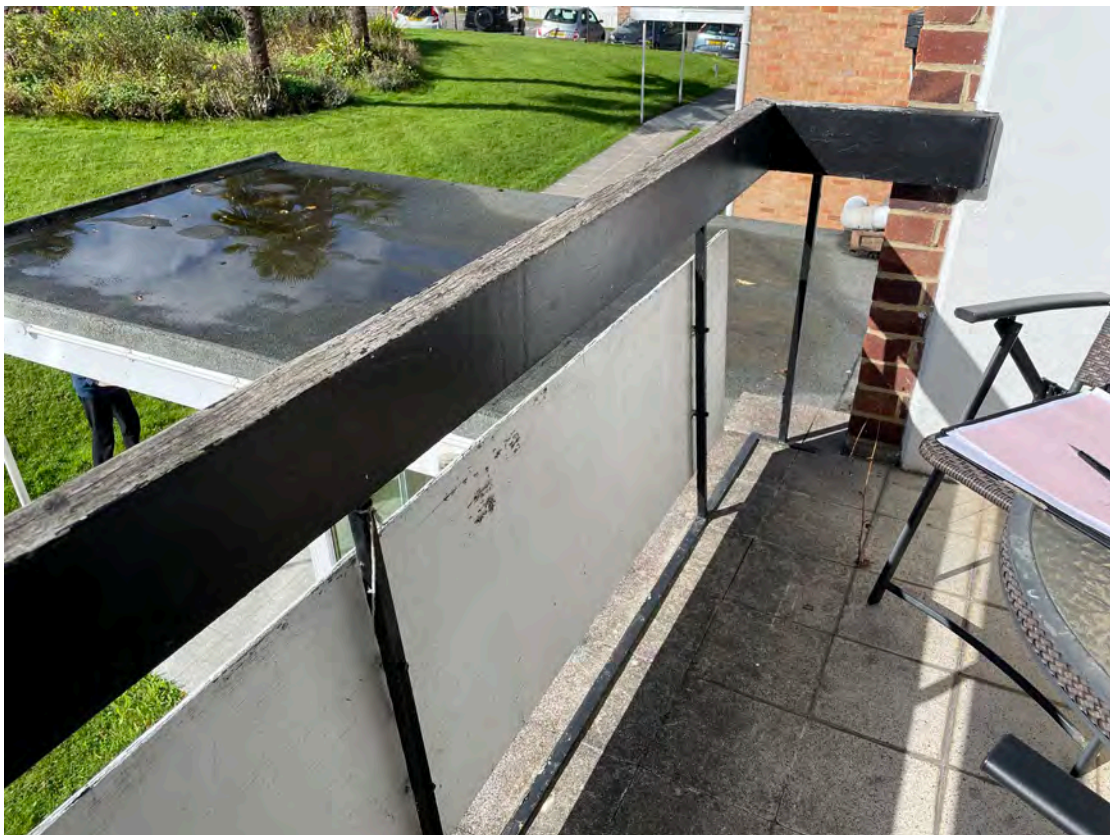
***18 – No. 10 Chaucer Court Balcony west side***

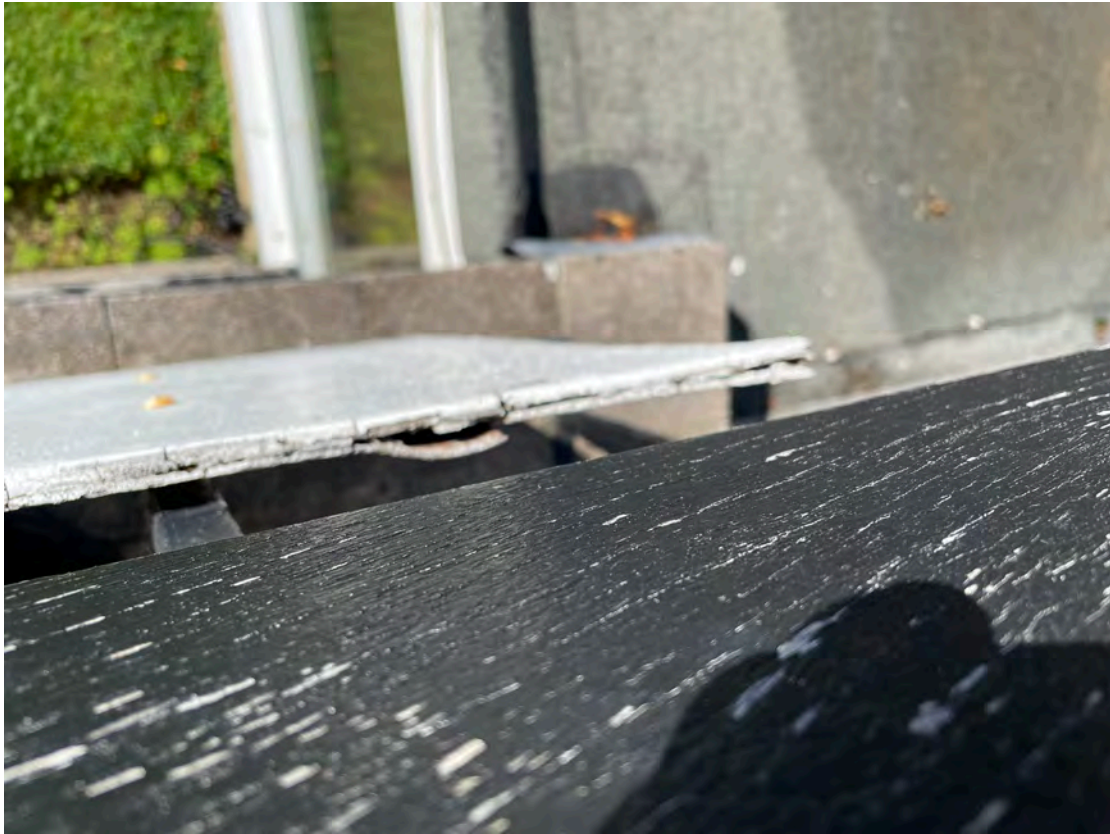
4.14 This was a first floor level apartment and the infill boarding was approximately 10mm thick ply which was delaminating particularly on the corners. Boarding was fixed with approximately 5mm diameter bolts through the 20 x 20 steel posts.

***19 - No. 10 Chaucer Court Balcony delamination of infill plyboard panel***

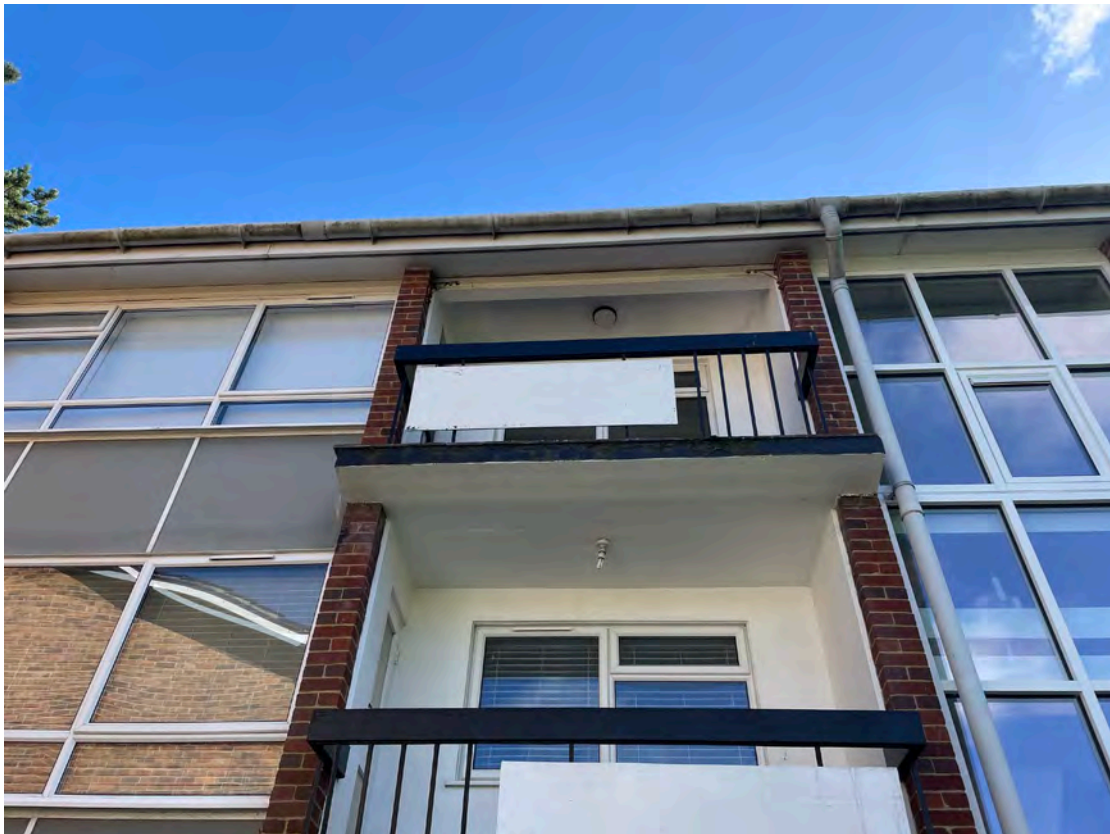
4.20 Height from floor to the top of the handrail was approximately 895mm.

***20 - Closer view of No.5 Byron Court Balcony (top floor)***

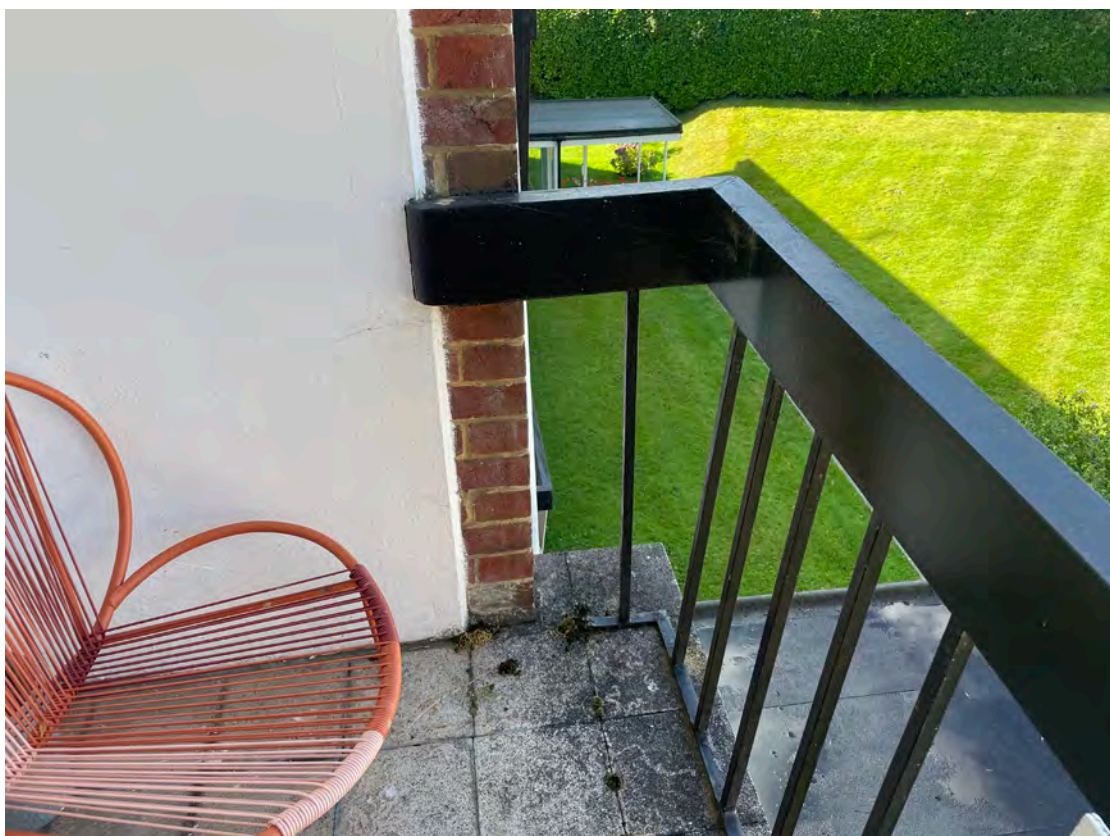
**21 - No. 5 Byron Court Balcony south side**

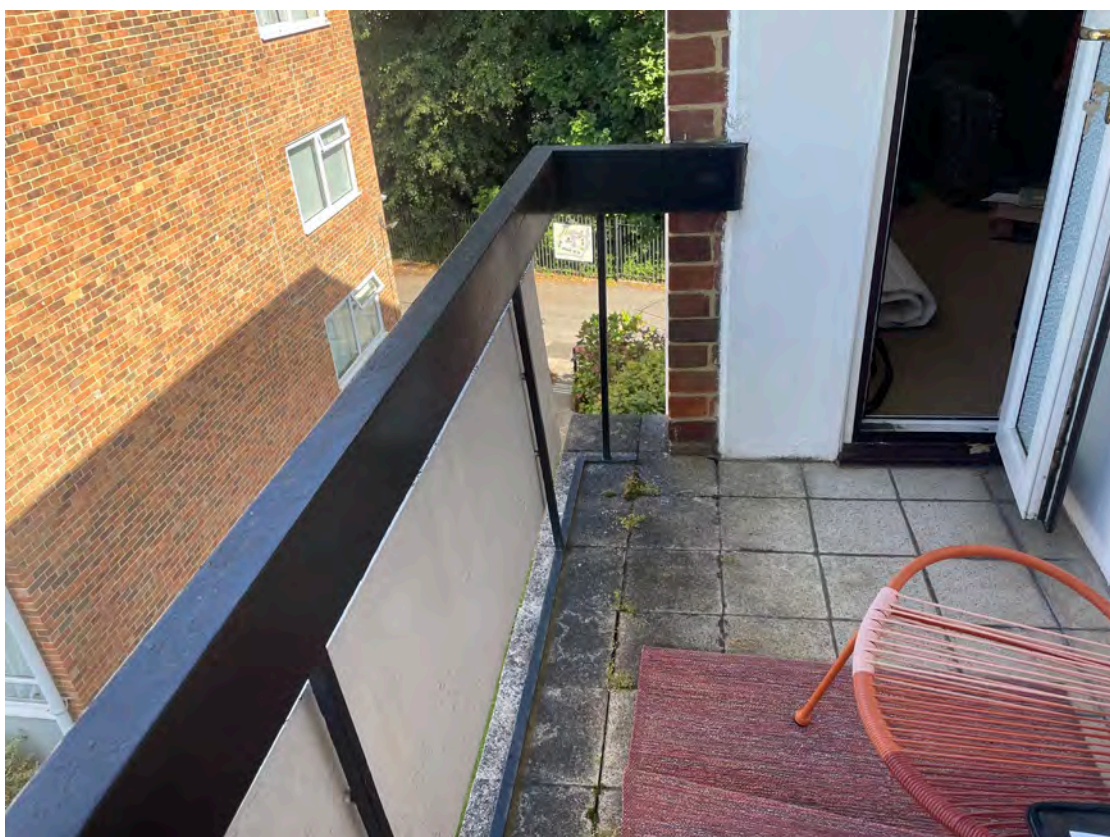
**22 - No. 5 Byron Court Balcony north side**

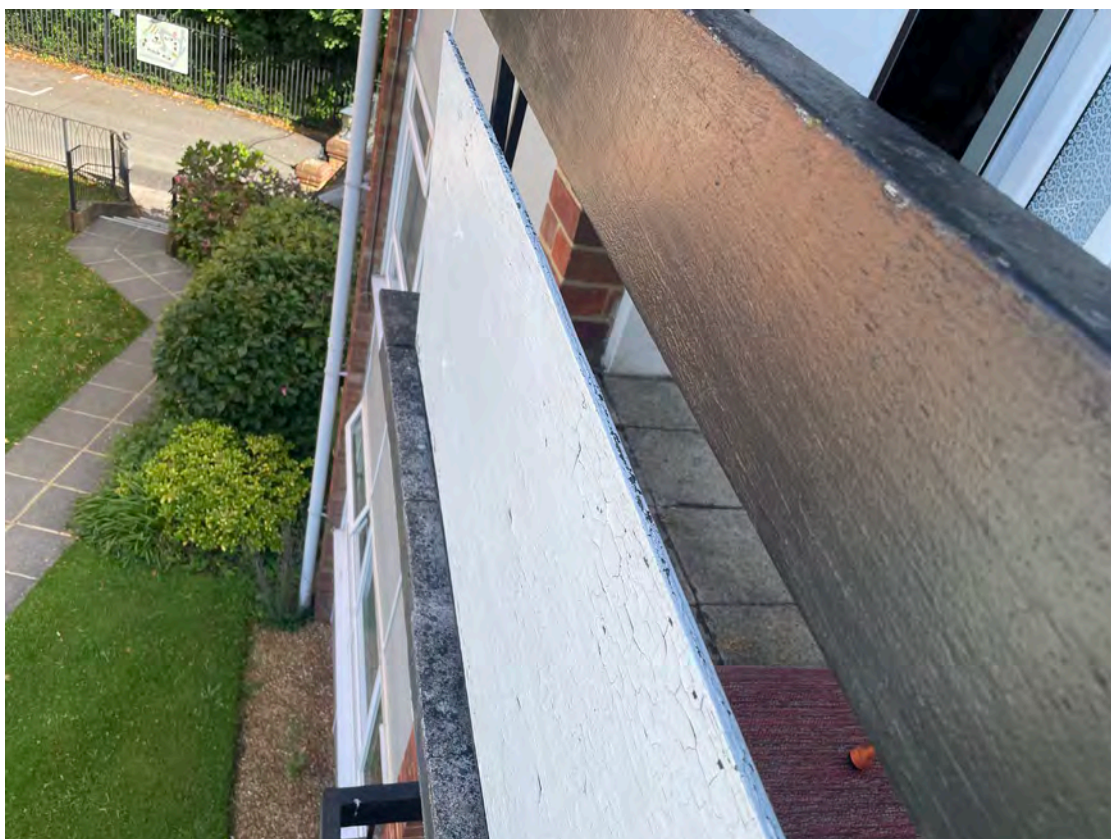
4.17 This was a second floor level apartment and the infill boarding was approximately 8mm thick plywood. Boarding was fixed with screw fixings into the 20 x 20 steel posts. The paint was flaking off the boarding.

**23 - No. 5 Byron Court Balcony plywood infill panel with flaking paintwork**

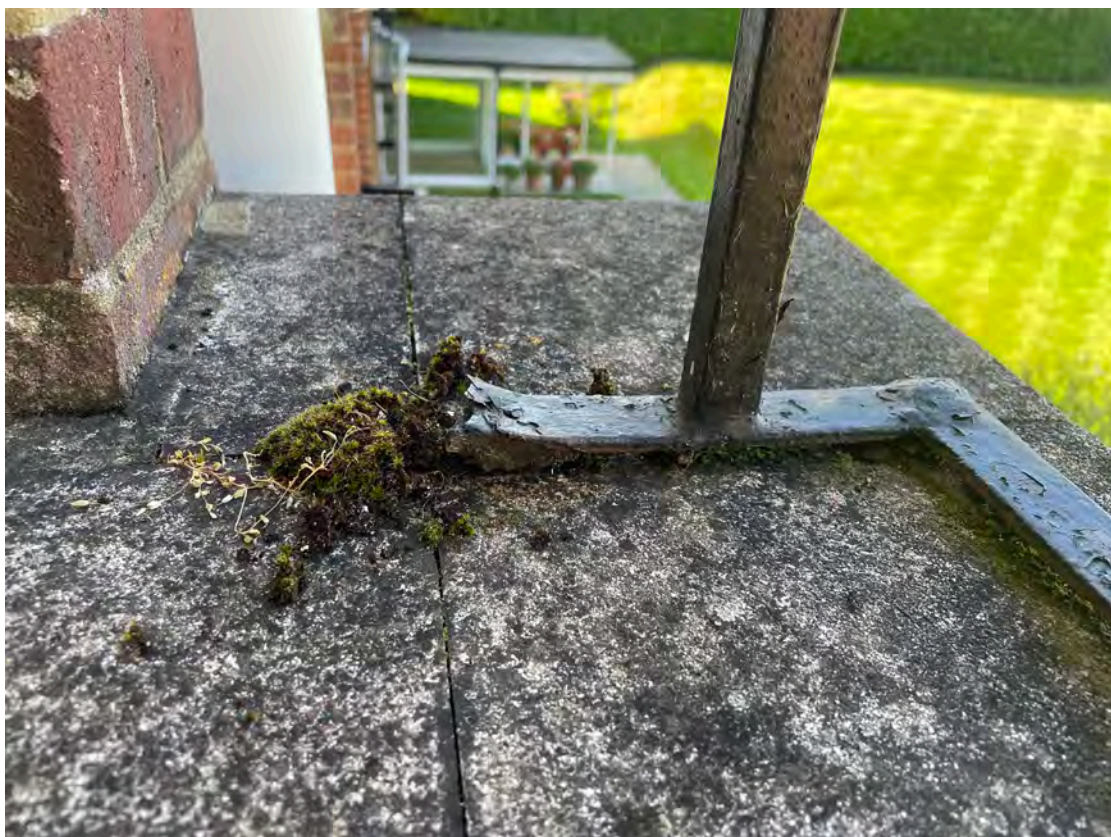
4.18 There was some corrosion and delamination noted on the ends of the bottom rail and some flaking paint to the upright bars.

4.19 There was a gap between the bottom rail and the paving slabs.

**24 - No. 5 Byron Court Balcony Corrosion & delamination of bottom rail**

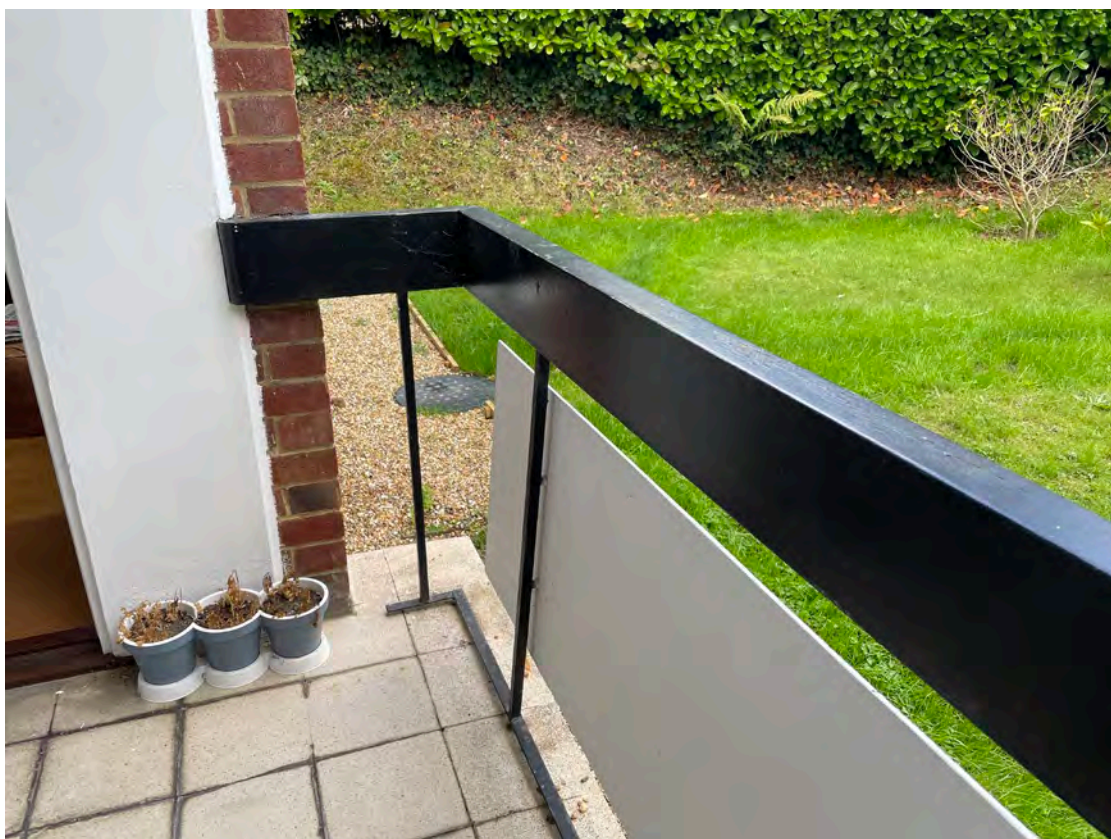
***25 – No. 8 Byron Court Balcony south end***

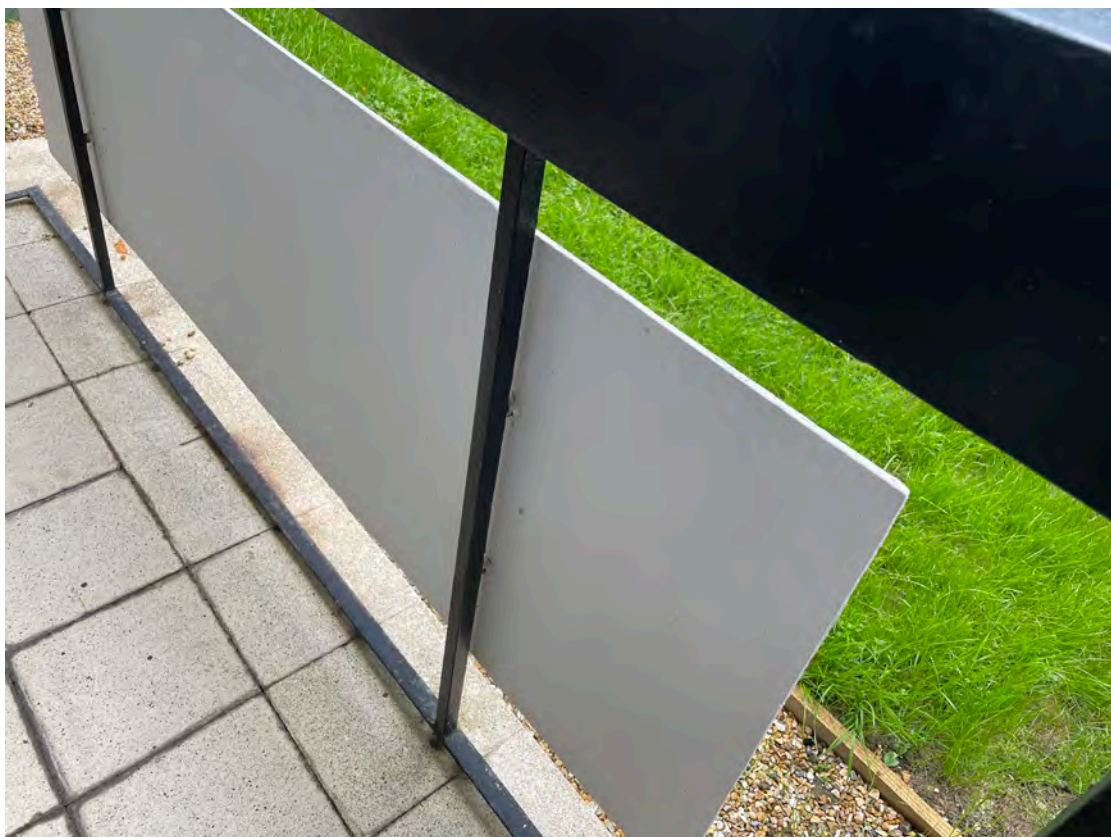
4.21 This was a ground floor level apartment and the infill boarding was fibre cement boarding approximately 6mm thick. Boarding was fixed with screw fixings into the 20 x 20 steel posts.

***26 – No. 8 Byron Court Balcony front infill panel***

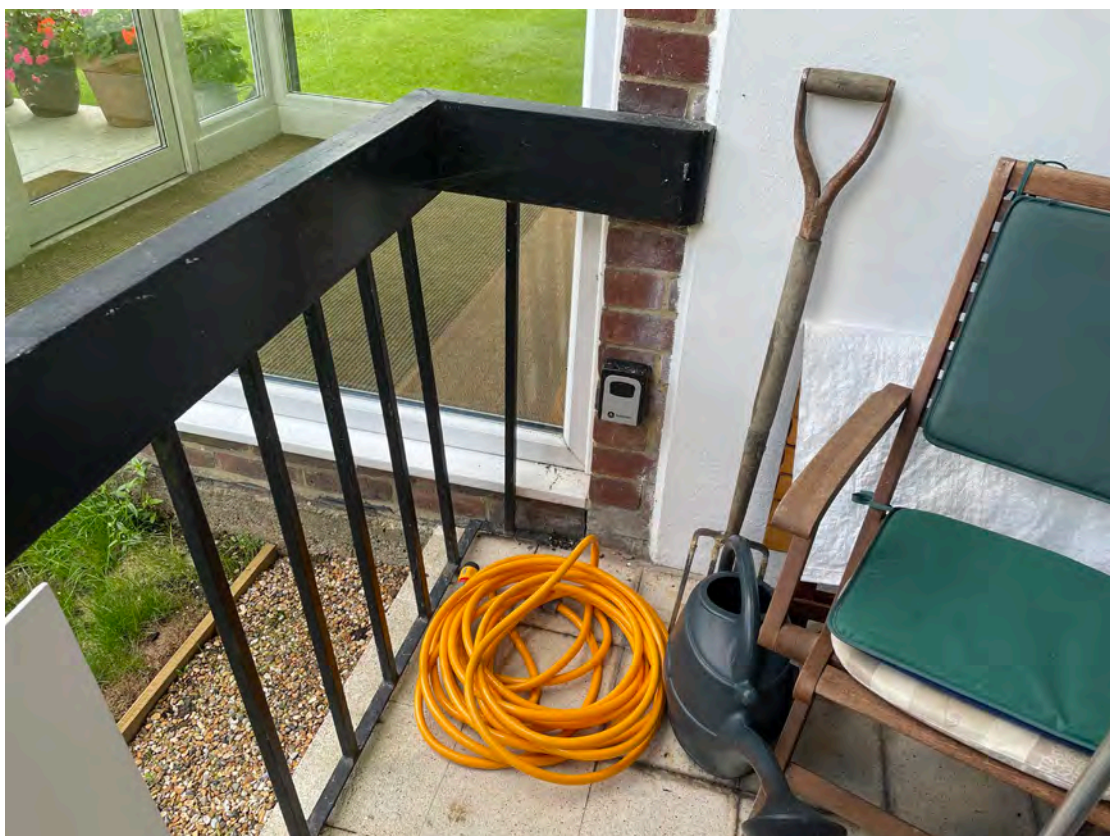
***27 - No. 8 Byron Court Balcony north end***
