DS/DS/MS05127

17<sup>th</sup> October 2024

**Structural Inspection of balcony balustrades on Chaucer & Byron Court buildings,  
Winnals Park, Haywards Heath**

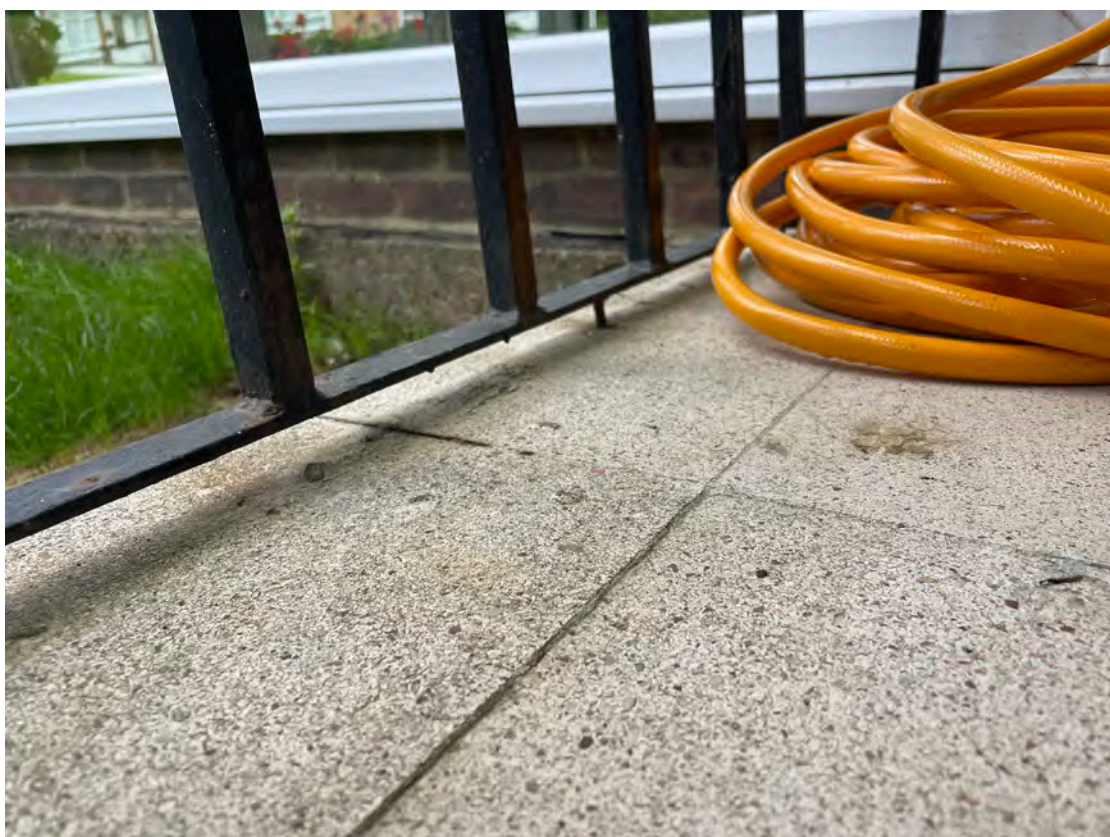
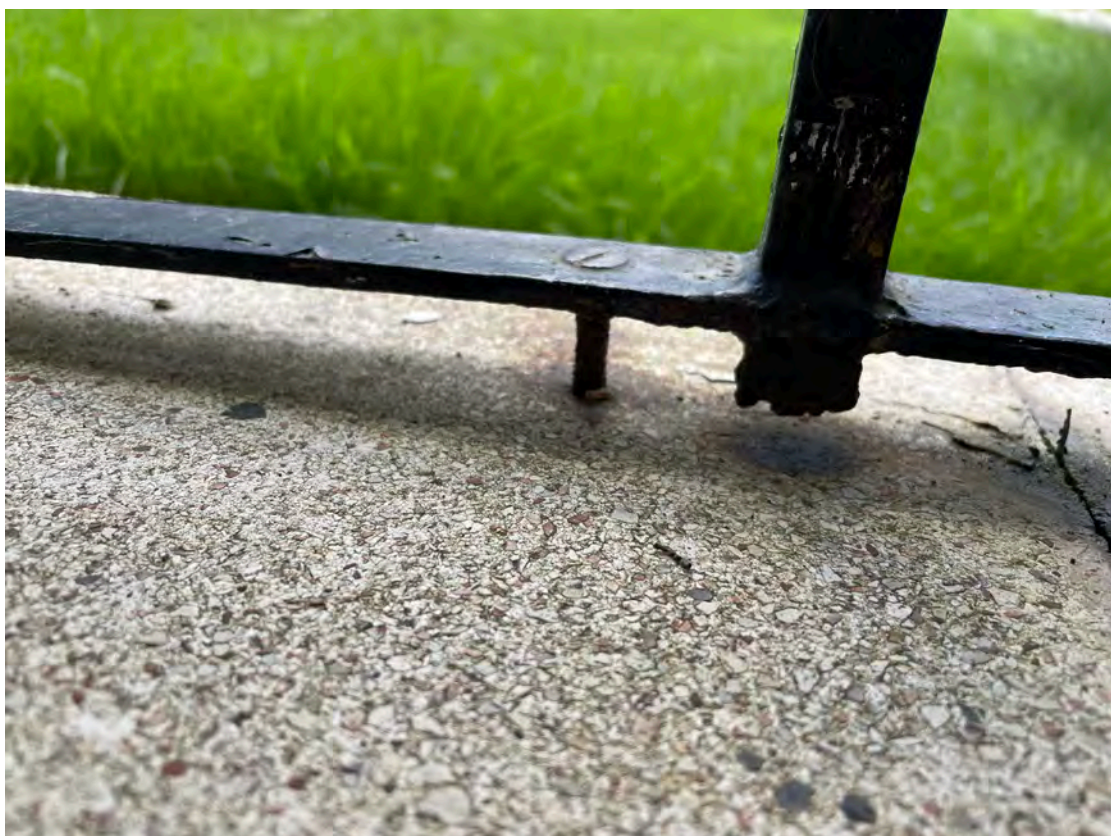
4.23 There was a gap between the bottom rail and the paving slabs and screw fixing between the bottom rail running into the paving slabs under.

***28 - No. 8 Byron Court Balcony gap and screw fixing at base of handrail***

***29 - No. 8 Byron Court Balcony gap and screw fixing at base of handrail***

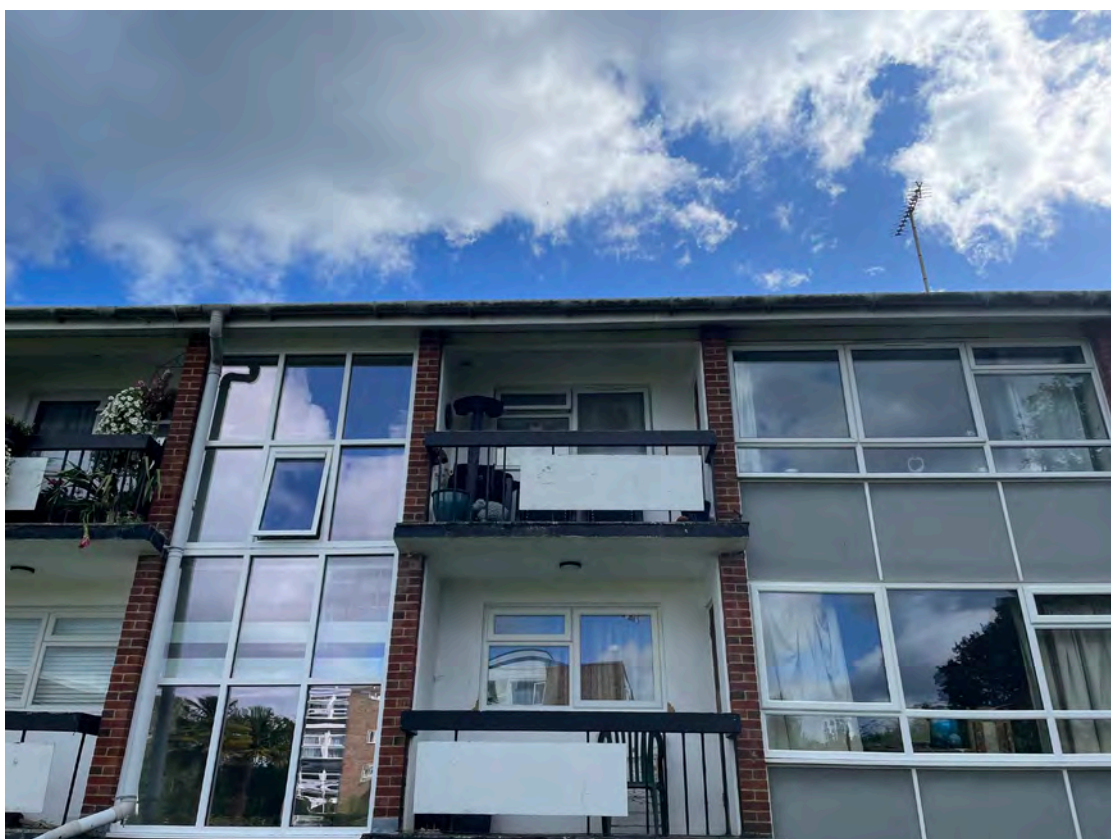
4.27 Height from floor to the top of the handrail was approximately 905mm.

***30 - Closer view of No.12 Byron Court Balcony (top floor)***

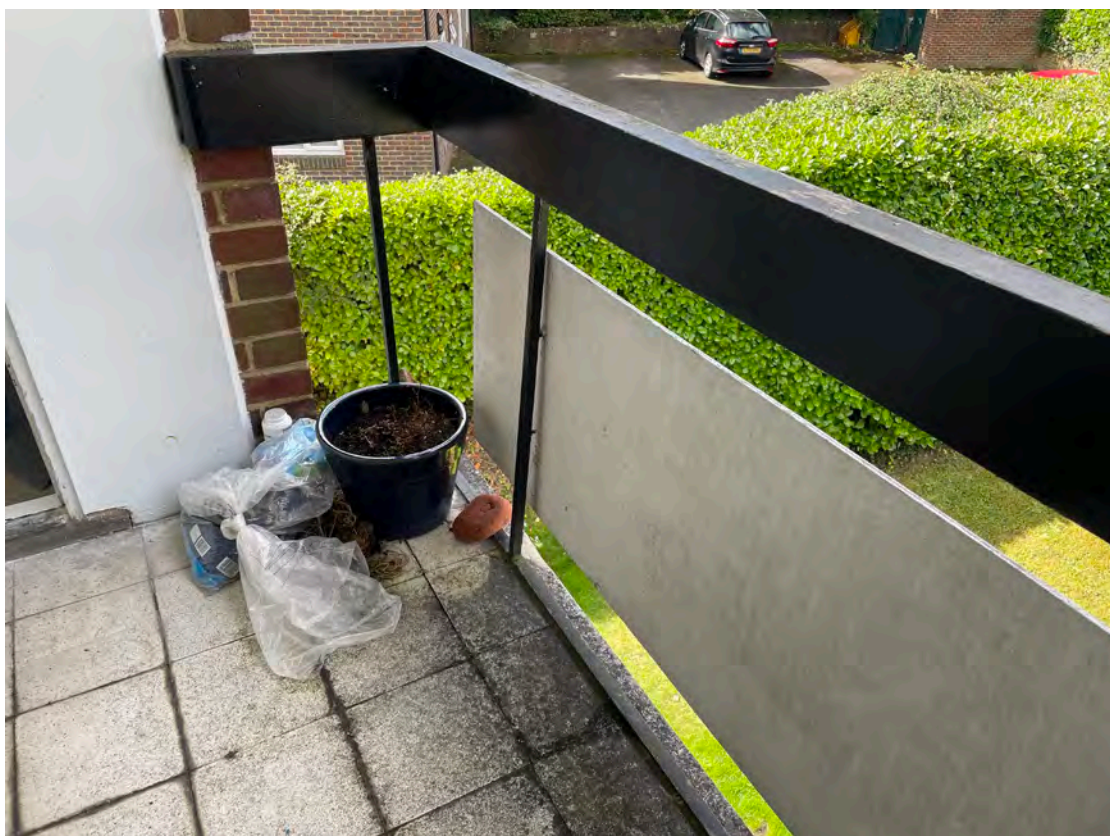
**31 - No. 12 Byron Court Balcony south end**

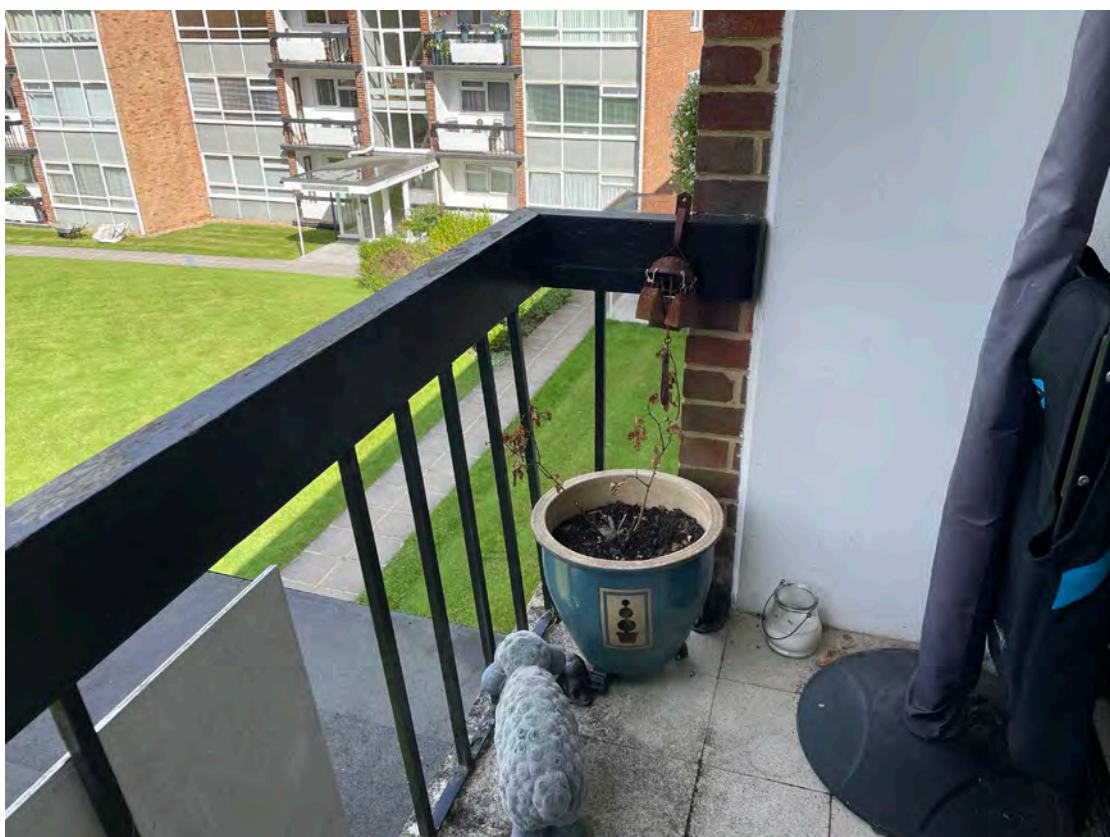
**32 – No. 12 Byron Court Balcony north end**

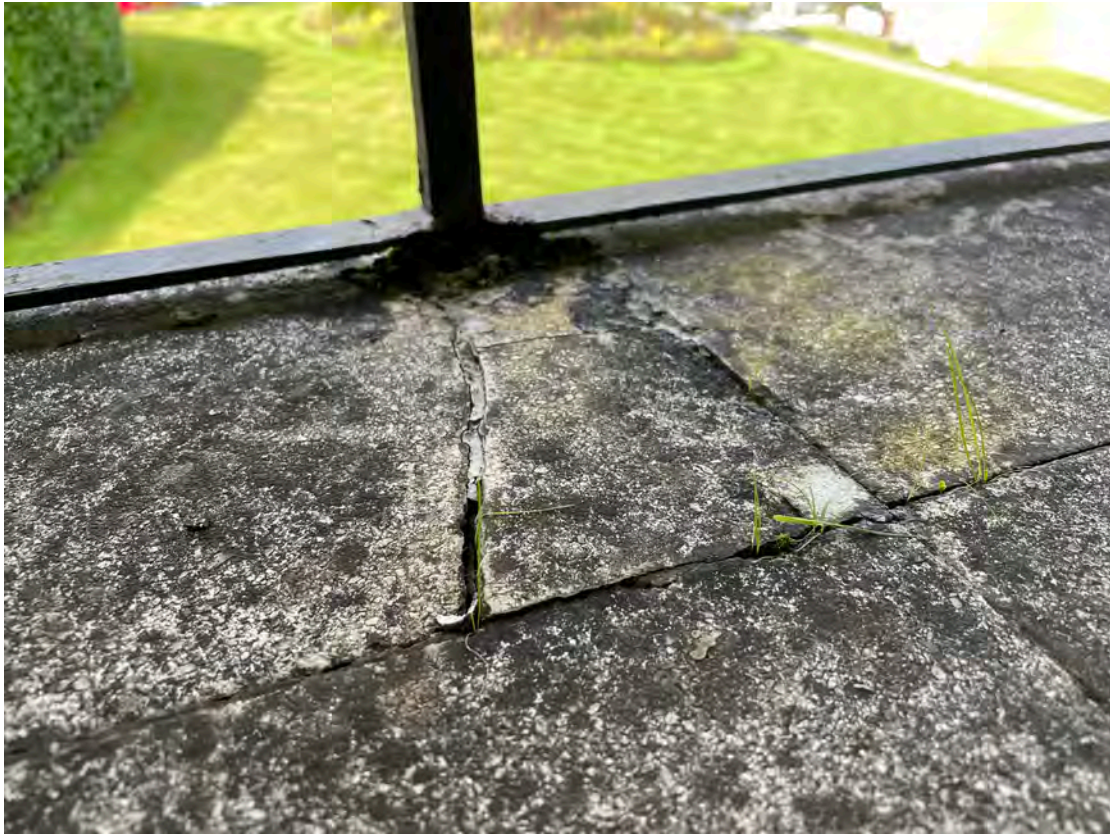
4.26 There was some corrosion noted on the ends of the bottom rail and some flaking paint to the upright bars. There was some delamination to the bottom rail midway along the front of the balcony and a gap under the bottom rail. The paving slab in the location of the rusting bottom rail had cracked.

**33 – No. 12 Byron Court Balcony front bottom rail corrosion and cracked paving slab**

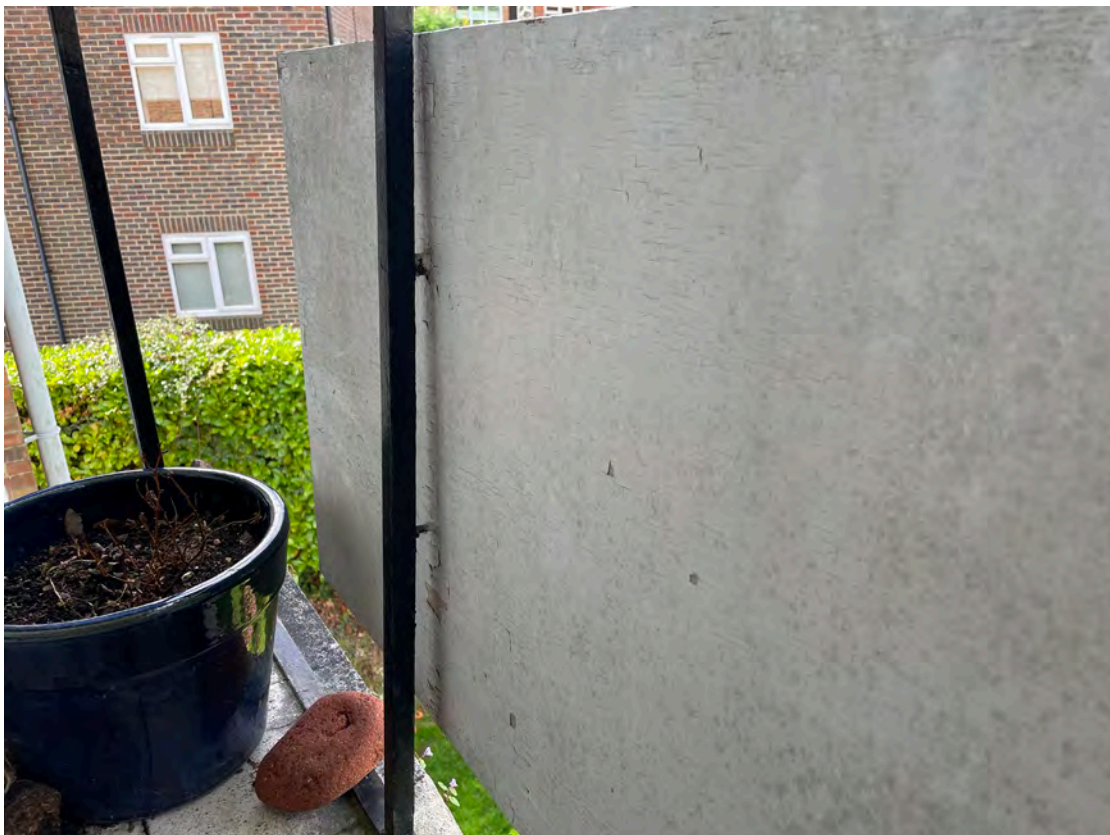
4.25 This was a second floor level apartment and the infill boarding was approximately 8mm thick plywood. Boarding was fixed with screw fixings into the 20 x 20 steel posts. The paint was flaking off the boarding.

**34 – No. 12 Byron Court Balcony front infill plywood panel fixing**
