# Arboricultural Appraisal Report

## Subsidence Damage Investigation at:

5 Moor Place  
East Grinstead  
RH19 2EY

| MWA REF: | SUB210423-8869 |

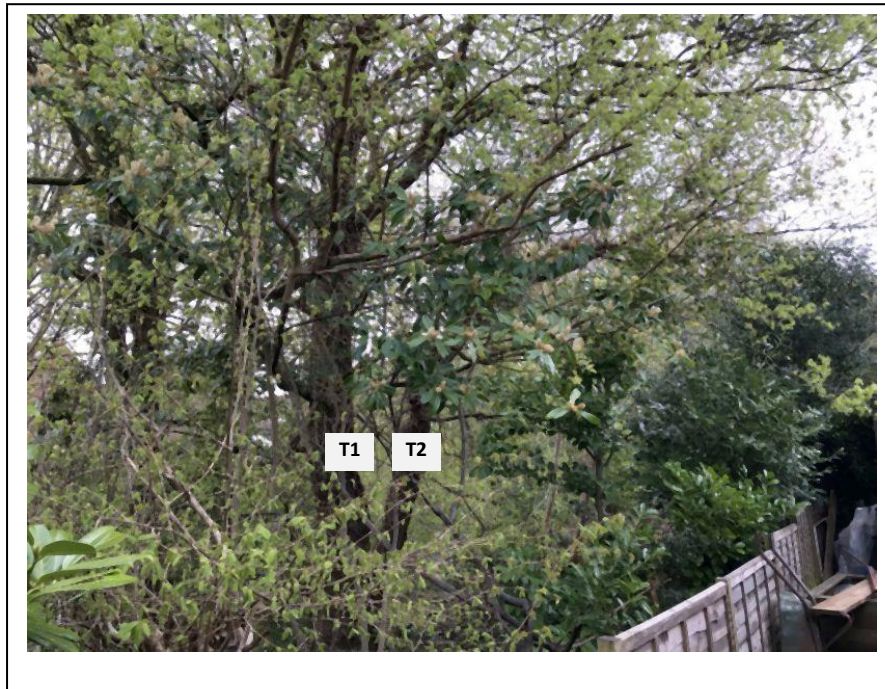
Based on the technical reports currently available, engineering opinion and our own site assessment we conclude the damage is consistent with shrinkage of the clay subsoil related to moisture abstraction by vegetation. Having considered the information currently available, it is our opinion that the Sycamore (T1), and the Oaks (T2 & T3) are the principal cause of or are materially contributing to the current subsidence damage.

View of T1 & T2

If an arboricultural solution is to be implemented to mitigate the influence of the implicated trees/vegetation we recommend that the Sycamore (T1), and the Oaks (T2 & T3) are removed. Other vegetation recorded presents a potential future risk to building stability and management is therefore recommended.

| Tree No. | Species | Ht (m) | Dia (mm) | Crown Spread (m) | Dist. to building (m) | Age Classification | Ownership |
|---|---|---|---|---|---|---|---|
| Recommendation | | Remove (fell) to near ground level and treat stump to inhibit regrowth. | | | | | |

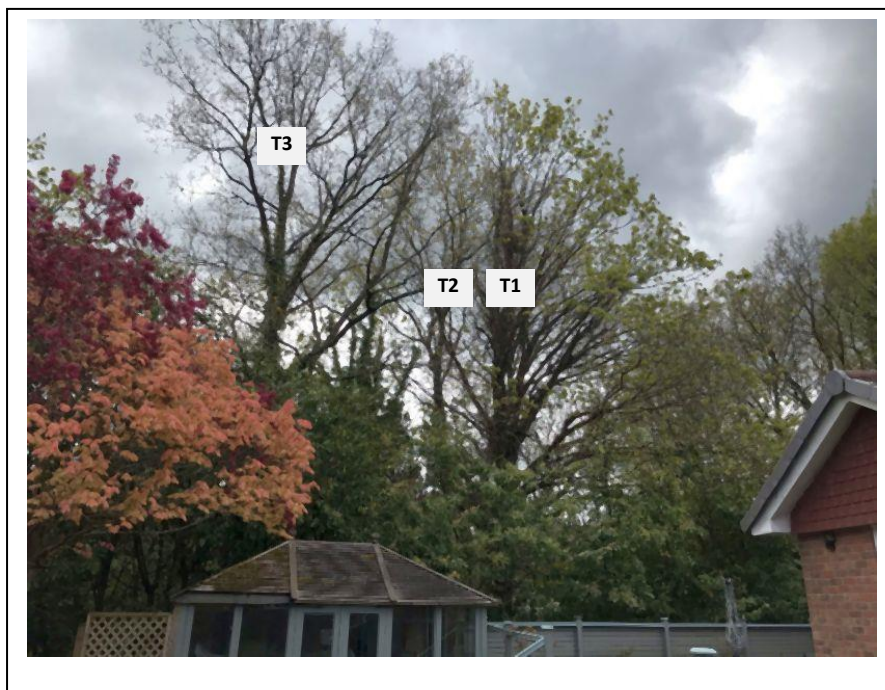
View of T1, T2 & T3

| Tree No. | Species | Ht (m) | Dia (mm) | Crown Spread (m) | Dist. to building (m) | Age Classification | Ownership |
|---|---|---|---|---|---|---|---|
| Recommendation | | Remove (fell) to near ground level and treat stump to inhibit regrowth. | | | | | |

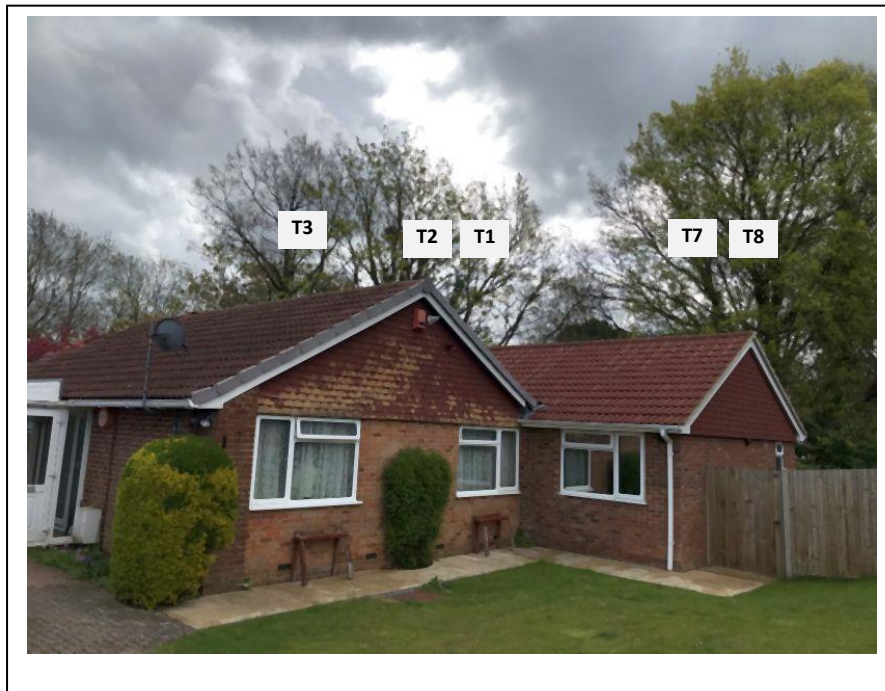
View of T1, T2, T3, T7 & T8

| Tree No. | Species | Ht (m) | Dia (mm) | Crown Spread (m) | Dist. to building (m) | Age Classification | Ownership |
|---|---|---|---|---|---|---|---|
| Recommendation | | Do not allow to exceed current dimensions. | | | | | |

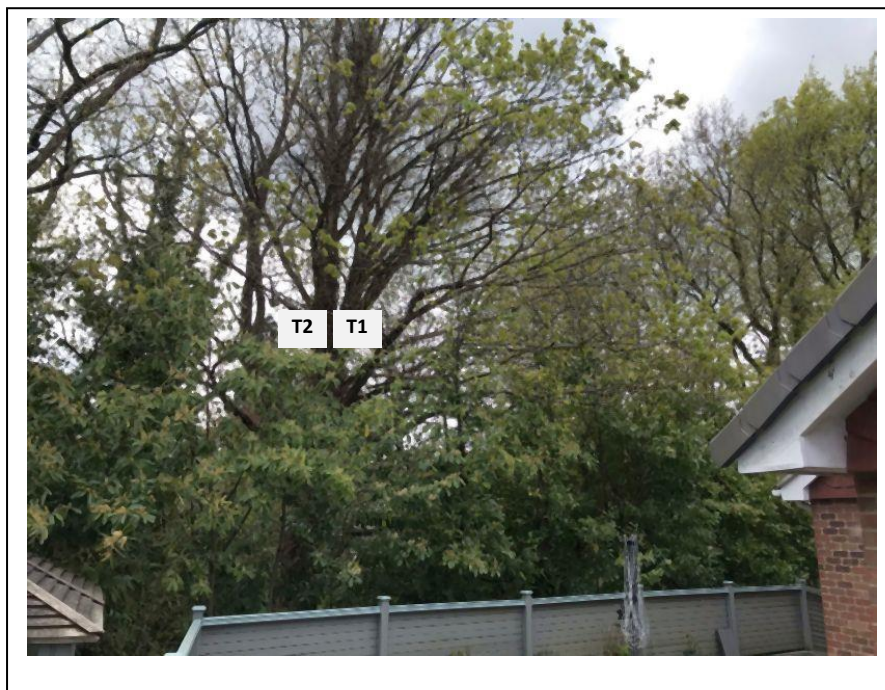
View of T1 & T2

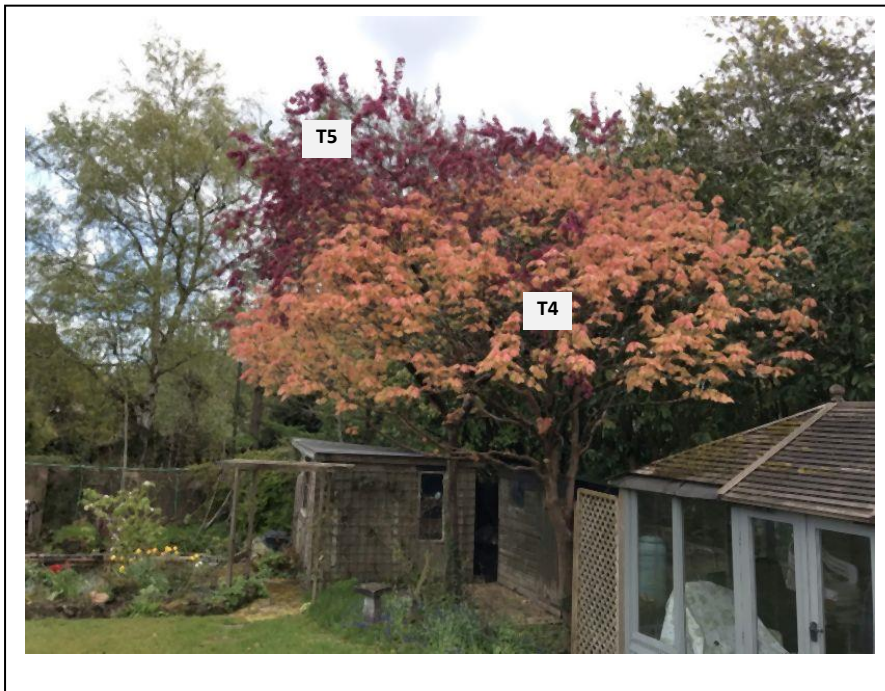
View of T4 & T5

| Tree No. | Species | Ht (m) | Dia (mm) | Crown Spread (m) | Dist. to building (m) | Age Classification | Ownership |
|---|---|---|---|---|---|---|---|
| Recommendation | | Maintain broadly at no more than current dimensions by periodic pruning. | | | | | |

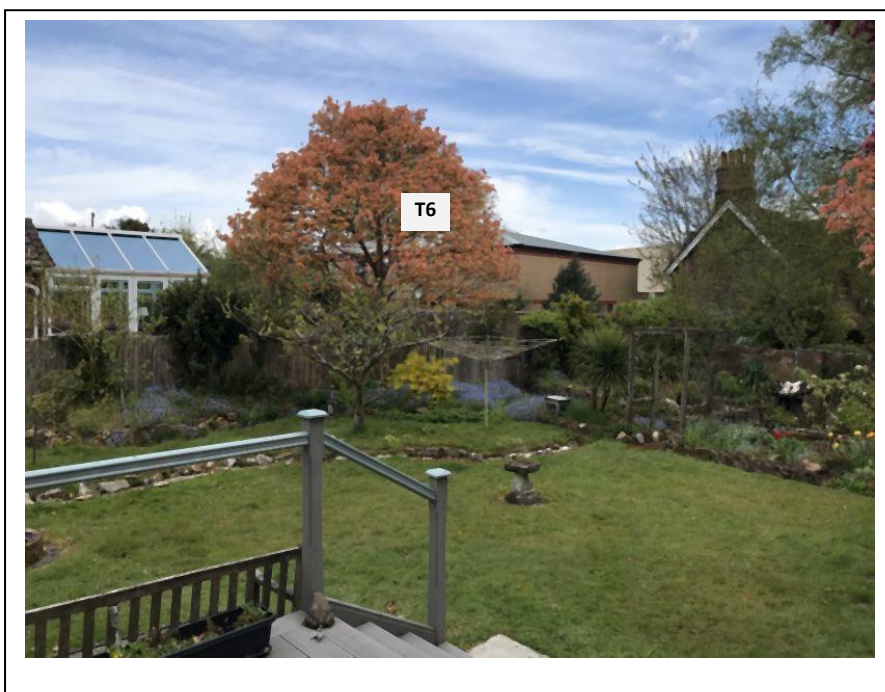
View of T6

| Tree No. | Species | Ht (m) | Dia (mm) | Crown Spread (m) | Dist. to building (m) | Age Classification | Ownership |
|---|---|---|---|---|---|---|---|
| Recommendation | | Maintain broadly at no more than current dimensions by periodic pruning. | | | | | |

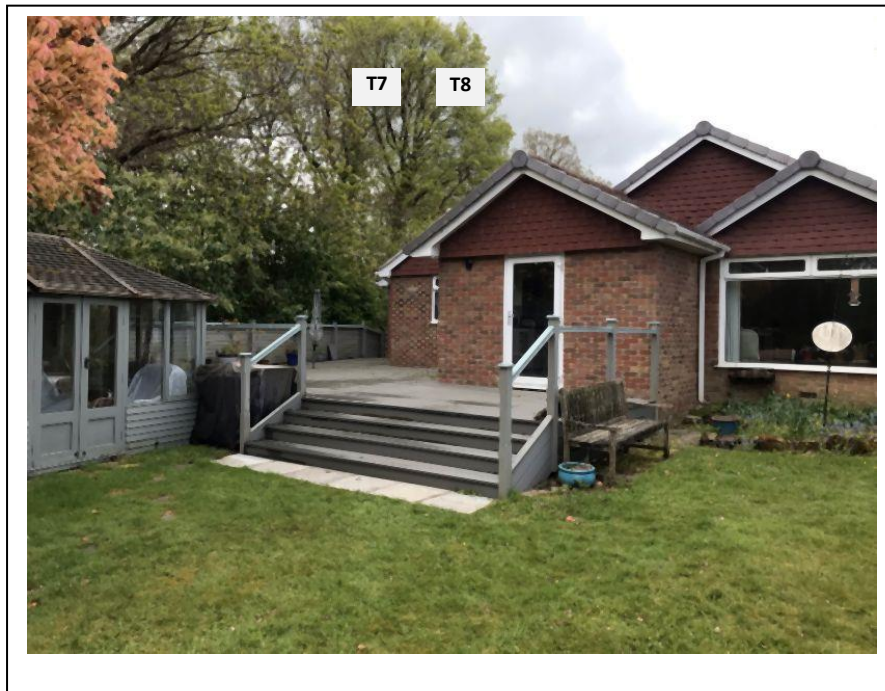
View of T7 & T8
