Ote Hall Farmshop, Janes Ln,  
Burgess Hill, RH15 0SR  
Ref: SKZ\_1689/21\_November 2021

**Project****Project Name:** Ote Hall Farm**Project Description:** CCTV Survey, Trace & Plot**Project Status:** Complete**Project Date:** 24/11/2021**Inspection Standard:** MSCC5 Sewers & Drainage GB (SRM5 Scoring)

**Table of Contents****Project Name**  
Ote Hall Farm**Project Number****Project Date**  
24/11/2021

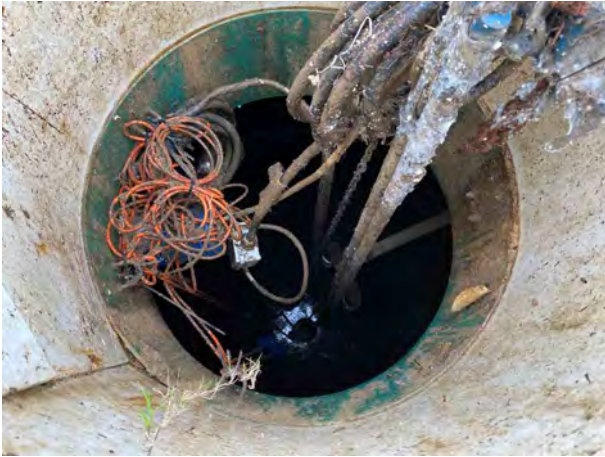
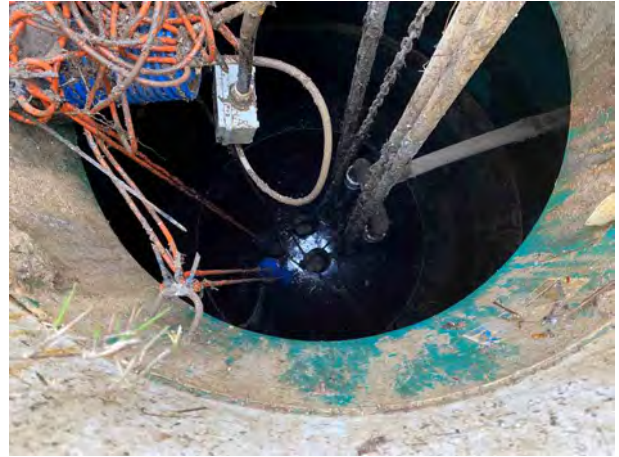
Pumping Chamber

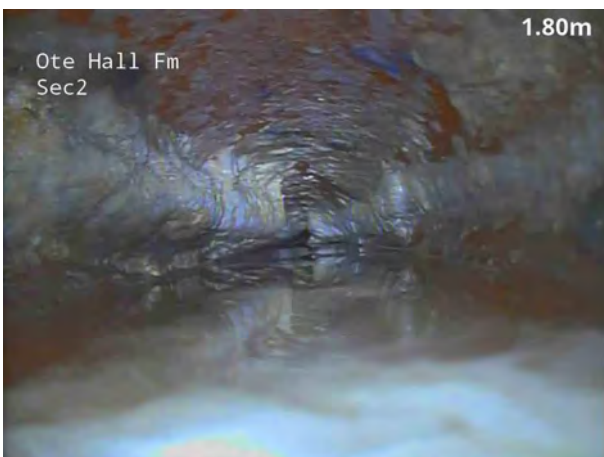
| No. | m+ | Code | Observation |
|---|---|---|---|
| 6 | 1.90 | DEG | Attached deposits, grease from 9 o'clock to 3 o'clock, 20% cross-sectional area loss, start |

5, 00:00:24, 1.90 m  
Attached deposits, grease from 9 o'clock to 3 o'clock, 20%  
cross-sectional area loss, start

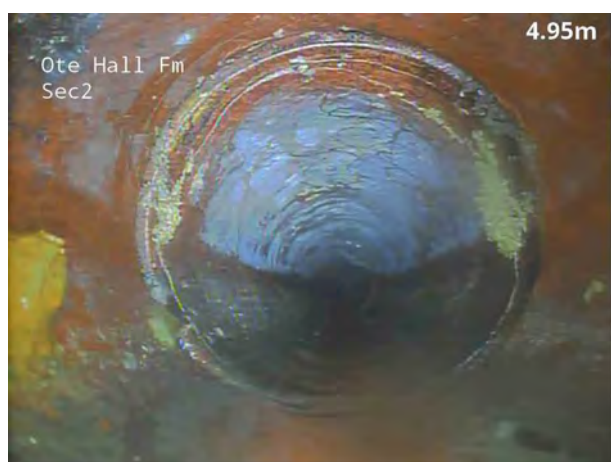
| No. | m+ | Code | Observation |
|---|---|---|---|
| 14 | 5.10 | FCJ | Fracture, circumferential at joint from 12 o'clock to 12 o'clock |

| Scale: 1:192 | Position [m] | Code | Observation | Grade |
|---|---|---|---|---|
| 5.10 | | FCJ | Fracture, circumferential at joint from 12 o'clock to 12 o'clock | 3 / 2 |

9, 00:06:06, 5.10 m  
Fracture, circumferential at joint from 12 o'clock to 12 o'clock

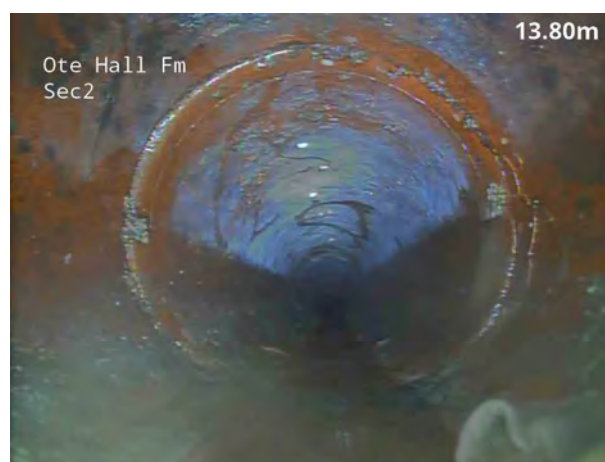
| No. | m+ | Code | Observation |
|---|---|---|---|
| 15 | 14.00 | FCJ | Fracture, circumferential at joint from 12 o'clock to 12 o'clock |

| Scale: 1:192 | Position [m] | Code | Observation | Grade |
|---|---|---|---|---|
| 14.00 | | FCJ | Fracture, circumferential at joint from 12 o'clock to 12 o'clock | 3 / 2 |

10, 00:05:23, 14.00 m  
Fracture, circumferential at joint from 12 o'clock to 12 o'clock

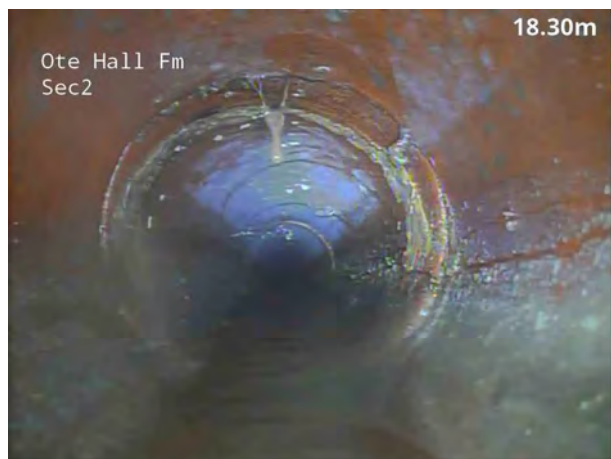
| No. | m+ | Code | Observation |
|---|---|---|---|
| 16 | 18.50 | FCJ | Fracture, circumferential at joint from 12 o'clock to 12 o'clock |

| Scale: | 1:192 | Position [m] | Code | Observation | Grade | | | | |
|---|---|---|---|---|---|---|---|---|---|
| | | 18.50 | FCJ | Fracture, circumferential at joint from 12 o'clock to 12 o'clock | 3 / 2 | | | | |

11, 00:05:04, 18.50 m  
Fracture, circumferential at joint from 12 o'clock to 12 o'clock

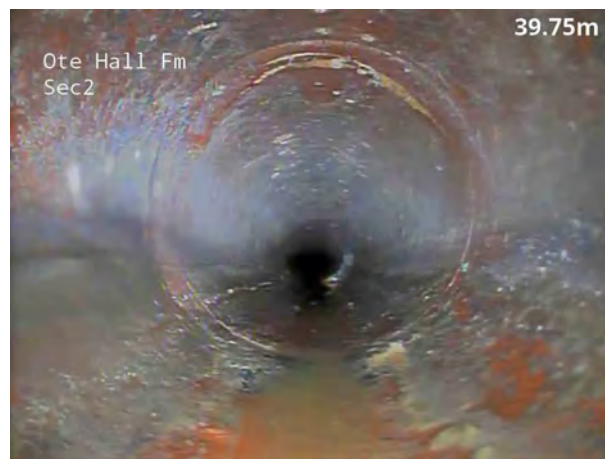
| No. | m+ | Code | Observation |
|---|---|---|---|
| 17 | 39.90 | FCJ | Fracture, circumferential at joint from 12 o'clock to 12 o'clock |

| Scale: | 1:192 | Position [m] | Code | Observation | Grade | | | | |
|---|---|---|---|---|---|---|---|---|---|
| | | 39.90 | FCJ | Fracture, circumferential at joint from 12 o'clock to 12 o'clock | 3 / 2 | | | | |

12, 00:03:18, 39.90 m  
Fracture, circumferential at joint from 12 o'clock to 12 o'clock

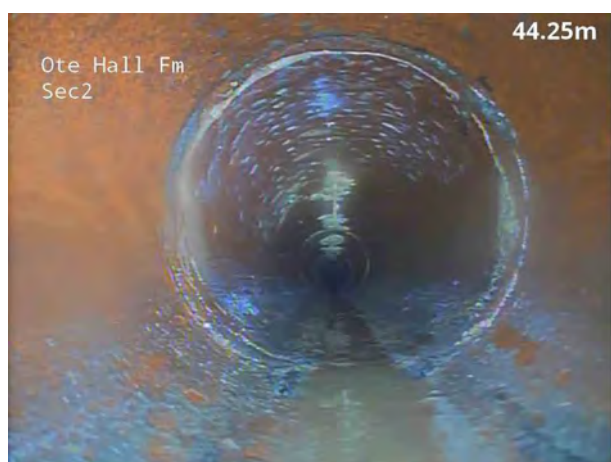
| No. | m+ | Code | Observation |
|---|---|---|---|
| 20 | 44.40 | FCJ | Fracture, circumferential at joint from 12 o'clock to 12 o'clock |

| Scale: | 1:192 | Position [m] | Code | Observation | Grade | | | | |
|---|---|---|---|---|---|---|---|---|---|
| | | 44.40 | FCJ | Fracture, circumferential at joint from 12 o'clock to 12 o'clock | 3 / 2 | | | | |

15, 00:02:38, 44.40 m  
Fracture, circumferential at joint from 12 o'clock to 12 o'clock

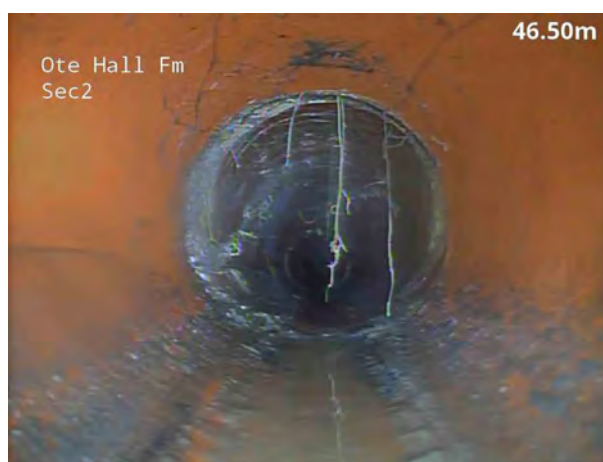
| No. | m+ | Code | Observation |
|---|---|---|---|
| 21 | 46.70 | RFJ | Roots, fine at joint |

16, 00:02:21, 46.70 m  
Roots, fine at joint

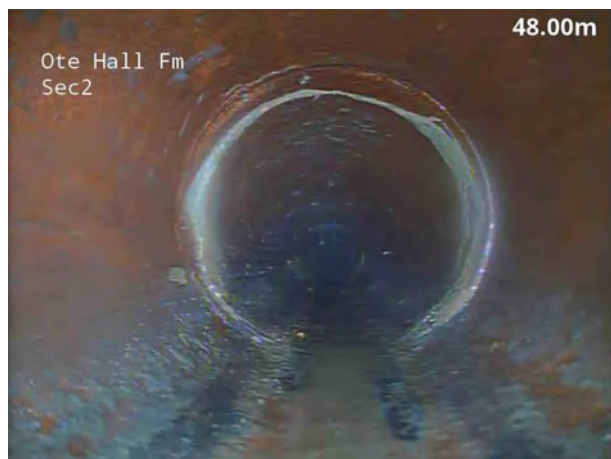
| No. | m+ | Code | Observation |
|---|---|---|---|
| 22 | 48.20 | FCJ | Fracture, circumferential at joint from 12 o'clock to 12 o'clock |

| Scale: | 1:192 | Position [m] | Code | Observation | Grade | | | | |
|---|---|---|---|---|---|---|---|---|---|
| | | 48.20 | FCJ | Fracture, circumferential at joint from 12 o'clock to 12 o'clock | 3 / 2 | | | | |

17, 00:02:12, 48.20 m  
Fracture, circumferential at joint from 12 o'clock to 12 o'clock

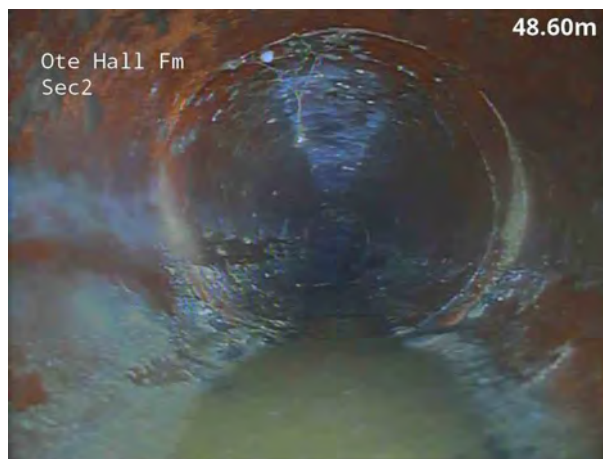
| No. | m+ | Code | Observation |
|---|---|---|---|
| 23 | 48.80 | FCJ | Fracture, circumferential at joint from 11 o'clock to 6 o'clock |

| Scale: | 1:192 | Position [m] | Code | Observation | Grade | | | | |
|---|---|---|---|---|---|---|---|---|---|
| | | 48.80 | FCJ | Fracture, circumferential at joint from 11 o'clock to 6 o'clock | 3 / 2 | | | | |

18, 00:02:05, 48.80 m  
Fracture, circumferential at joint from 11 o'clock to 6 o'clock

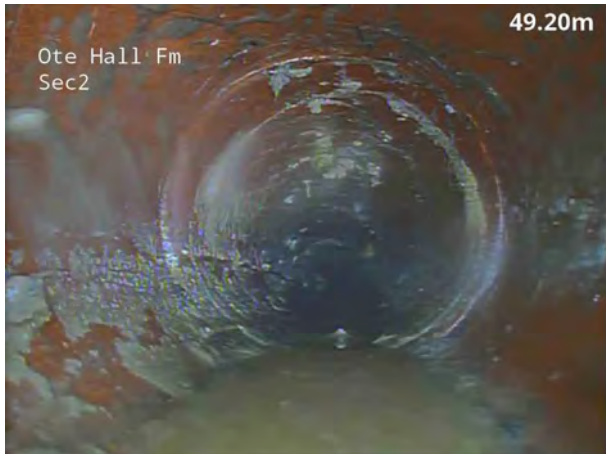
| No. | m+ | Code | Observation |
|---|---|---|---|
| 24 | 49.40 | FCJ | Fracture, circumferential at joint from 12 o'clock to 12 o'clock |

| Scale: | 1:192 | Position [m] | Code | Observation | Grade | | | | |
|---|---|---|---|---|---|---|---|---|---|
| | | 49.40 | FCJ | Fracture, circumferential at joint from 12 o'clock to 12 o'clock | 3 / 2 | | | | |

19, 00:01:57, 49.40 m  
Fracture, circumferential at joint from 12 o'clock to 12 o'clock

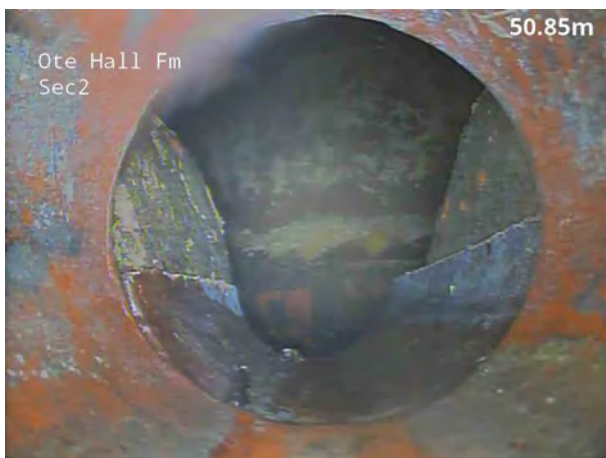
21, 00:01:47, 51.00 m  
Finish node, manhole, reference: FW3, Not located

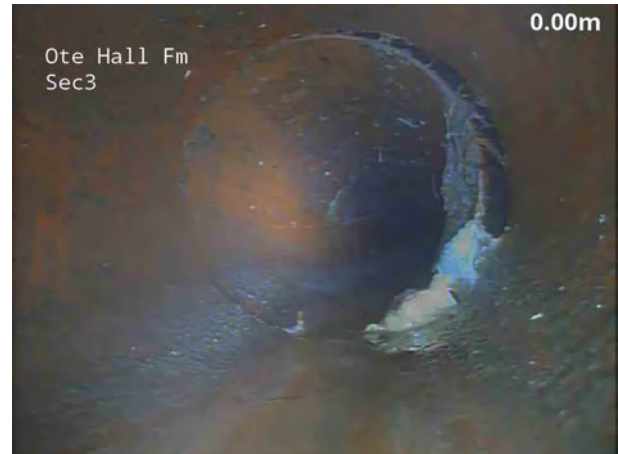
2, 00:00:11, 0.30 m  
Roots, fine at joint

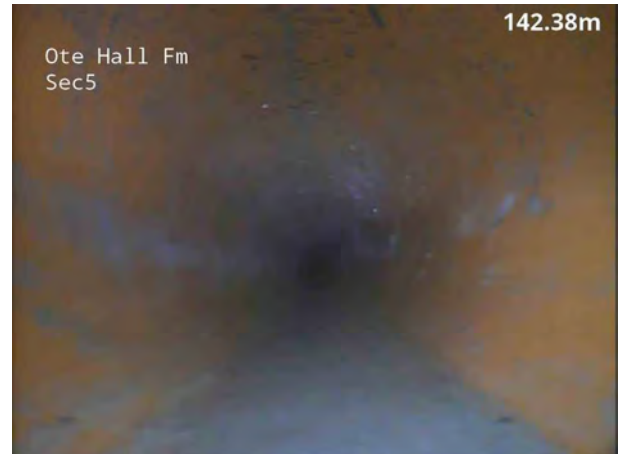
2, 00:05:11, 142.40 m  
Survey abandoned, Unable to reach chamber, to come up from FW2

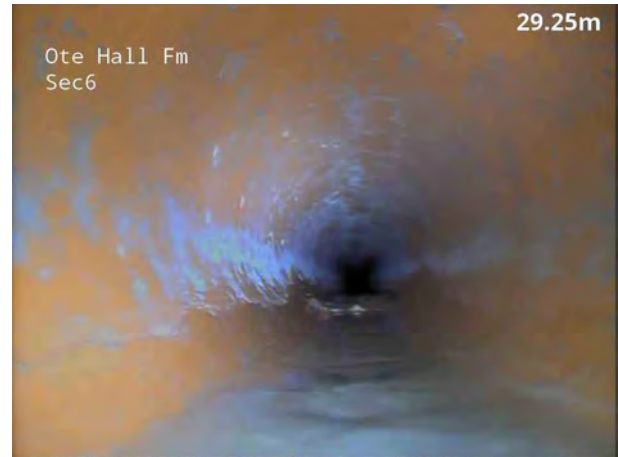
2, 00:01:14, 29.30 m  
Survey abandoned, Past crossover point
