## **Resistograph Tree Report**

**Lindfield Primary Academy,  
Primary Academy, School Lane,  
Lindfield,  
Haywards Heath,  
RH16 2DX**

**Prepared by  
Richard Daubeney Our Ref 0825-RD  
12th August 2025**

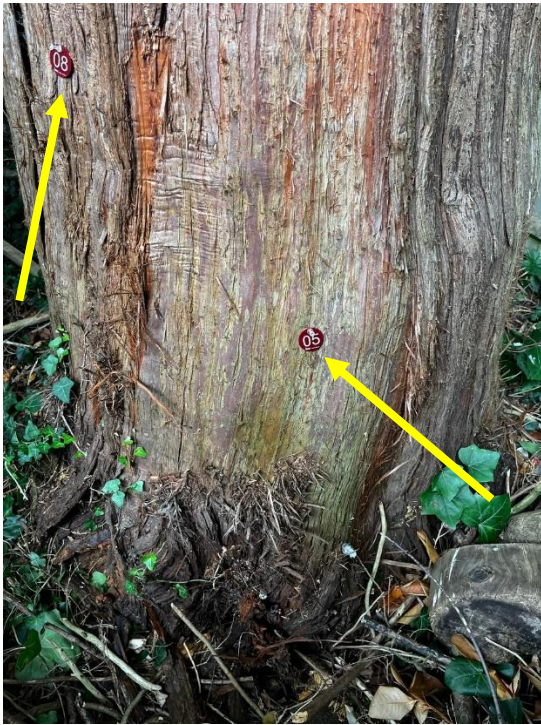
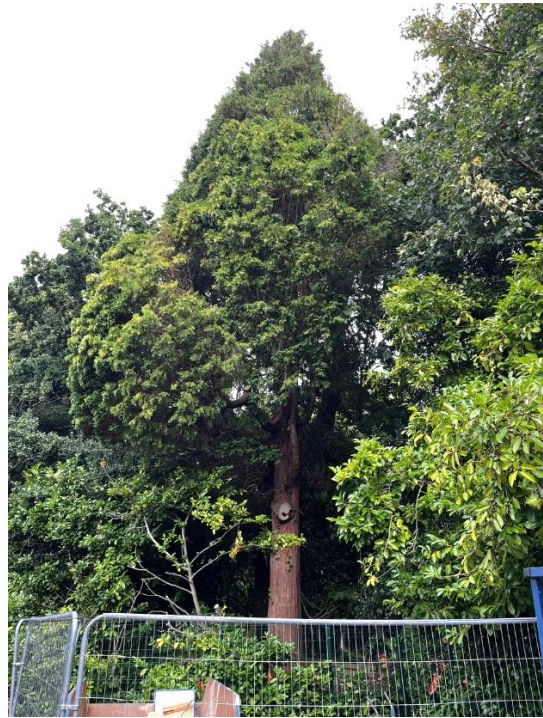
- 5.3 Following the resistograph testing of T114 Western red cedar tree, the results were shown to have minor area of decay within the stem based on reading no. 1 to the North side, the remaining readings showed moderate levels of sound and live residual wood remaining throughout the stem. Old pruning wound is noted on stem at 6m to the South side, with cavity and decay within the historic wound on the stem. Slight and early onset of crown dieback noted within the canopy, but not significant at this time.

- 6.2 The results gathered from the testing of T114 Western red cedar tree, have highlighted there is little in way of decay within the stem, based upon the readings provided. There is, however, a cavity located on stem which requires further investigation. The tree is located within an area of high risk, with school grounds, buildings, and general public all within striking distance of tree. We therefore based on the above evidence,

| Tree No.<br>Tree<br>Tag. | Tree<br>Species | Hgt<br>(m) | Past<br>Management | Age Class | Risk Target | TPO Status | Defects | Works | Work Priority |
|---|---|---|---|---|---|---|---|---|---|
| T114<br>Tree<br>tag: N/A | Western<br>red cedar | 15-<br>19m | Subject to<br>previous<br>management | Mature | High/<br>reinspect<br>July 2027 | No TPO in place<br>and Conservation<br>Area restrictions for<br>Mid Sussex District<br>Council. (CA)<br><br>Botanical Name:<br>( <i>Thuja plicata</i> ) | Hazardous Defect Noted.<br>Minor cavity at ground level to West<br>side. Hollow sounding to the South<br>side at 1m above ground level, when<br>tapped with sounding hammer.<br>Recently crown lifted over school<br>grounds. Cavity at 6m to the south<br>side, within old historic pruning<br>wound. Crown showing signs of<br>thinning. | Climbing inspection to determine<br>the condition of cavity formation<br>within historic pruning wound.<br>If found to be not significant then<br>proceed with crown reduction.<br><br>Reduce height by 3-4m and<br>reduce lateral spread by 1-2m.<br>All Tree works to BS3998 (2010) | Urgent within<br>3 month. |

**T114 Western red cedar measurement looking Northwest towards drill location 5 and 8.**

**T114 Western red cedar looking West.**

to carry out a climbing inspection of the cavity on the stem, if not found significant then proceed with height reduction by 3-4m and crown spread to be reduced by 1-2m. The work is to be completed within 3 months on urgent basis.

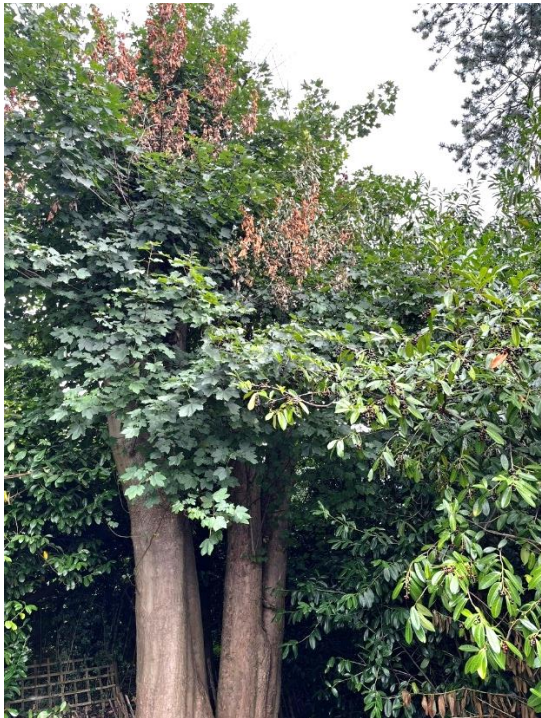
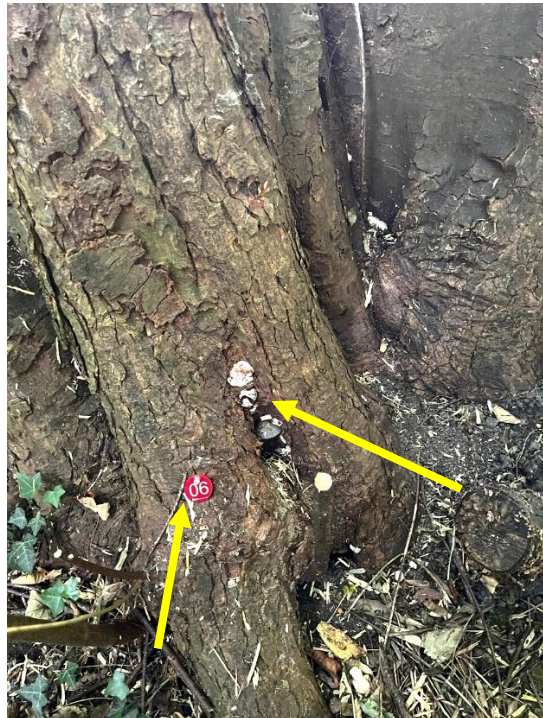
- 5.4 Following the resistograph testing of T126 Sycamore tree, the testing revealed major decay within the readings No. 6 to the Northwest side. This is linked to the (*Ganoderma spp.*) Fruiting bodies to the North and East sides of the stem at 30cm above ground level. The fruiting bodies are noted to be fresh in appearance. The remaining readings showed areas of moderate sound live residual wood within the stem. The Sycamore tree has been previously managed as a low pollard. Tree has put out dense regrowth formed from old pruning points.

- 6.3 The results gathered from the testing of T126 Sycamore tree, have indicated there is moderate decay noted within the stem based on the readings provided, this also includes the addition of fresh fruiting bodies of *Ganoderma spp* based on the North and East sides of the two stems. However, Sycamore T126 has been managed as a low pollard. The tree is located within an area of high risk, with school grounds, general public all within striking distance of the tree. We therefore based on the above evidence, recommend re-pollard back to point of previous pruning to T126 Sycamore tree. The work is to be completed within 3 months on urgent basis.

| Tree No.<br>Tree<br>Tag. | Tree<br>Species | Hgt<br>(m) | Past<br>Management | Age Class | Risk Target | TPO Status | Defects | Works | Work Priority |
|---|---|---|---|---|---|---|---|---|---|
| T126<br>Tree<br>tag: N/A | Sycamore | 5-<br>10m | Managed as<br>pollard. | Mature | High/<br>reinspect<br>July 2027 | No TPO in place<br>and Conservation<br>Area restrictions for<br>Mid Sussex District<br>Council (CA)<br><br>Botanical Name:<br>( <i>Acer<br/>pseudoplatanus</i> ) | Gross Defect Noted. Twin stemmed at<br>60cm above ground level. Fresh in<br>appearance and small fruiting bodies<br>of <i>Ganoderma spp.</i> located to North<br>and East side of stem at approx. 30cm<br>above ground level. When tapped to<br>those areas with sounding hammer,<br>was found to have slight hollow sound.<br>Historic pollard. | Re-pollard to previous pruning<br>points. | Urgent within<br>3 month. |

**T126 Sycamore tree looking North**

**T126 Sycamore tree looking South towards Drill location No.6 and *Ganoderma* spp. fruiting bodies.**

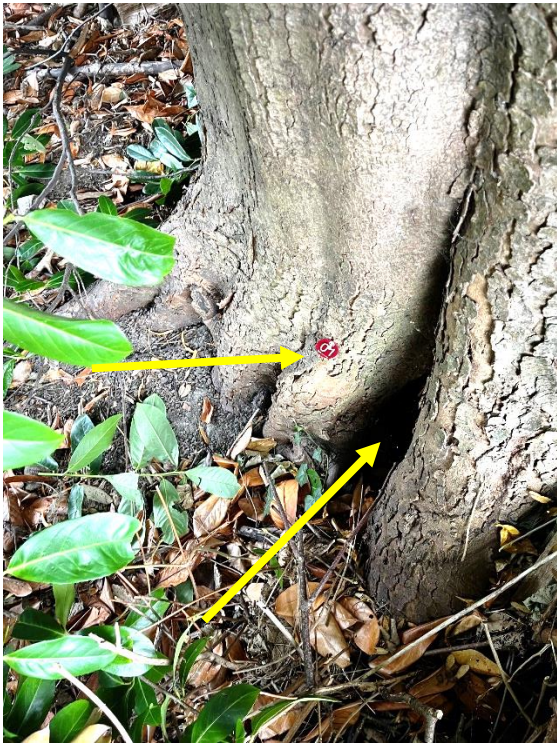
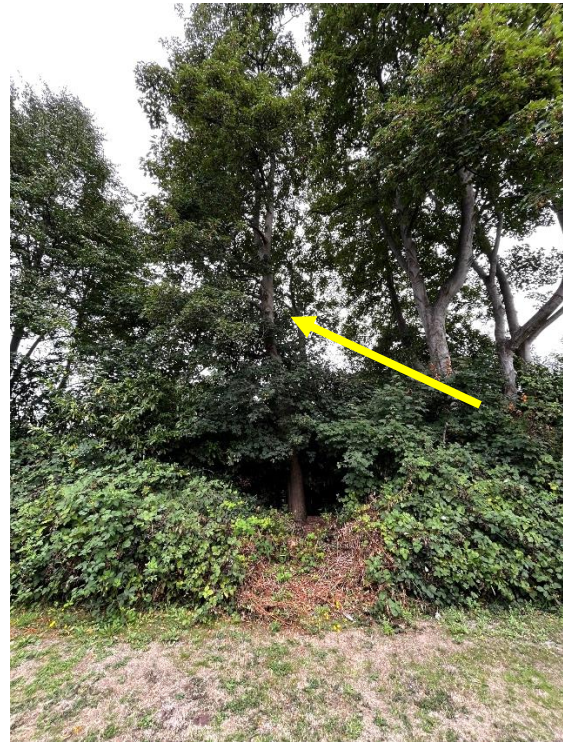
- 5.5 Following the resistograph testing of T131 Sycamore tree, the results revealed major decay and cavity formation within the stem, based on readings no. 1, 3 and 4 to the North, East, and South sides. The remaining sound and residual wood within the stem surrounding the decay is at unacceptable levels to retain this tree within this setting. The basal cavity to the South side is linked to internal decay within the stem.

- 6.4 The results gathered from the testing of T131 Sycamore tree, have shown there is major decay within the stem based upon the readings given, this creates an unacceptable level of sound and residual wood surrounding the decay. The tree is located within an area of high risk, with school grounds, general public and third-party properties all within striking distance of tree. We therefore based on the above evidence on recommend felling the Sycamore T131 to ground level. A replacement similar tree should be replanted within Winter 2025/2026.

| Tree No.<br>Tree<br>Tag. | Tree<br>Species | Hgt<br>(m) | Past<br>Management | Age Class | Risk Target | TPO Status | Defects | Works | Work Priority |
|---|---|---|---|---|---|---|---|---|---|
| T131<br>Tree<br>tag: N/A | Sycamore | 15-<br>19m | Subject to<br>previous<br>pruning. | Mature | High/<br>reinspect<br>July 2027 | No TPO in place<br>and Conservation<br>Area restrictions for<br>Mid Sussex District<br>Council . (CA)<br><br>Botanical Name:<br>( <i>Acer<br/>pseudoplatanus</i> ) | Gross Defect Noted. Major cavity to<br>Southwest side at ground level. Ivy on<br>stem previously severed. Multiple<br>pruning wounds on stem. Asymmetric<br>canopy. | Fell to ground level. | Urgent within<br>3 month. |

**T131 Sycamore measurement looking Northeast towards drill location 1 and basal cavity location.**

**T131 Sycamore looking North**

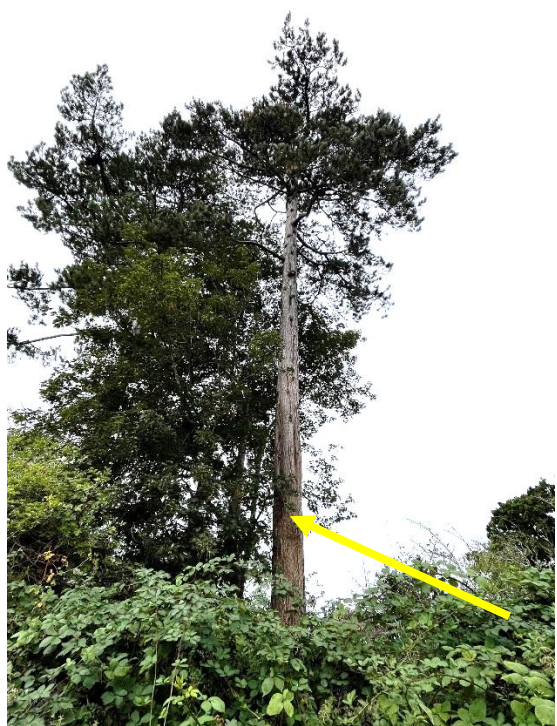
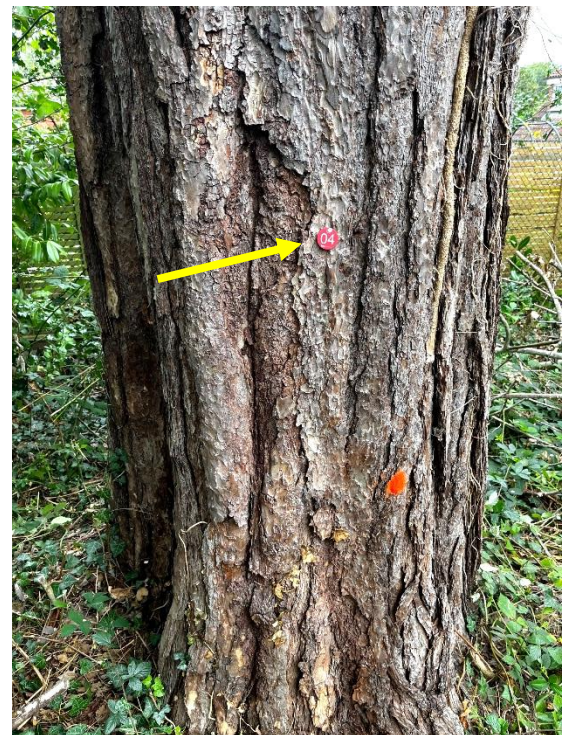
- 5.6 Following the resistograph testing of T138 Corsican pine, the testing indicated minor area of decay within the readings No. 2 And 3 to the West and Southwest side of the stem, but not significant at this time. The remaining readings taken for the tree highlighted good areas of sound and live residual sound wood. However, there is noted cavity on stem which require further investigation. Crown deadwood throughout canopy.

- 6.5 The results gathered from the testing of T138 Corsican pine tree, highlighted good areas of sound wood present, despite the minor area of decay within the stem, this is not significant at this time. The cavity located on the stem is a cause of concern and requires further investigation. The tree is located within area of high risk, with general public, third party properties, and school grounds all within striking distance of tree. We therefore based on the above evidence, to carry out a climbing inspection for the cavity to T138 Corsican pine and report back on the outcome of this inspection. The deadwood over 100mm throughout the canopy should also be removed. The work is to be completed within 3 months on urgent basis.

| Tree No.<br>Tree<br>Tag. | Tree<br>Species | Hgt<br>(m) | Past<br>Management | Age Class | Risk Target | TPO Status | Defects | Works | Work Priority |
|---|---|---|---|---|---|---|---|---|---|
| T138<br>Tree<br>tag: N/A | Corsican<br>pine | 20-<br>25m | Subject to<br>past<br>management | Mature | High/<br>reinspect<br>July 2027 | No TPO in place<br>and Conservation<br>Area restrictions for<br>Mid Sussex District<br>Council (CA)<br><br>Botanical Name:<br>( <i>Pinus nigra</i> ) | Hazardous Defect Noted, Fluting of<br>lower stem, Multiple pruning wounds<br>on stem. Cavity on stem at 6m above<br>ground level to Southeast side. Crown<br>dieback to 10-20%. Crown deadwood<br>present. | Removal of deadwood over<br>100mm throughout canopy.<br><br>Carry out climbing inspection for<br>cavity. Report back on outcome<br>of inspection. | Urgent within<br>3 months |

**T138 Corsican pine looking West.**

**T138 Corsican pine looking North towards Drill location No.4**

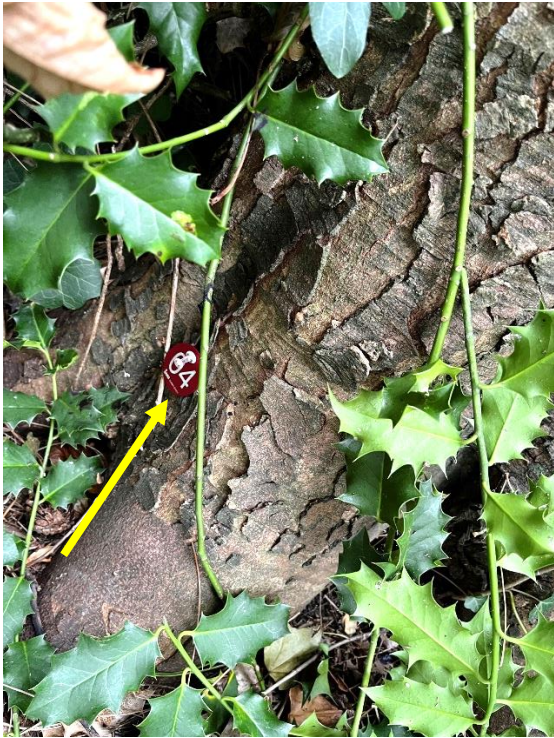
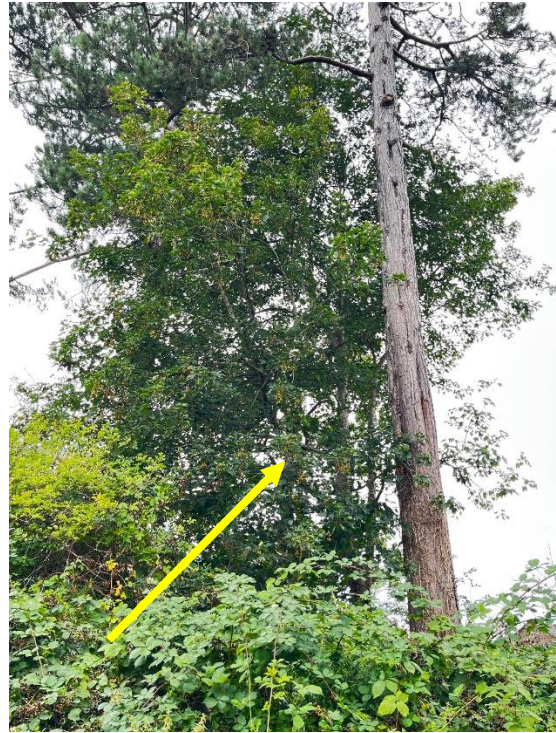
- 5.7 Following the resistograph testing of T139 Sycamore tree, the results indicated moderate levels of decay within readings No. 4 and 5 to the South and Southwest side of the stem. The remaining readings 1, 2, and 3 indicated moderate levels of sound and residual wood surrounding the decay. The stem is currently rubbing on chain link fence. The crown is suppressed due to tree group pressure from the North and South sides. Overall poor shape and form.

- 6.6 The results gathered from the testing of T139 Sycamore tree, have shown there is an area of moderate decay present within the stem, however there is still moderate sound and residual wood within the stem to retain this tree within the current height and spread. However, the tree is not suited for this setting with wire boundary fencing growing into the stem and the tree showing a poor form due to tree group pressures to the East and West sides of canopy spread. The T139 Sycamore tree is located within a high risk, with general public, third party properties, and school grounds all within striking distance of tree. We, therefore, based upon the evidence provided, recommend felling to ground level. The work is to be completed within 6 months on High priority basis. A replacement similar tree should be replanted within Winter 2026.

| Tree No.<br>Tree<br>Tag. | Tree<br>Species | Hgt<br>(m) | Past<br>Management | Age Class | Risk Target | TPO Status | Defects | Works | Work Priority |
|---|---|---|---|---|---|---|---|---|---|
| T139<br>Tree<br>tag: N/A | Sycamore | 15-<br>19m | Subject to<br>past<br>management | Mature | High/<br>reinspect<br>July 2027 | No TPO in place<br>and Conservation<br>Area restrictions for<br>Mid Sussex District<br>Council. (CA)<br><br>Botanical Name:<br>( <i>Acer<br/>pseudoplatanus</i> ) | Gross Defect Noted. Stem growing into<br>boundary wire mesh fencing. Slight<br>hollow sound when tapped to the<br>Southeast side of stem. Decayed<br>branch to the West side at 5m above<br>ground level. Poor shape and form.<br>Tree of this size is not suited for this<br>location. | Fell to ground level. | High within 6<br>months. |

**T139 Sycamore measurement looking Northeast towards drill location 4 and basal cavity location.**

**T139 Sycamore looking North**

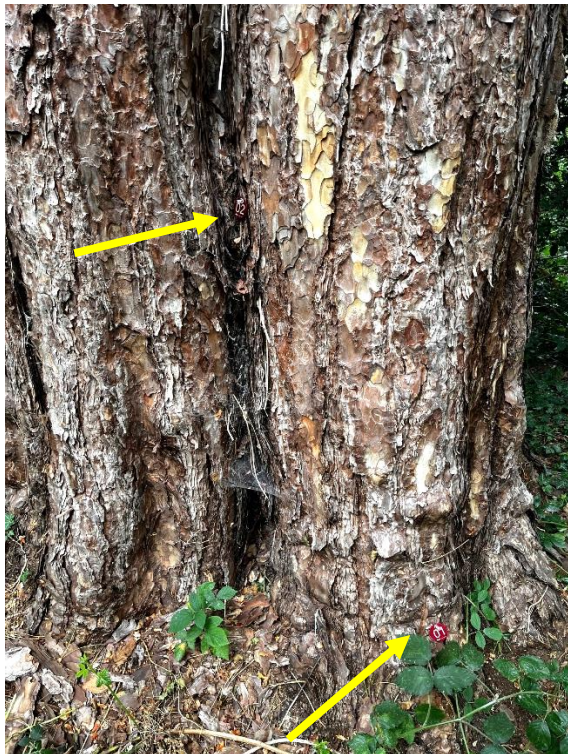
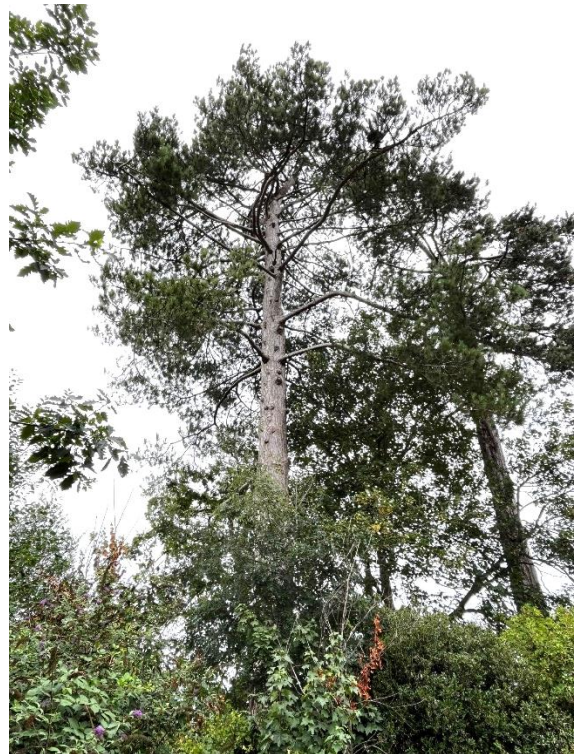
- 5.8 Following the resistograph testing of T140 Corsican pine tree, the testing indicated no decay within the stem based on the readings given, the readings showed good areas of sound and residual live wood throughout the stem. Crown deadwood is present throughout the canopy.

- 6.7 The results gathered from the testing of T140 Corsican pine tree, indicated good areas of sound wood throughout the stem based on the readings taken. There is deadwood present throughout the canopy. We, therefore, based on the evidence provided, recommend carrying out a climbing inspection throughout the canopy. Report back on outcome of this inspection. Remove deadwood over 100mm throughout canopy. The work is to be completed within 3 months on urgent basis.

| Tree No.<br>Tree<br>Tag. | Tree<br>Species | Hgt<br>(m) | Past<br>Management | Age Class | Risk Target | TPO Status | Defects | Works | Work Priority |
|---|---|---|---|---|---|---|---|---|---|
| T140<br>Tree<br>tag: N/A | Corsican<br>pine | 20-<br>25m | Subject to<br>past<br>management | Mature | High/<br>reinspect<br>July 2027 | No TPO in place<br>and Conservation<br>Area restrictions for<br>Mid Sussex District<br>Council (CA)<br><br>Botanical Name:<br>( <i>Pinus nigra</i> ) | No gross Defect Noted. Fluting to<br>lower stem, with pockets of soft wood<br>between buttress roots. Multiple<br>pruning wounds on stem. Deadwood<br>present within canopy. | Climbing inspection throughout<br>canopy. Report back on outcome<br>of inspection.<br><br>Removal of deadwood over<br>100mm throughout canopy. | Urgent within<br>3 months |

**T140 Corsican pine looking North towards Drill location No.1 and 2**

**T140 Corsican pine looking West.**

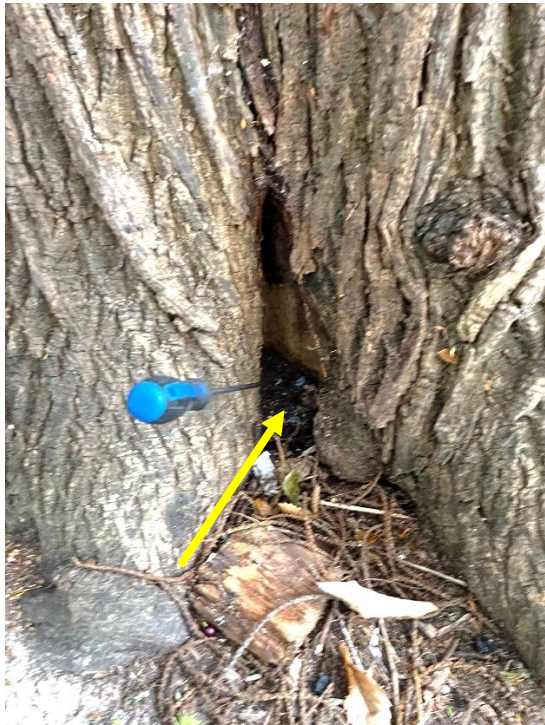
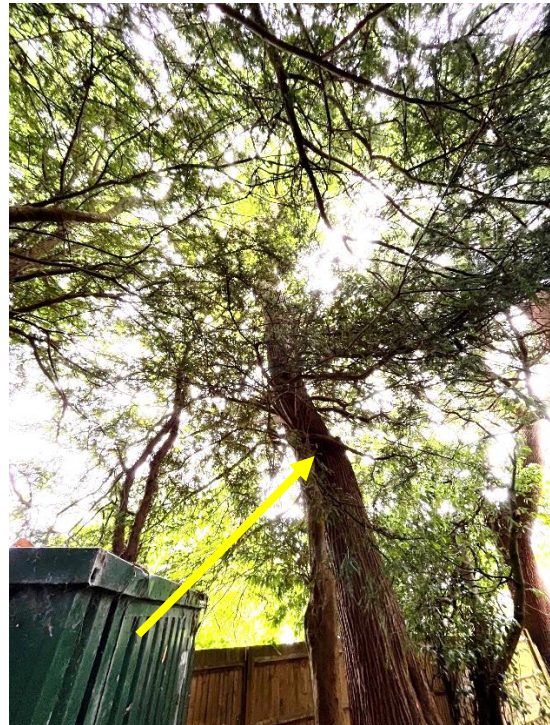
- 5.9 Following the resistograph testing of T166 Sweet chestnut tree, the results indicated sound and residual live wood throughout the readings provided. Despite the basal cavity to the East side, there is no significant link of decay to the basal cavity within the stem based on the readings provided. The crown is densely covered by adjacent tree growth and is hindering a full ground observation of the stem and canopy.

- 6.8 The results gathered from the testing of T166 Sweet chestnut tree, have shown throughout the readings that there is moderate to good levels of sound and residual wood throughout the stem, with no direct link of decay from the basal cavity. The crown inspection from ground level is hindered by adjacent tree growth, this requires further investigation. The tree is located in a rear of high risk, with forest school area, general public, third party properties and school grounds all within striking distance of tree. We, therefore, based on the evidence provided, recommend carrying out a climbing inspection throughout the canopy. Report back on outcome of this inspection. The work is to be completed within 3 months on urgent basis.

| Tree No.<br>Tree<br>Tag. | Tree<br>Species | Hgt<br>(m) | Past<br>Management | Age Class | Risk Target | TPO Status | Defects | Works | Work Priority |
|---|---|---|---|---|---|---|---|---|---|
| T166<br>Tree<br>tag: N/A | Sweet<br>chestnut | 20-<br>25m | Subject to<br>recent<br>deadwood<br>removal. | Mature | High/<br>reinspect<br>July 2027 | No TPO in place<br>and Conservation<br>Area restrictions for<br>Mid Sussex District<br>Council. (CA)<br><br>Botanical Name:<br>( <i>Castanea sativa</i> ) | No Gross Defect Noted.<br>Basal cavity to the East side, when<br>probed with probing tool, was found<br>to have depth of approx. 20-30cm,<br>with exposed heartwood, but not<br>significant at this time. Deadwood<br>within canopy recently removed.<br>Canopy inspection from ground level<br>restricted by neighbouring tree<br>growth. Crown weighted towards the<br>West due to tree group pressure from<br>South and North sides. | Climbing inspection throughout<br>canopy. Report back on outcome<br>of inspection. | Urgent within<br>3 month. |

**T166 Sweet chestnut measurement looking West towards basal cavity, note probing tool.**

**T166 Sweet chestnut looking West**

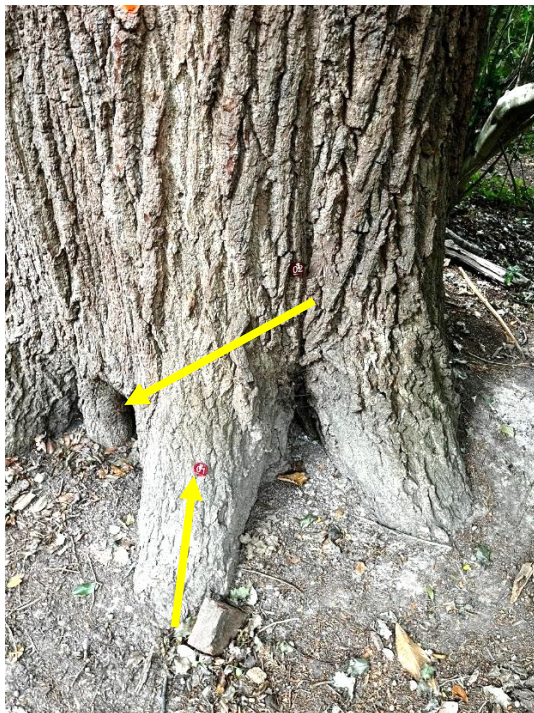
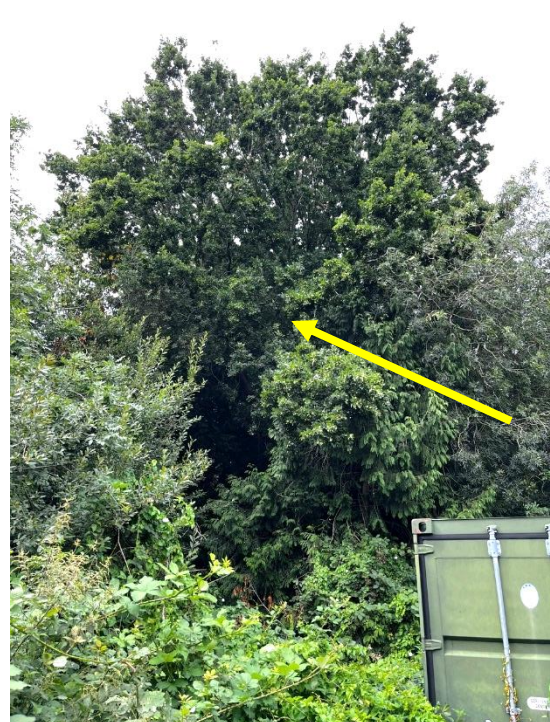
- 5.10 Following the resistograph testing of T174 English oak tree, the testing revealed areas of minor to moderate decay within the reading no. 1, 2, East side of stem, however, there is still good areas of sound and residual live wood surrounding the areas of decay within the readings No. 3, 4,5 and 6. To the North, South and West sides of stem. The tree has co-dominant stems at 5m above ground level, with multiple decayed stems at 8m and 16m above ground level to East and West sides of canopy. Crown deadwood present throughout canopy.

- 6.9 The results gathered from the testing of T174 English oak tree, have indicated areas of moderate decay within the stem, based on the readings provided. However, there is evidence of sound and residual live wood surrounding the areas of decay within the stem to retain this tree within its current height and spread. However, there are concerns of decayed stems further up within the canopy which require closer inspection. The tree is located in a rear of high risk, with forest school area, general public, third party properties and school grounds all within striking distance of tree. Based on the evidence provided, we therefore recommend T174 English oak to carry out a climbing inspection within the canopy, and report back on the outcome of this inspection. Remove deadwood over 100mm throughout canopy. The work is to be completed within 3 months on urgent basis.

| Tree No.<br>Tree<br>Tag. | Tree<br>Species | Hgt<br>(m) | Past<br>Management | Age Class | Risk Target | TPO Status | Defects | Works | Work Priority |
|---|---|---|---|---|---|---|---|---|---|
| T174<br>Tree<br>tag: | English<br>oak | 20-<br>25m | Subject to<br>past<br>management | Mature | High/<br>reinspect<br>July 2027 | No TPO in place<br>and Conservation<br>Area restrictions for<br>Mid Sussex District<br>Council. (CA)<br><br>Botanical Name:<br>( <i>Quercus robur</i> ) | No Gross Defect Noted. Basal cavity to<br>the Southeast side, with depth of<br>40cm approx. Slight hollow sound<br>when tapped to that area. Multiple<br>pruning wounds on stem. Co dominant<br>stems at 5m above ground level.<br>Decayed stem at 16m above ground<br>level to East and 2 decayed stems to<br>West sides at 8m above ground level.<br>Deadwood present within canopy. | Climbing inspection throughout<br>canopy, report back on outcome<br>of inspection.<br><br>Removal of deadwood over<br>100mm throughout canopy. | Urgent within<br>3 month. |

**T174 English oak looking West towards Drill location No.1 and basal cavity location.**

**T174 English oak looking North.**

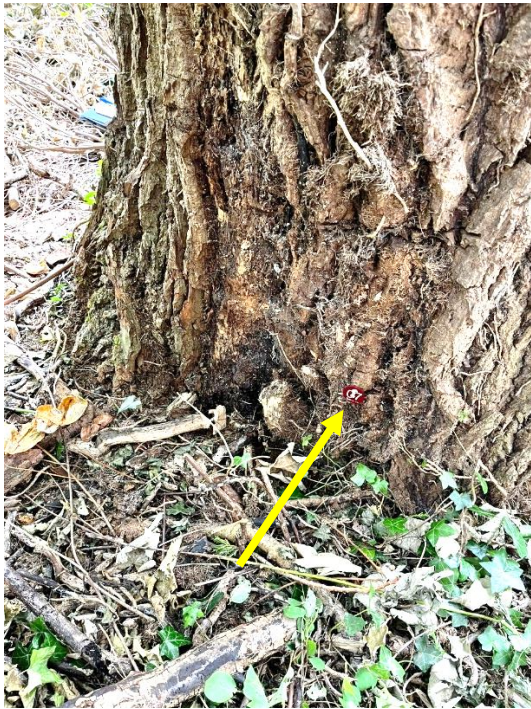
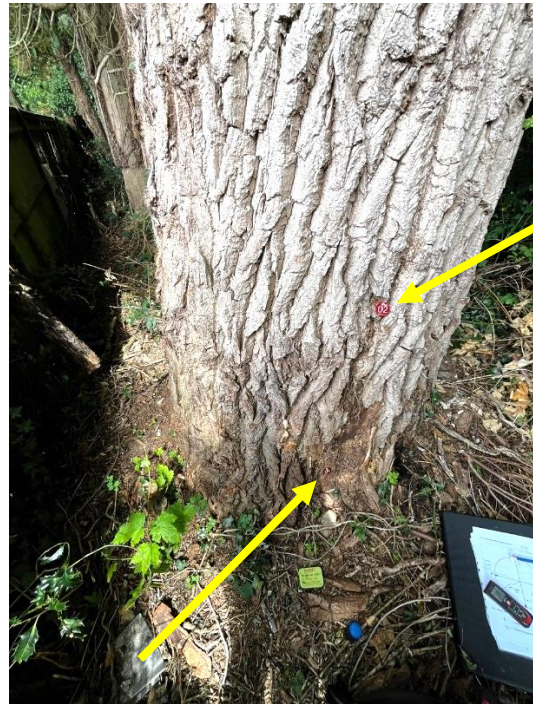
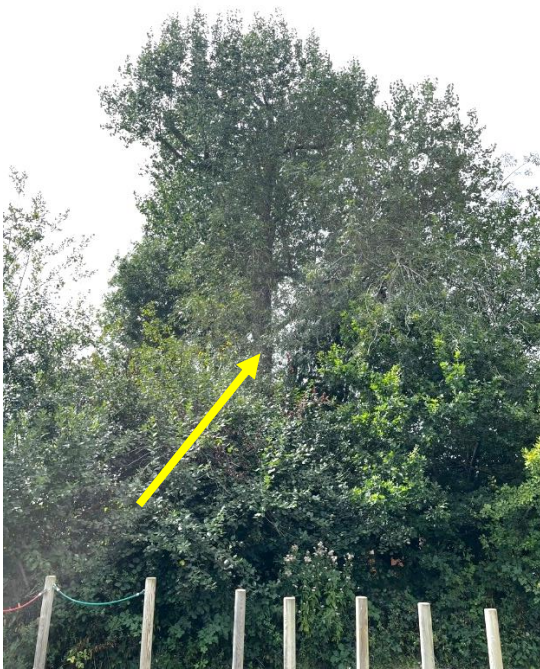
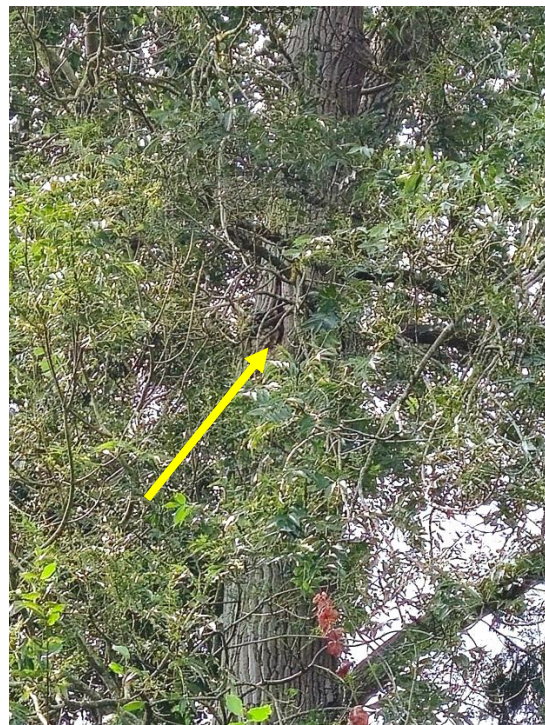
- 5.11 Following the resistograph testing of T206 Poplar spp, the results indicated major decay within the stem to the East and Southwest side within readings No. 1 and 7, the remaining readings indicated unacceptable levels of sound wood surrounding the decayed area of the stem to retain this tree at its current height and spread. A cavity is located on stem at 9m above ground level. The tree has been previously pollarded.

- 6.10 The results gathered from the testing of T206 Poplar spp. have highlighted within the readings major decay within the stem, with unacceptable levels of sound and residual wood to retain this tree at its current height and spread. The tree is also noted to have cavity located on main stem at approx. 9m above ground level. Due to the location of this tree T206 Poplar spp, the tree is in an area of high risk with general public, third party properties and school grounds all within striking distance of tree, we therefore based upon the evidence provided to carry out a climbing inspection for the cavity on the main stem, if found not significant then proceed with pollard to 8m above ground level. The work is to be completed within 3 months on urgent basis.

| Tree No.<br>Tree<br>Tag. | Tree<br>Species | Hgt<br>(m) | Past<br>Management | Age Class | Risk Target | TPO Status | Defects | Works | Work Priority |
|---|---|---|---|---|---|---|---|---|---|
| T206<br>Tree<br>tag: N/A | Poplar<br>spp. | 20-<br>25m | Managed as<br>high pollard | Mature | High/<br>reinspect<br>July 2027 | No TPO in place<br>and Conservation<br>Area restrictions for<br>Mid Sussex District<br>Council. (CA)<br><br>Botanical Name:<br>( <i>Populus spp</i> ) | Gross Defect Noted.<br>Major stem decay to East side, major<br>hollow sound when tapped with<br>sounding hammer to 30cm above<br>ground level. Multiple pruning wounds<br>on stem. Cavity on stem at 9m above<br>ground level towards Southwest side.<br>Historic pollard. | Climbing inspection for cavity on<br>stem. Report back on outcome of<br>inspection.<br><br>Pollard to 8m above ground level. | Urgent within<br>3 month. |

**T206 Poplar spp. Looking West towards  
measurements drill location No.7**

**T206 Poplar spp. Looking Northeast towards  
measurements drill location No.1 and 2.**

**T206 Poplar spp. Looking West.**

**T206 Poplar spp. looking West towards cavity  
location on stem.**
