Asbestos Refurbishment Survey

6800

2 Sussex Road

Report produced for
Dearling Ltd

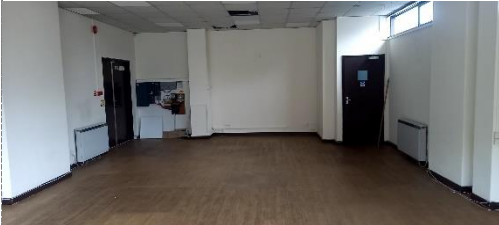
Item	Level	Location / Room number	Survey Type	Sample Reference	Quantity				
1	Ground floor	Shop	Refurbishment / Pre-Demolition

Material Description						
			Solid construction- Ceiling, floor and walls						
			Additional Information						
			No further action required						
			Access	Prod Type	Ext of Damage	Surface Treat	Asbestos Type	Material Risk	Asbestos Type
			-	-	-	-	-	-	Nadis
Recommendations									
No further action required

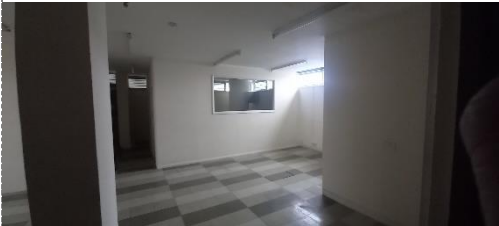
Item	Level	Location / Room number	Survey Type	Sample Reference	Quantity				
2	First Floor	Offices	Refurbishment / Pre-Demolition

Material Description						
			Solid construction- Ceiling, floor and walls						
			Additional Information						
			No further action required						
			Access	Prod Type	Ext of Damage	Surface Treat	Asbestos Type	Material Risk	Asbestos Type
			-	-	-	-	-	-	Nadis
Recommendations									
No further action required

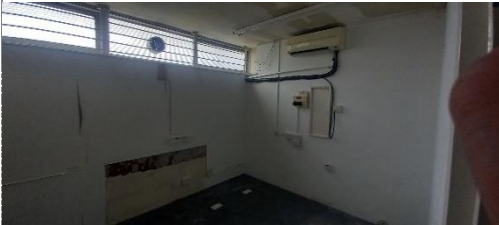
Item	Level	Location / Room number	Survey Type	Sample Reference	Quantity				
3	First floor	Storage	Refurbishment / Pre-Demolition

Material Description						
			Solid construction- Ceiling, floor and walls, floor tiles						
			Additional Information						
			No further action required						
			Access	Prod Type	Ext of Damage	Surface Treat	Asbestos Type	Material Risk	Asbestos Type
			-	-	-	-	-	-	Nadis
Recommendations									
No further action required

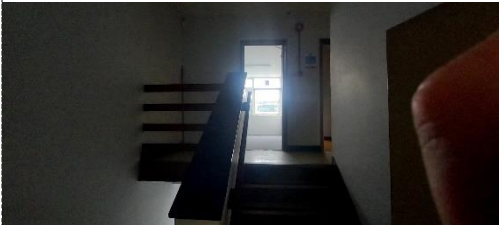
Item	Level	Location / Room number	Survey Type	Sample Reference	Quantity				
4	First Floor	Staircase	Refurbishment / Pre-Demolition

Material Description						
			Solid construction- Ceiling, floor and walls Floor Modern Tiles						
			Additional Information						
			No further action required						
			Access	Prod Type	Ext of Damage	Surface Treat	Asbestos Type	Material Risk	Asbestos Type
			-	-	-	-	-	-	Nadis
Recommendations									
No further action required

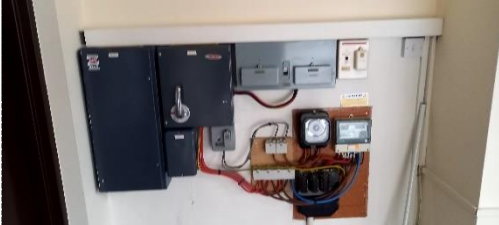
Item	Level	Location / Room number	Survey Type	Sample Reference	Quantity				
6	Ground	Electric box	Refurbishment / Pre-Demolition

Material Description						
			Walls – solid construction						
			Additional Information						
			No further action required						
			Access	Prod Type	Ext of Damage	Surface Treat	Asbestos Type	Material Risk	Asbestos Type
			-	-	-	-	-	-	Nadis
Recommendations									
No further action required

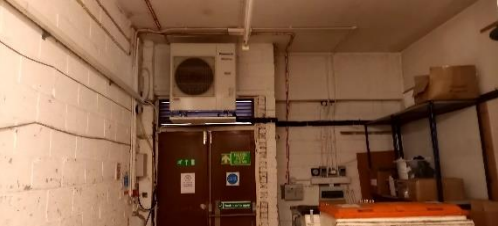
Item	Level	Location / Room number	Survey Type	Sample Reference	Quantity				
7	First	Storage Room	Refurbishment / Pre-Demolition

Material Description						
			Solid construction- Ceiling, floor and walls						
			Additional Information						
			No further action required						
			Access	Prod Type	Ext of Damage	Surface Treat	Asbestos Type	Material Risk	Asbestos Type
			-	-	-	-	-	-	Nadis
Recommendations									
No further action required
