JUSTIFICATION

TIMBER FRAME REPAIR TO MAIN PARLOUR

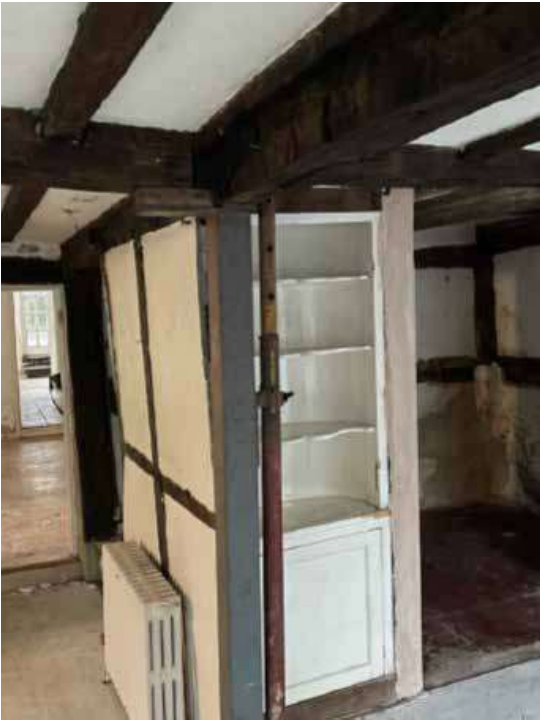
Pre-construction photograph - steel post supporting timber frame

The replacement of the steel post propping the building’s timber frame has been approved at planning. This has been implemented and the steel post was replaced with a traditional gun stock post in seasoned oak. HCUK Heritage Report notes that:

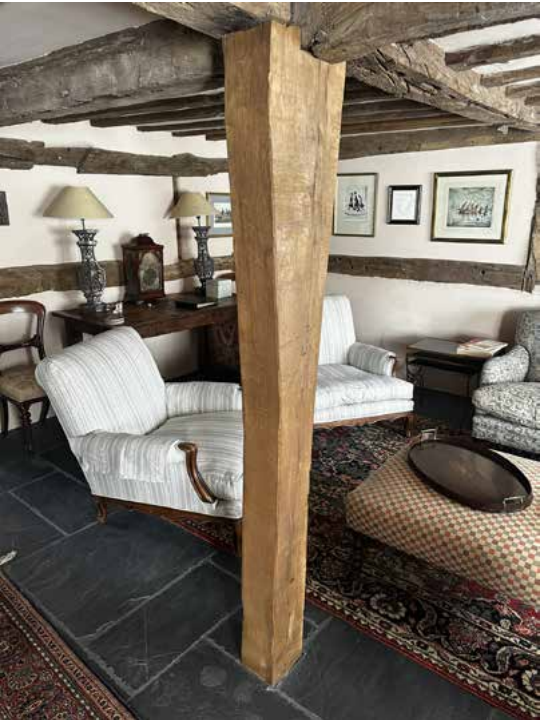
Steel post replaced with traditional gunstock post in seasoned oak

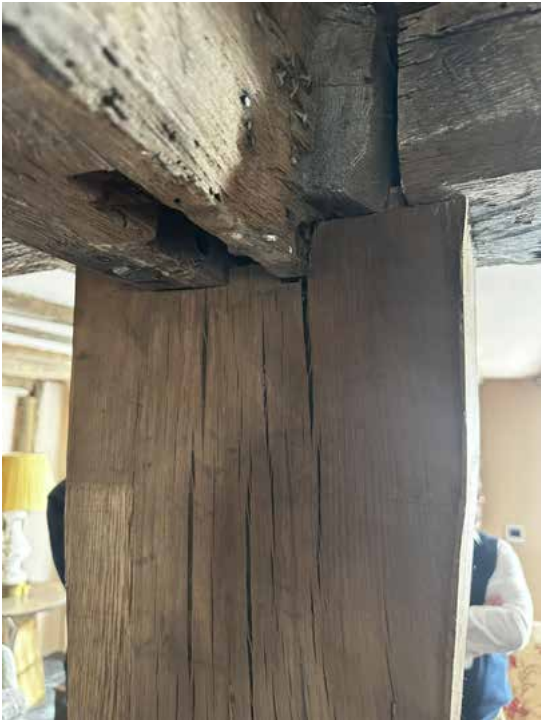
Junction of the traditional gunstock post in seasoned oak to existing ceiling beams

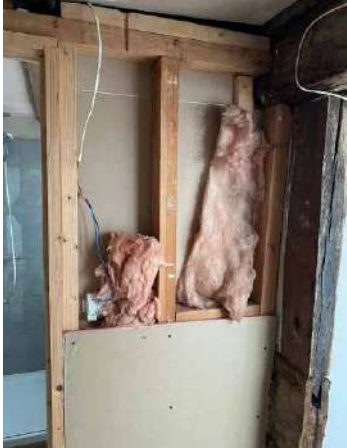
Poor quality bathroom wall build up exposed before demolition

Removal of existing, poor quality wall and construction of new partition wall, reinstatement of sliding door to en-suite.

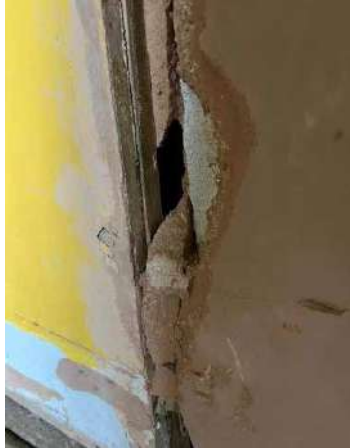
Poor quality bathroom wall before demolition

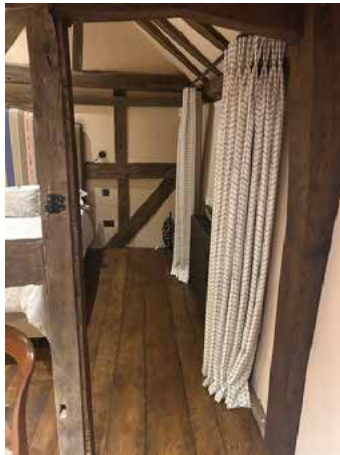
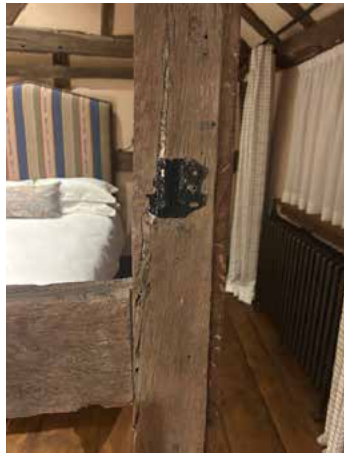
The non-original infill to the partition wall between two rooms was removed, the addition of doors was not implemented. Original timber frame retained. Historically the opening that is present was indeed present. There are stains on the original oak frame that indicate the location of a butterfly door hinge, and thus the installation of a door. The infill panels were infilled with modern finishes that broke away when the stair was removed up to the attic – works that had permission. The original frame has been retained in all it's beauty to ensure the legibility of the secular rooms in this area, but infill panels of modern materials removed. It is proposed that the lime plaster infill panels will be reinstated within the timber frame.

Photographs of the historic door frame hinge stain in the northern bedroom proving there was a door

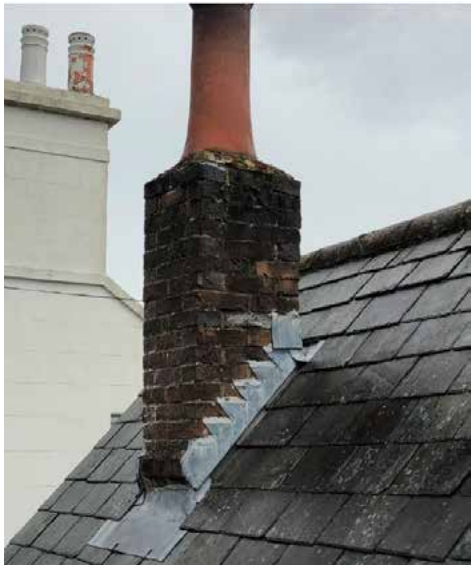
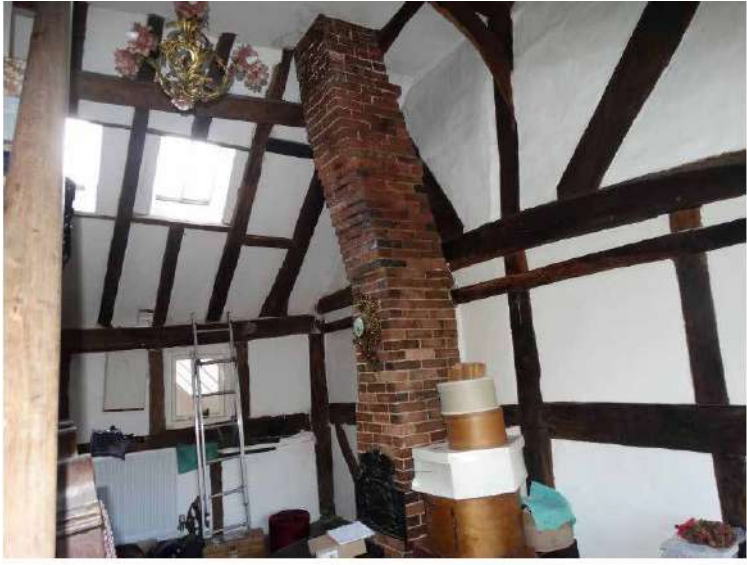
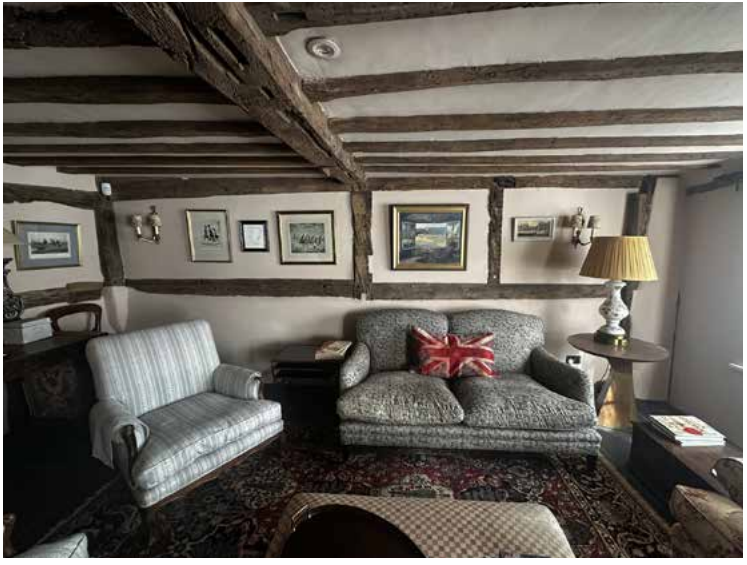
The existing chimney stack was in a poor structural condition, as quoted below from ‘Condition Report’ by Gould Baxter:

1. In general terms the stack remains reasonably upright and plumb, although it is noted that where it penetrates the master bedroom below, it is raked to an angle.

3. The flaunching appears to be coming to the end of its useful

4. The chimney pot appears to remain in satisfactory condition with some soot staining noted. When replacing the flaunching allowances should be made to replace the pot and cap if no longer in use.

5. The stack is not provided with a horizontal damp tray to mitigate vertical damp penetration.

6. The junction between the stack and roof slopes are weathered with lead flashing. From our vantage point the flashing appeared in serviceable condition, but the presence of damp staining internally would suggest current or historic damp penetration. Further investigation is required once high level access is provided but we would anticipate the flashing will require renewal. life expectancy, with cracking and surface spalling noted. The flaunching should be renewed, with high level access provided to facilitate works.

External and internal photographs of the chimney stack prior to removal

The condition of the chimney stack was assessed by Structural Engineer McCarey Simmons. The adjacent Structural Report produced on the 29th of August 2023 highlights that the chimney within the north bedroom was structurally unsound due to excessive corbelling without adequate restraint. The upper brickwork and mortar was in poor condition, with areas of displacement noted, and there was evidence of water ingress from defective flashing. Given the extent of the corbel and lack of structural support, repair works would present a significant risk.

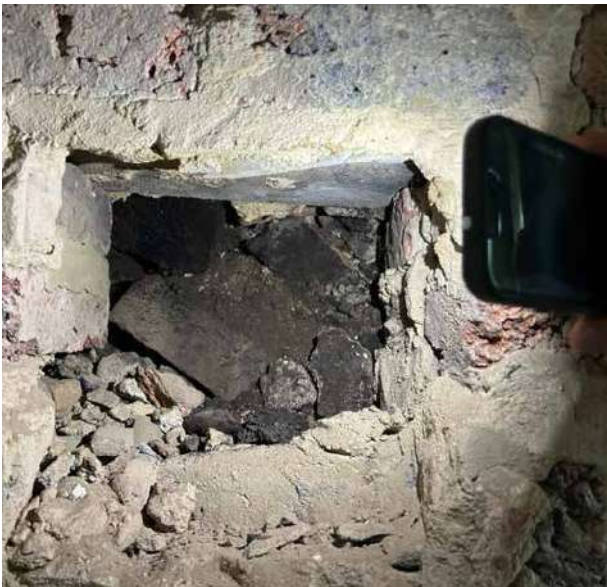
Ground floor living chimney breast assessment, opening from hall side. Chimney breast blocked up and not usable.

1. Initial, exploratory hole made on hallway side of chimney to visually investigate the construction of the chimney - blockwork was found to be located within the build ups

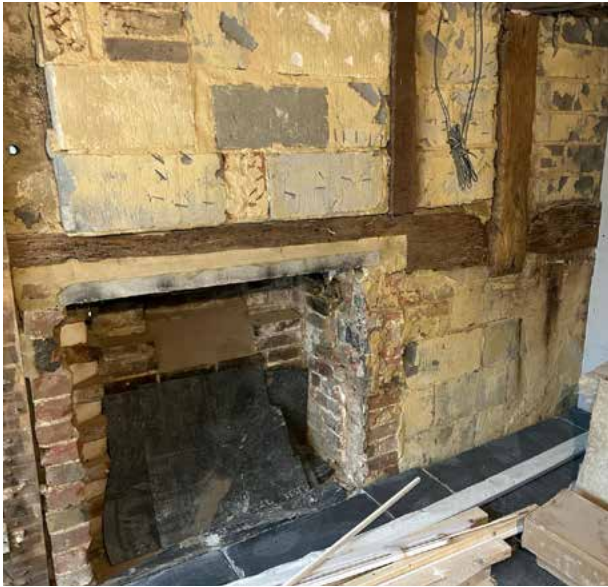
Ground floor living chimney breast under construction, prior to re-facing. Non-original blockwork wall infill exposed.

2. Existing blockwork removed from behind the existing hearth
3. Reclaimed brickwork cleaned where required across full extent of chimney prior to any repair works.

4. Any serious erosion from spalled brickwork removed, then cleaned out and infilled with new brickwork and mortar mix with colour, texture and pointing to match existing.

5. Chipped or cement coated bricks removed, cleaned out and infilled with new brickwork and mortar mix with colour, texture and pointing to match existing.

6. Any open mortar joints, if not found to be a consequence of structural defects, cleaned out and infilled with new mortar mix with colour, texture and pointing to match existing.

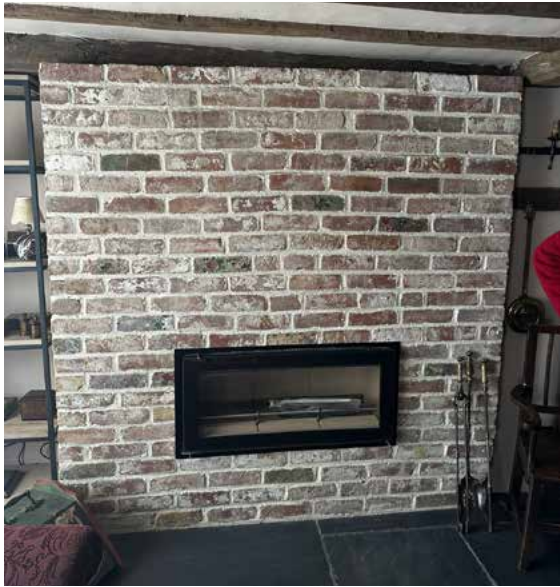
Ground floor living room re-faced chimney breast

The condition of the ground floor main chimney breast has been significantly improved. The chimney breast has been re-faced in reclaimed brick using hydraulic lime mortar, with a new hearth being incorporated. This is considered an improvement to the listed house and a heritage benefit as outlined in the supporting HCUK heritage statement.

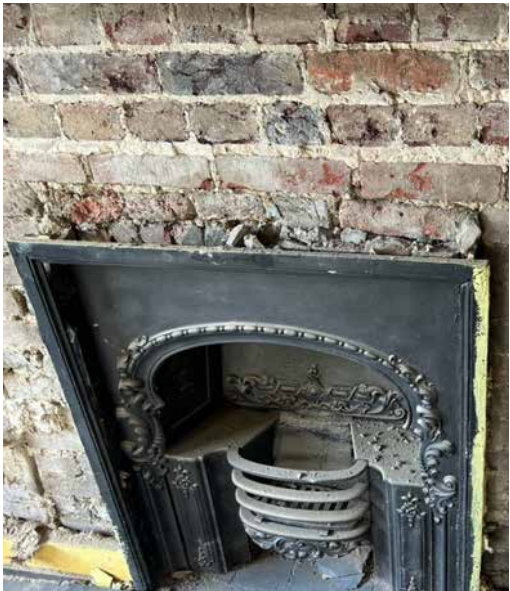
First floor bedroom fireplace and chimney breast before works

1. Existing fireplace insert removed
2. Brickwork infill around inserted fireplace removed to reinstate the historic firebox
3. Reclaimed brickwork cleaned where required across full extent of chimney prior to any repair works.
4. Any serious erosion from spalled brickwork removed, then cleaned out and infilled with new brickwork and mortar mix with colour, texture and pointing to match existing.
5. Chipped or cement coated bricks removed, cleaned out and infilled with new brickwork and mortar mix with colour, texture and pointing to match existing.
6. Any open mortar joints, if not found to be a consequence of structural defects, cleaned out and infilled with new mortar mix with colour, texture and pointing to match existing.
7. New timber mantle by Nick Cane of Cruck Frame Carpentry installed above the opening. Timber treated to match the floorboards.

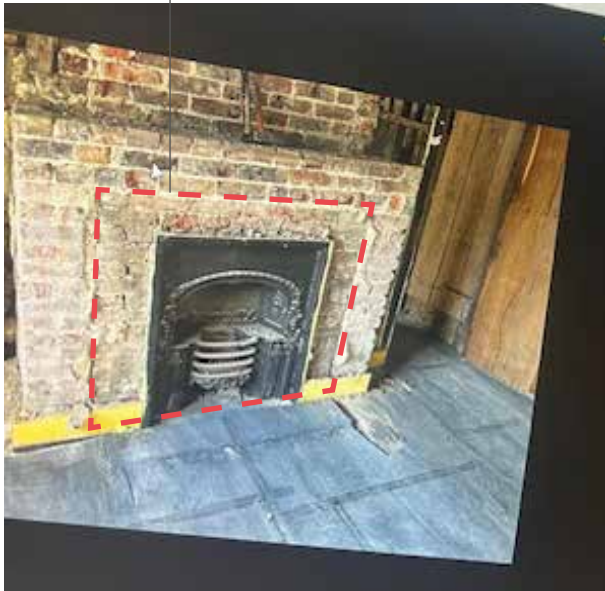
Original firebox blocked up

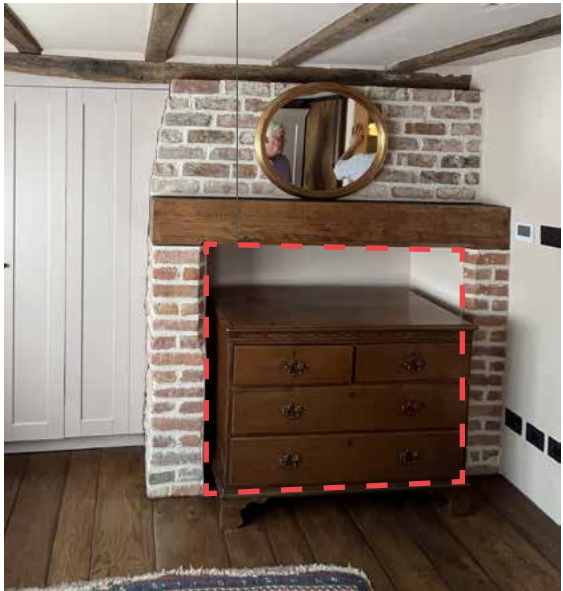
Original firebox retained

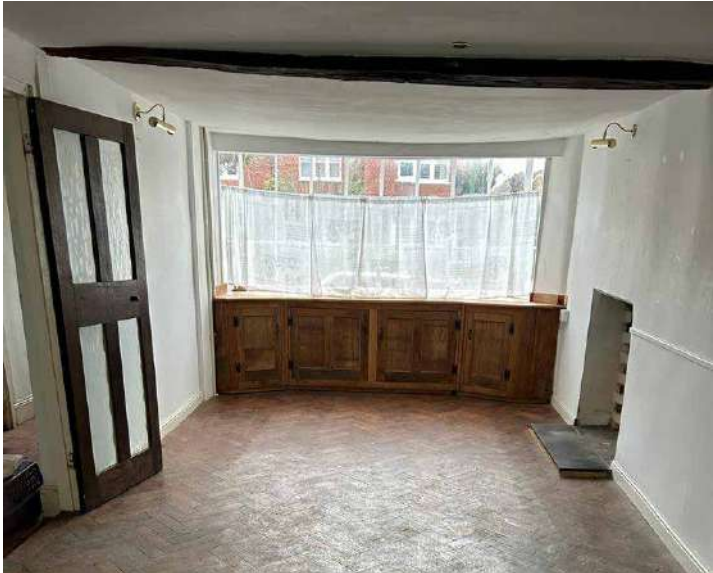
Ground floor study fireplace before works- opening on the right side

1. Previously blocked up firebox opened up
2. Firebox cleaned up, debris removed
3. Opening decreased in height - using masonry infill with lime plaster covering, decorated to match surrounding wall finish
4. New electric fireplace insert installed

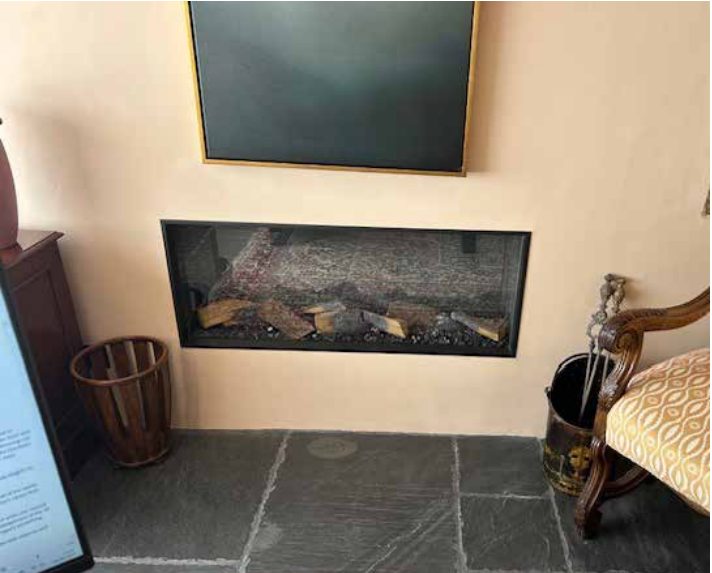
Ground floor study fireplace- electric fire place on the right side
