**Reference:** WGCS/T1/VTA/2025

**RE: Visual Tree Assessment (VTA) of Mature Oak at Grovelands Farm, Highbrook Lane, West Hoathly, RH19 4PL**

Following my site visit dated **21st November 2025**, and completion of a **ground-level Basic Visual Tree Assessment (VTA)** of the mature Oak (T1) located at **Grovelands Farm**, please find below the full written report of findings.

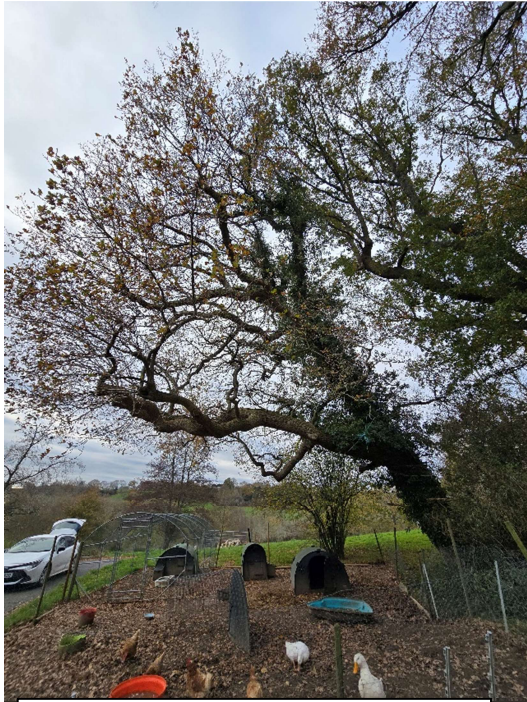
Photo B7 – Northwestern Aspect  
Showing Lean and Ivy

Structurally, the tree exhibits a pronounced lean toward the west. This lean appears long-established and is likely the result of historical competition for light from adjacent trees, combined with the tree's own adaptive growth over time. The ground on the north-east side of the stem has been raised historically, with soil built up against the trunk in a way that obscures part of the natural root flare. This raised ground prevented a full inspection of the basal area on that side.

A significant amount of ivy is present on the main stem and throughout the crown. The ivy restricts visibility of several unions and prevents a complete assessment of their structural integrity; however, where unions were visible, they appeared strong and generally U-shaped.

The presence of ivy throughout the crown and across parts of the main stem restricted full visibility of the unions and the basal area. For this reason, it would be beneficial to sever the ivy at the base to allow it to die back naturally, after which a clearer assessment can be made. Monitoring of the basal area and the suspected fungal activity is advised over time, particularly following periods of heavy wind or ground saturation.

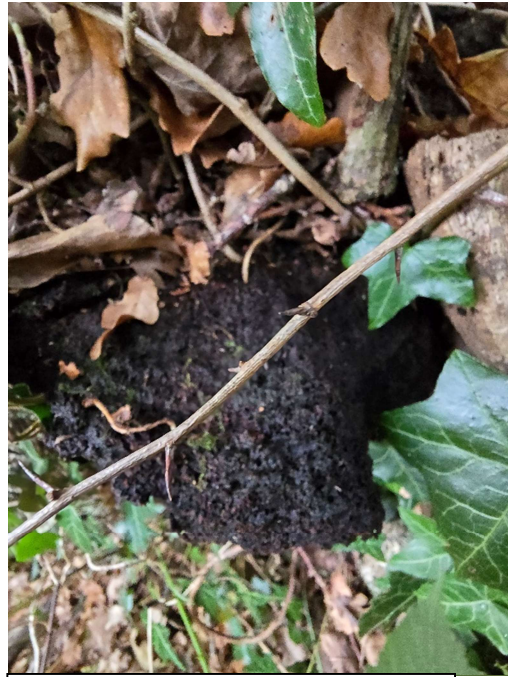
Photo B1 – Basal Ganoderma  
Fruiting Body (In Situ)

Fungal brackets, consistent in appearance with Ganoderma, are present low on the east side of the stem. Probing behind the area where the bracket was observed identified a shallow pocket of decay confined to the outer section of the stem, but firm wood was encountered beyond this depth. At the time of inspection, this decay did not appear to be causing significant structural compromise, although ongoing monitoring will be required.

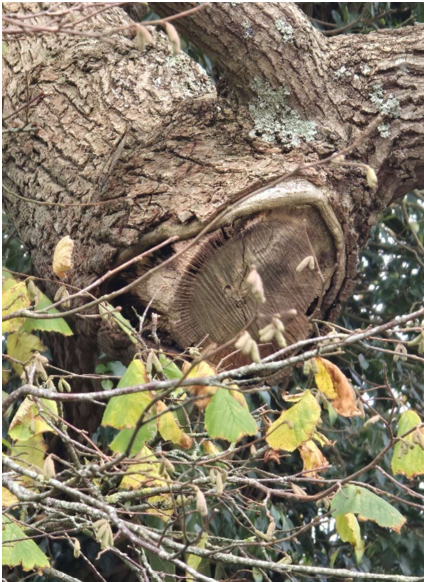
Photo B4 – Old Pruning Wound  
on Lower Western Limb

Several older pruning wounds were noted on the lower southern and western limbs. These wounds exhibit normal reactionary growth, with callus tissue forming around the cut surfaces. Some exposed heartwood is still visible, with minor cracking that is typical of historic pruning rather than indicative of active decay. No major dysfunctional wood or cavities were identified around these pruning sites.
