ground floor plan

notes + revisions					client + project		title		scale	number
					Telbridge Properties		Existing Ground Floor Plan		1 : 50 @ A3	2236.S06
					Twineham Court Farmhouse				date	status
					Bob Lane, Twineham				14.11.2022	SURVEY

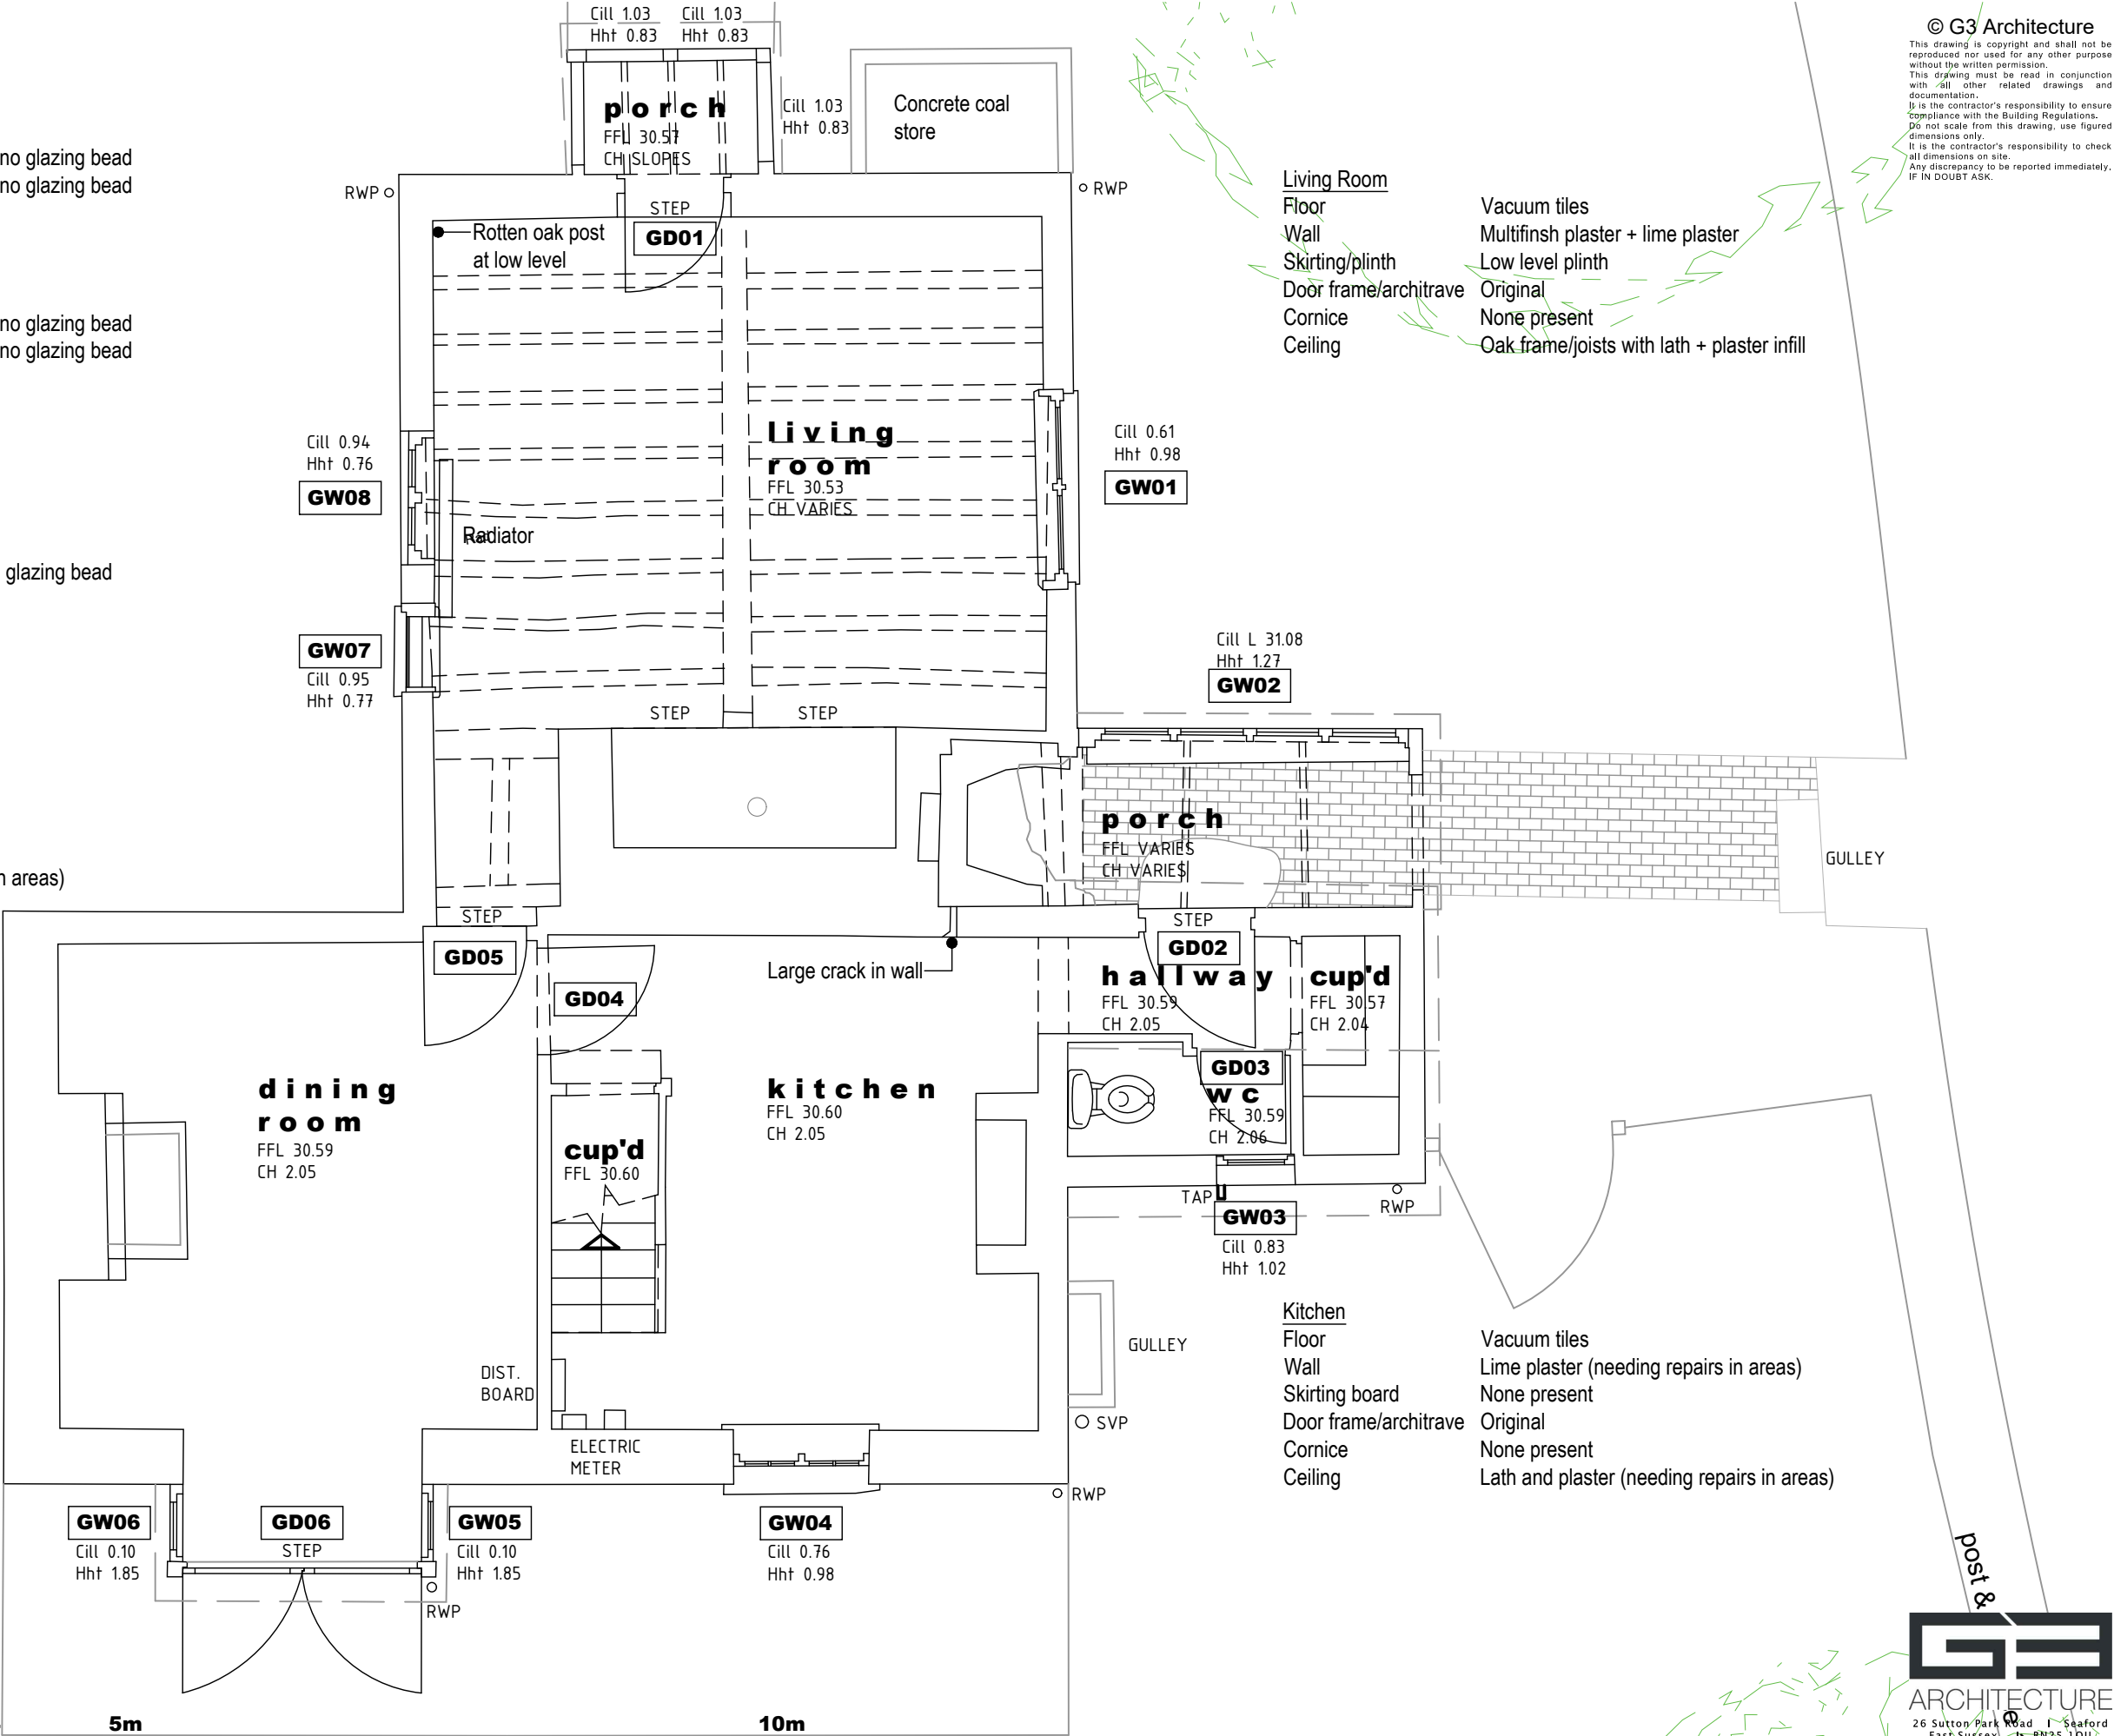
| GW01 | Living Room | Window frame in sound condition, no glazing bead |
| GW02 | Porch | Window frame in sound condition, no glazing bead |
| GW03 | WC | Poor quality replacement |
| GW04 | Kitchen | Good quality replacement |
| GW05 | Dining Room | Good quality replacement |
| GW06 | Dining Room | Good quality replacement |
| GW07 | Living Room | Window frame in sound condition, no glazing bead |
| GW08 | Dining Room | Window frame in sound condition, no glazing bead |

| GD01 | Living Room | Original |
| GD02 | Porch | Original |
| GD03 | WC | Original |
| GD04 | Kitchen/Dining Room | Original |
| GD05 | Dining Room/Living Room | Original |
| GD06 | Dining Room | Good condition, no glazing bead |
| Radiator | Not historic - modern panel radiator |

| Floor | Vacuum tiles |
| Wall | Lime plaster |
| Skirting board | None present |
| Door frame/architrave | Original |
| Cornice | Not historic |
| Ceiling | Lath and plaster (needing repairs in areas) |

| Wall | Multifinsh plaster + lime plaster |
| Skirting/plinth | Low level plinth |
| Cornice | None present |
| Ceiling | Oak frame/joists with lath + plaster infill |

| Wall | Lime plaster (needing repairs in areas) |
