notes + revisions						client + project		title		scale		number	
						Telbridge Properties		Existing Rear + Side Elevations		1 : 50 @ A3		2337.S08	
						Twineham Court Garage				date		status	
						Bob Lane, Twineham				09.06.2023		SURVEY

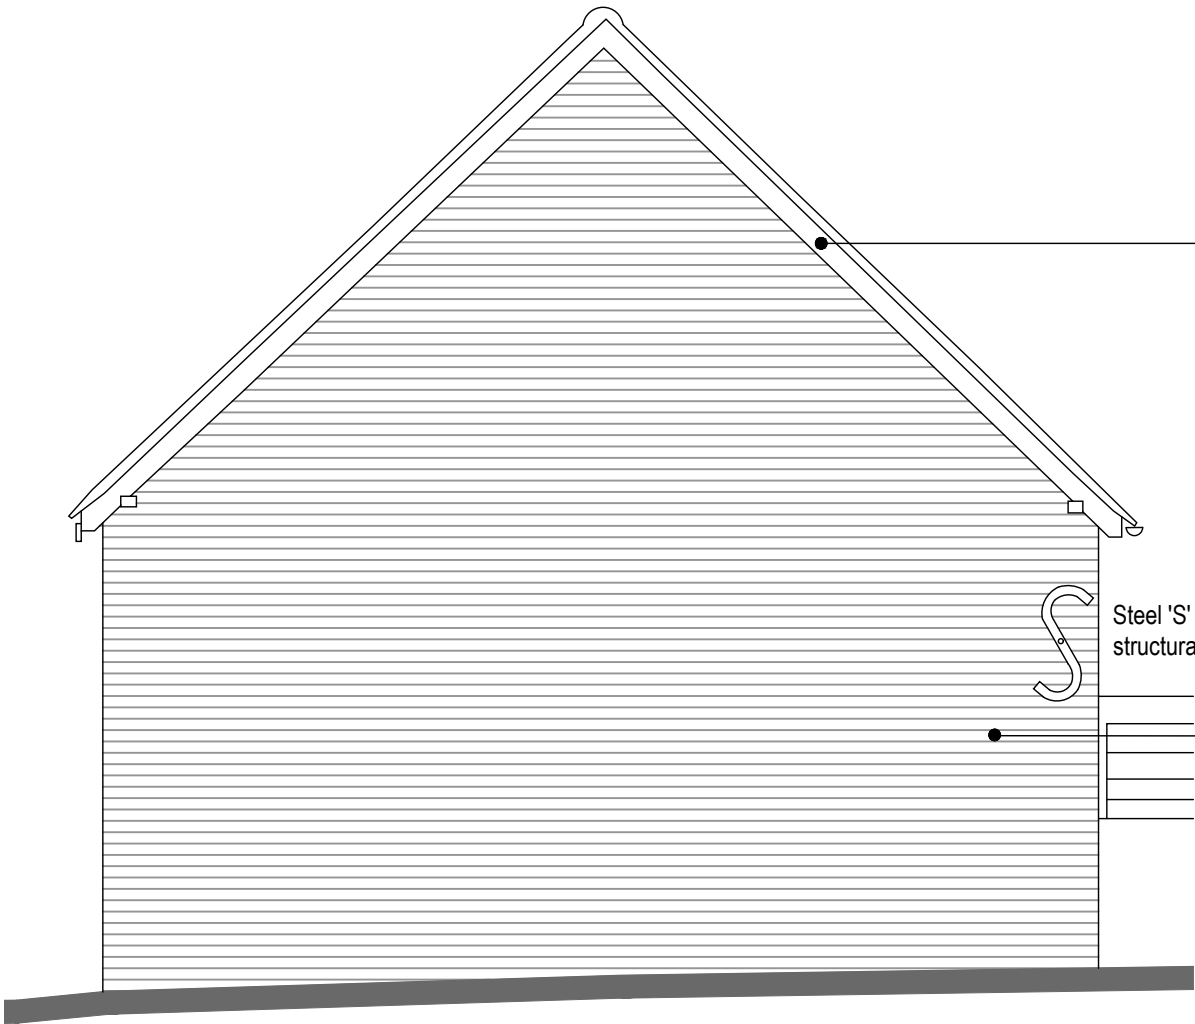
rear elevation
north

Various slipped tiles + missing tiles. The roof tiles look to be in good condition (subject to closer inspection and seeing the nibs)

Existing clay peg tiles vary in size between 150x255mm to 160x252mm

Timber verge to gable

No gutter present, only gutter brackets remain

Face brickwork, general condition is good (will require some localised repair work, to match existing bricks and lime mortar)

Rainwater pipe does not go to the eaves

Cementitious low level render

Steel 'S' structural tie

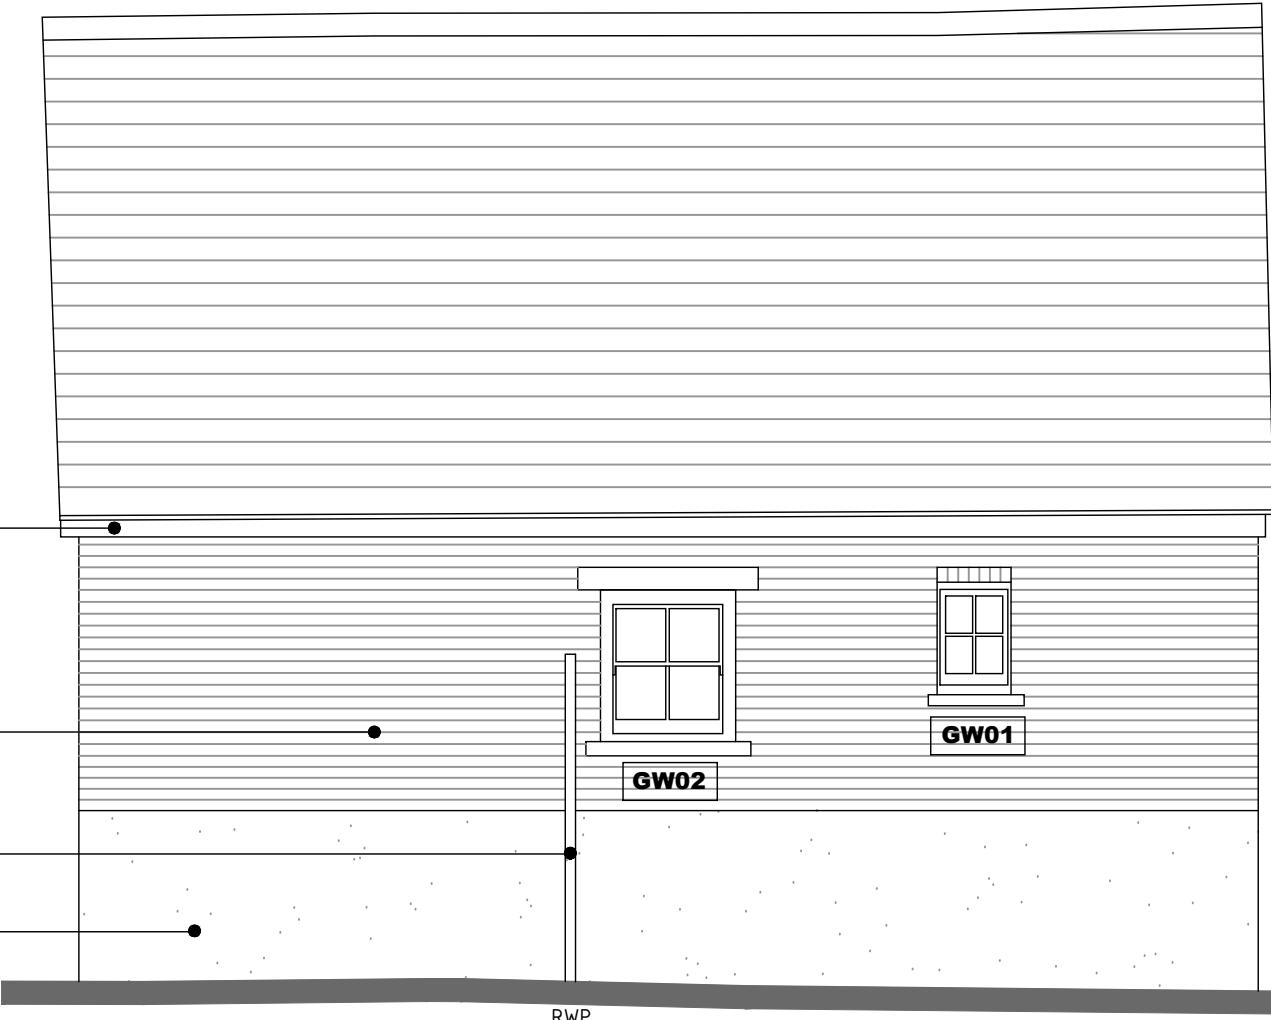
side elevation
east

Windows
GW01 Garage Timber casement, requires localised repair work + decoration
GW02 Garage Timber sash, requires localised repair work + decoration
