## Appendix C – Construction Photographs

WORK ALLOCATION SHEET

| Work Description | Pond installation |

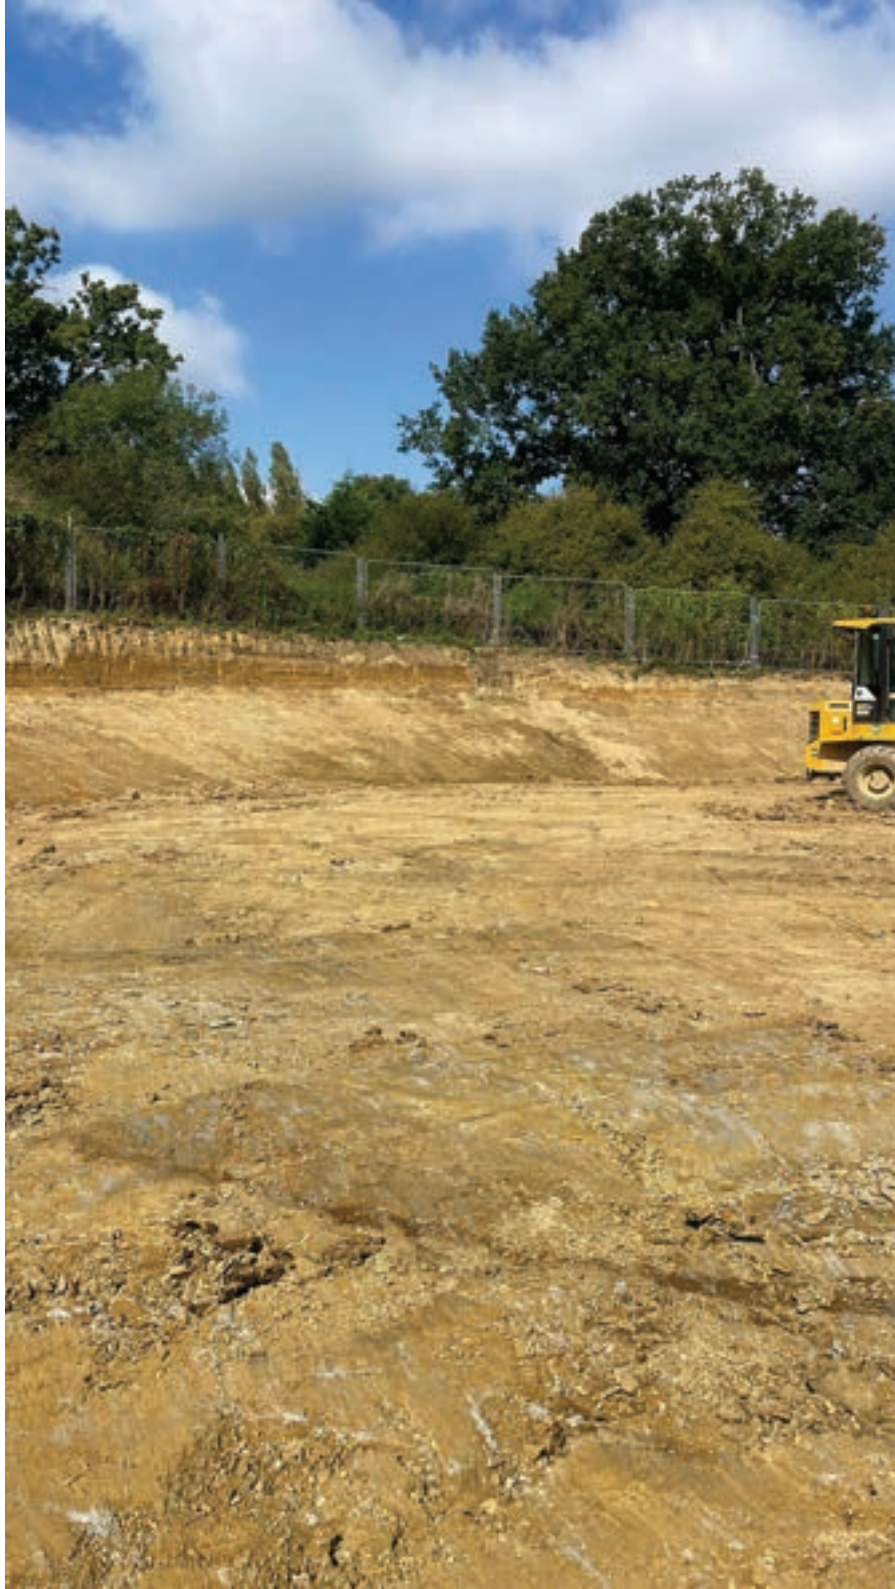
Photo 1 - Pond earthworks

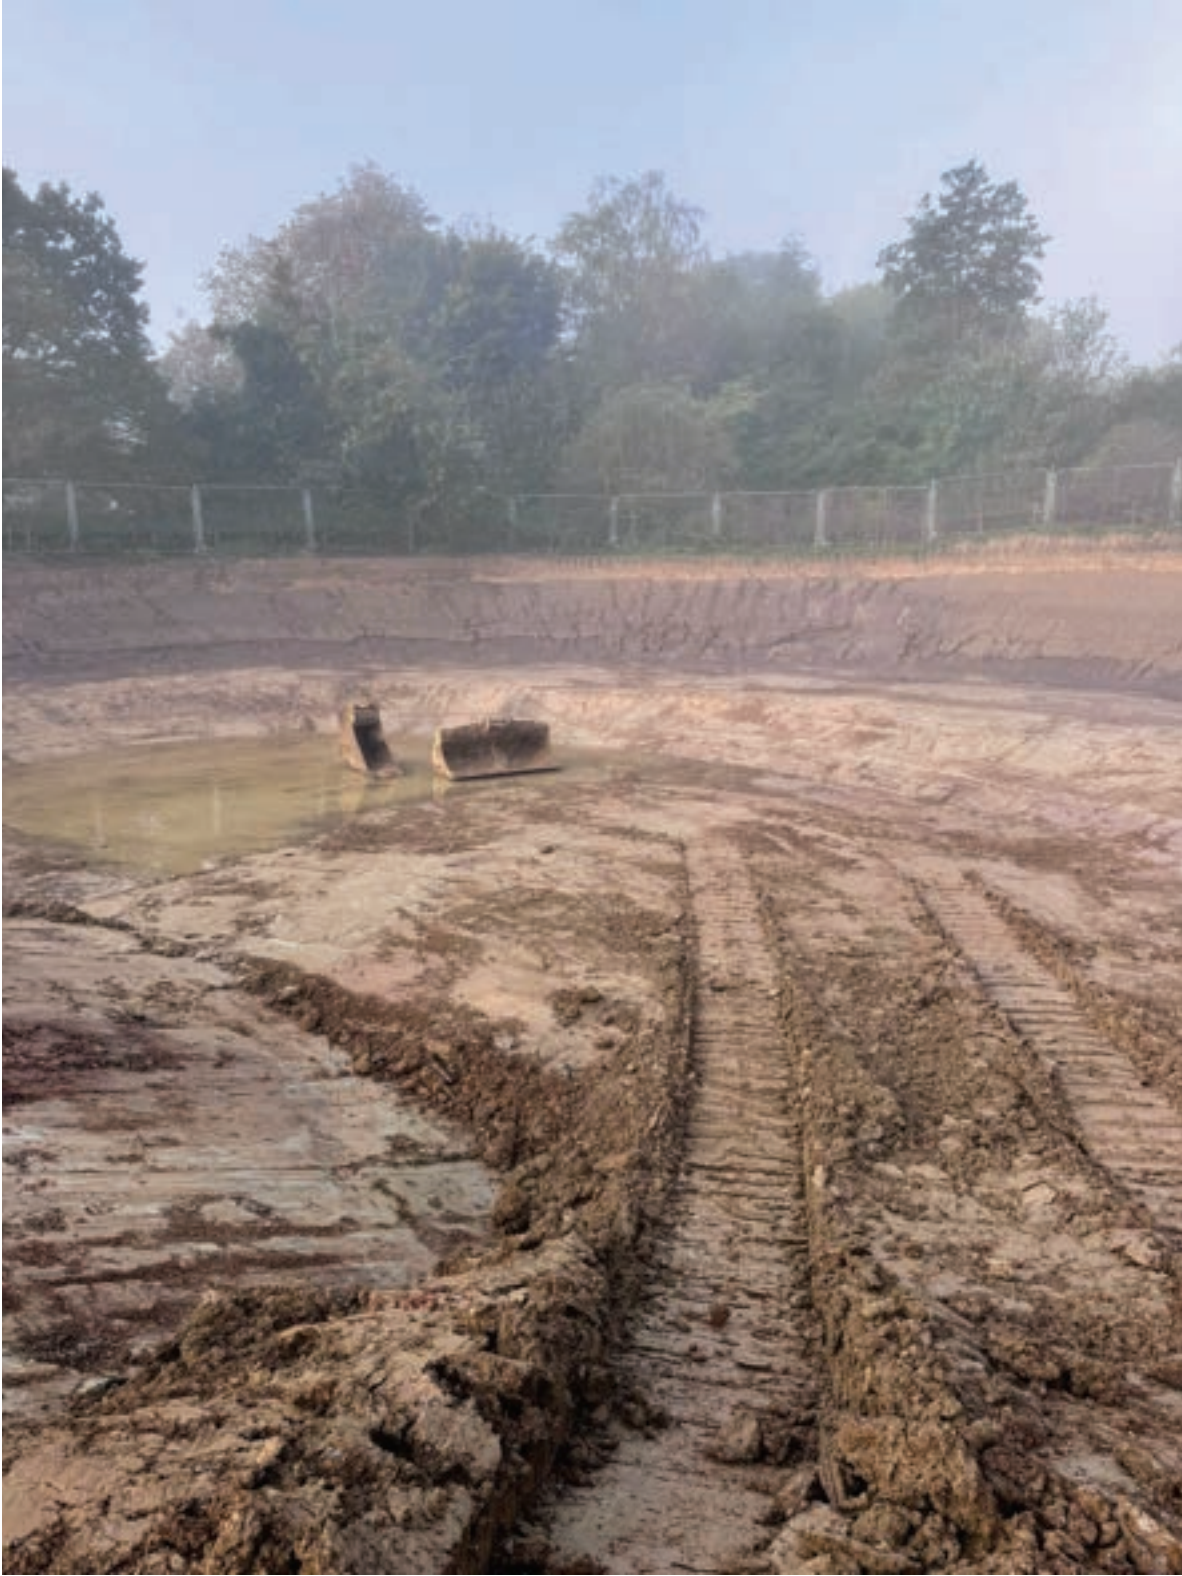
Photo 2 - Pond earthworks

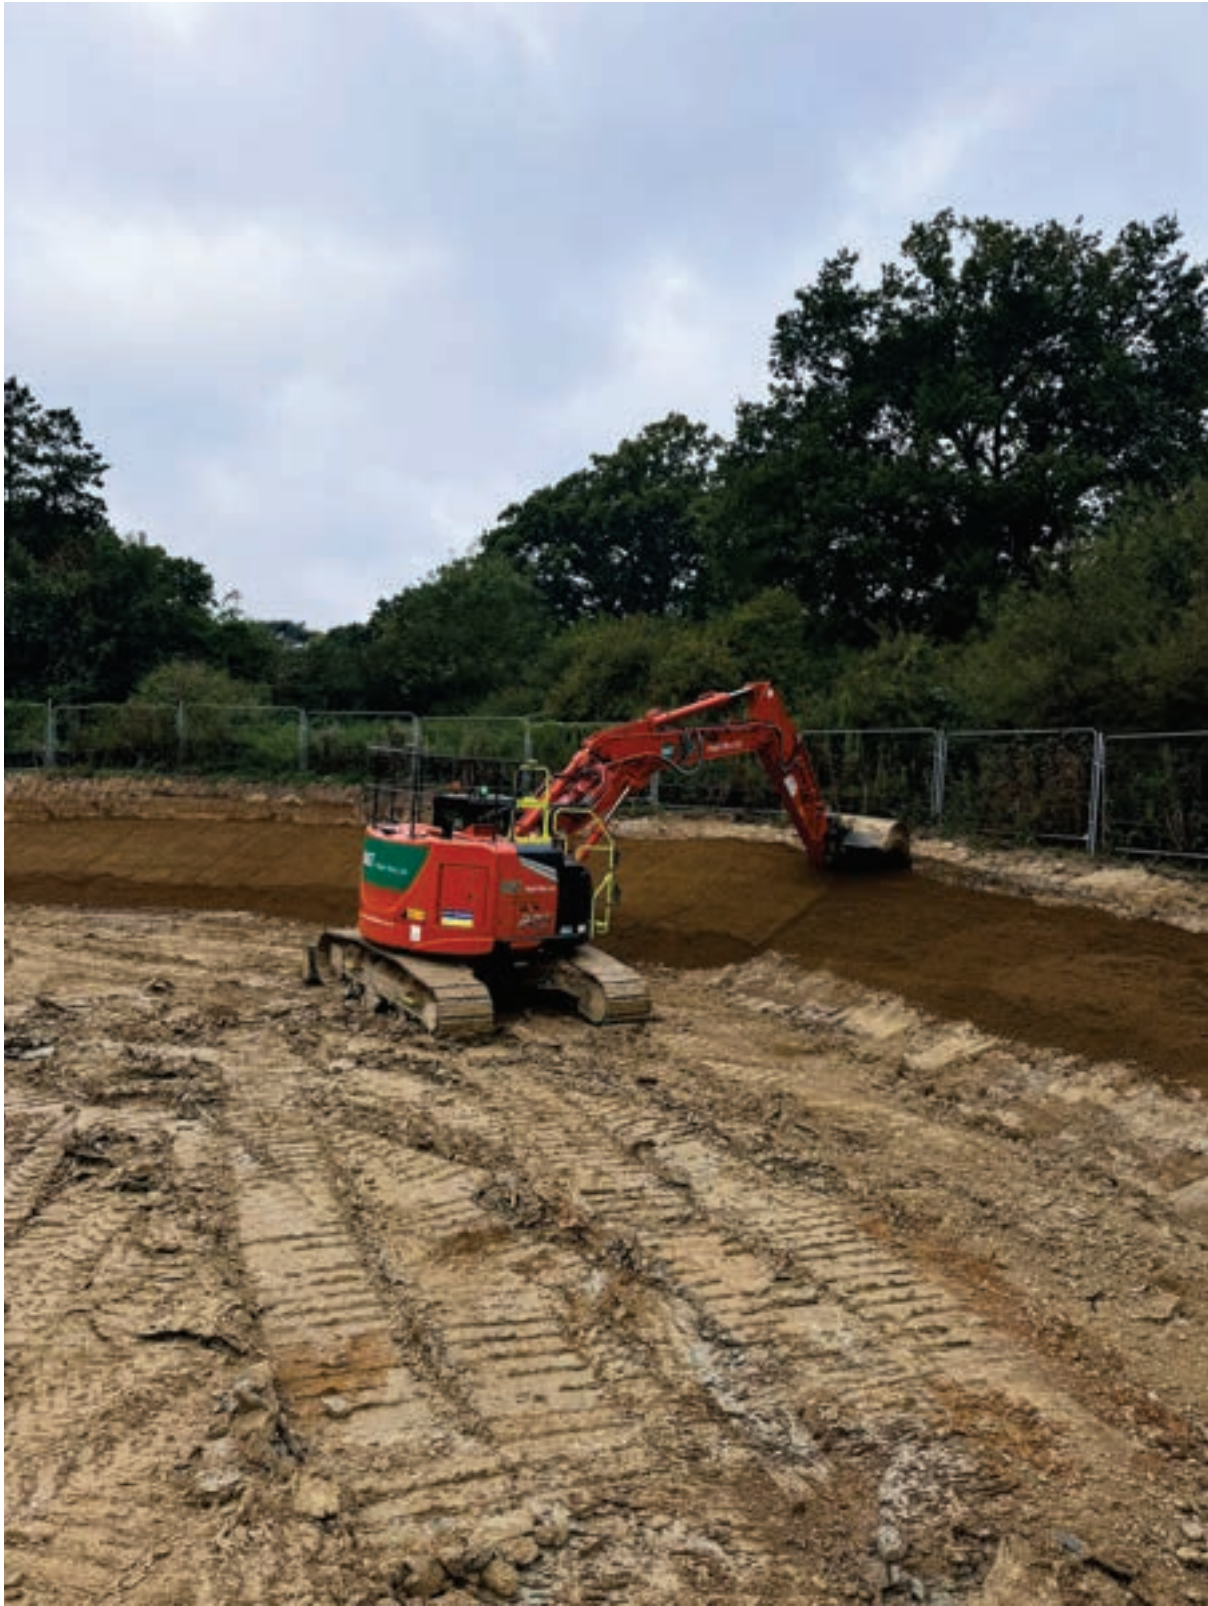
Photo 3 - Pond earthworks

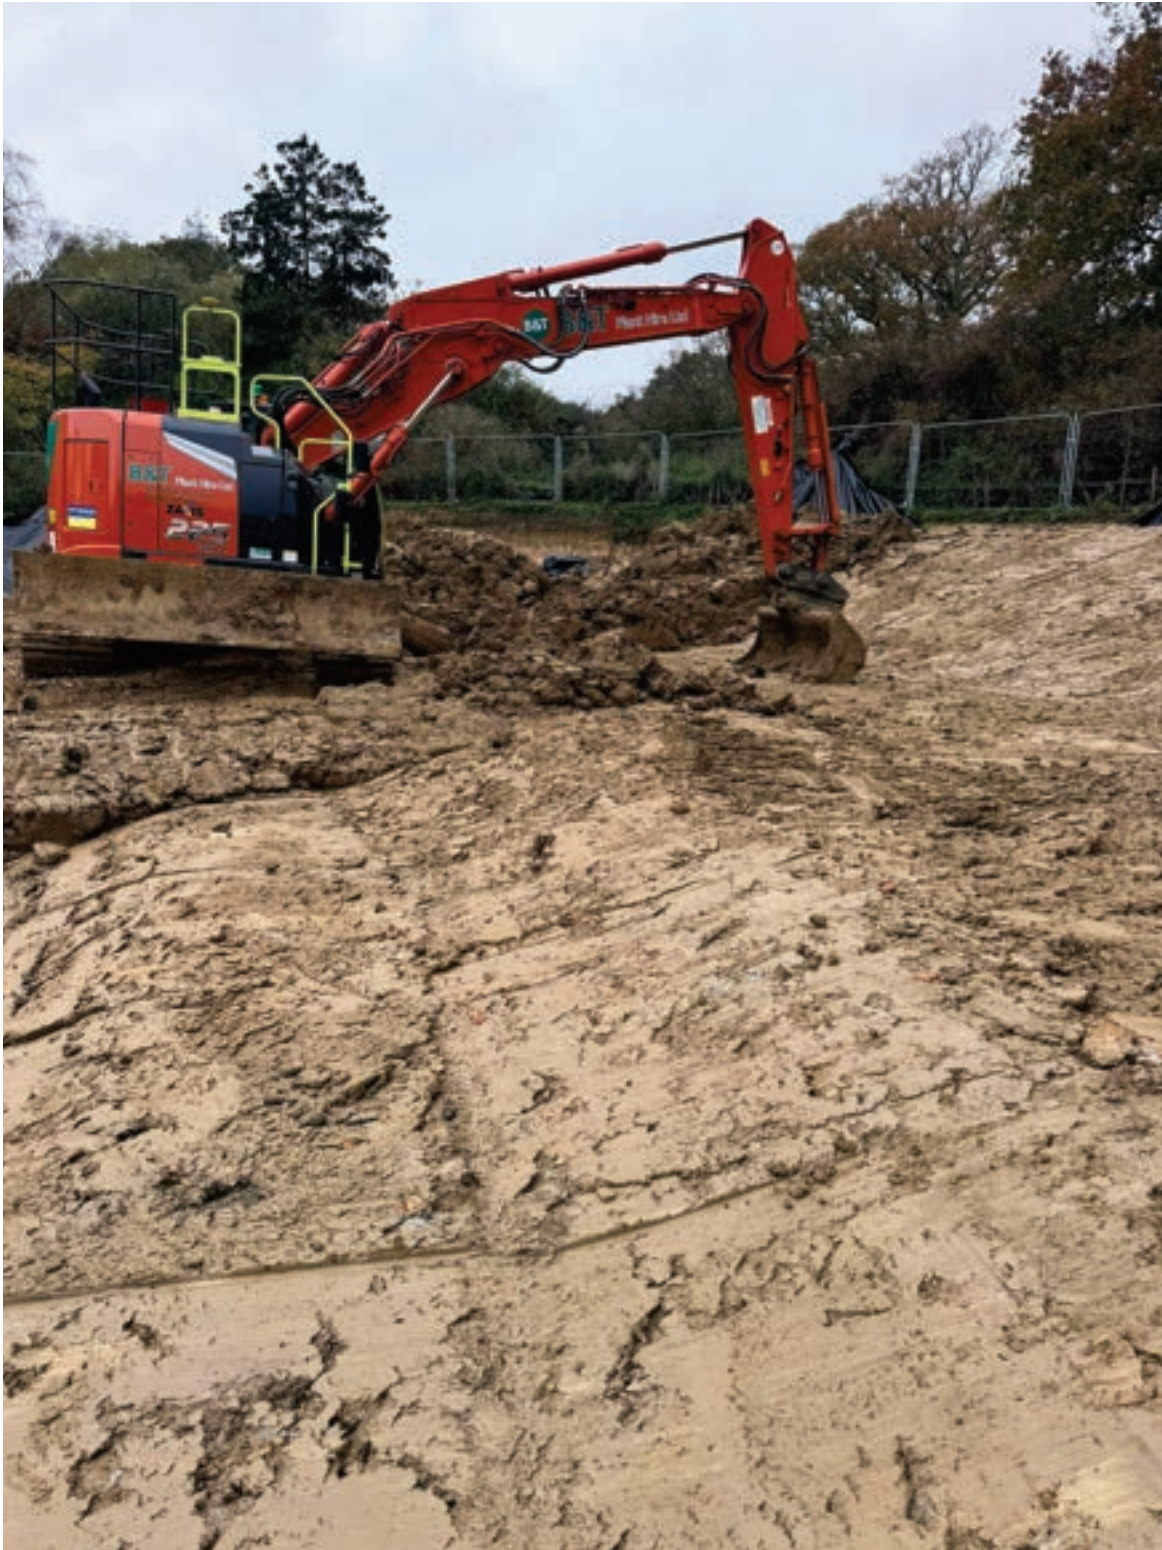
Photo 4 - Pond earthworks

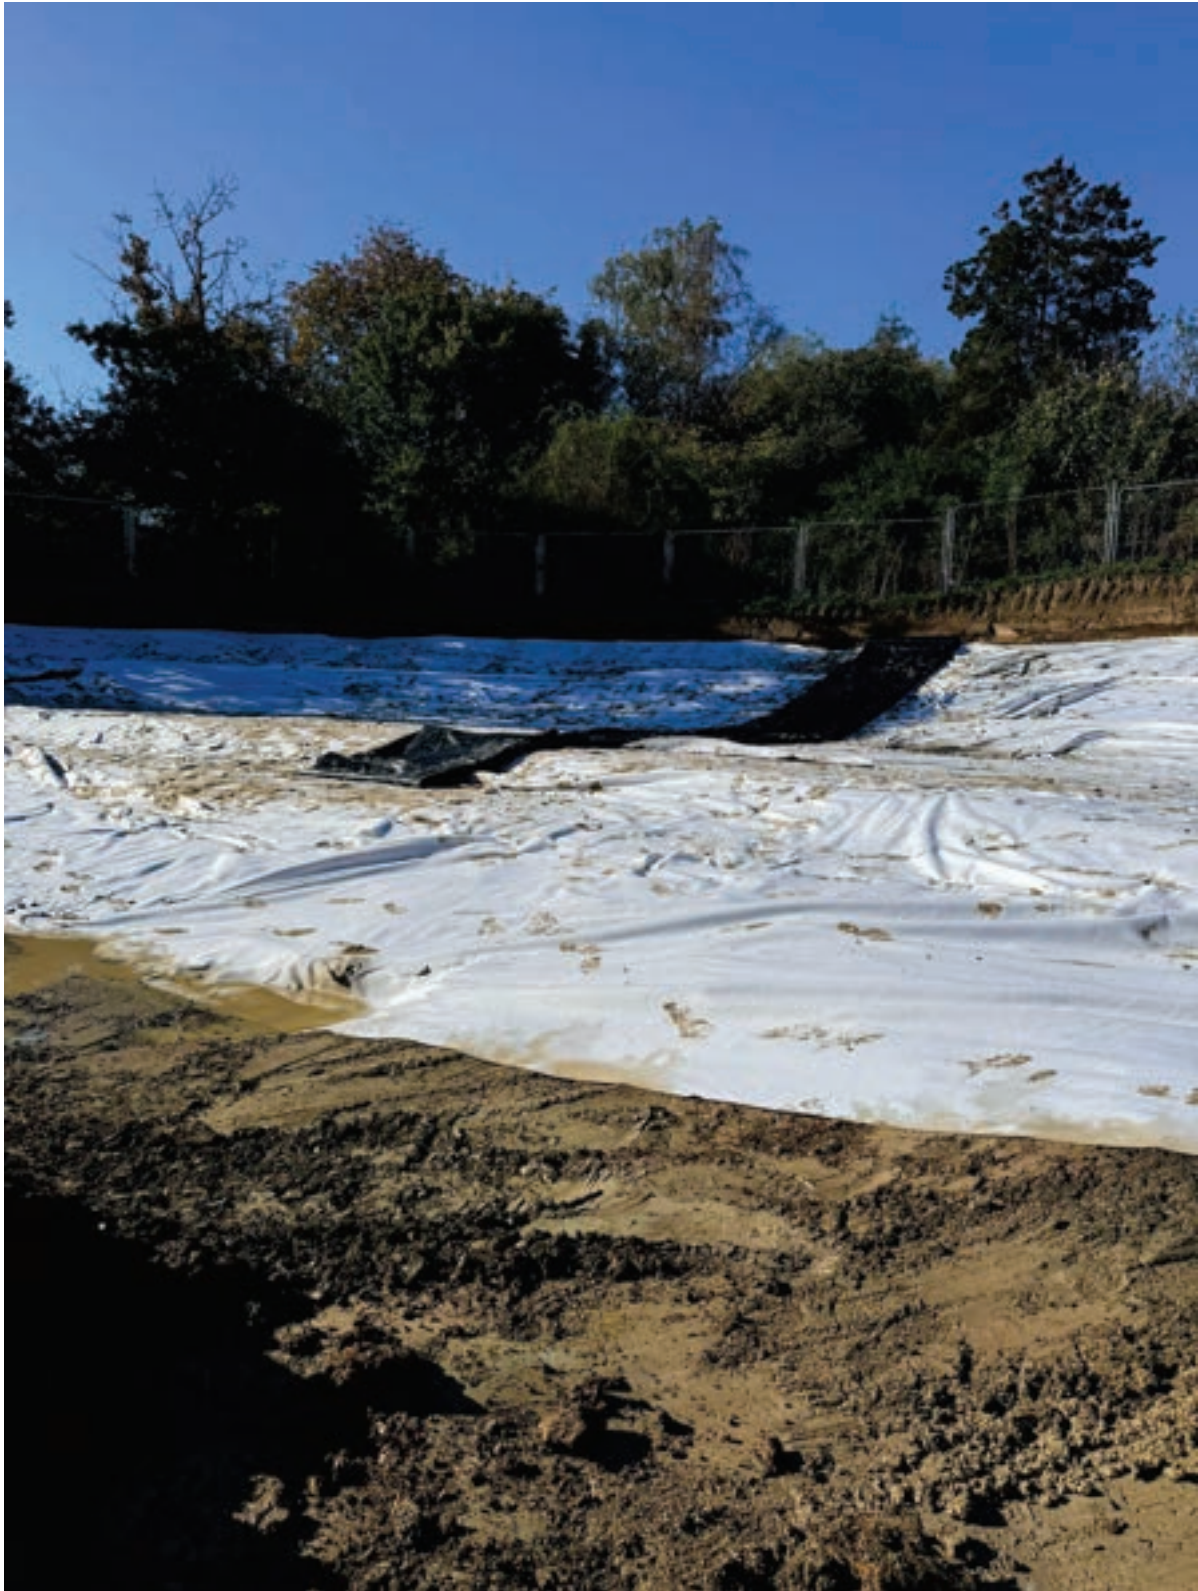
Photo 5 - Pond lining

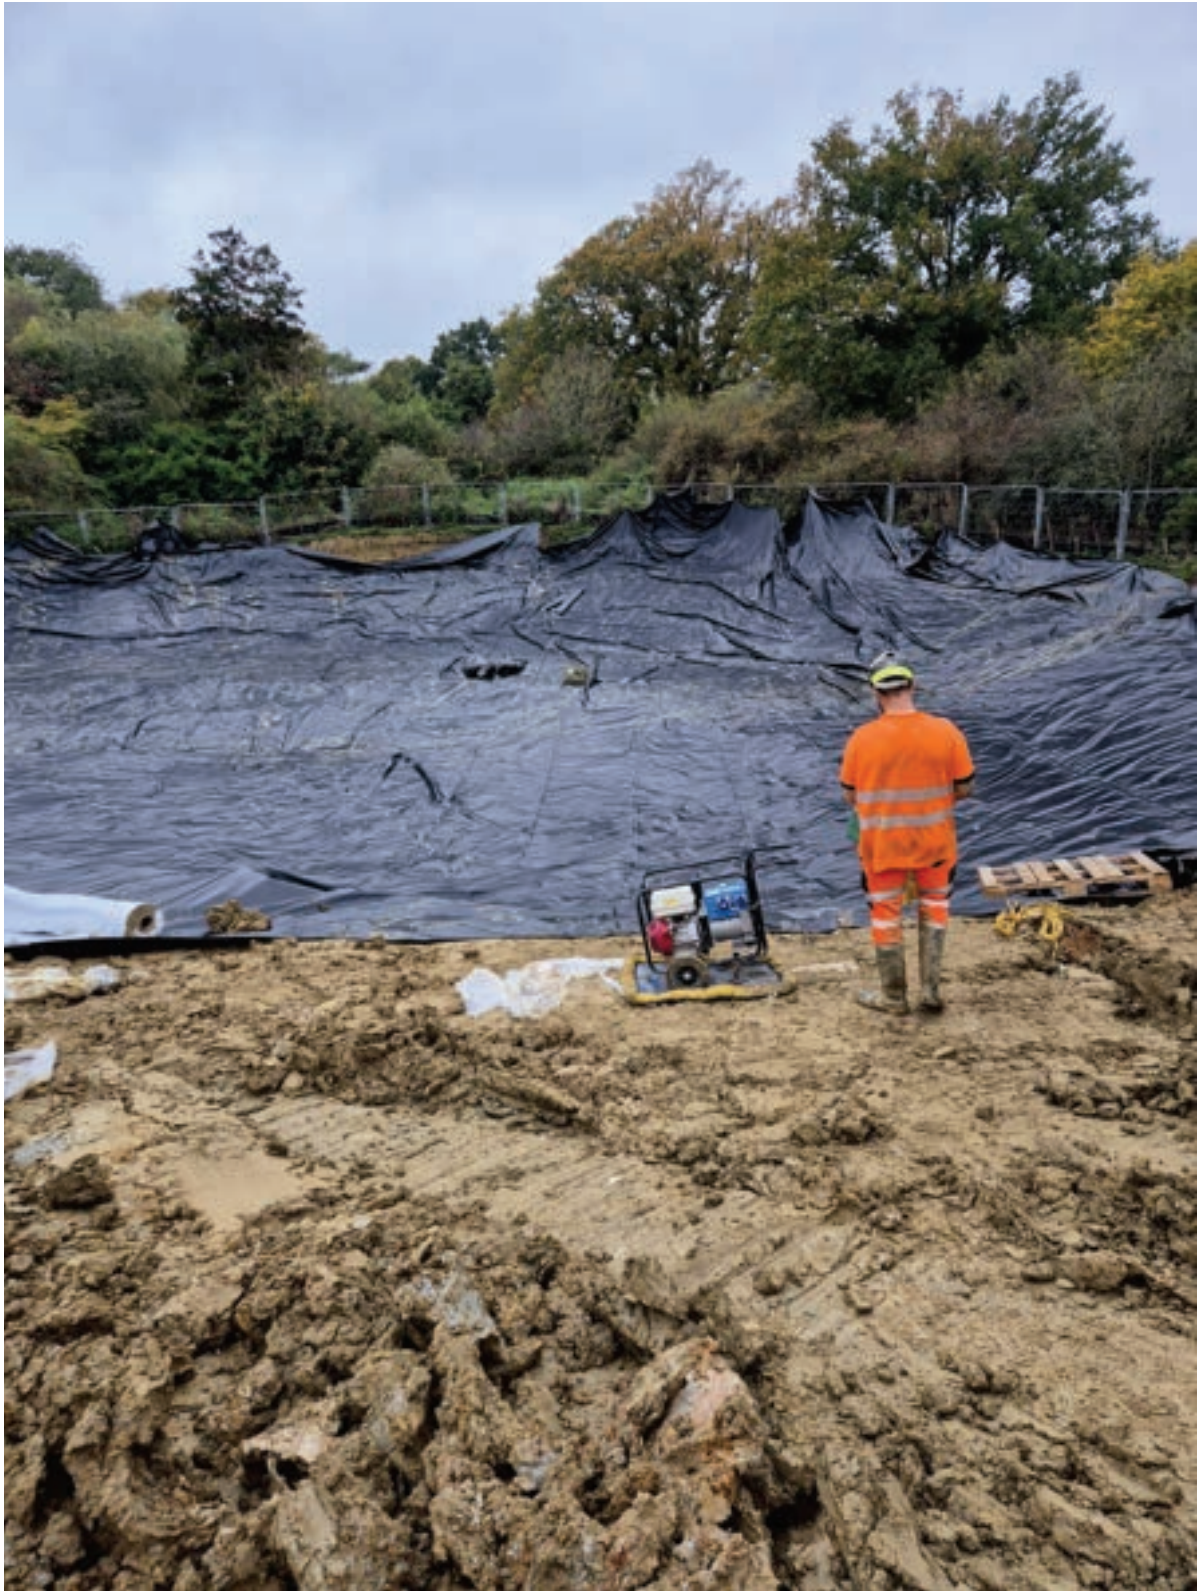
Photo 6 - Pond lining

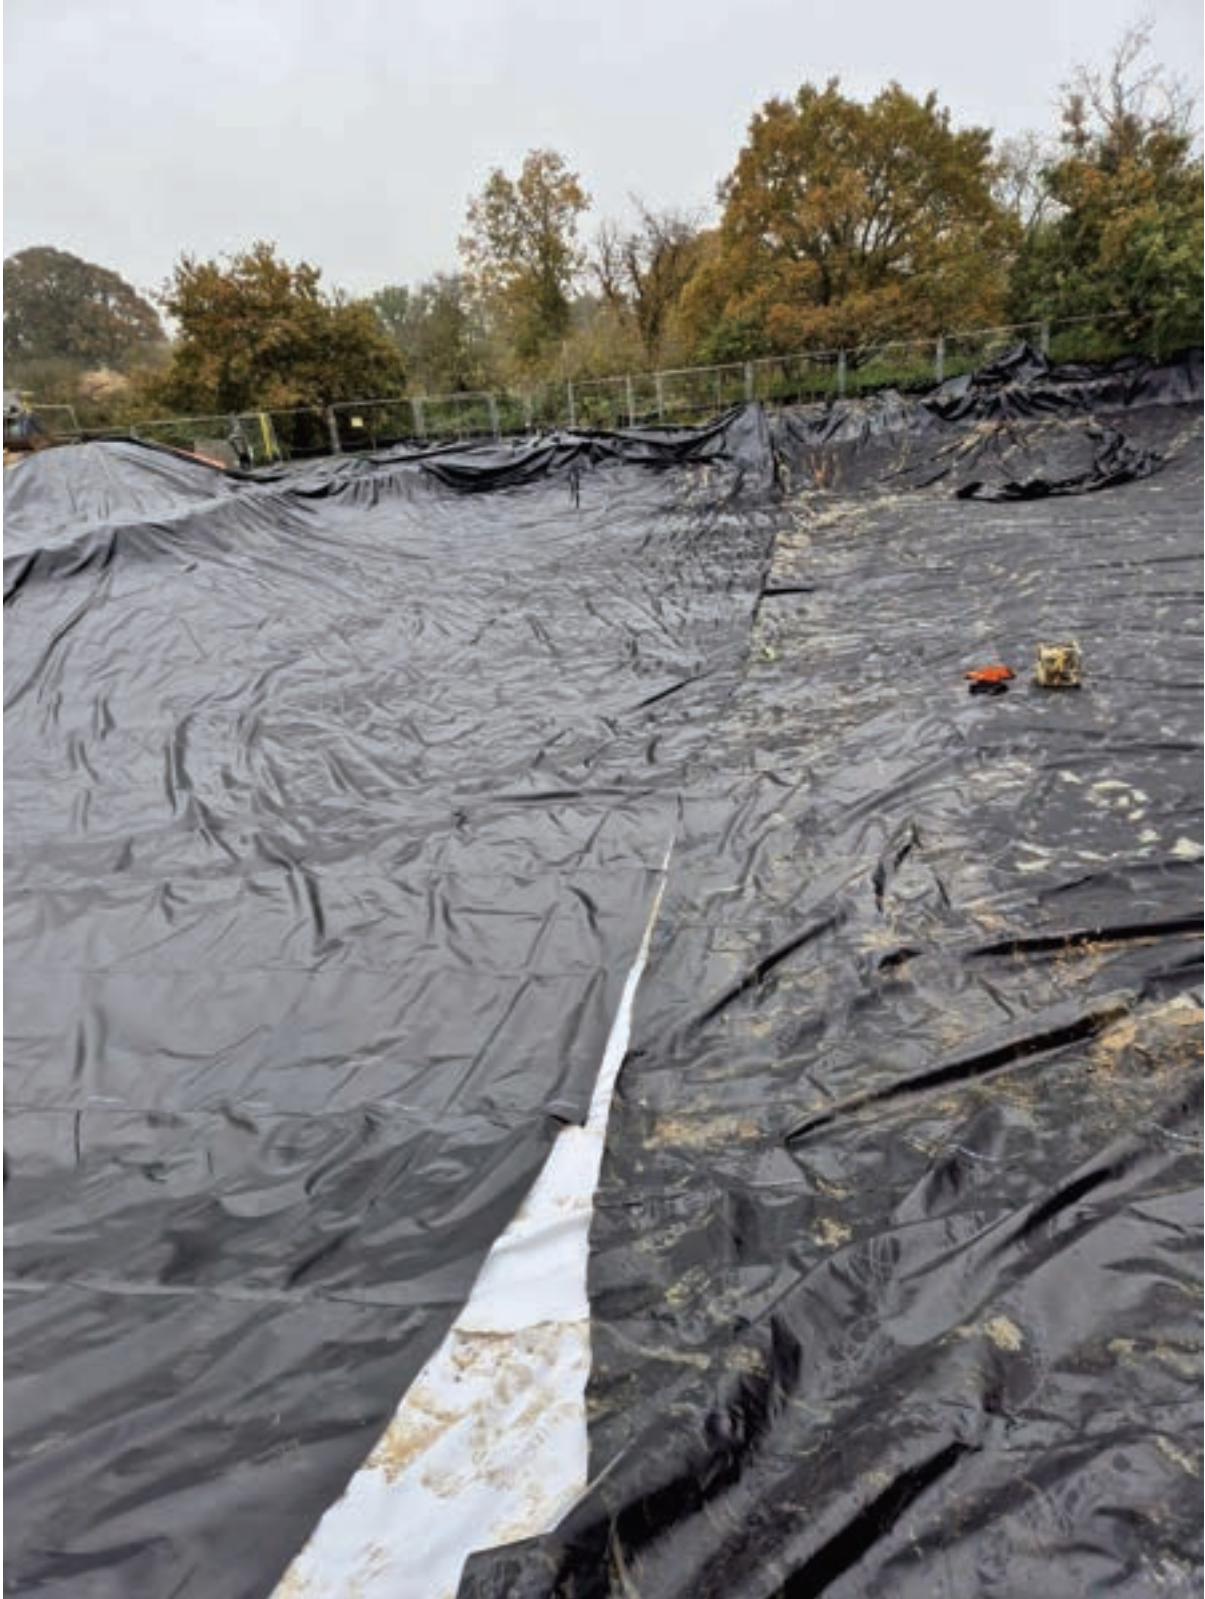
Photo 7 - Pond lining

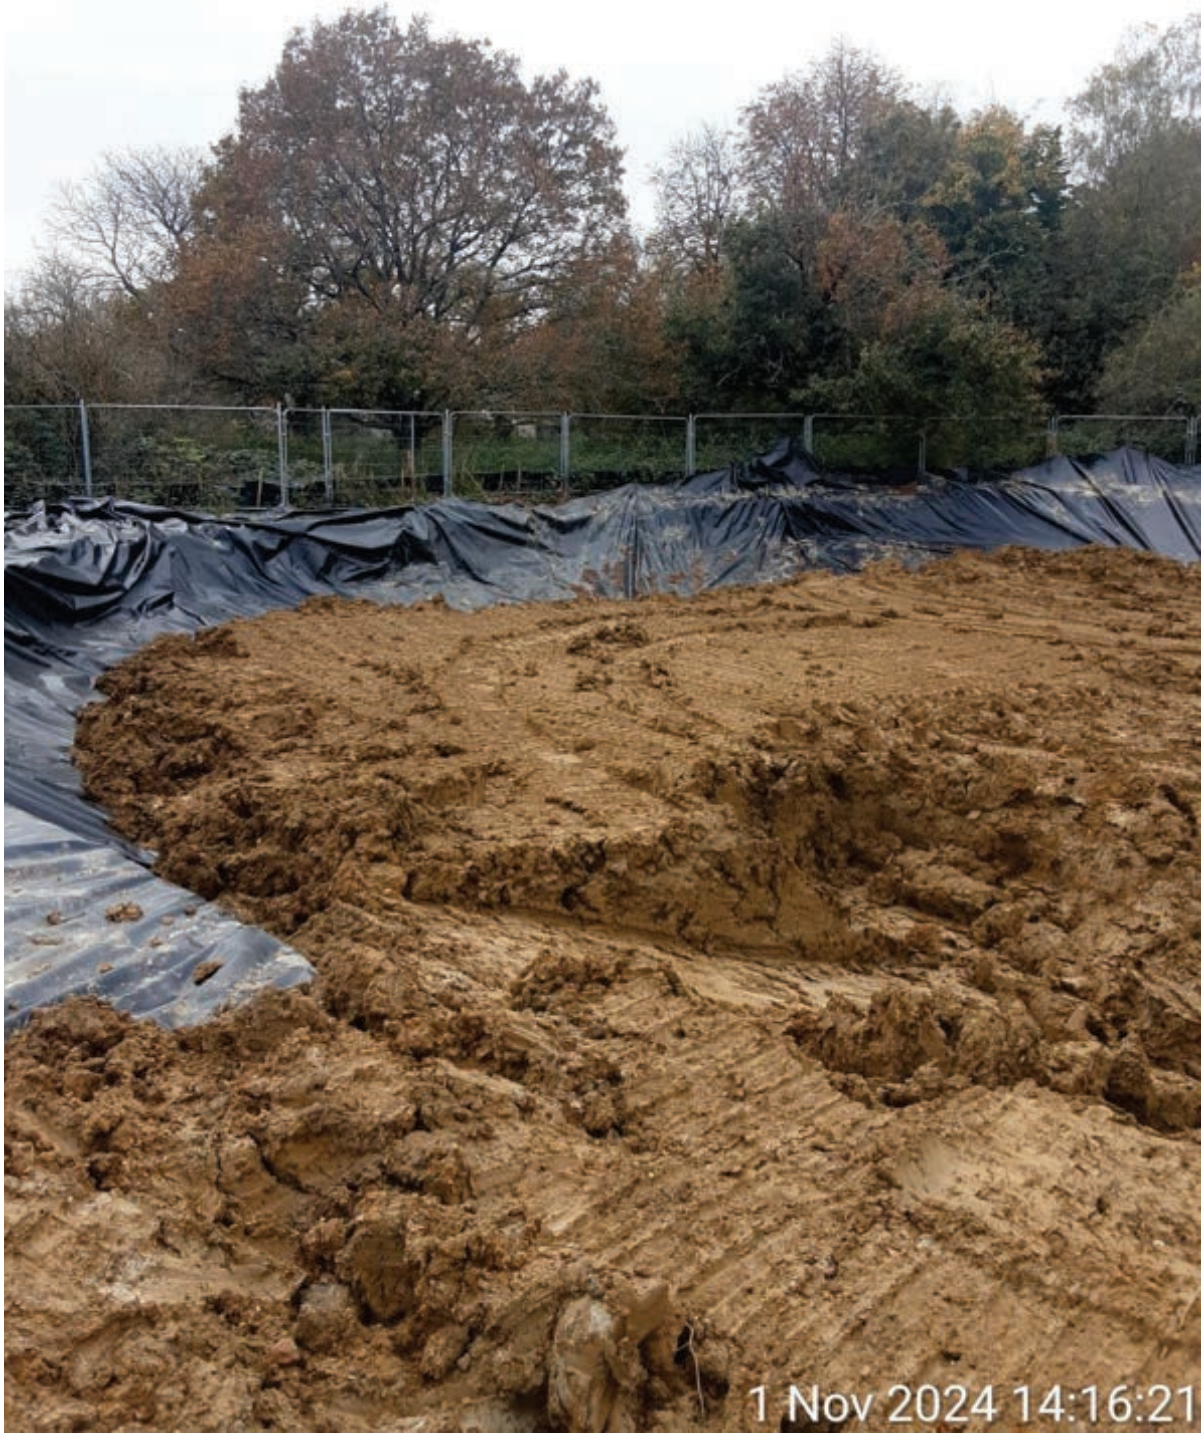
Photo 8 - Pond lining

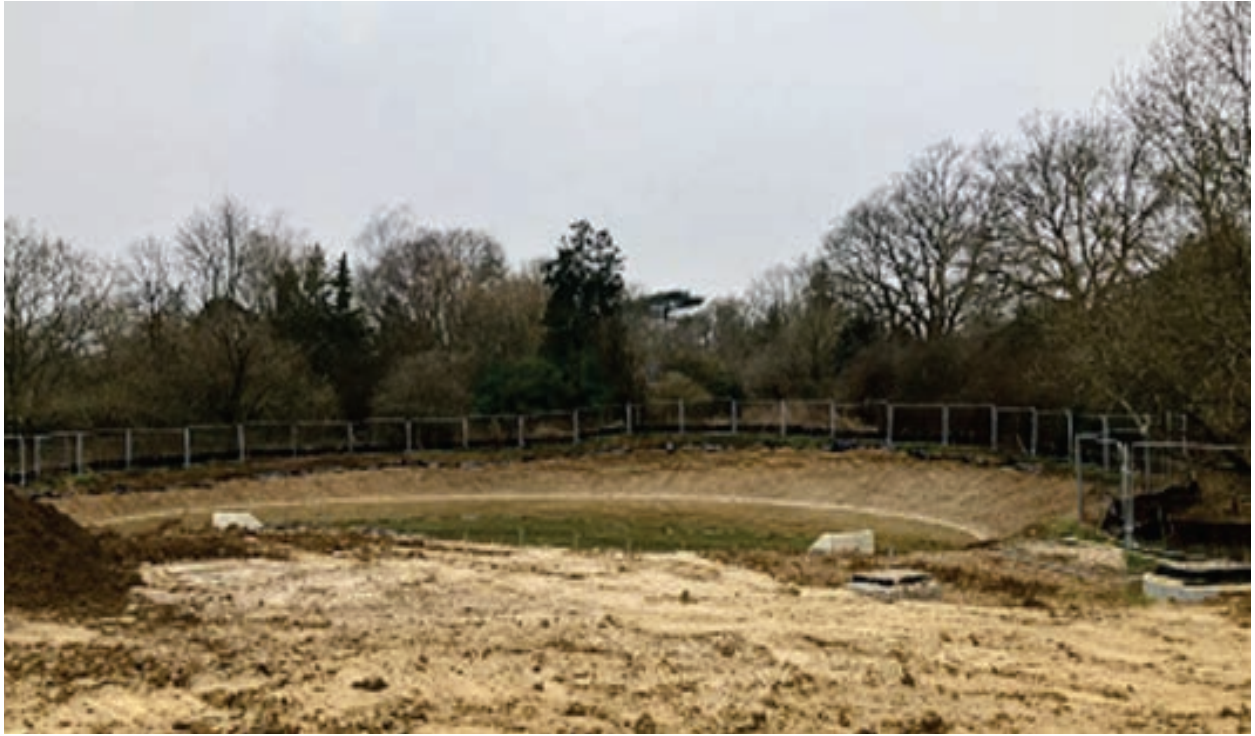
Photo 9 – Completed pond

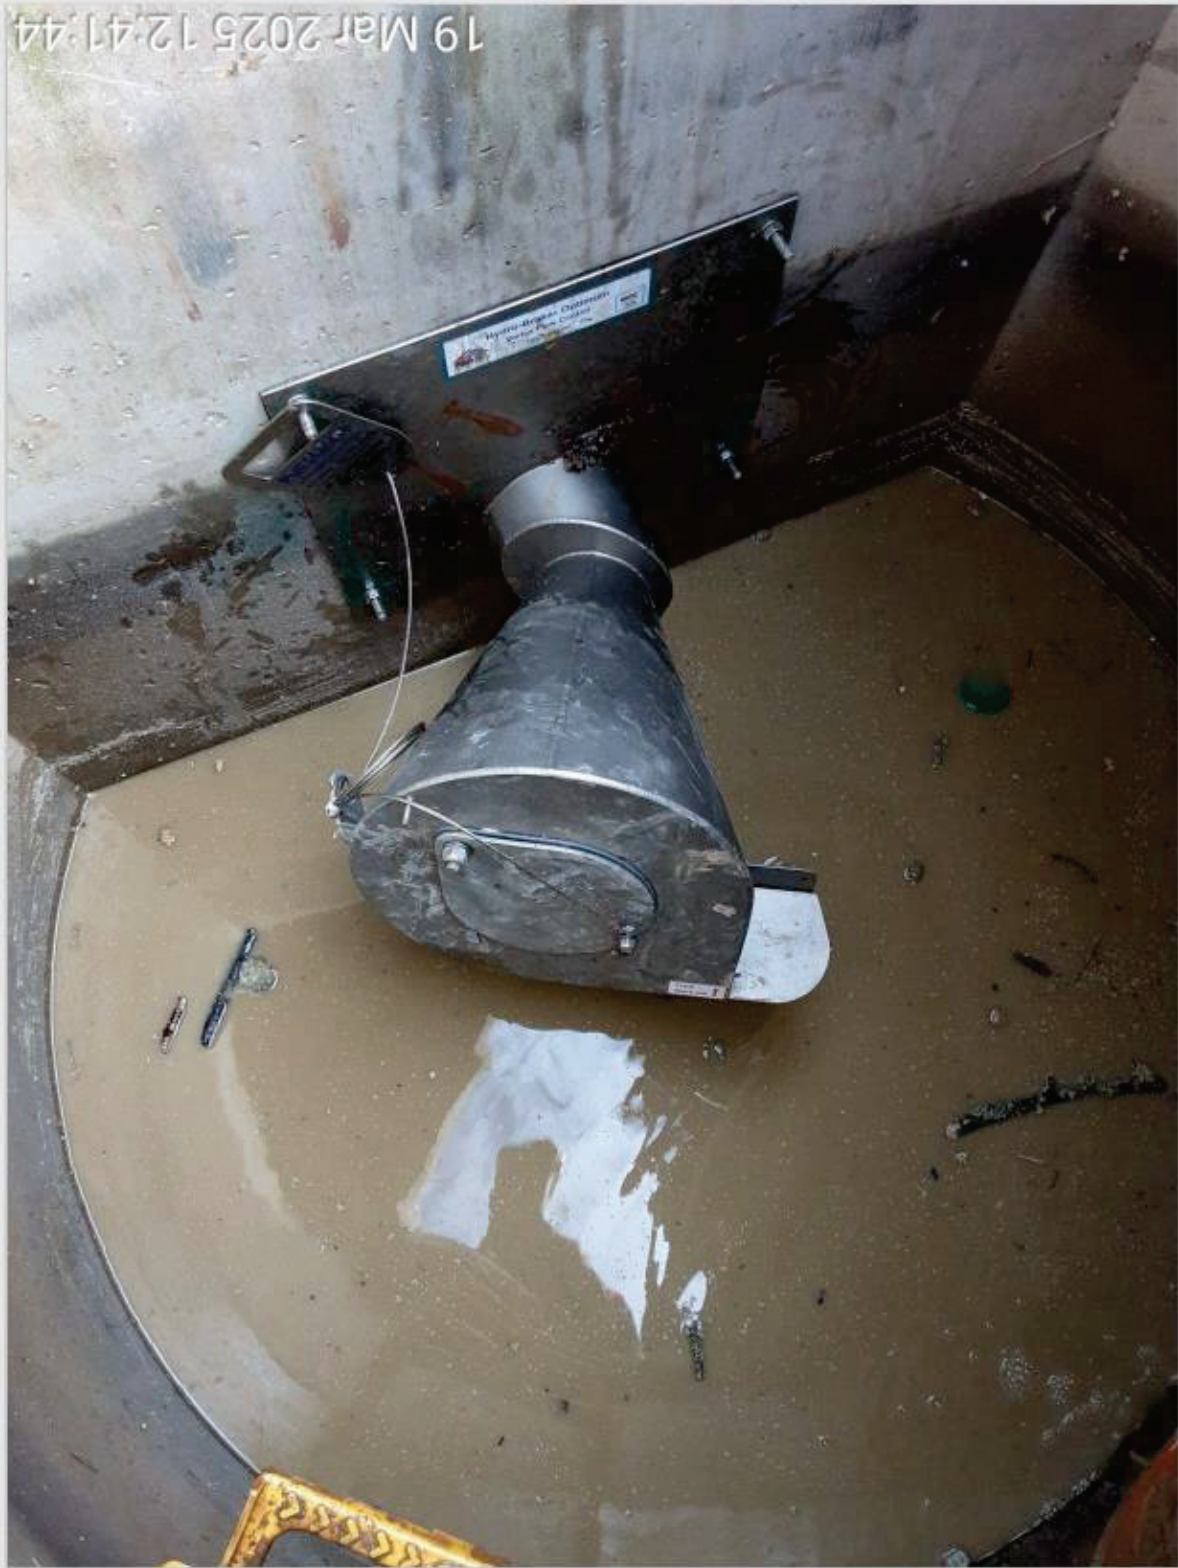
Photo 10 – Hydro-brake installed

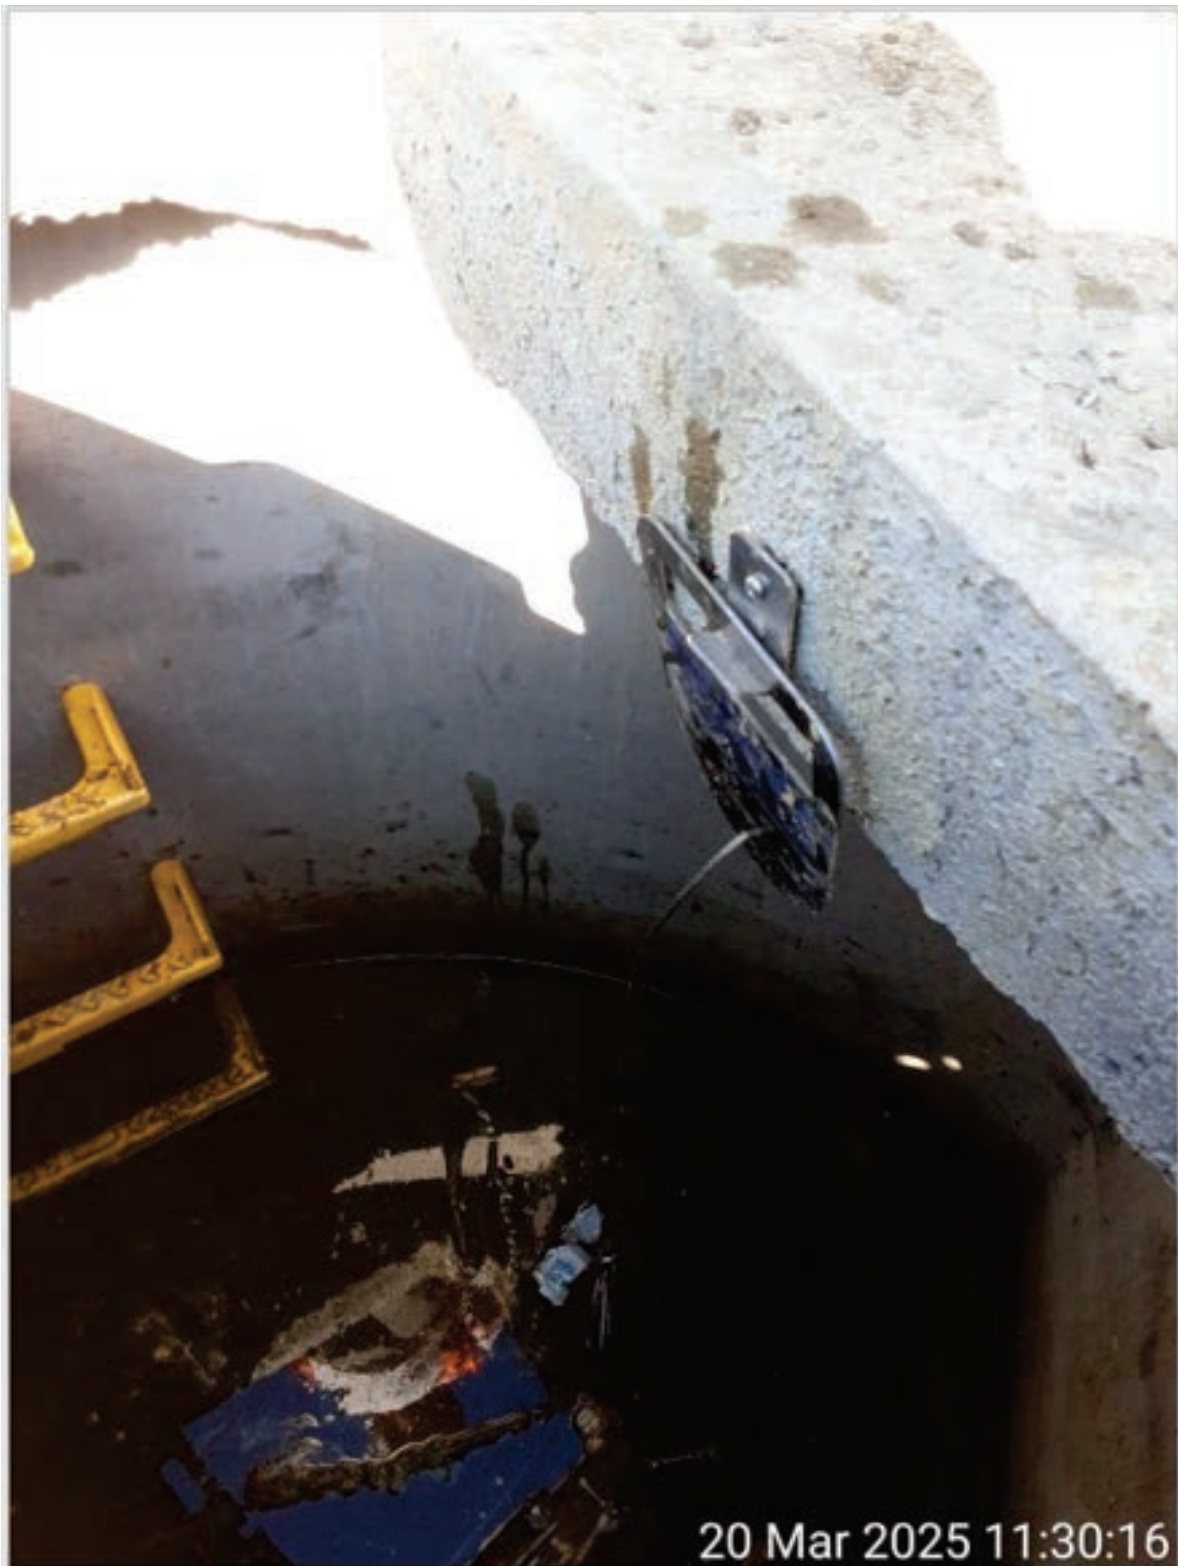
Photo 11 – Hydro-brake pull handle

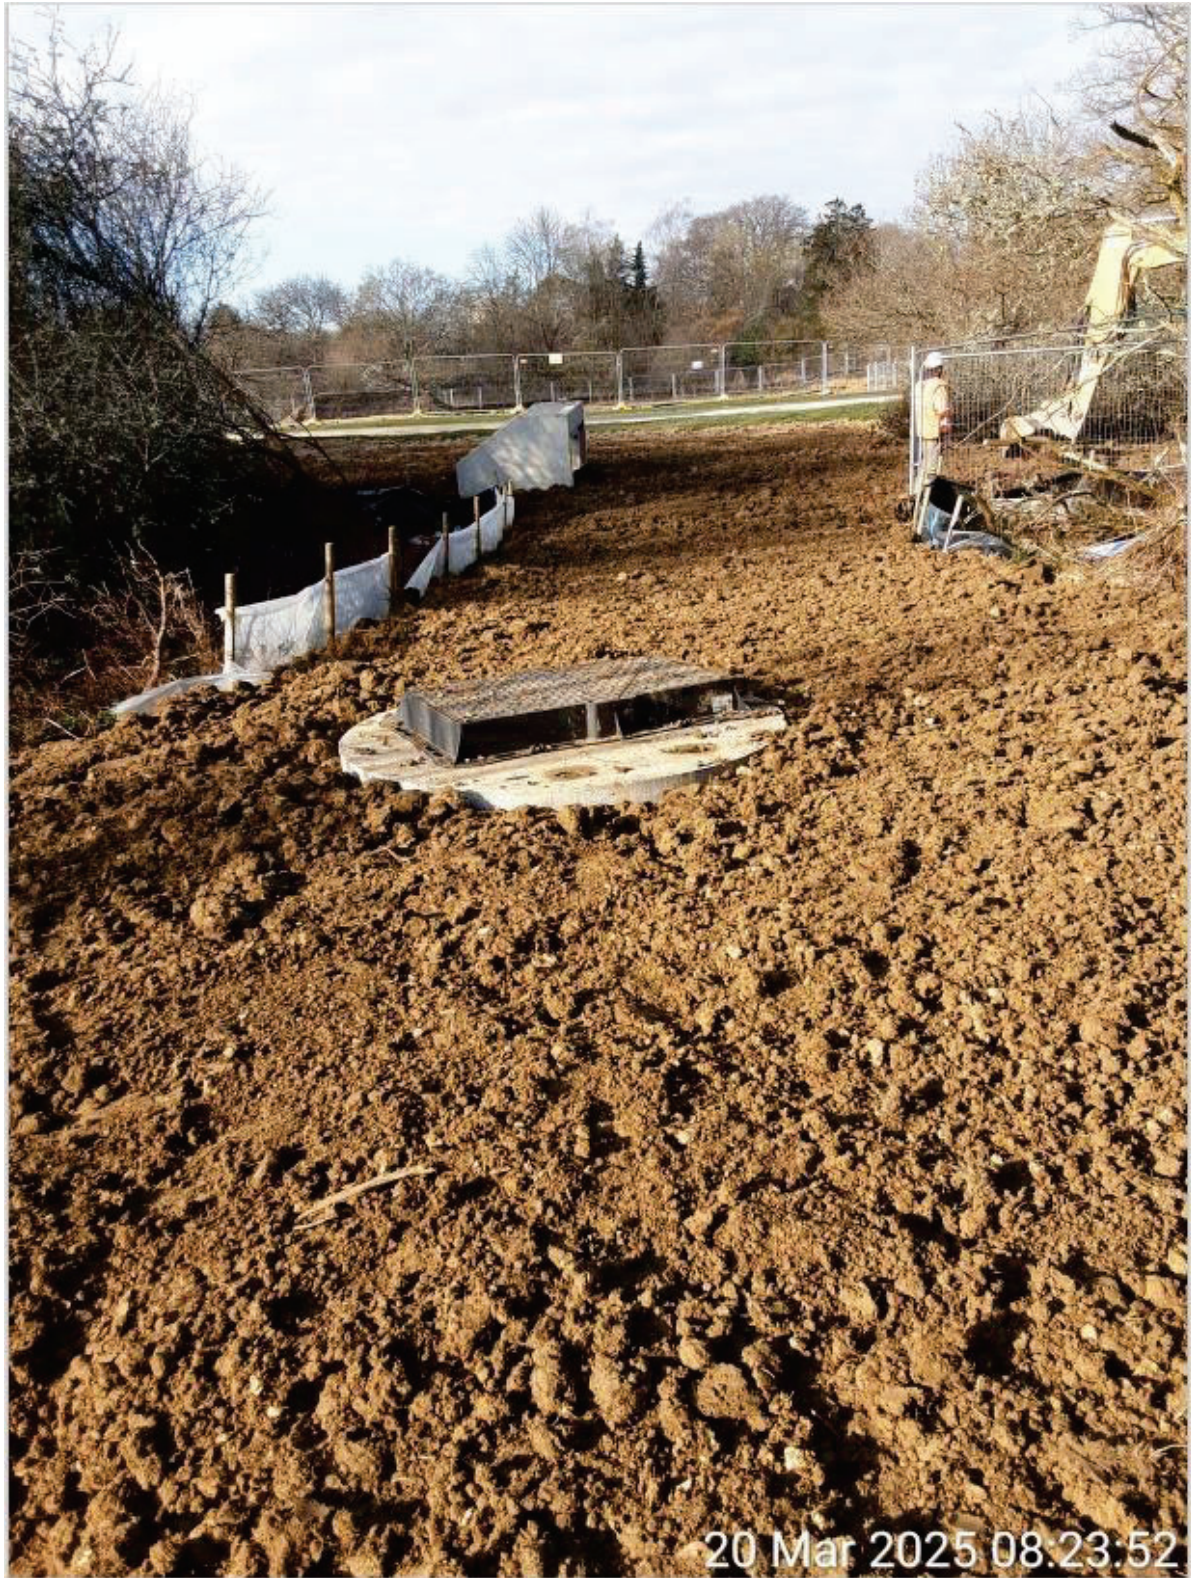
Photo 12 – Manhole S44 Hydro-brake

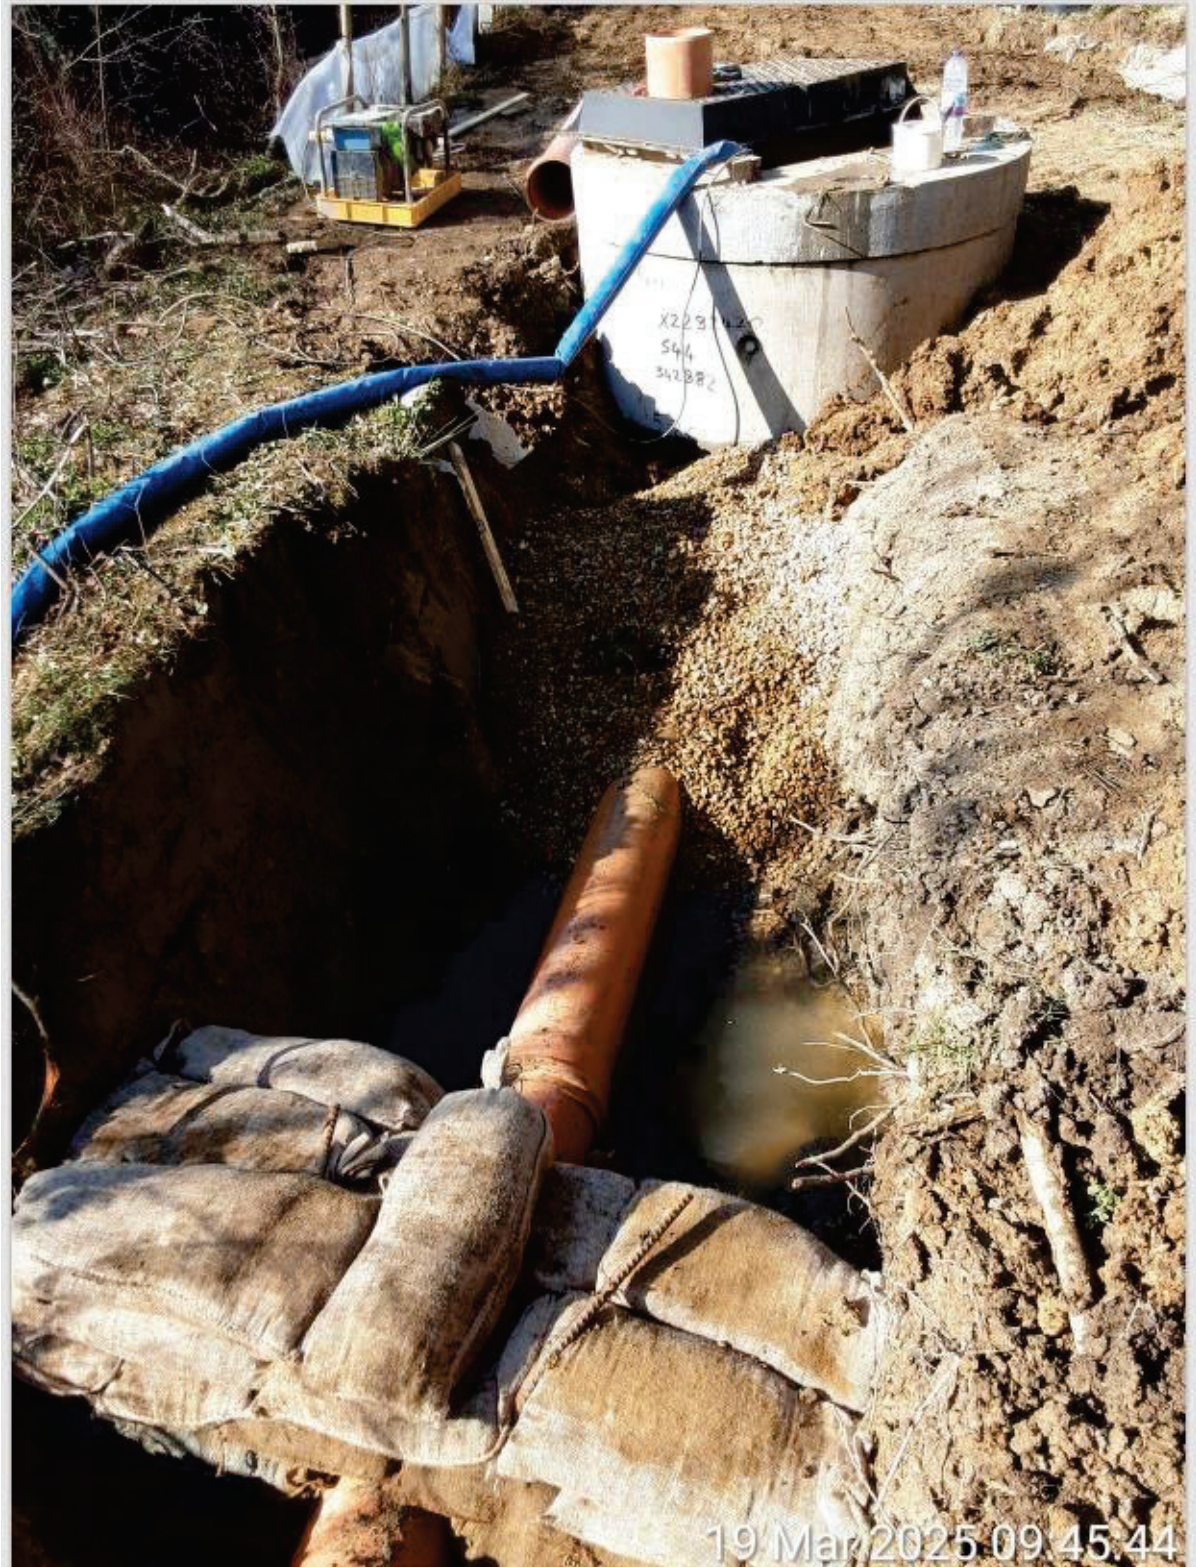
Photo 13 – View of manhole S44 and outfall
