## Appendix C – Construction Photographs

WORK ALLOCATION SHEET

| Work Description | Pond installation |

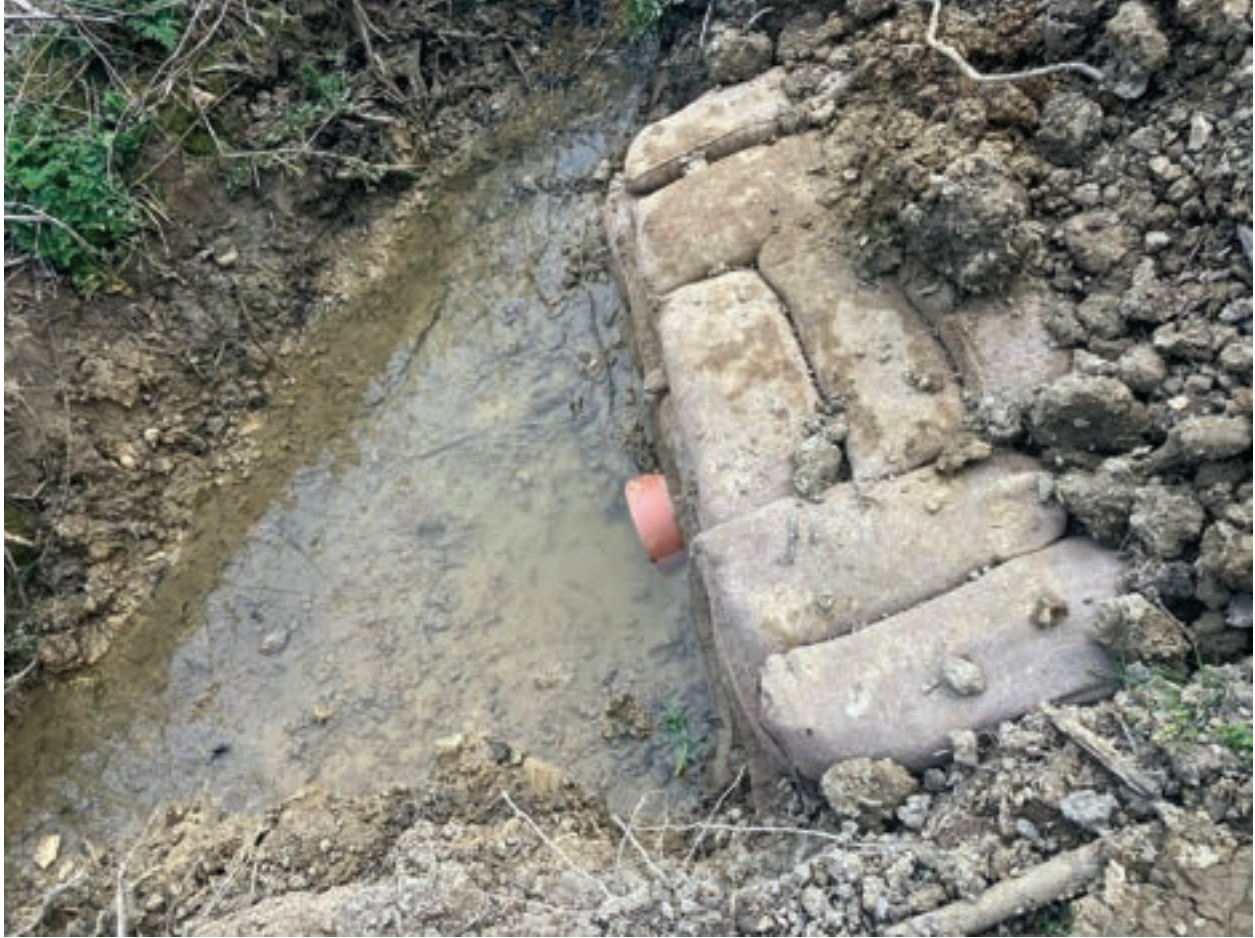
Photo 14 – View of outfall

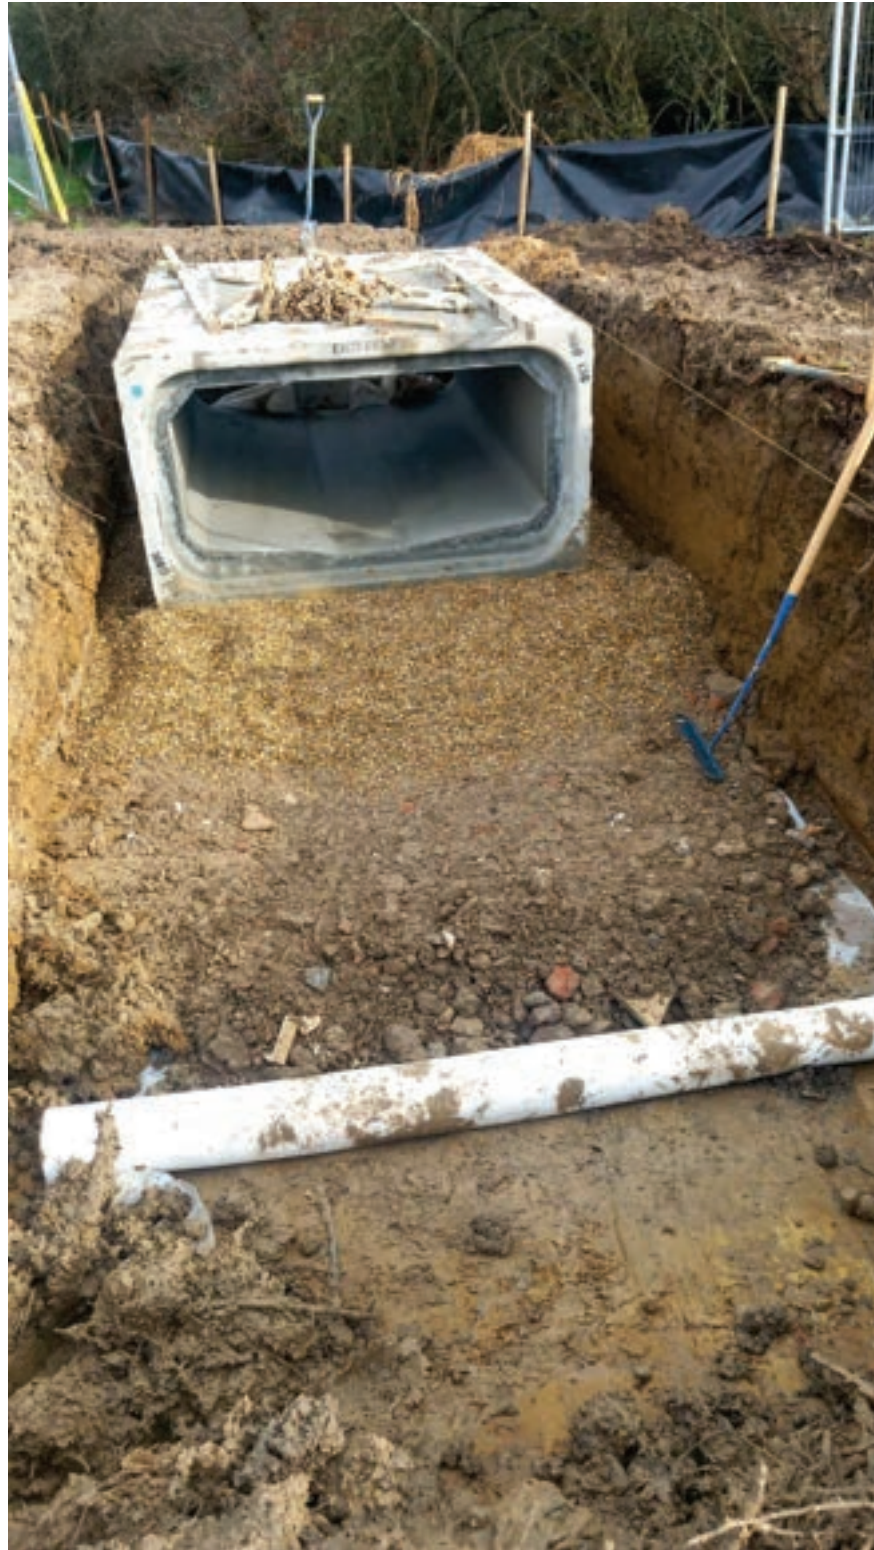
Photo 15 – Culvert A

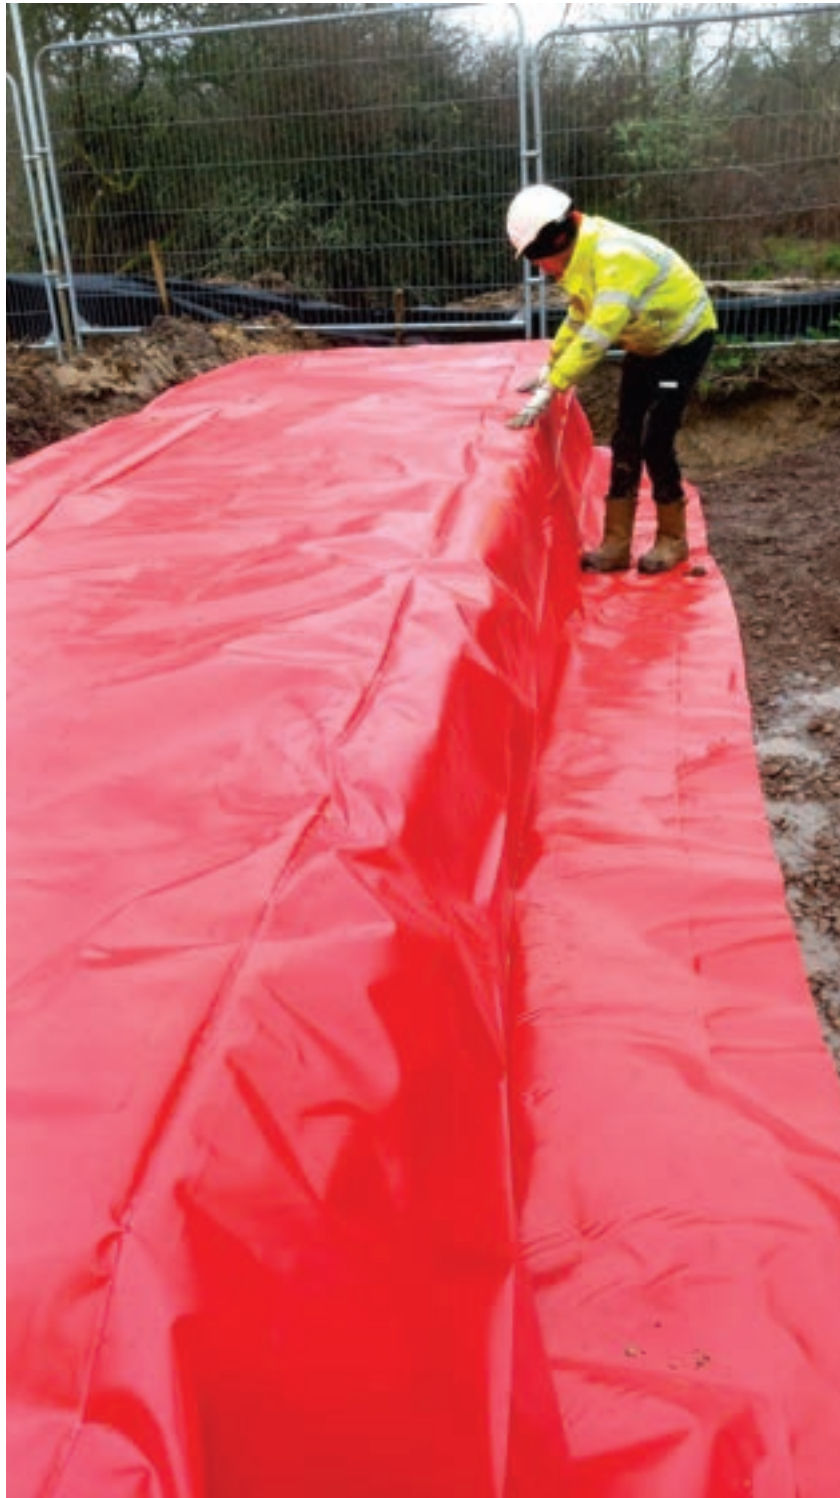
Photo 16 – Culvert A membrane installation

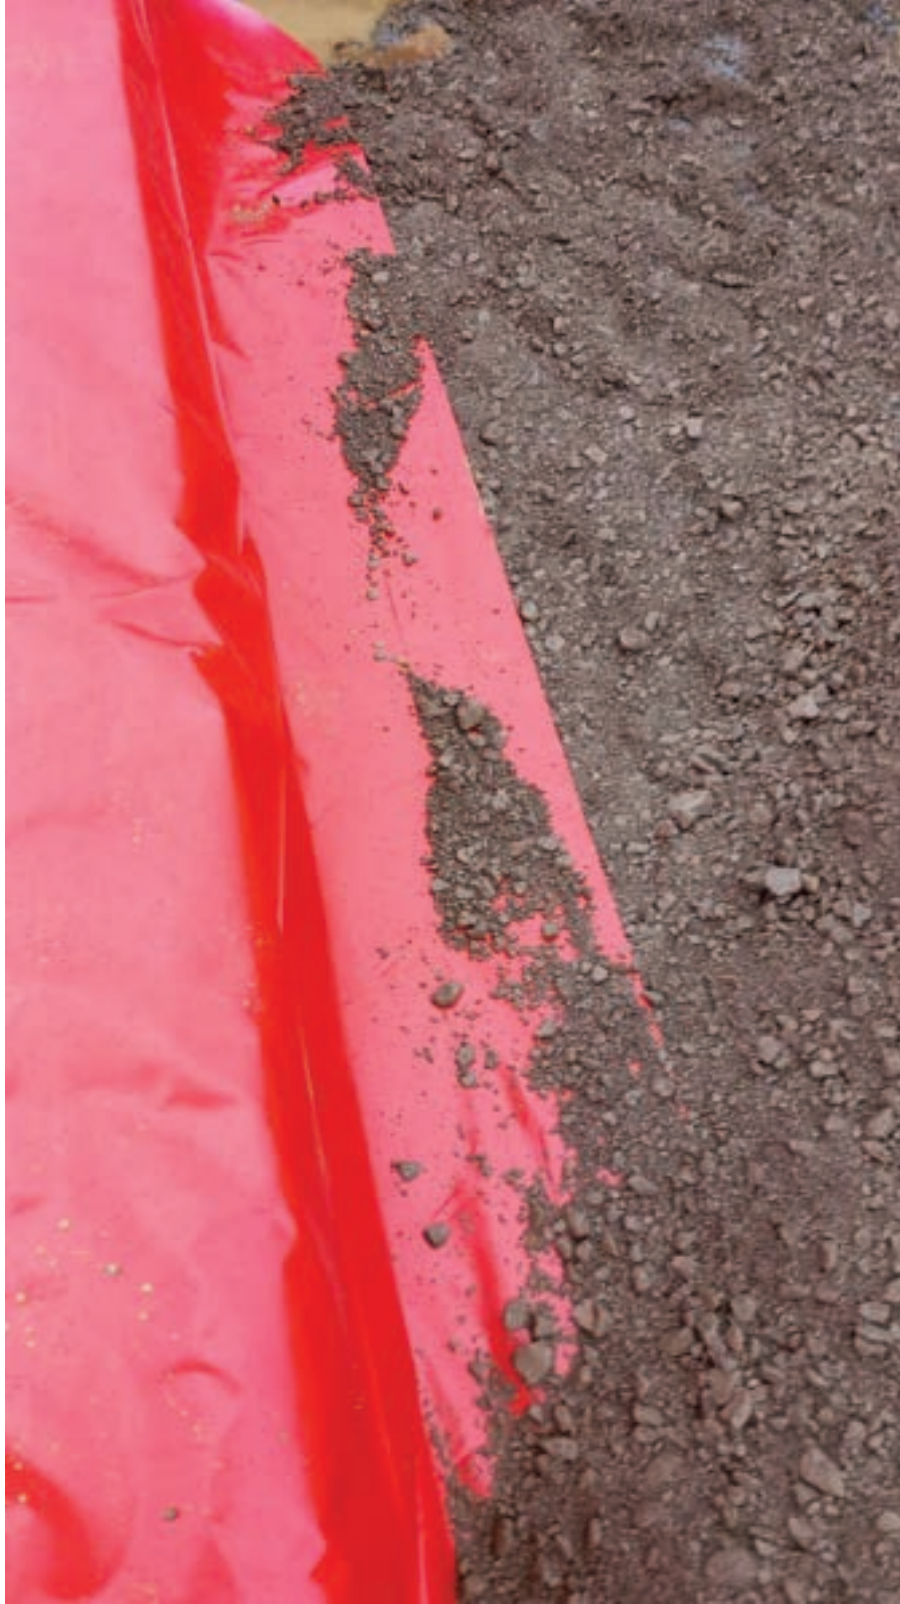
Photo 17 – Culvert A membrane installation

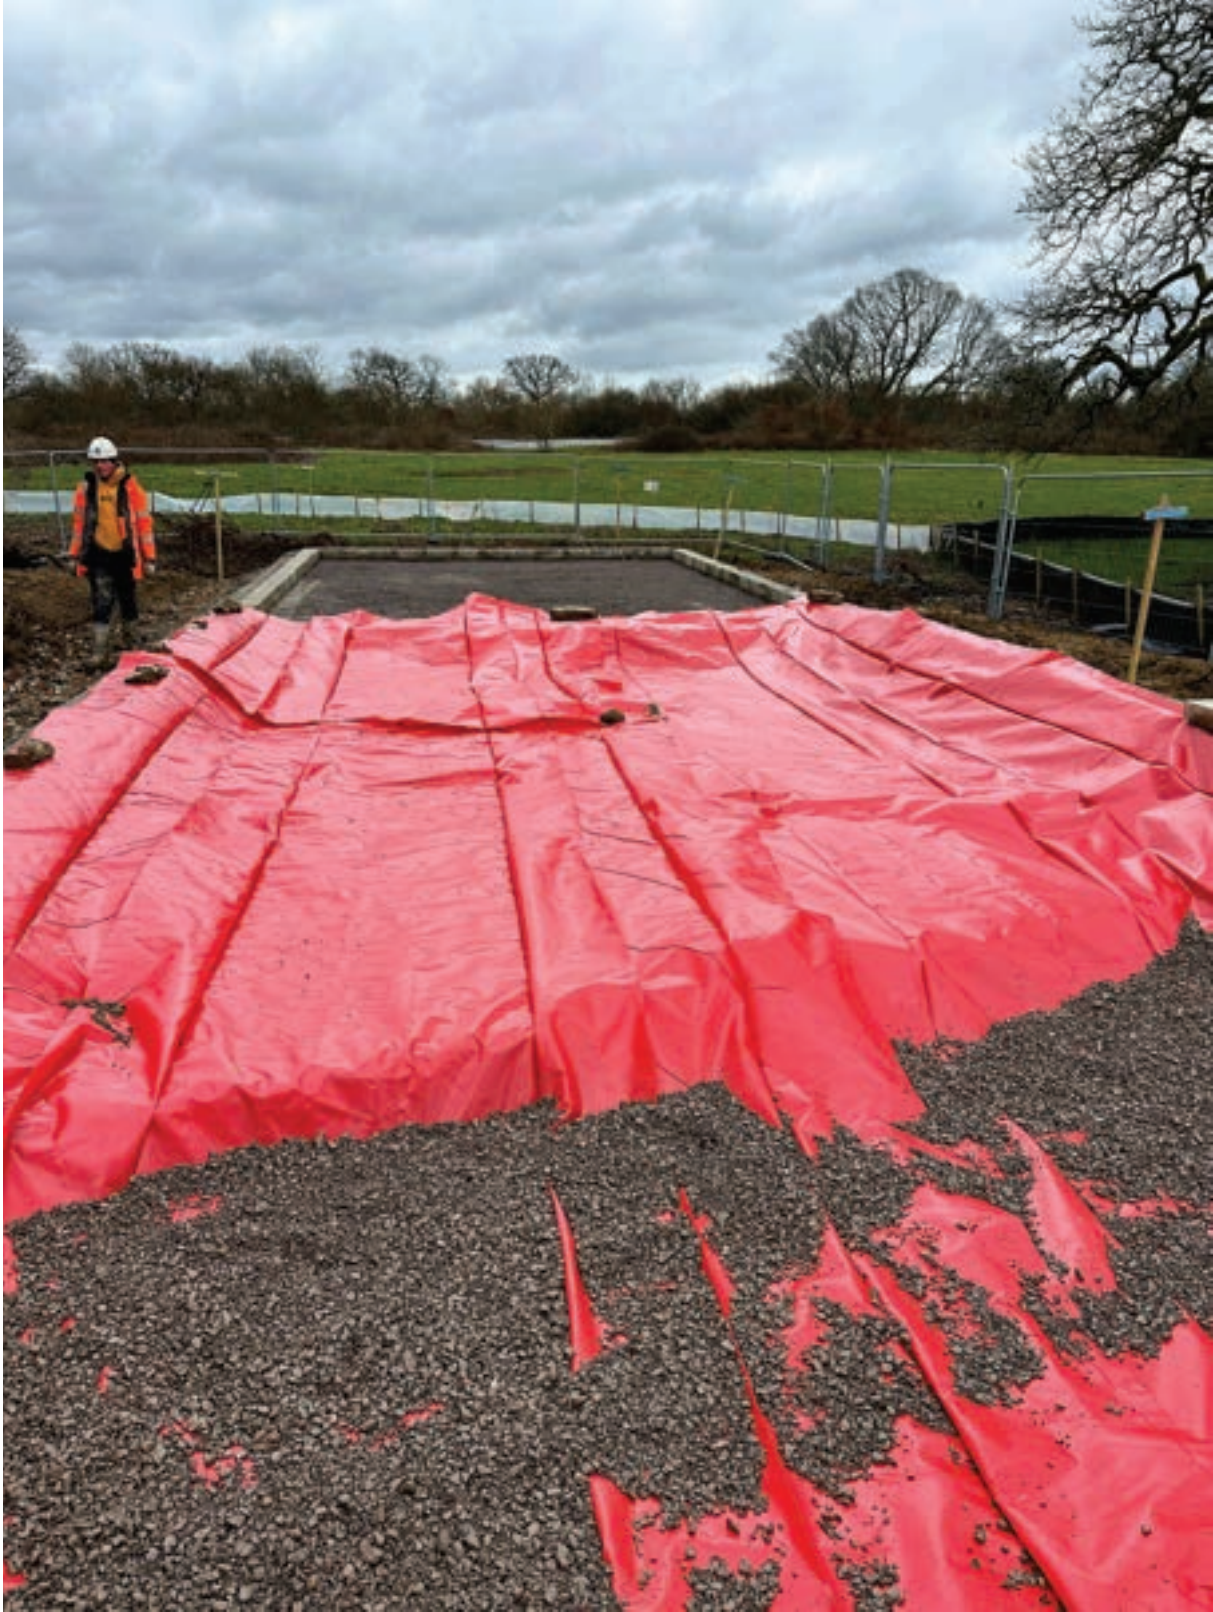
Photo 18 – Culvert A membrane installation

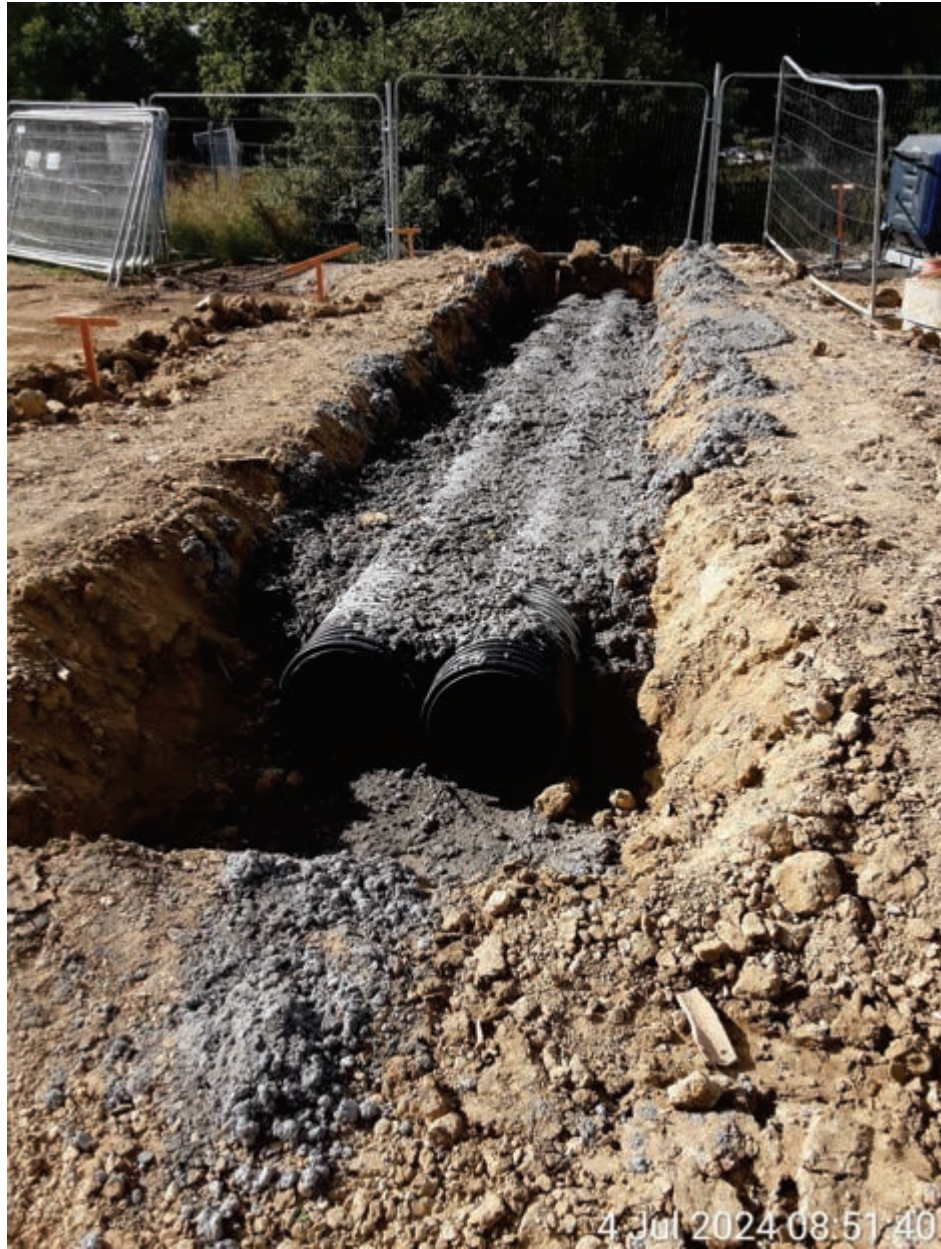
Photo 19 – Culvert B

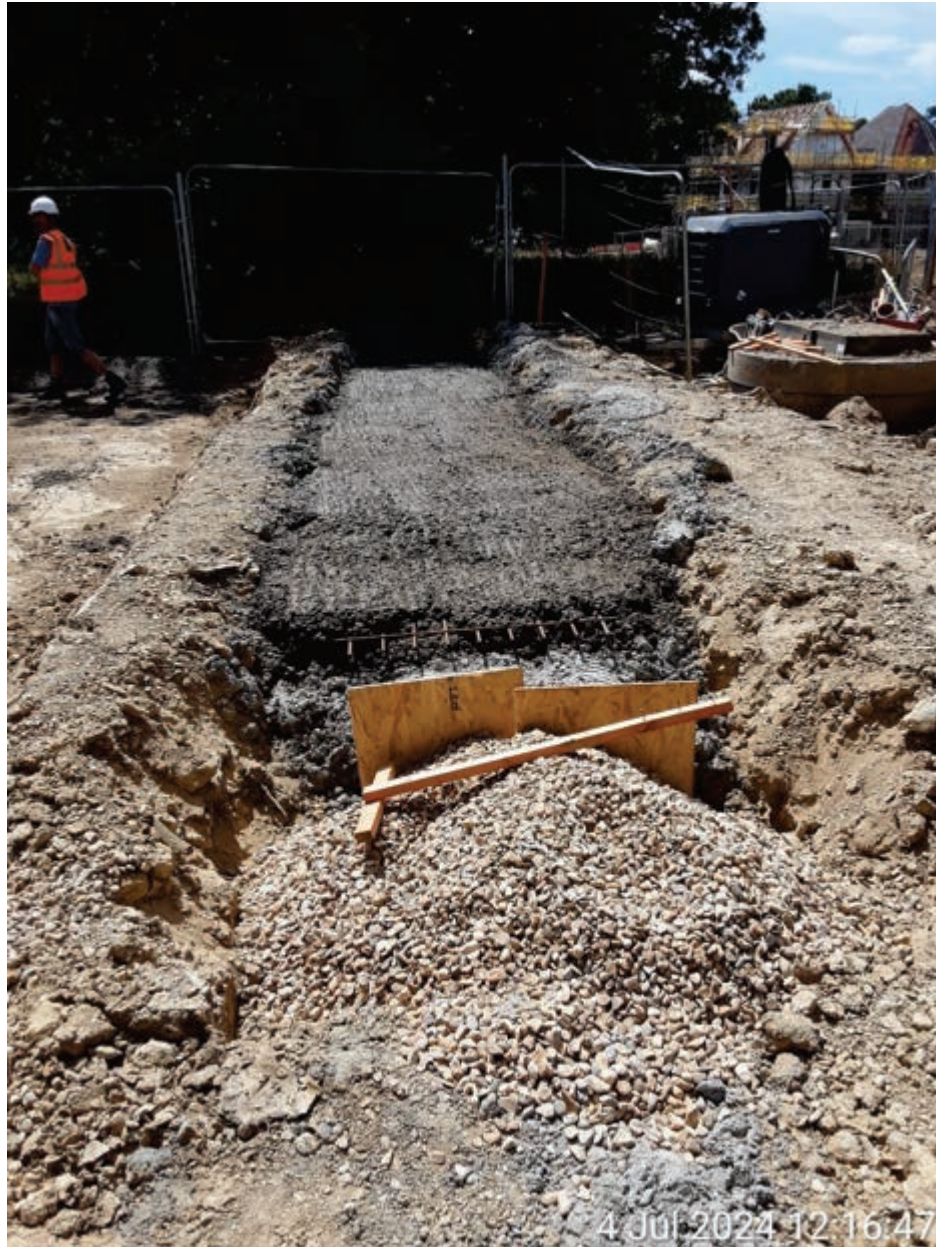
Photo 20 – Culvert B installation

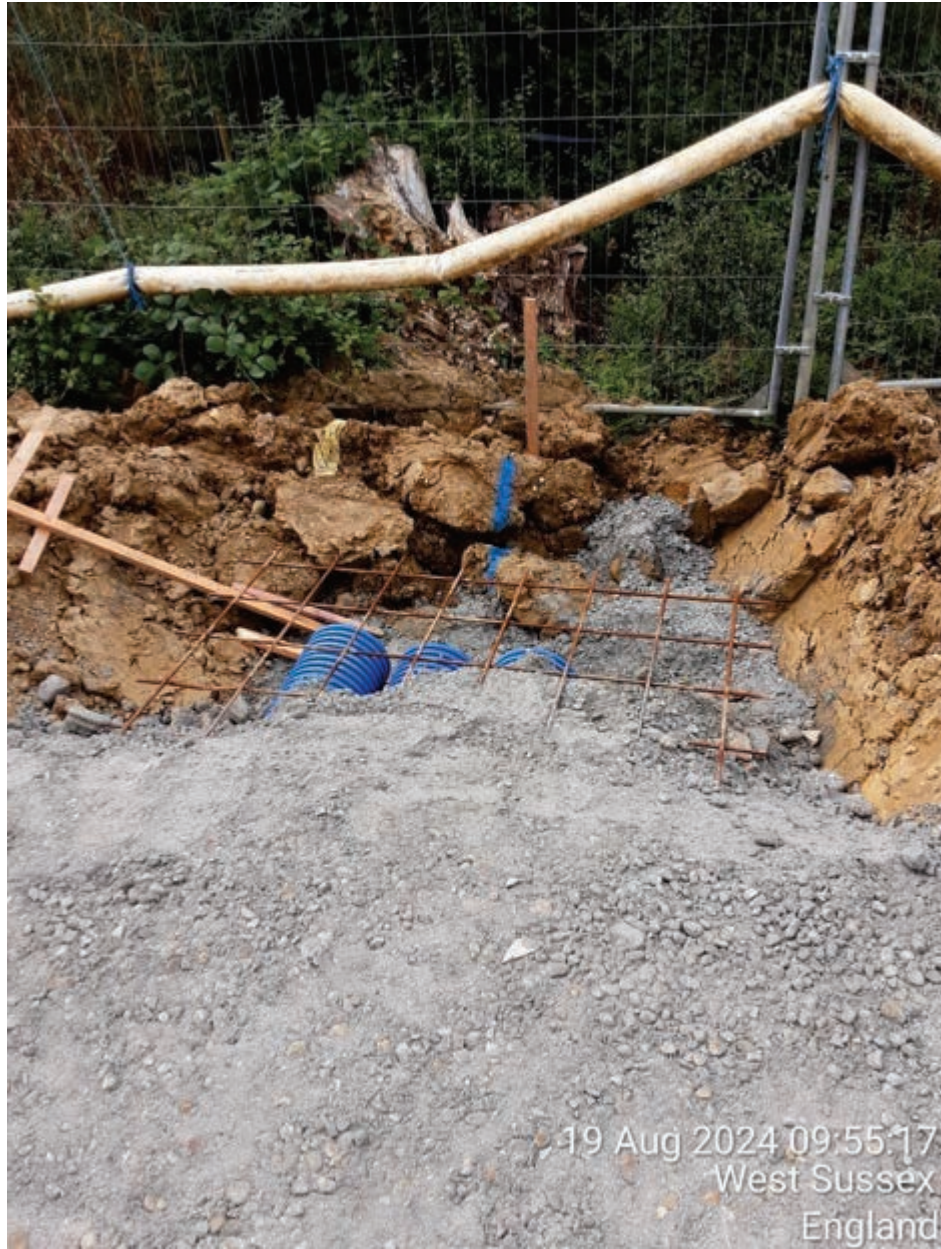
Photo 21 – Culvert C installation

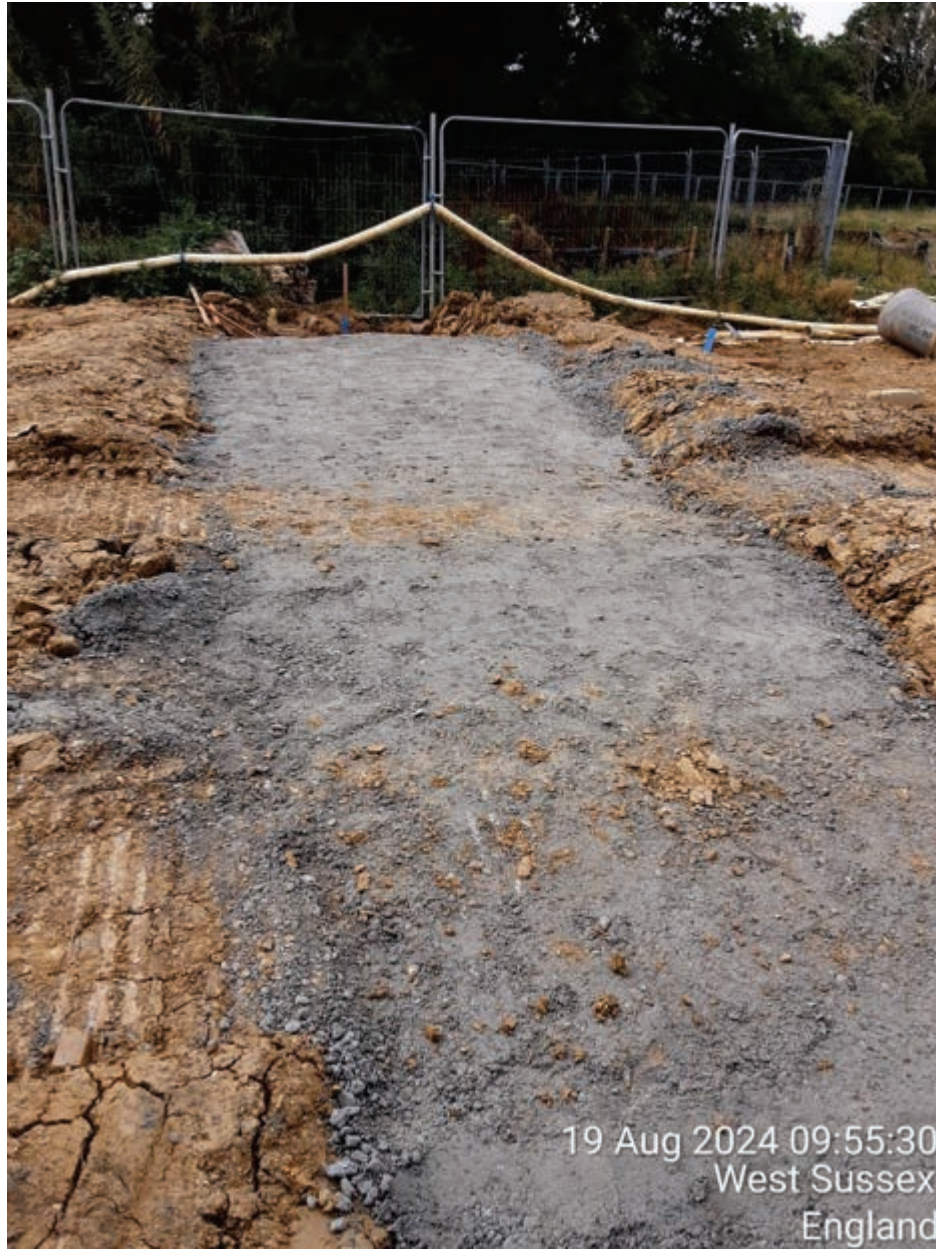
Photo 22 – Culvert C installation

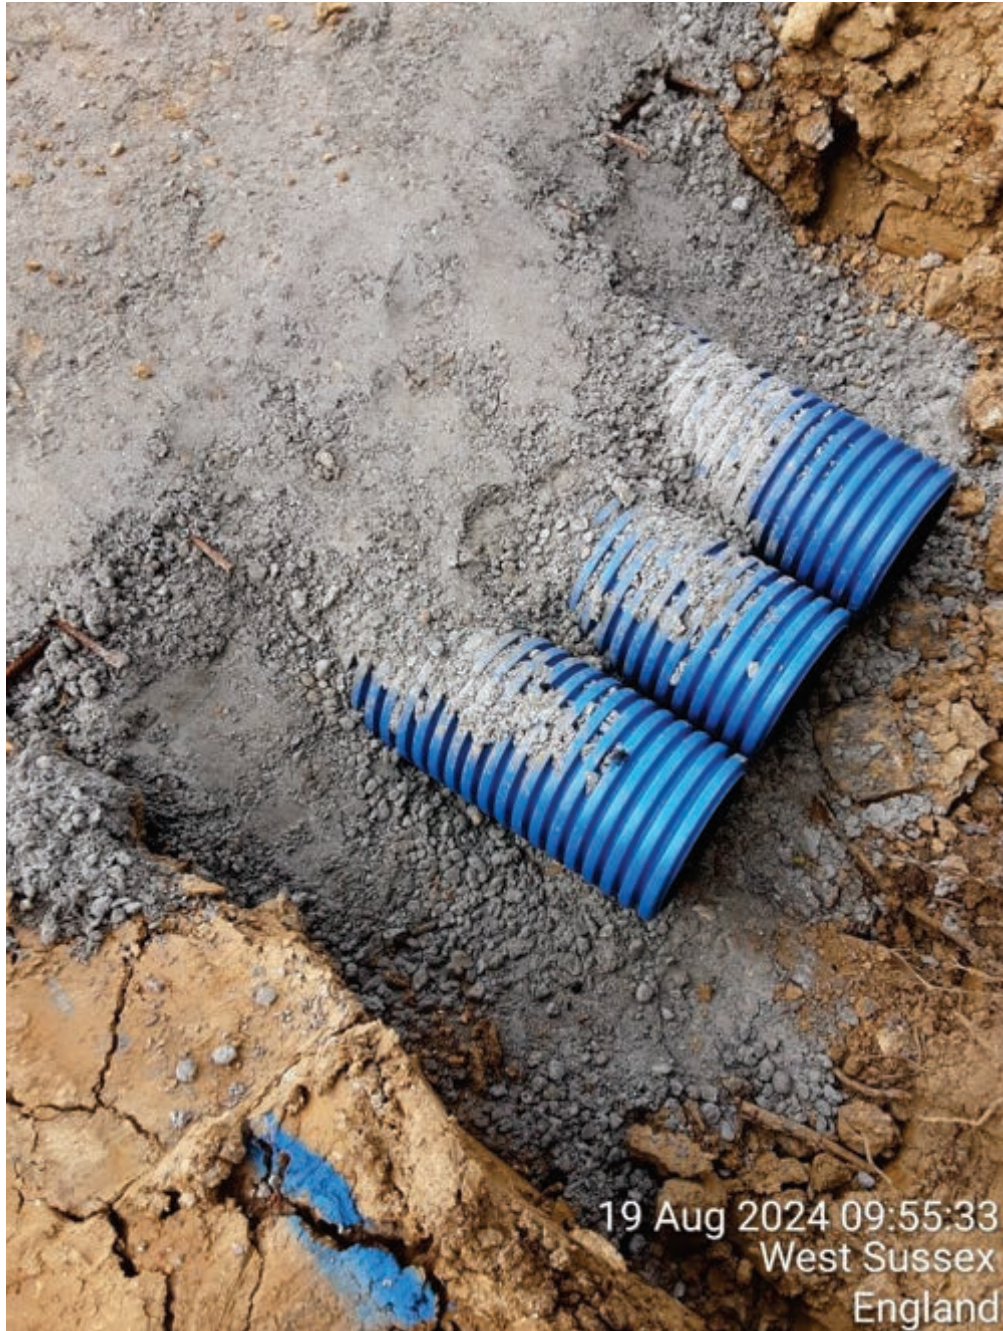
Photo 23 – Culvert C installation

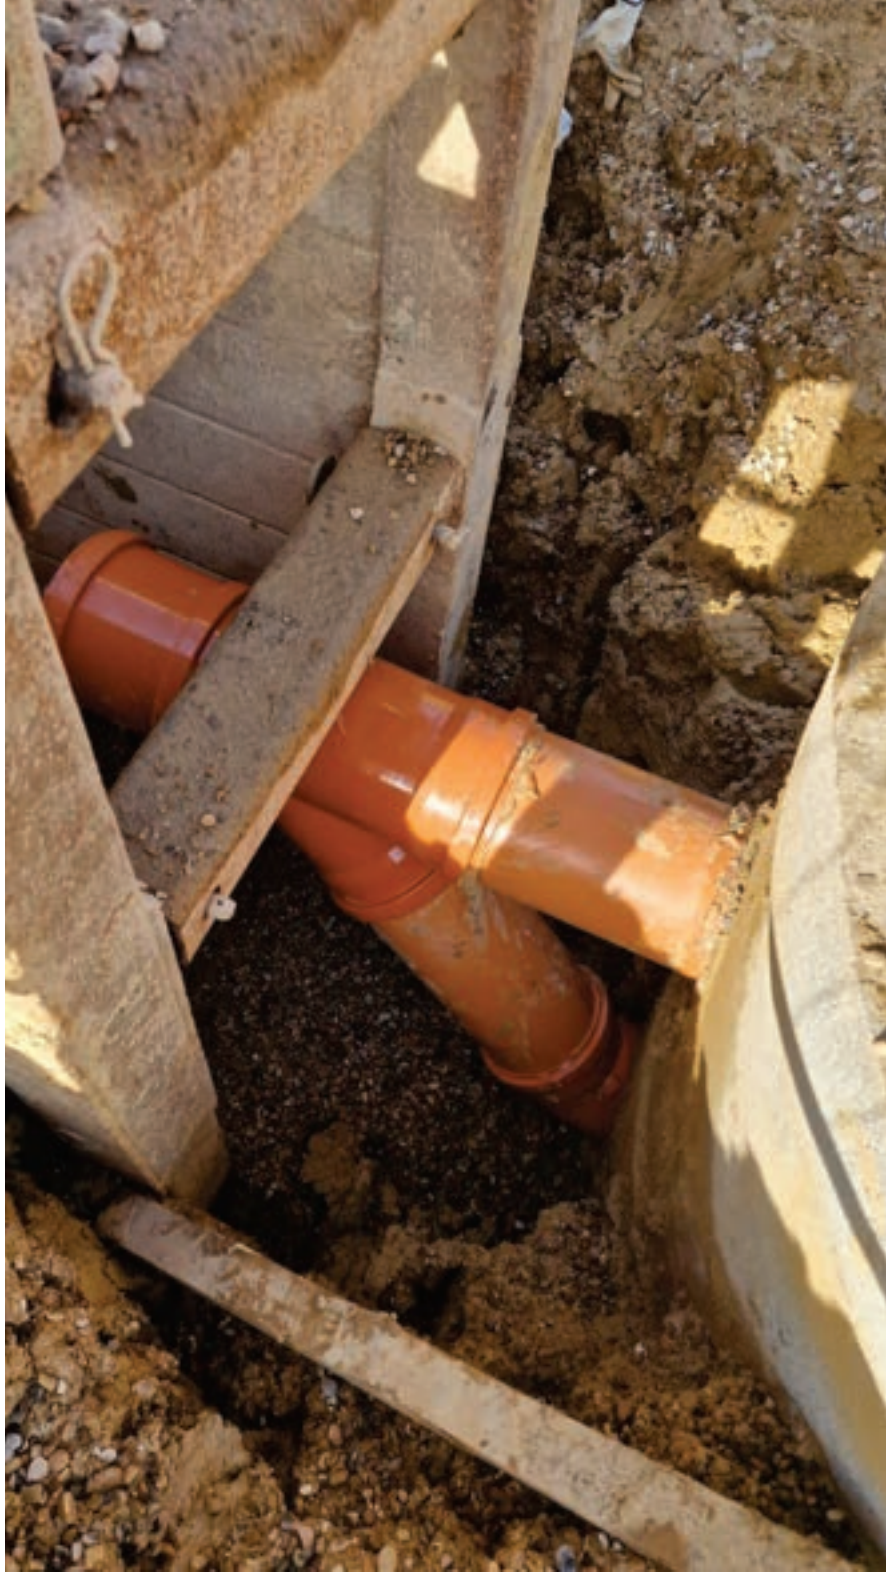
Photo 24 – Back drop to manhole S24

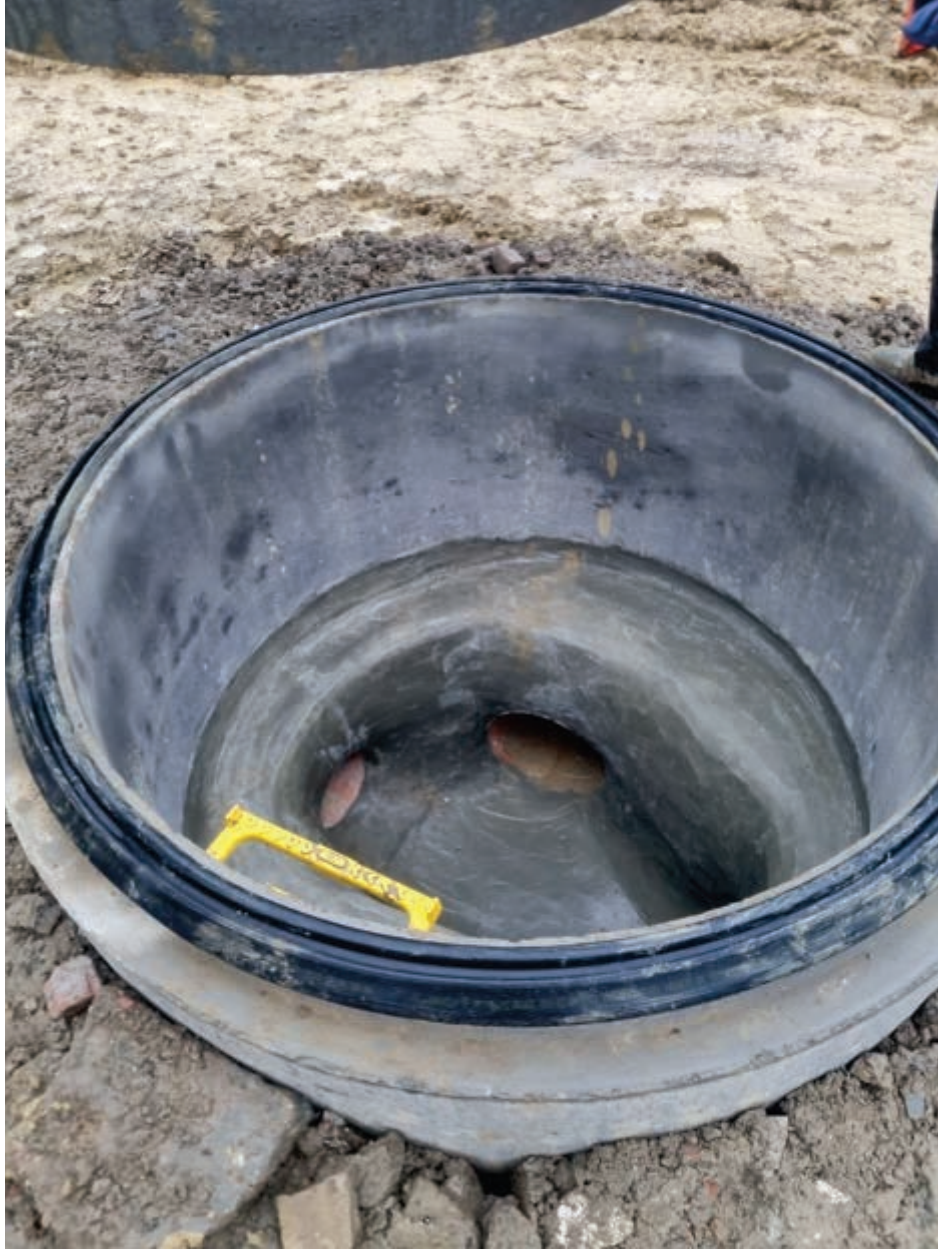
Photo 25 – Base of manhole S28

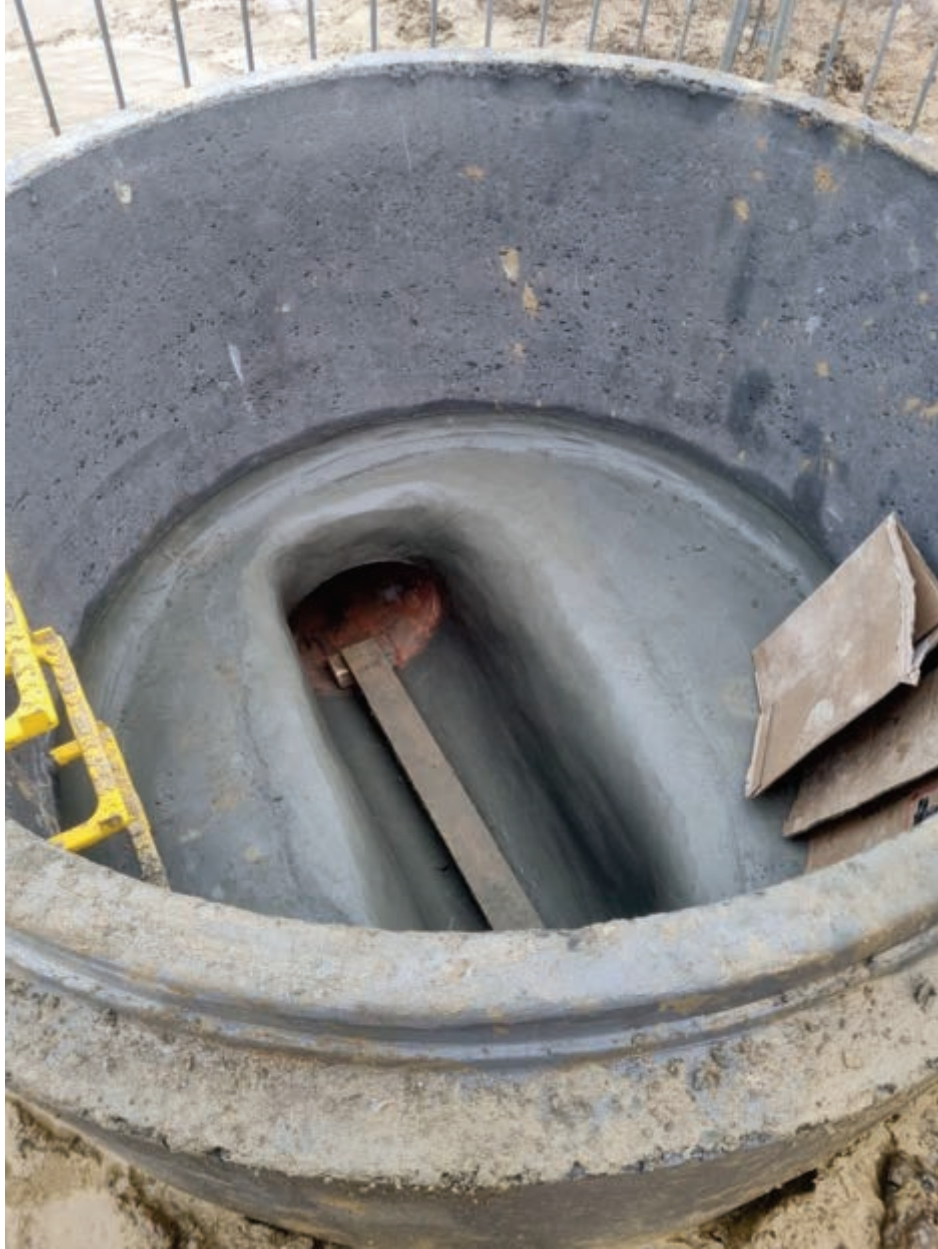
Photo 26 – Base of manhole S29

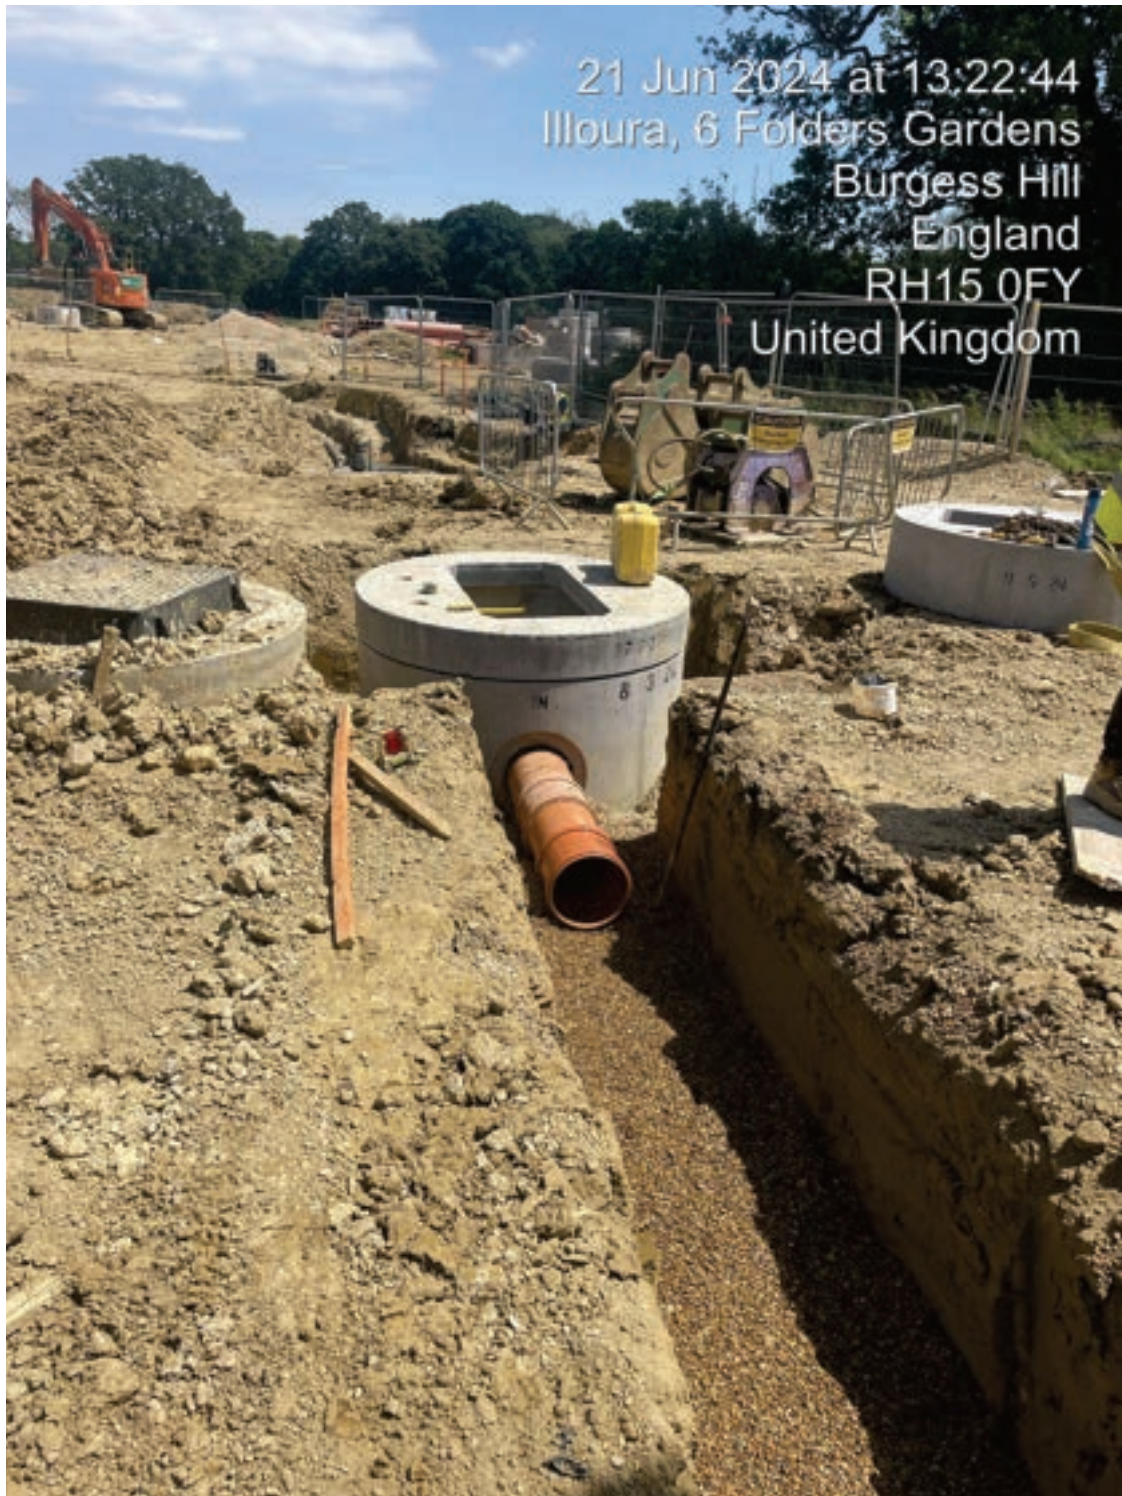
Photo 27 – Manhole S33

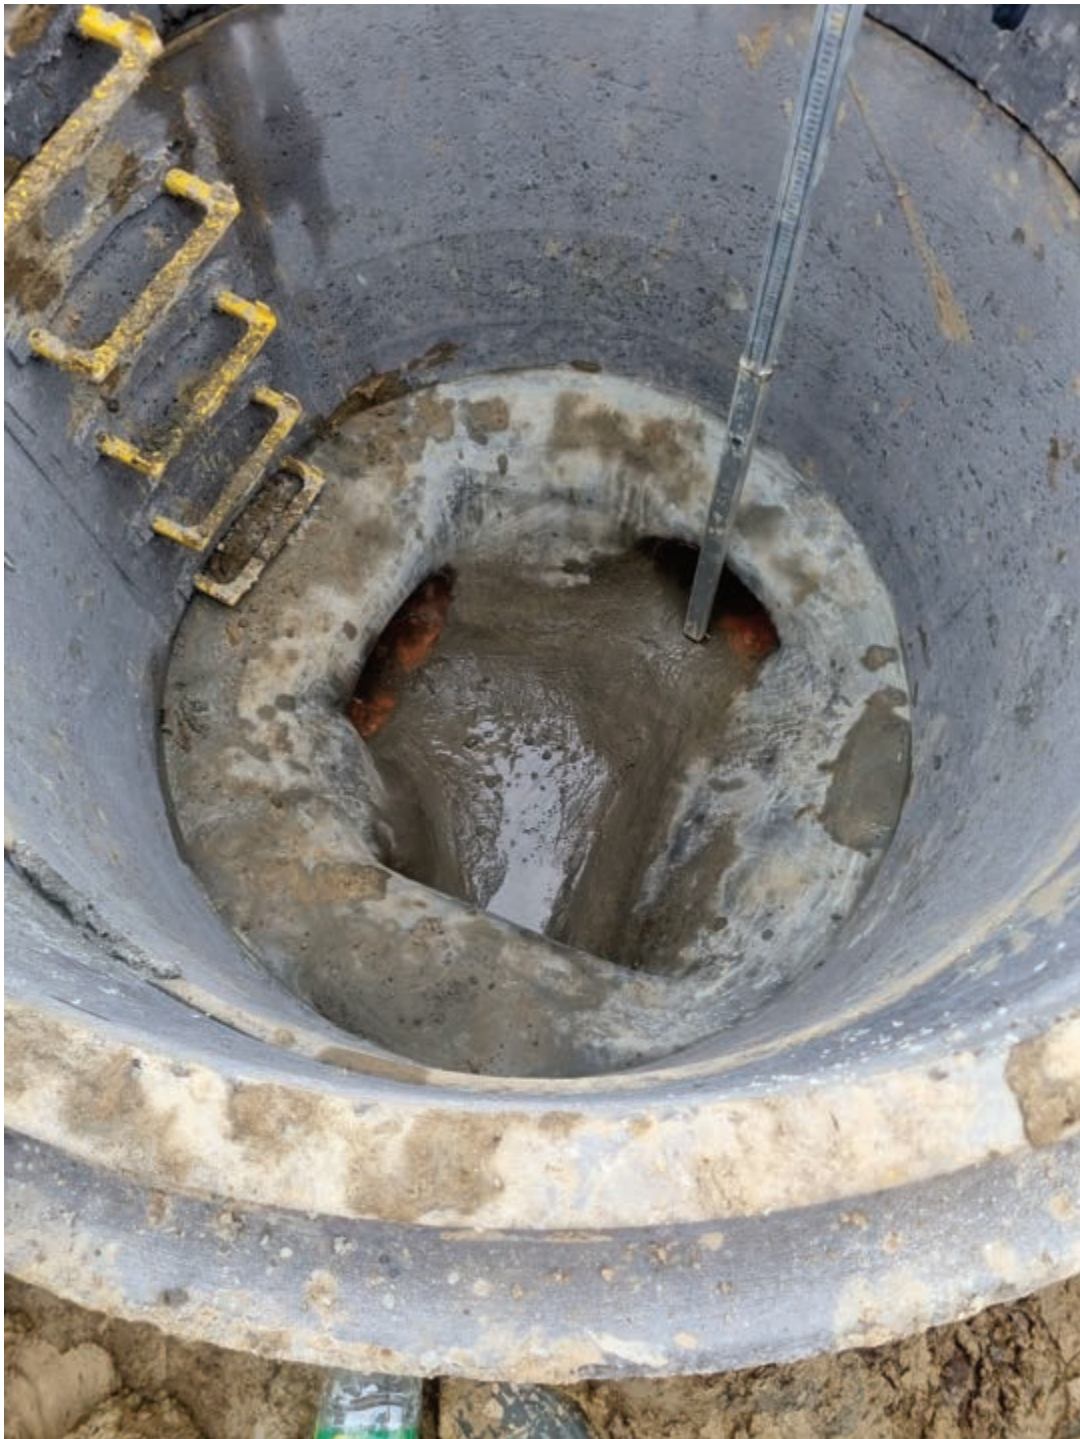
Photo 28 – Manhole S36
