# DEMOLITION ASBESTOS SURVEY REPORT

**Swimming Pool**  
Hurst College  
College Lane  
Hurstpierpoint  
Hassocks  
BN6 9JS

| PROJECT NO: | B-01044 |
| ISSUE DATE: | 19/05/2022 |

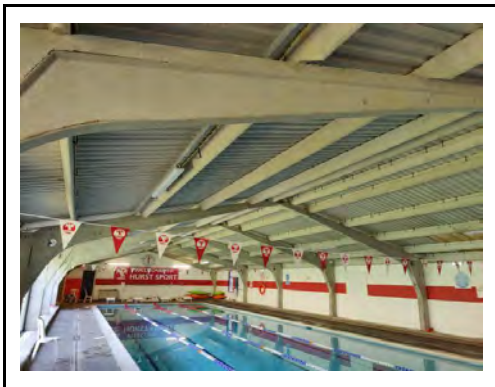
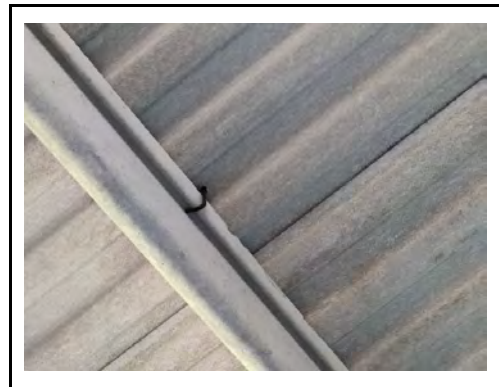
| <b>Level of Identification</b> | Sampled | <b>Sample Ref</b> | S001 |
| <b>Extent</b> | See exterior m <sup>2</sup> | <b>Accessibility</b> | Difficult |

Item Notes: Exposed underside of asbestos cement roof.

| | | Score |
|---|---|---|
| <b>Damage</b> | No visible damage | 0 |

Recommendation: Remove prior to refurbishment/demolition (non-licensable works).

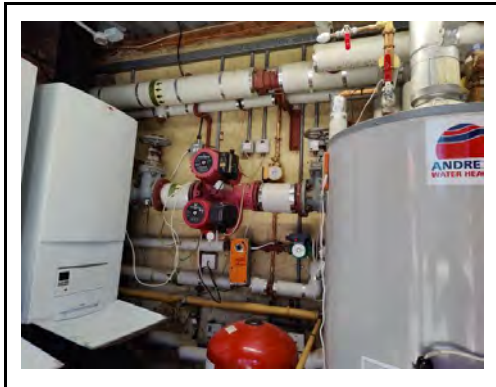
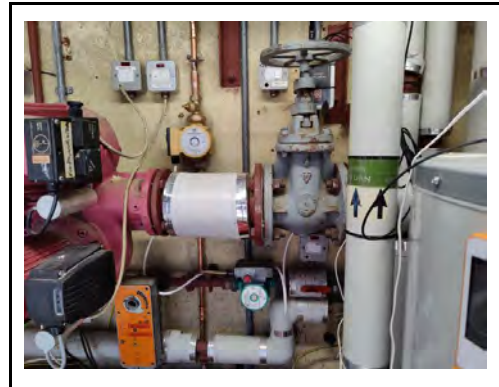
| <b>Level of Identification</b> | Sampled | <b>Sample Ref</b> | S003 |
| <b>Extent</b> | Approx. 20 no | <b>Accessibility</b> | Difficult |

Item Notes: Compressed gaskets to pipework

| | | Score |
|---|---|---|
| <b>Damage</b> | Low | 1 |

Recommendation: Remove prior to refurbishment/demolition (non-licensable works).

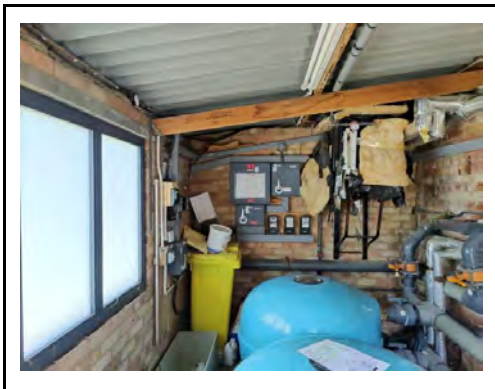
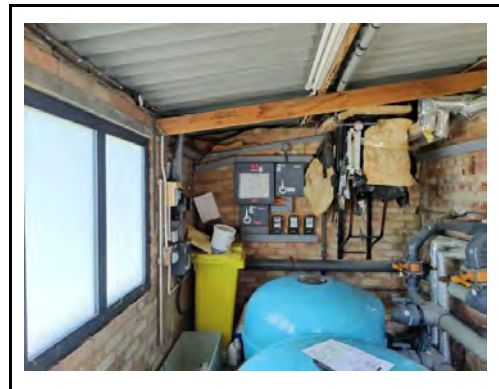
| <b>Level of Identification</b> | Presumed | <b>Sample Ref</b> | P |
| <b>Extent</b> | 4 no | <b>Accessibility</b> | Medium |

Item Notes: Live electrics presumed to contain asbestos.

| | | Score |
|---|---|---|
| <b>Damage</b> | No visible damage | 0 |

Recommendation: Remove prior to refurbishment/demolition (non-licensable works).

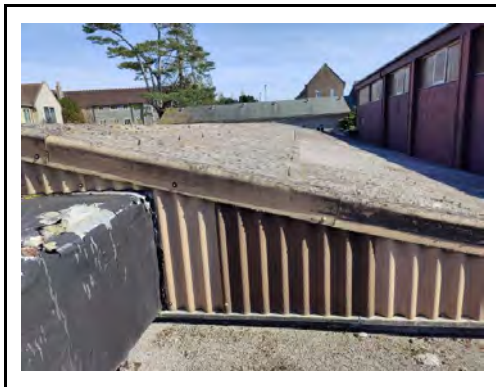
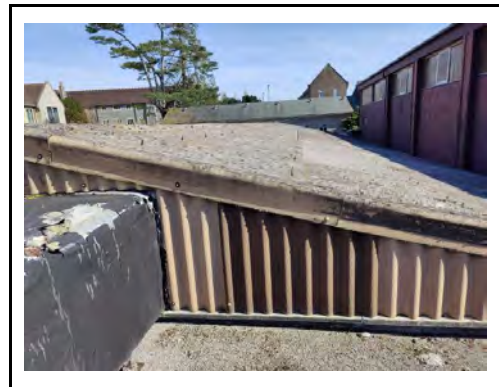
| <b>Level of Identification</b> | Same as | <b>Sample Ref</b> | X001 |
| <b>Extent</b> | Approx. 390 m <sup>2</sup> | <b>Accessibility</b> | Difficult |

Item Notes: Roof sheeting and cladding to pool.

| | | Score |
|---|---|---|
| <b>Damage</b> | Low | 1 |

Recommendation: Remove prior to refurbishment/demolition (non-licensable works).

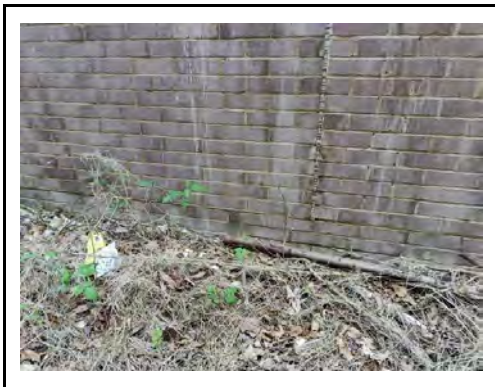
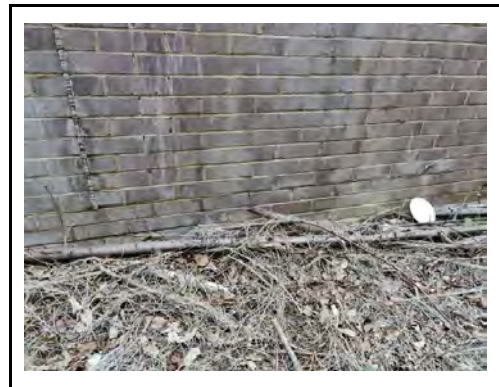
The bitumen damp proof course is very low risk - it may not be reasonably practicable to remove this product prior to demolition.

| <b>Level of Identification</b> | Sampled | <b>Sample Ref</b> | S004 |
| <b>Extent</b> | 85 lin m | <b>Accessibility</b> | Difficult |

Item Notes: Damp proof course.

| | | Score |
|---|---|---|
| <b>Damage</b> | No visible damage | 0 |

Recommendation: Remove prior to refurbishment/demolition (non-licensable works).

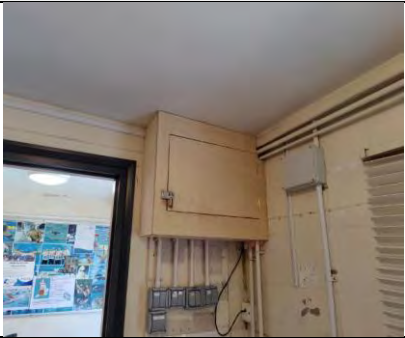
| Swimming Pool | | | | |
|---|---|---|---|---|
| 125405 | Store | G.002 | Cupboard | Not able to open the cupboard - padlock key required. |

| Swimming Pool | | | | | | |
|---|---|---|---|---|---|---|
| 125405 | Store<br>G.002 | Cupboard | No access gained | | | |

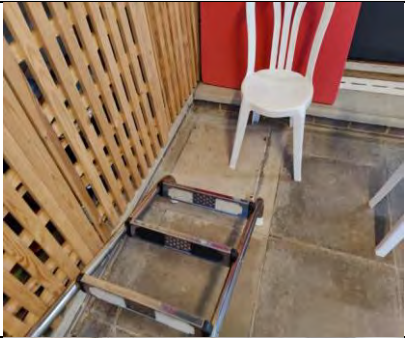
| Swimming Pool | | | | |
|---|---|---|---|---|
| 125415 | Swimming pool | G.004 | Drain covers | Not able to remove drain covers - not able to access without breaking and area still operational - demolition works must proceed progressively. |

| Swimming Pool | | | | | | |
|---|---|---|---|---|---|---|
| 125415 | Swimming pool<br>G.004 | Drain covers | Limited access gained | | | |

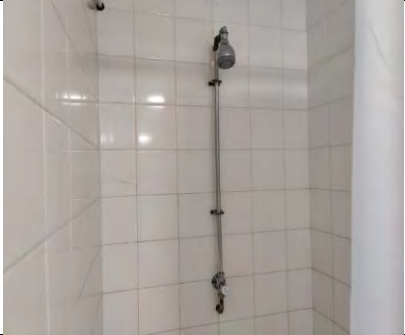
| Swimming Pool | | | | |
|---|---|---|---|---|
| 125416 | Shower area | G.005 | Behind shower valve | Shower valve not disturbed - demolition works must proceed progressively. |

| Swimming Pool | | | | | | |
|---|---|---|---|---|---|---|
| 125416 | Shower area<br>G.005 | Behind shower valve | Limited access gained | | | |

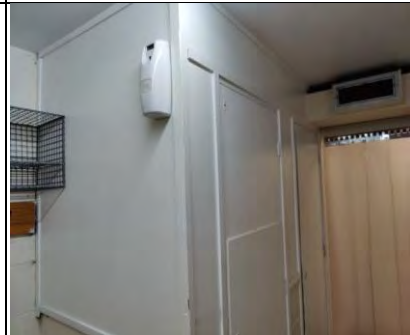
| Swimming Pool | | | | |
|---|---|---|---|---|
| 125434 | Cupboard | G.008 | All items | Not able to open the door. |

| Swimming Pool | | | | | | |
|---|---|---|---|---|---|---|
| 125434 | Cupboard<br>G.008 | All items | No access gained | | | |

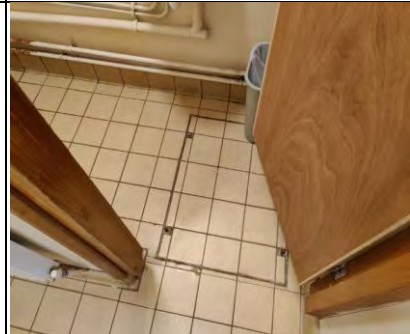
| Swimming Pool | | | | |
|---|---|---|---|---|
| 125453 | WC | G.012 | Duct cover | Not able to remove drain cover - not able to access without breaking & area still operational - demolition works must proceed progressively. |

| Swimming Pool | | | | | | |
|---|---|---|---|---|---|---|
| 125453 | WC<br>G.012 | Duct cover | Limited access gained | | | |

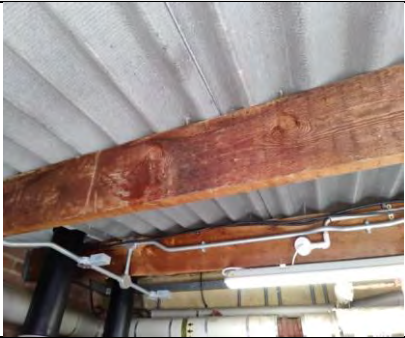
| Swimming Pool | | | | | | |
|---|---|---|---|---|---|---|
| 125468 | Boiler room<br>G.013 | Underside of cement roof<br>sheeting | Cement product | X002 | NAD | |

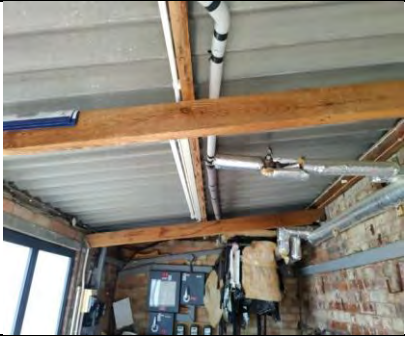
| Swimming Pool | | | | | | |
|---|---|---|---|---|---|---|
| 125467 | Pool plant room<br>G.014 | Underside of cement roof<br>sheeting | Cement product | X002 | NAD | |

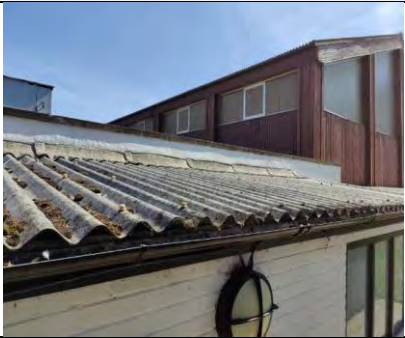
| Swimming Pool | | | | | | |
|---|---|---|---|---|---|---|
| 125470 | Exterior<br>EX.001 | Roof sheeting to plant rooms | Cement product | S002 | NAD | |

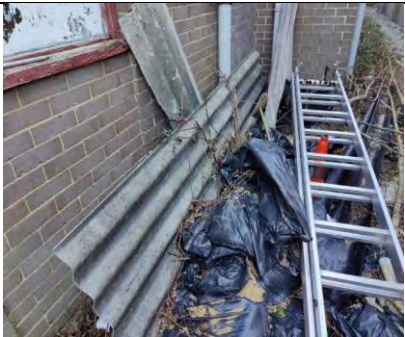
| Swimming Pool | | | | | | |
|---|---|---|---|---|---|---|
| 125475 | Exterior<br>EX.001 | Cement sheet debris | Cement product | S005 | NAD | |

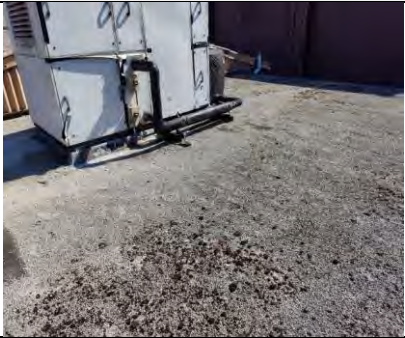
| Swimming Pool | | | | | | |
|---|---|---|---|---|---|---|
| 125476 | Exterior<br>EX.001 | Felt to flat roof | Bituminous product | S006 | NAD | |
