## Tree inspection and report for Mr Peter Parsons

Date- 8/2/2025

Surveyor- Mr Antony Geer TechArborA

### Tree (1)

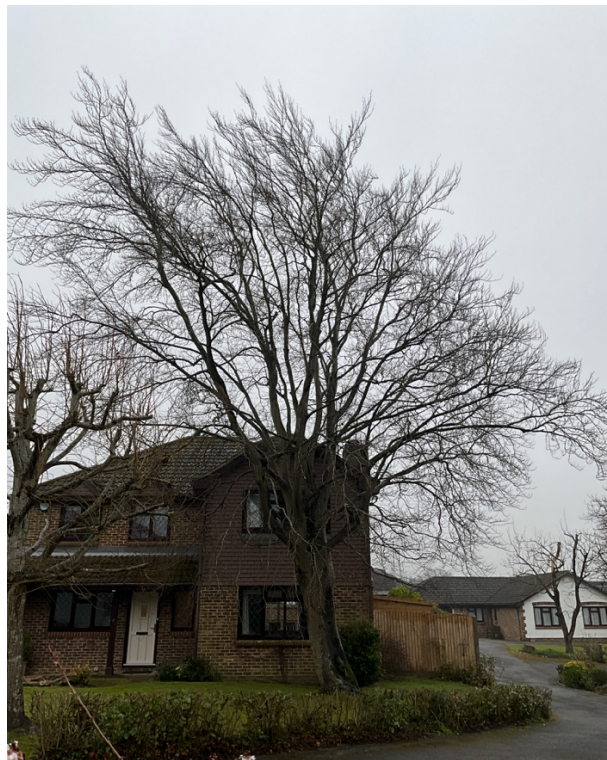
Due to location of the tree (next to house) the tree is one sided. There is no vitality visible at this time of year although the amount of visible bud is very good. There are a few gaps in the canopy to the west. The tree has many main leaders all fighting for apical dominance. 3 branches are crossing and causing weak points. The stem separates at 3.5 meters into 4 stems, this has resulted in pockets where water and debris can collect.

Reduce the tree by up to 1.5 meters and rebalance \*see west photo

Remove small limbs crossing over major limbs on west side to prolong life of major limbs.

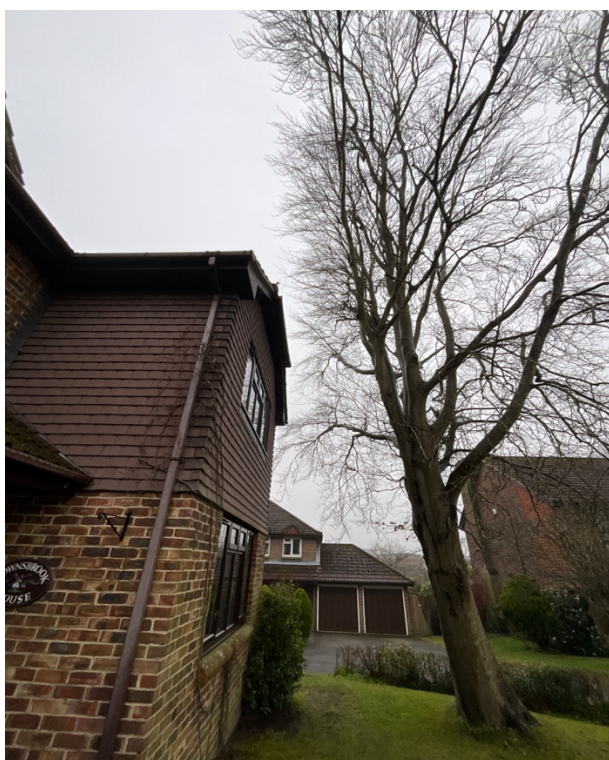
Between house and tree

The tree's origin is 2.8 meters away from the building and therefore reducing light into property.

Raise canopy to 4 meters to help light into property

Remove growth towards property to remove and future property damage
