Lullings Cottage

Structural Assessment

Stantec UK Limited

6 August 2025

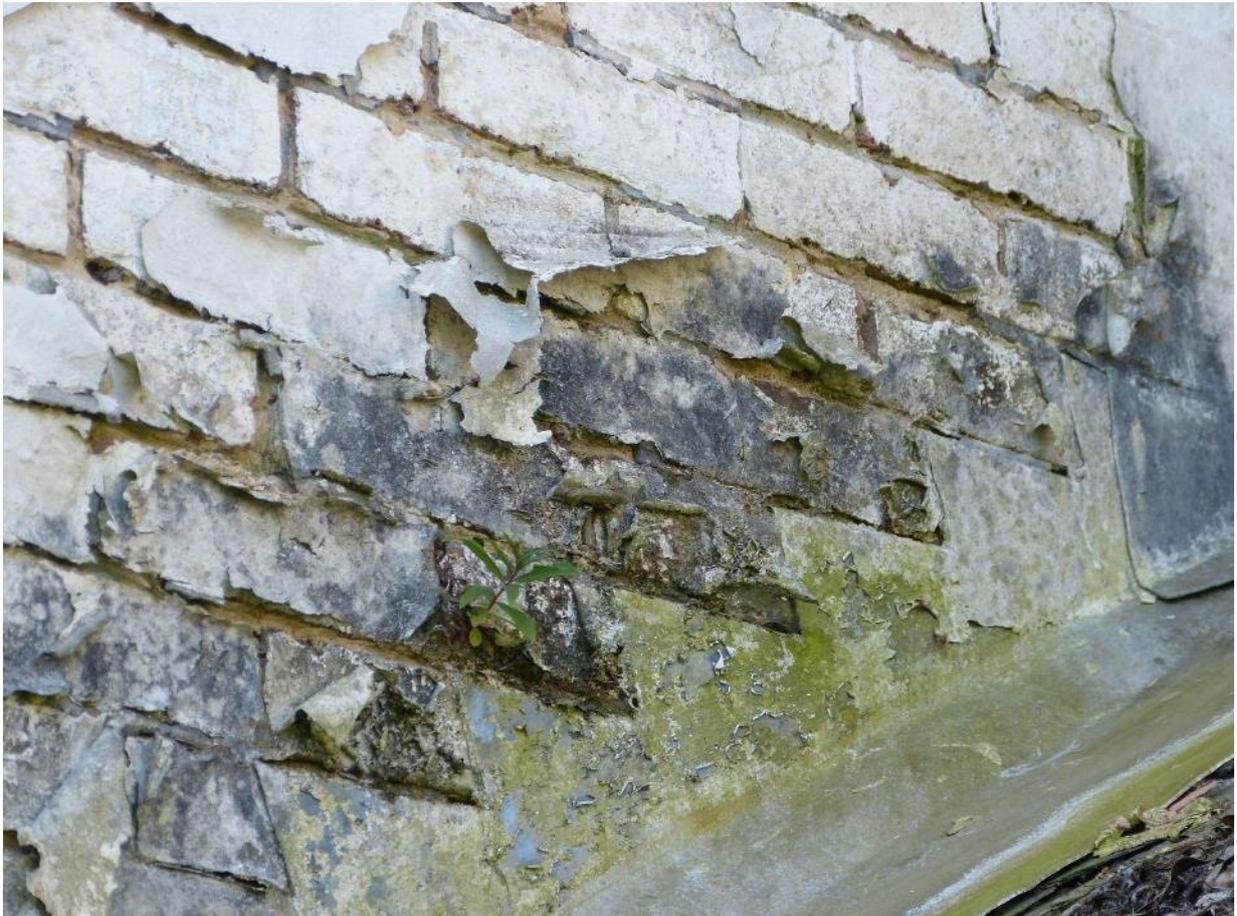
There were no indications of movement in the external walls, no significant cracking was observed, and all walls appeared vertical and in generally fair structural condition. External walls were of painted brick in a stretcher bond. Multiple layers of paint were apparent with some layers appearing to be brittle and impermeable, flaking off in various locations especially where exposed to moisture.

Figure 3 - Example flaking paint

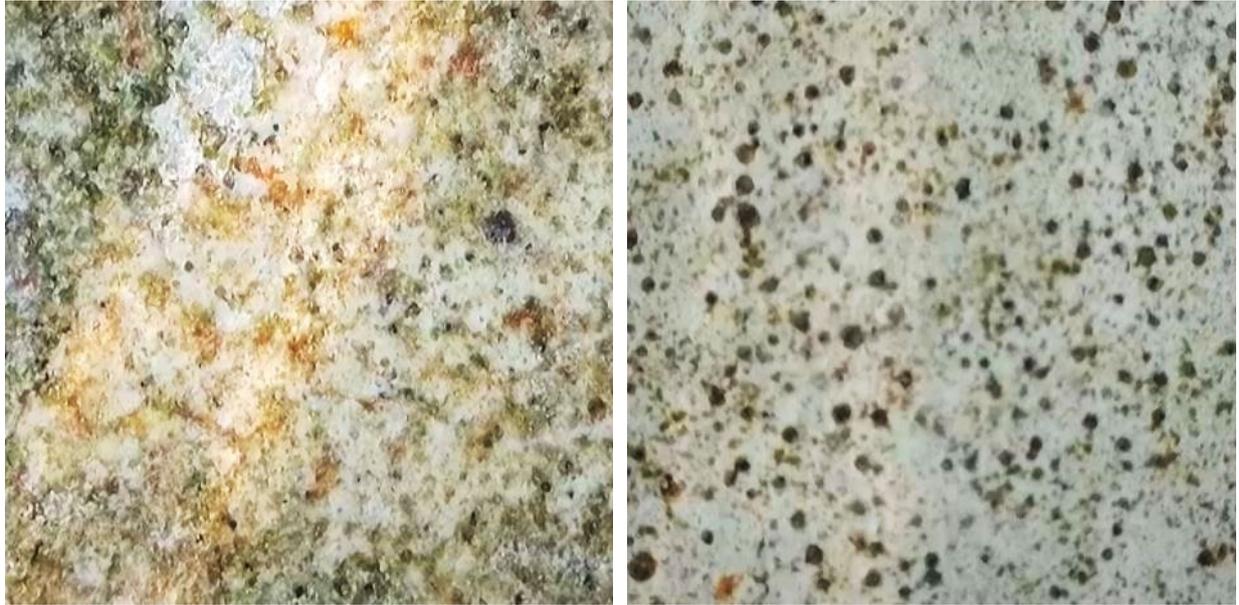
Field microscopy suggested previous layers of paint are more porous and potentially more permeable than the outermost layer.

Figure 4 - Inner paint layer (left), outer paint layer (right)

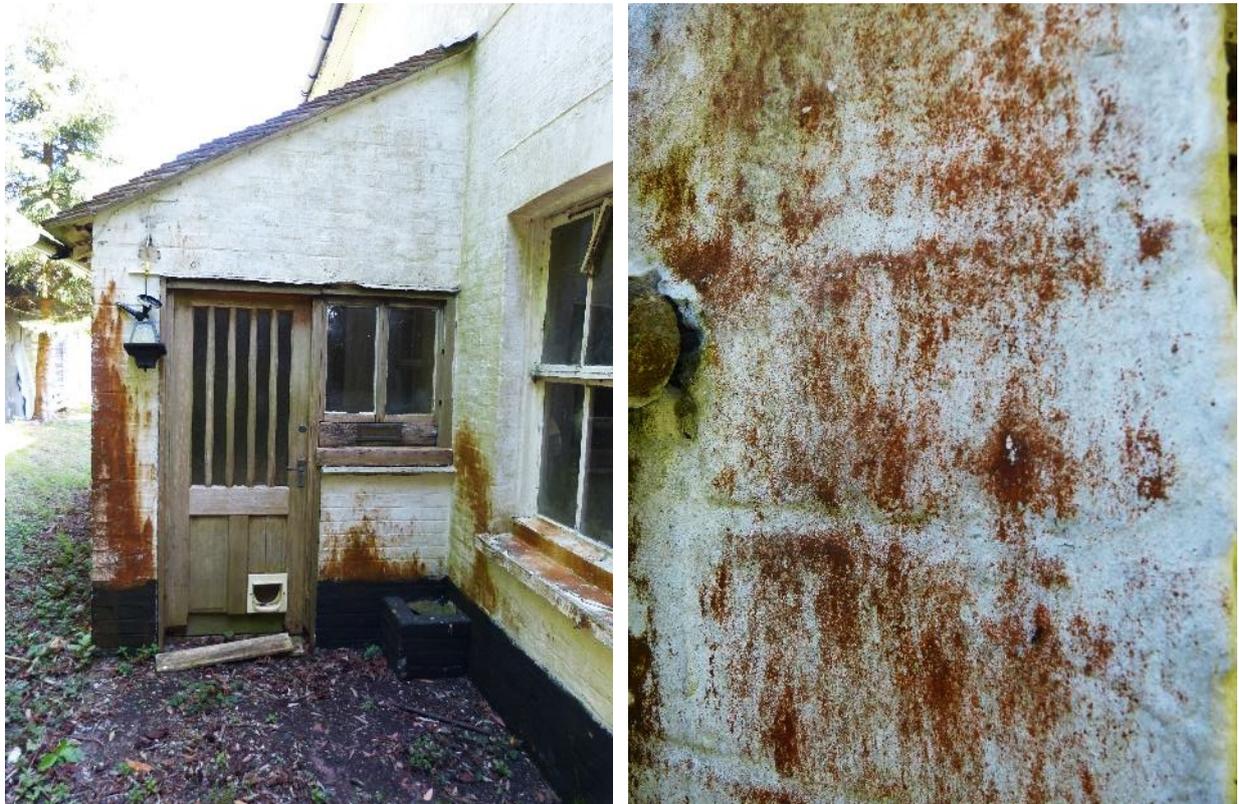
Localised areas around the western side of the building had surface growth of russet coloured mould/lichen suggesting elevated moisture levels, likely due to these elevations being in shade and protected from both sun and wind by substantial tree cover.

Figure 5 – External Mould/Lichen

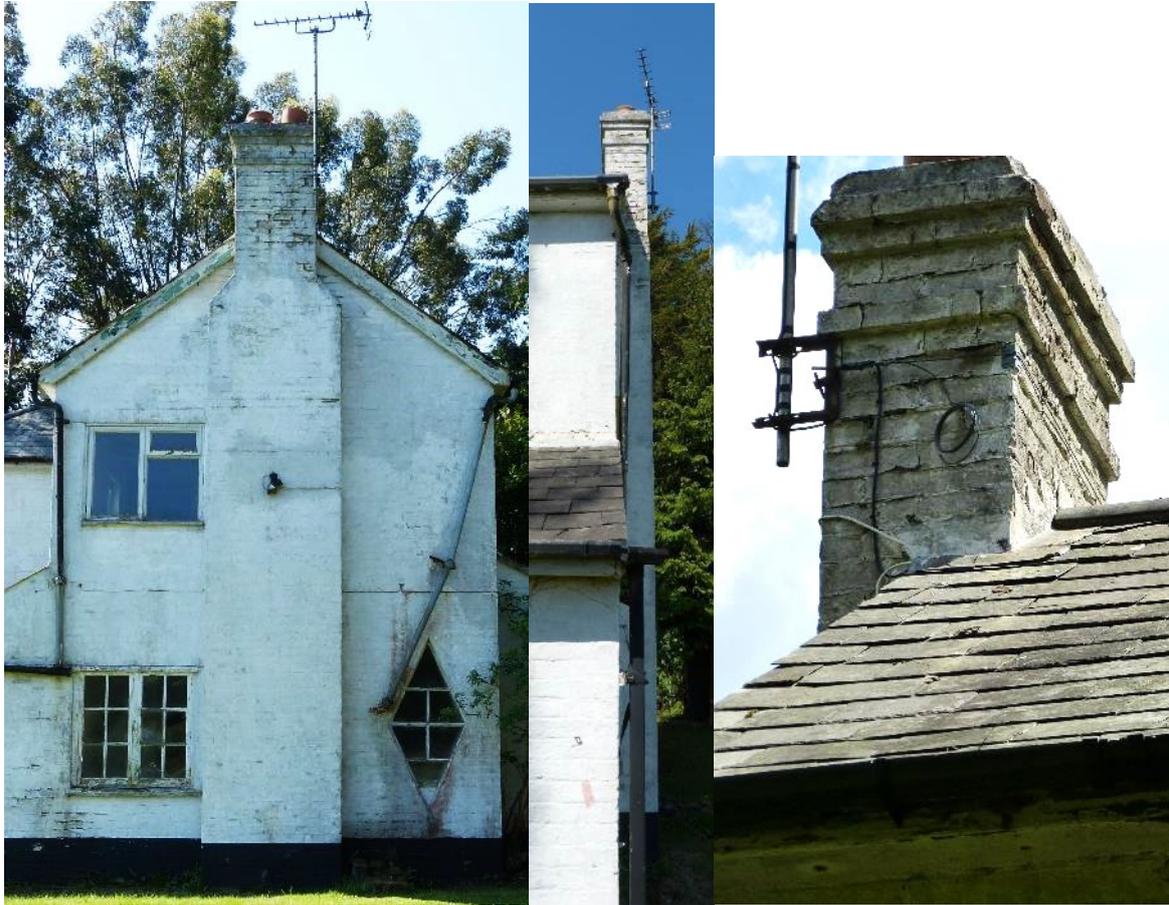
The cottage features three chimney stacks. The north chimney appeared vertical and in fair condition.

Figure 6 - North chimney

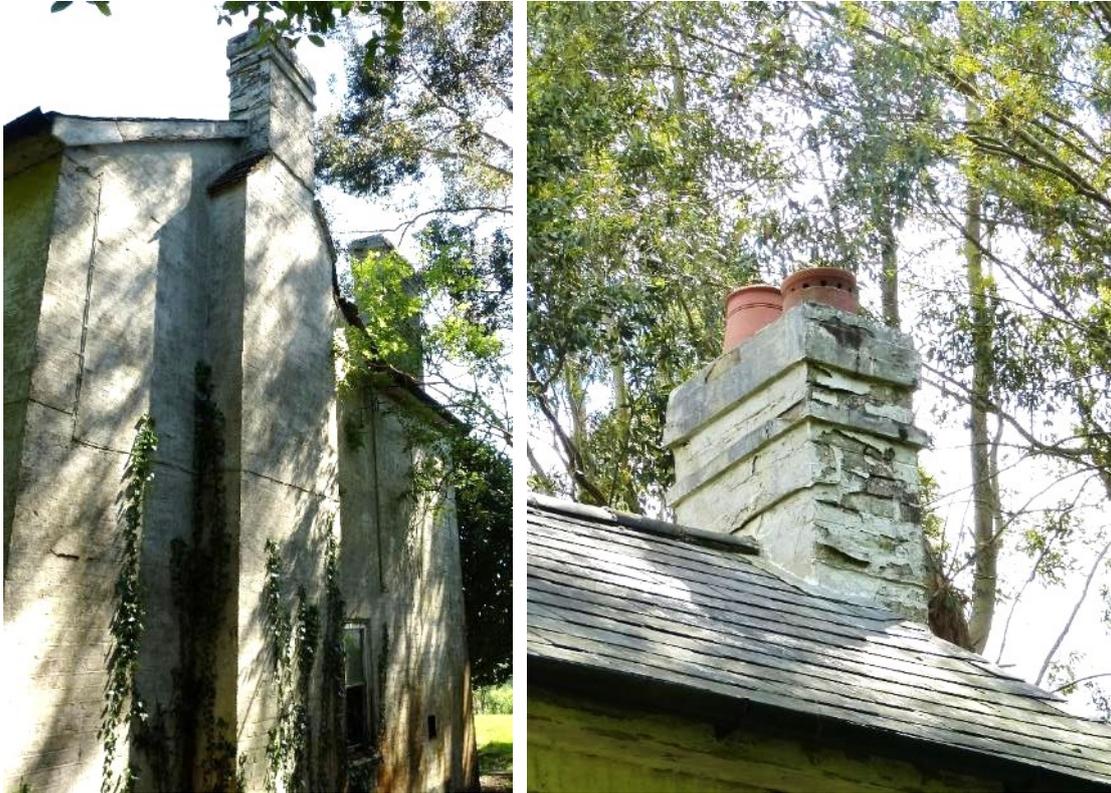
The southwest chimney appeared vertical and generally in fair condition. The stack had a greater degree of paint flaking than the northern chimney which is indicative of moisture ingress and perhaps indicates some deterioration of the brickwork. Closer high-level inspection would need to be undertaken to establish the condition of the existing bricks.

Figure 7 - Southwest chimney

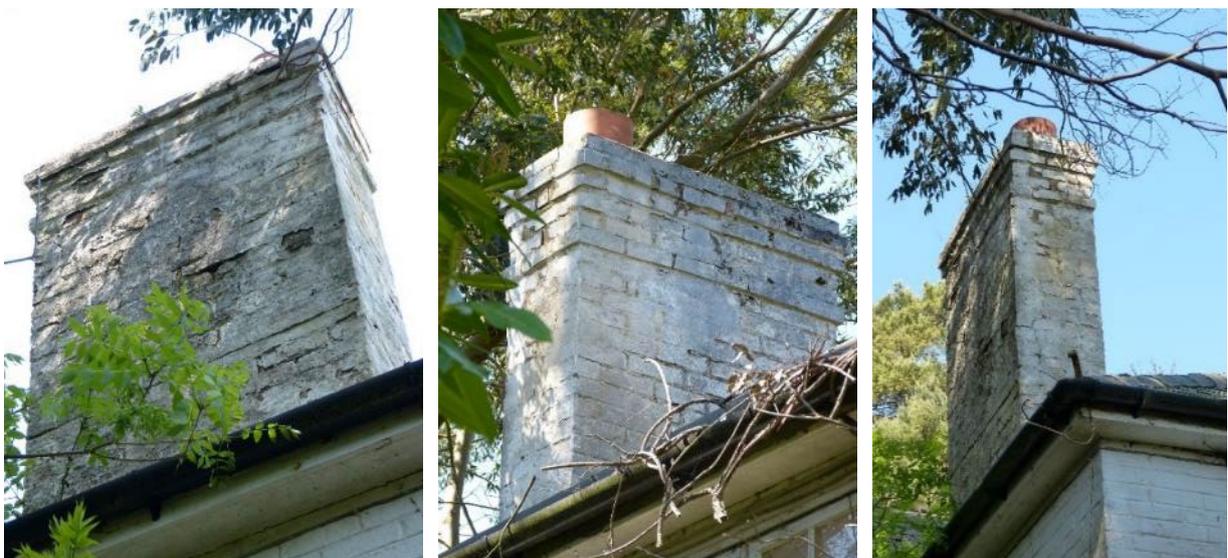
The southeast chimney appeared vertical and was generally in fair condition with localised deterioration, primarily to the south face.

Figure 8 - Southeast chimney

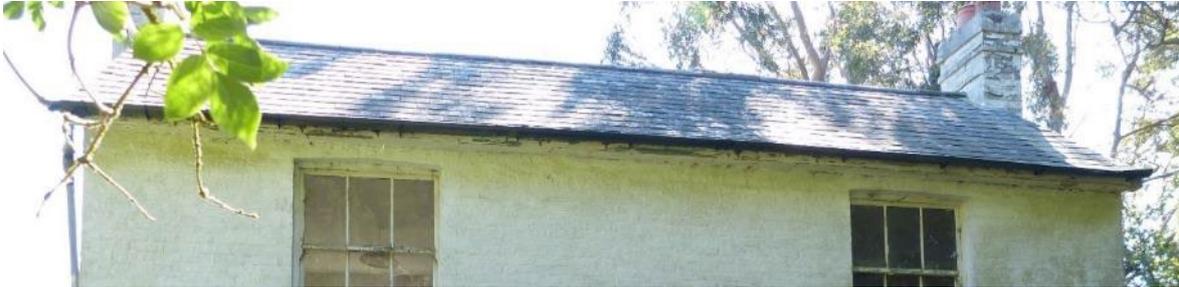
Figure 9 - Main roof (from west)

The main roof had a level ridge and hips with little visible indication of movement. The tiles on each slope appeared to be in fair condition without significant slippage or damage.

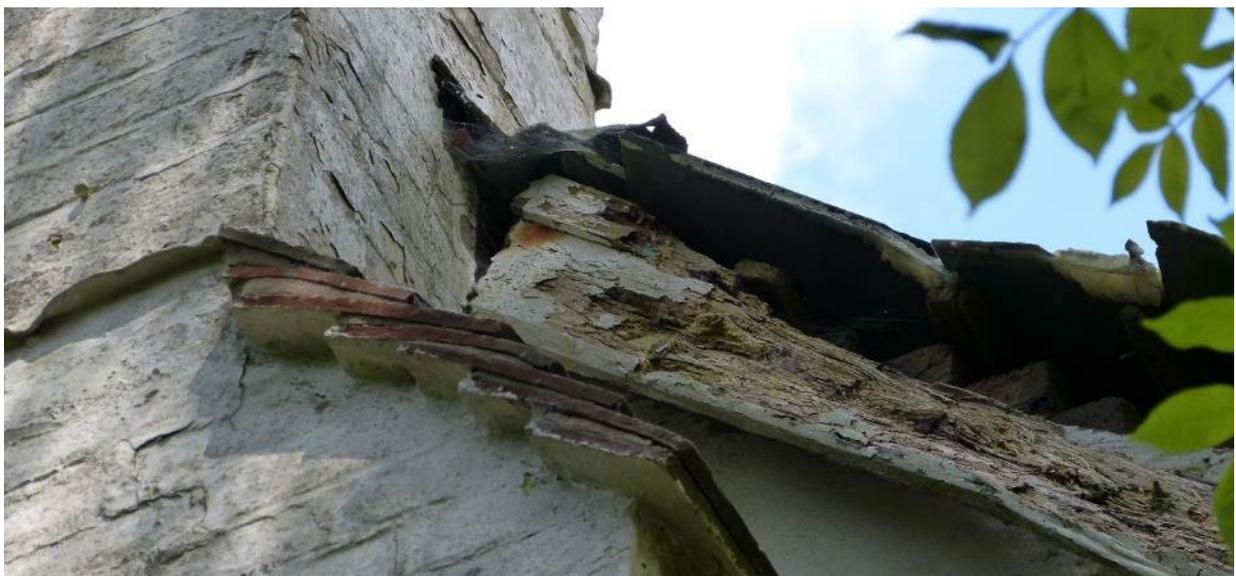
A small section of roof adjacent to the southwest chimney appeared damaged but no vantage point could be gained to obtain a clear view of it as a result of existing vegetation. This would need to be investigated further in order to establish what damage has occurred and determine possible cause.

Figure 11 - Main roof damage

A section of ceiling in the southwest corner had failed and staining is visible in the surrounding plaster. This appeared to be the result of water damage. This area is roughly in the position of the main roof damage noted in 2.1.3.

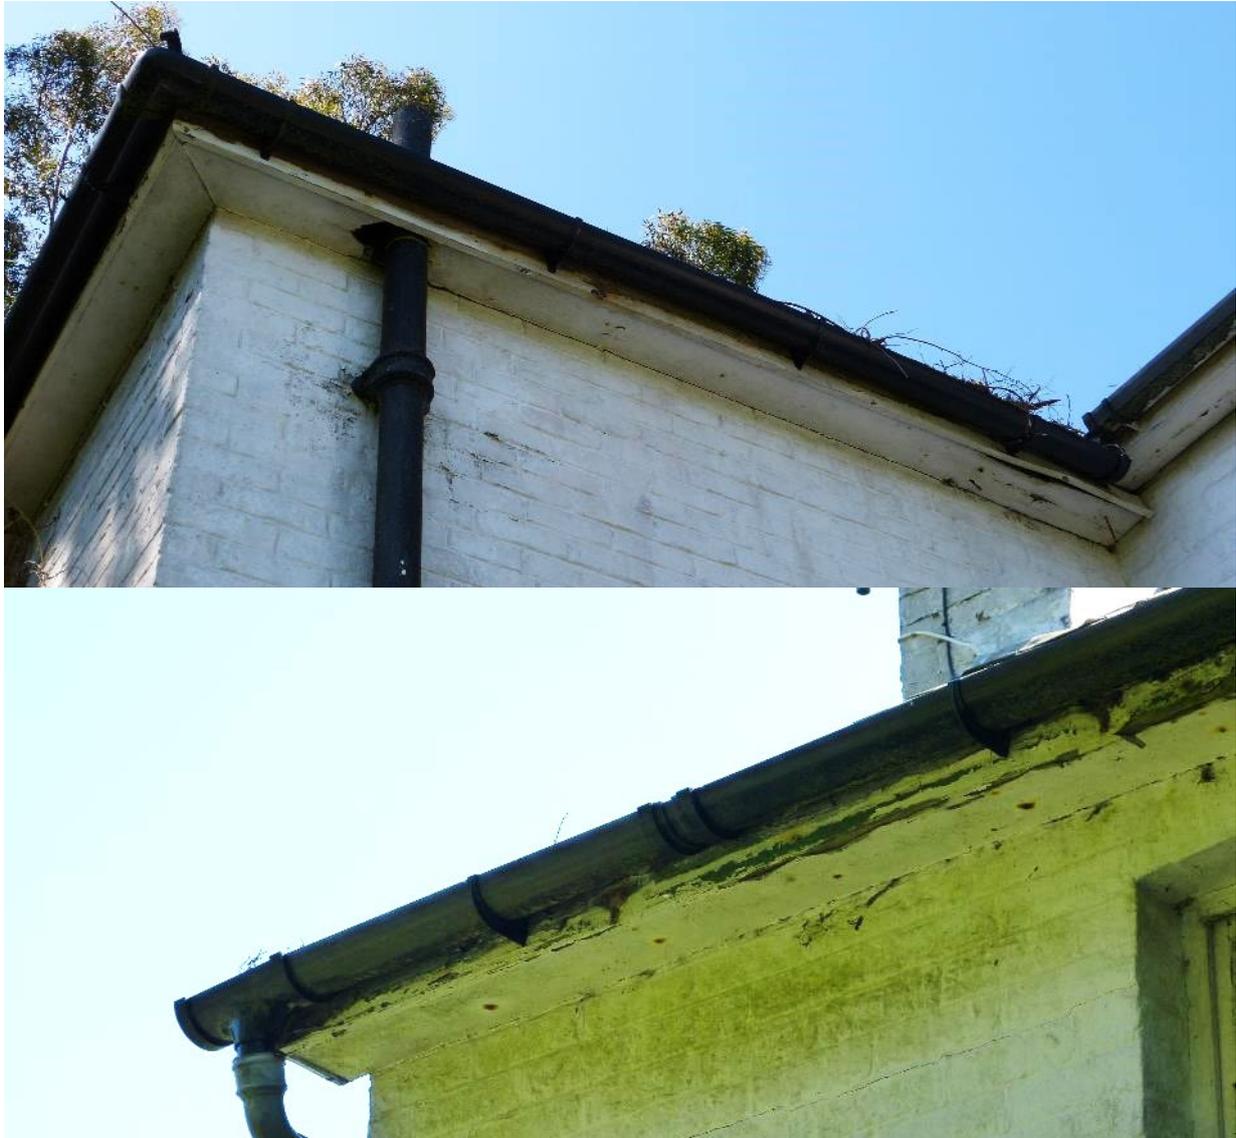
The majority of soffits and fascias on the main roof had flaking paint but visible damage and decay was viewed. This was localised to a few specific areas. Generally, boards appeared to be soundly attached.

Figure 12 - Main roof example soffits and fascias

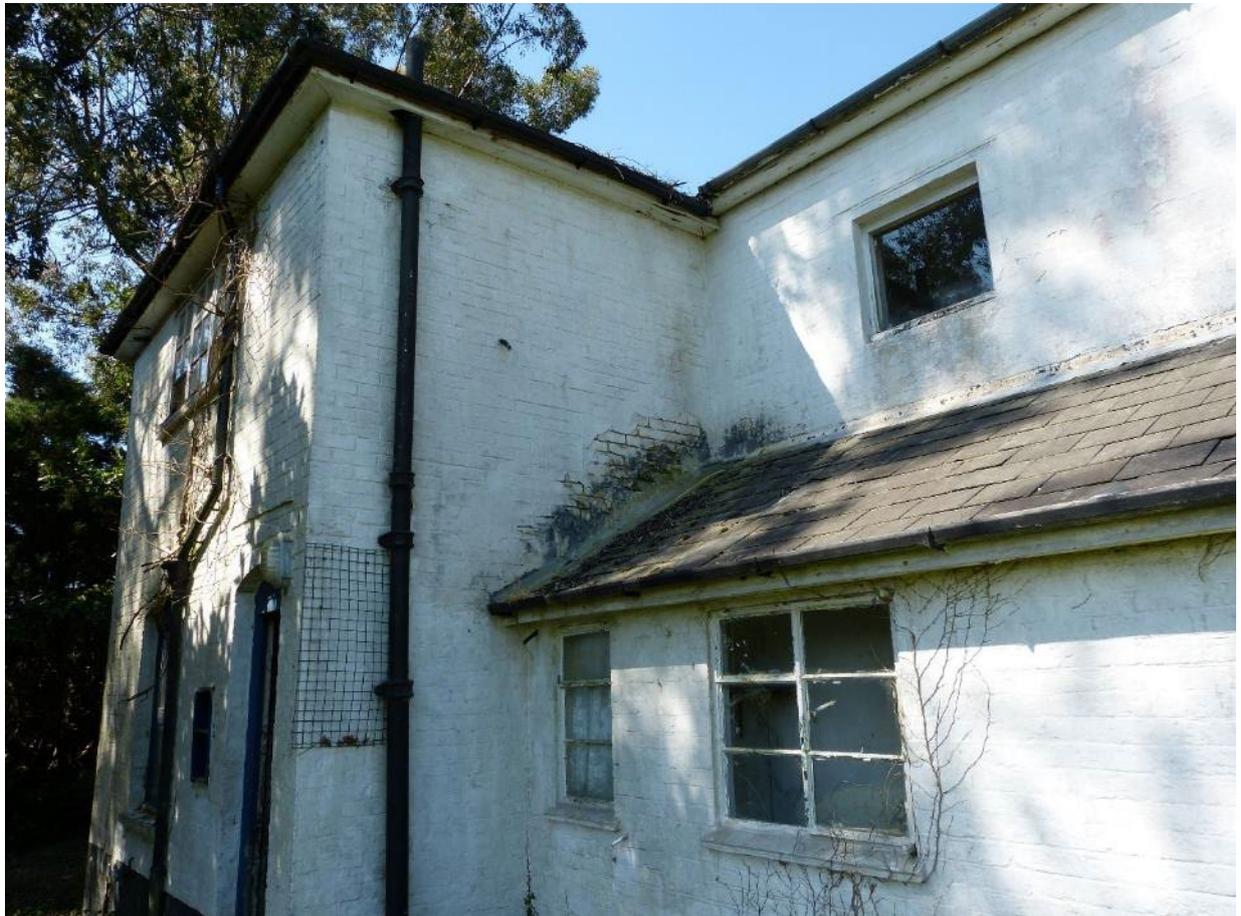
Figure 13 - Northeast lean-to roof

The northeast lean-to roof was in fair condition with no visible structural deterioration and limited movement of tiles. The flashing detail at the southern end appeared to have deteriorated, with the adjacent wall showing signs of moisture damage, potentially linked to the condition of the guttering above.

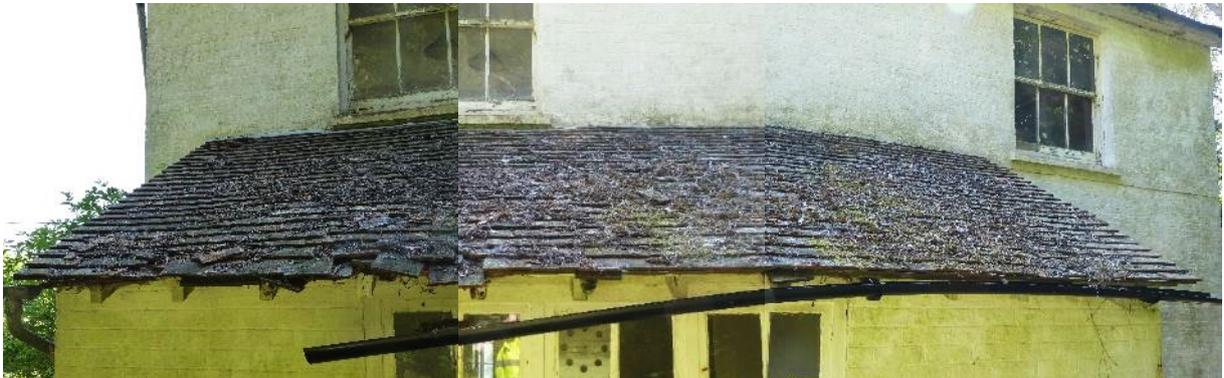
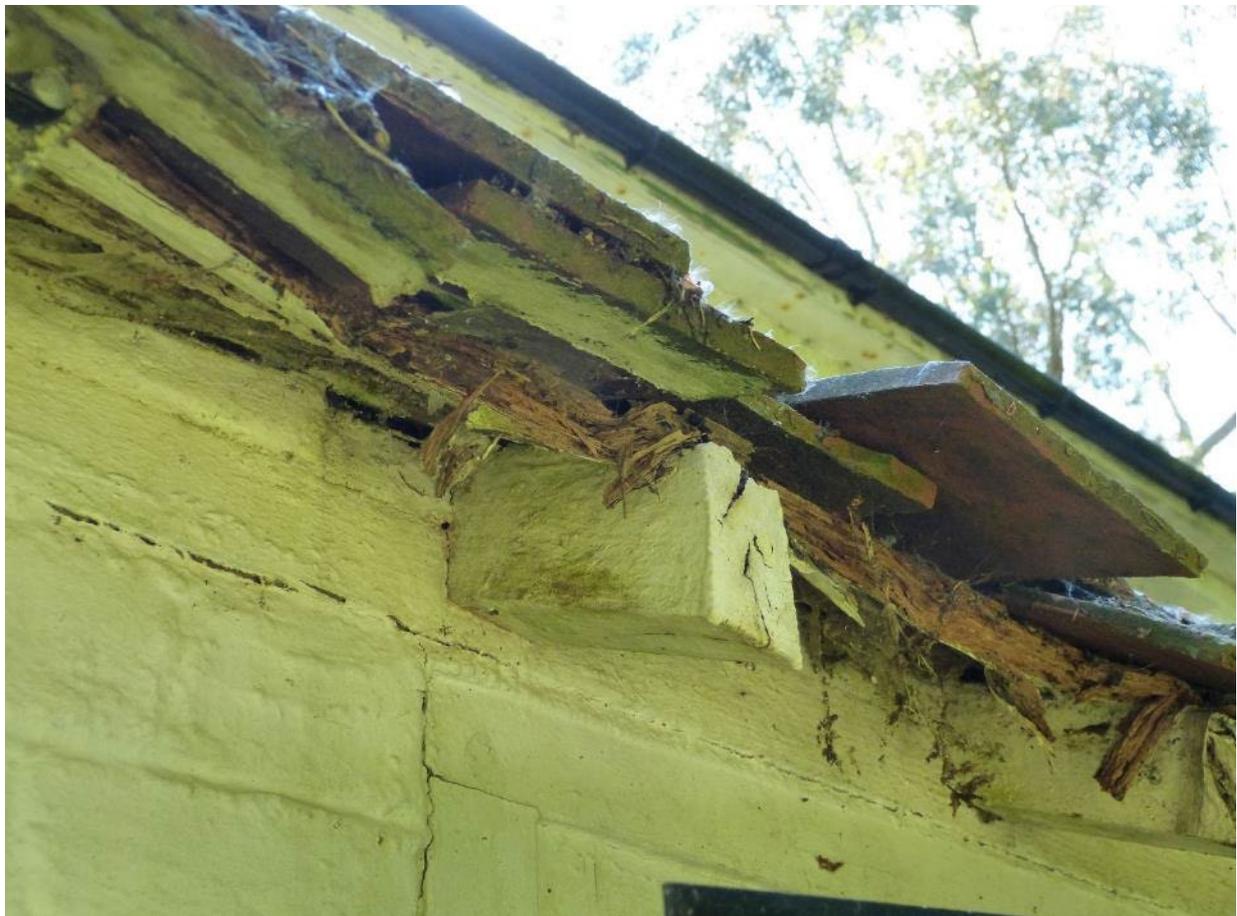
Figure 14 - West lean-to roof

The western lean-to roof was in poor condition. The eaves at the northern end had decayed, guttering was missing and had failed, and several tiles had slipped. Generally, the tiles need maintenance and there was extensive moss growth, likely exacerbated by windblown debris from adjacent trees.

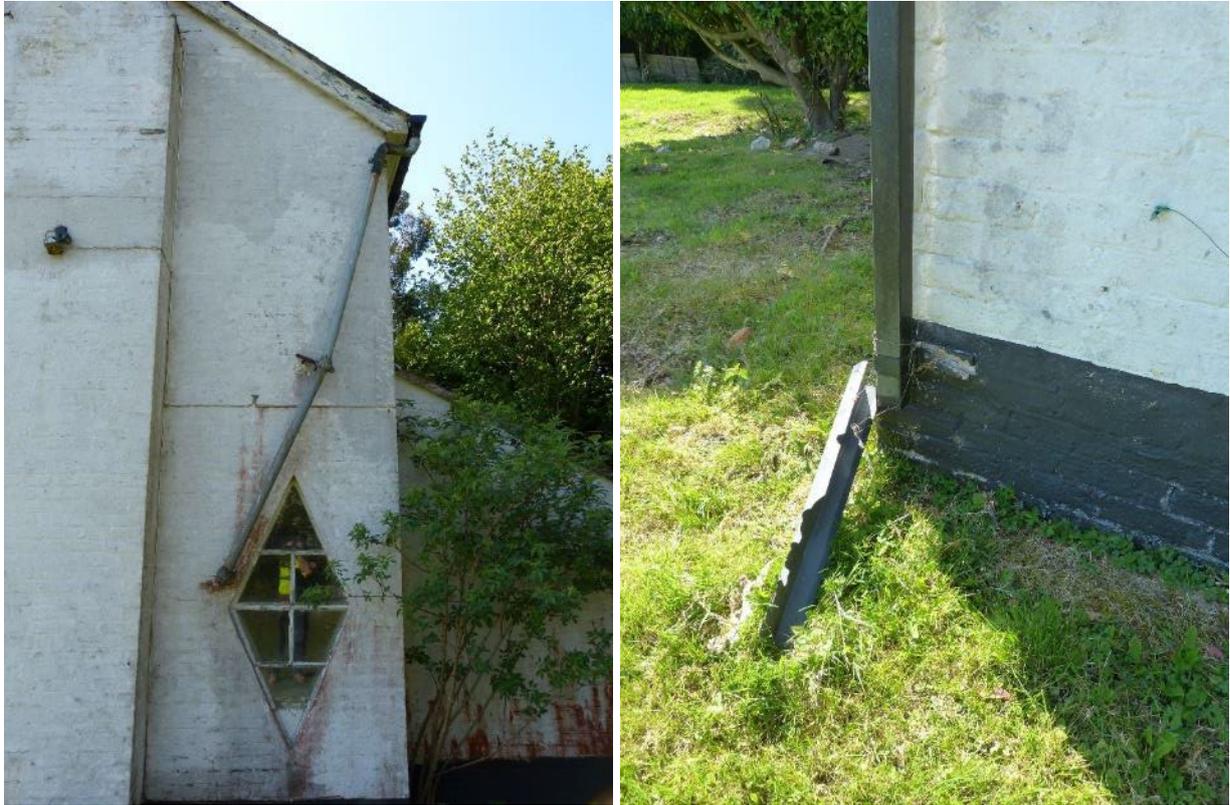
Generally guttering was present but in localised areas was missing or detached. Several sections appeared from ground level to be blocked with debris. Down pipes were generally present but with several damaged areas where they did not connect into below ground drainage.

Figure 15 - Example downpipe damage

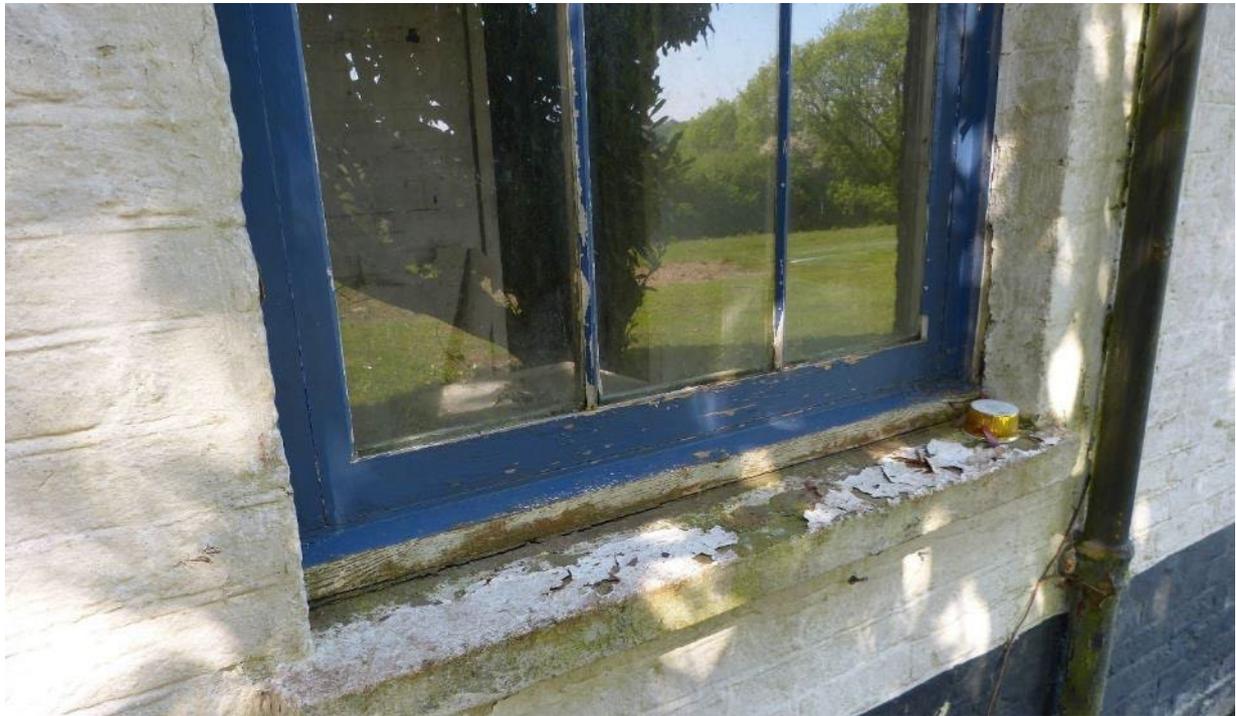
Timber door and window framing was of mixed condition from fair with localised deterioration to poor with large areas of decay. The northeast lean-to features metal framed windows that appeared to be in fair condition.

Figure 16 - Window frame in fair condition

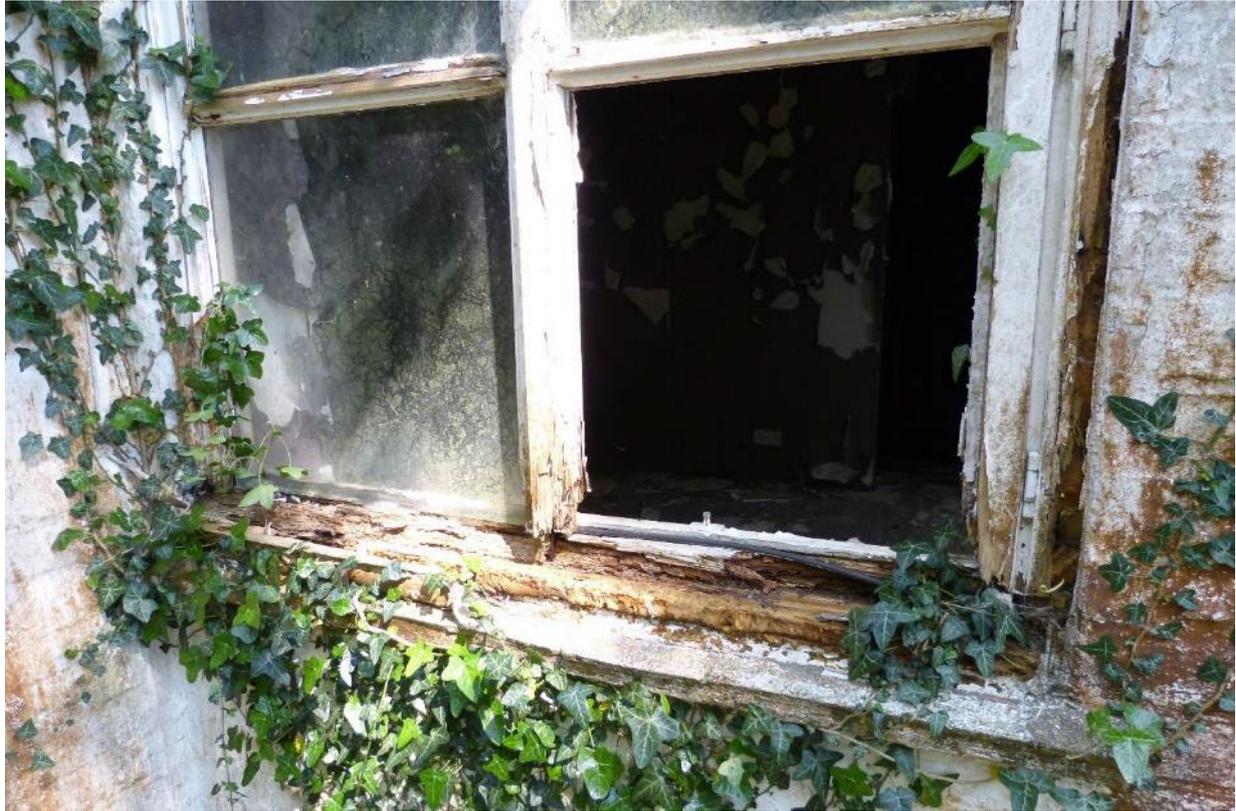
Figure 17 - Window frame in poor condition

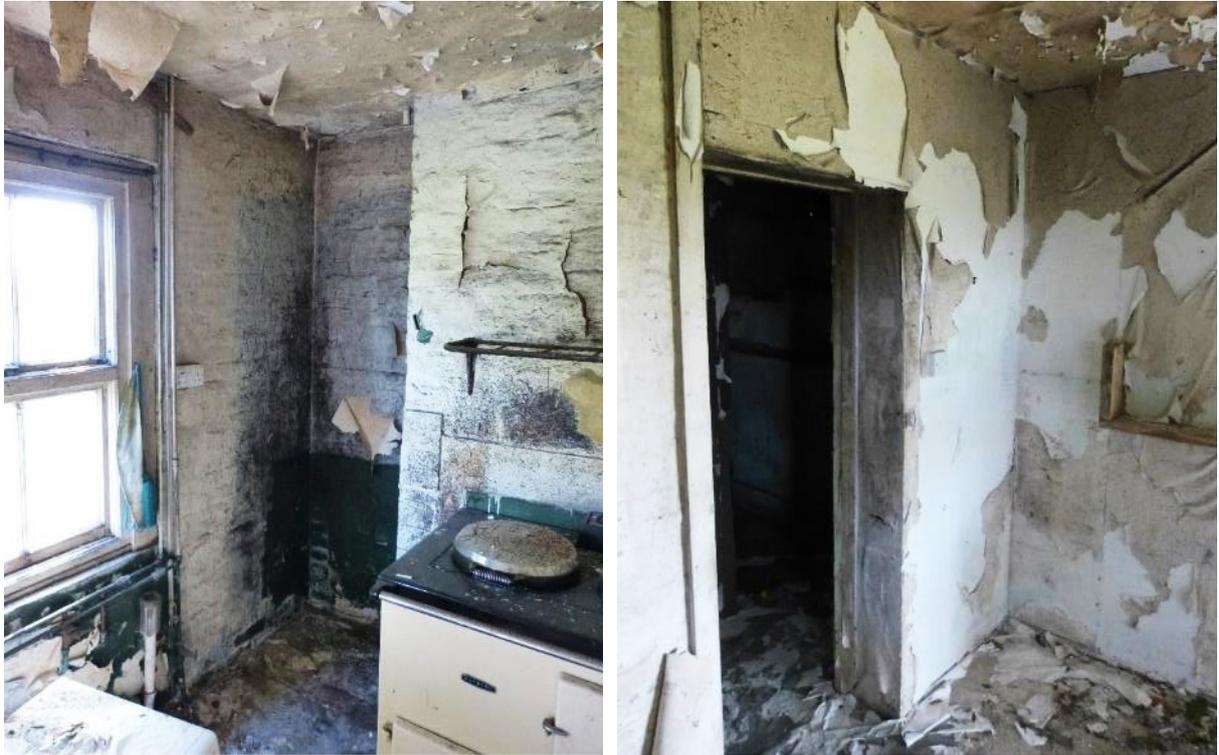
Figure 19 - Kitchen

The kitchen floor was bare concrete and appeared structurally sound. Walls were brick and appeared structurally sound but with various layers of paint extensively peeling, blistering and flaking off. Large

sections of the walls appeared to have black mould growth, especially in the corners behind the stove. All of which are indicative of high moisture level within the room. The ceiling also had blistering and peeling finishes but appeared to be structurally sound. There were no obvious points of water ingress, and it is likely that the high moisture content has arisen as a result of the prolonged lack of heating and ventilation within the building.

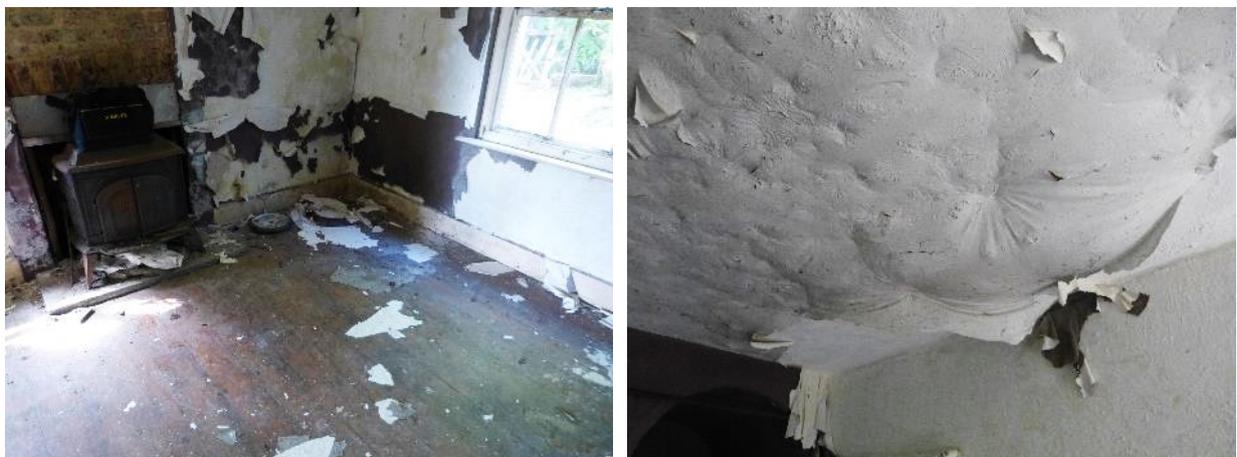
Figure 20 - Dining room

The floor was timber boards and walls were generally finished in plaster/board with the chimneybreast exposed brick. Floor, walls and ceiling all appeared structurally sound but with blistering/peeling finishes.

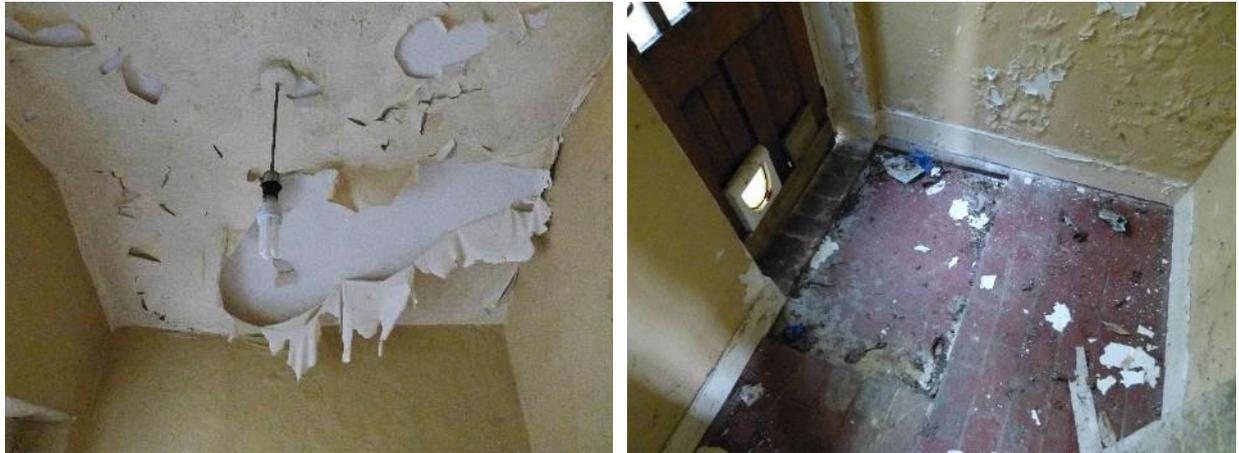
Figure 21 - Entrance

The entrance had an exposed brick floor, and the same peeling wall and ceiling finishes found throughout. Floor, walls and ceiling appeared structurally sound.

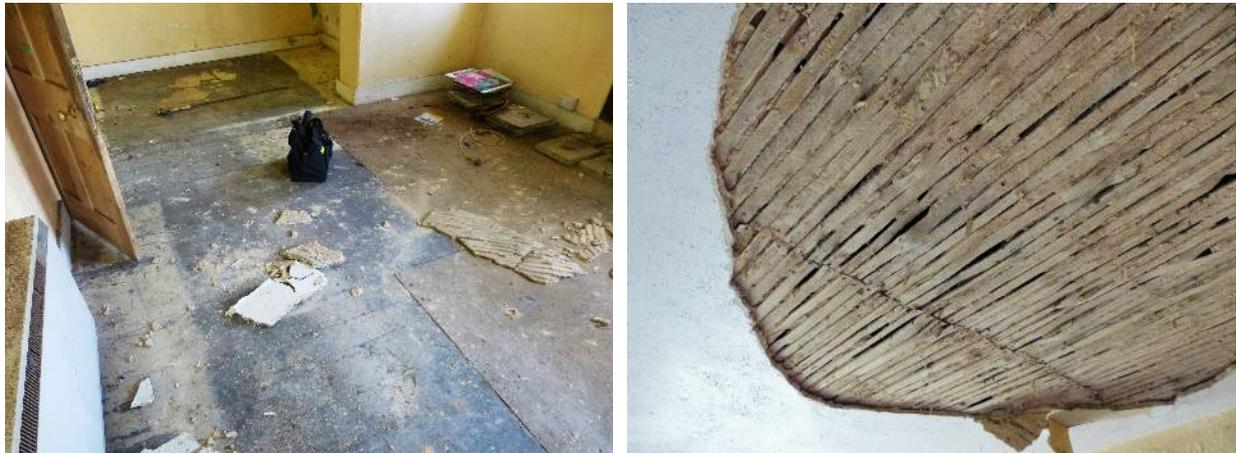
Figure 22 - Living room

The living room comprised timber floorboards in fair condition, plastered walls with some paint blistering and a ceiling with some blistering of finishes and a large area of plaster delamination revealing the lath structure above. The extent of plaster loss on the ceiling is suggestive of water ingress rather than high moisture content generally within the building.

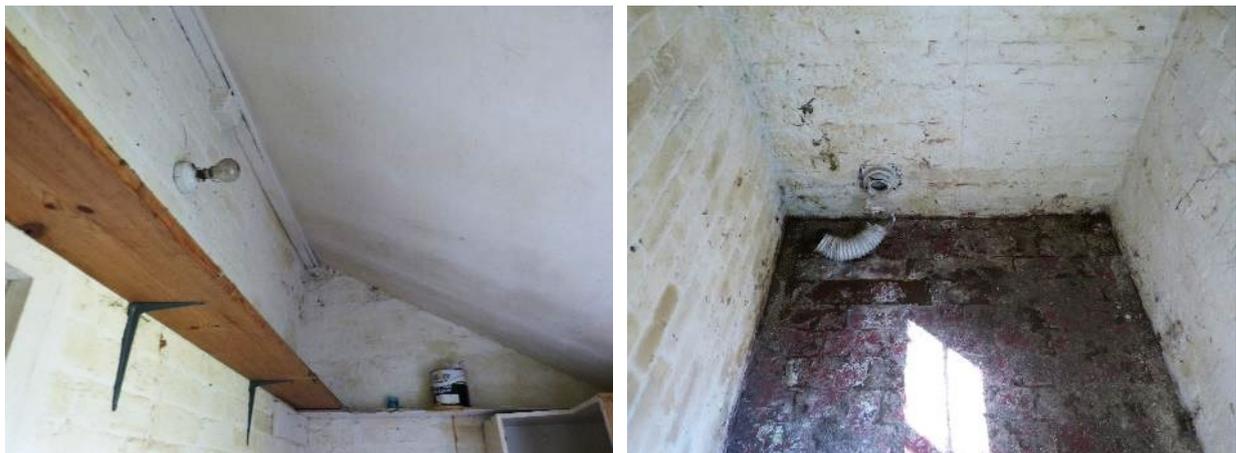
Figure 23 - Store and WC

The ground floor store and WC comprised a brick floor, painted brick walls and probably a plasterboard ceiling. There were no indications of structural damage to any of these elements, although the rooms were in a general state of disrepair with failing finishes etc.

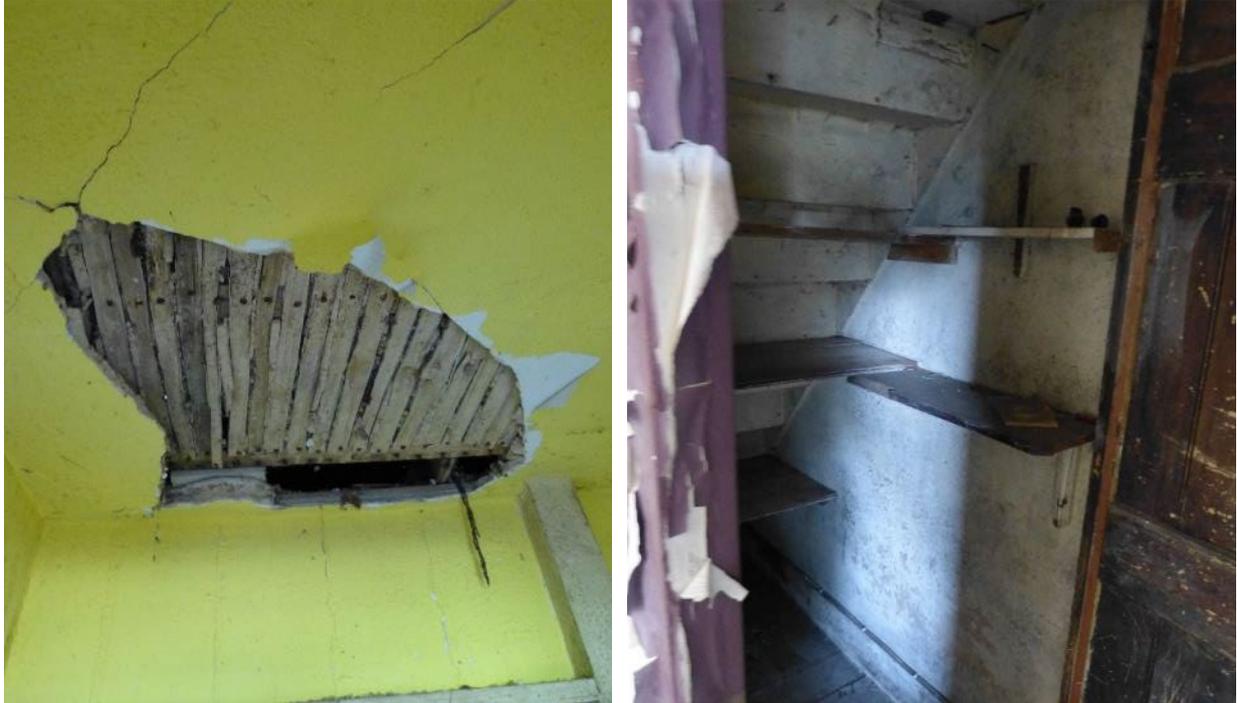
Figure 24 – Stairs

The stairs themselves were timber and appeared to be in a fair condition without significant creaking or similar when used. The ceiling of the first-floor landing had a large section of delaminated plaster revealing the lath structure behind with further cracking visible..

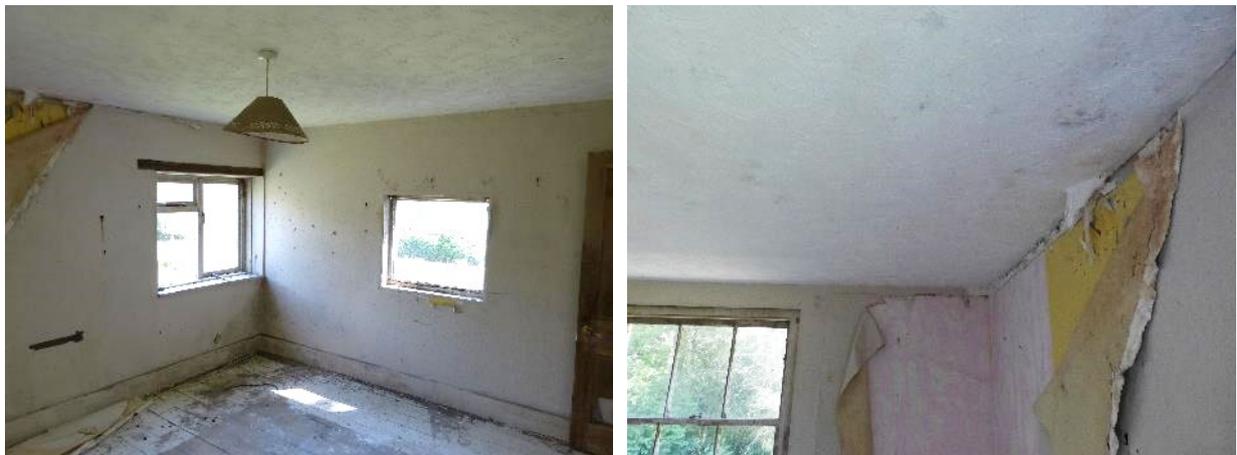
Figure 25 - Bedroom (North)

Ceiling, walls and floor all appeared to be in fair condition structurally. The northwest corner specifically had more deterioration of finishes, with peeling wallpaper, indicative of trapped moisture similar to that observed elsewhere in the property.

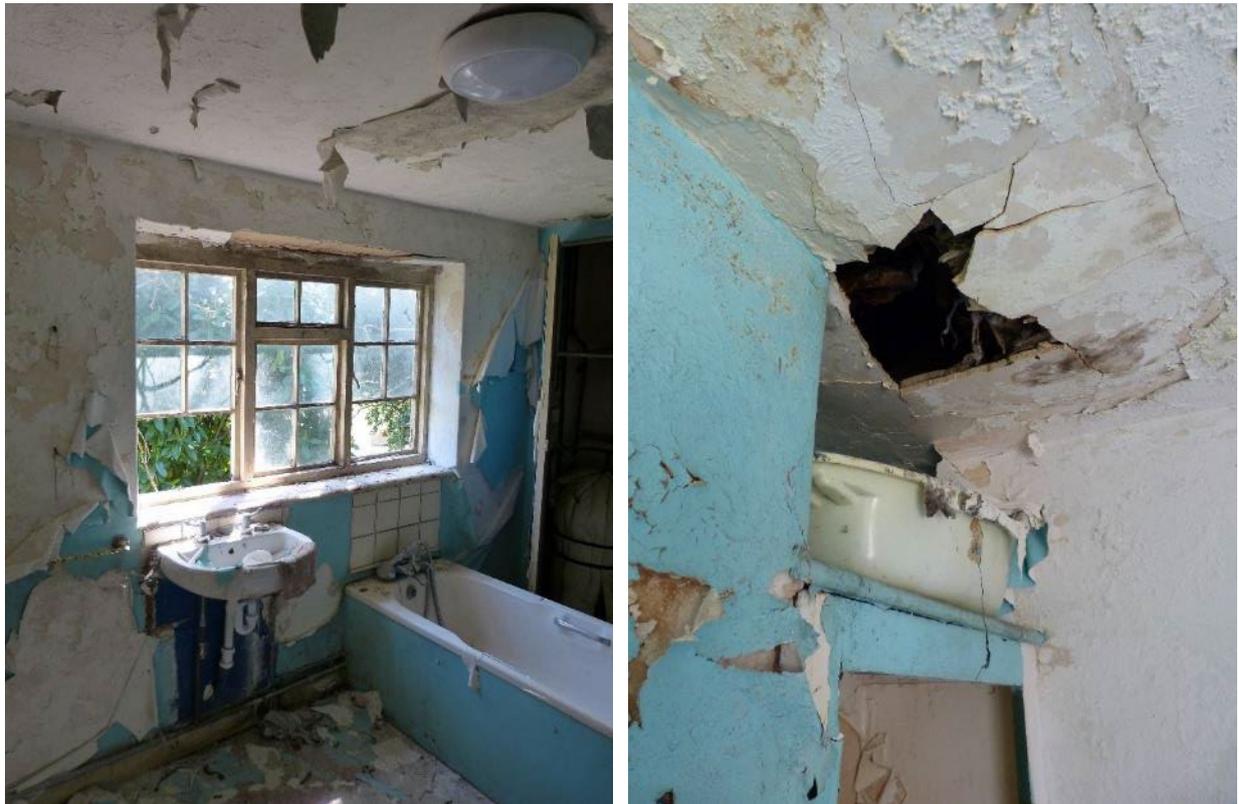
Figure 26 - Bathroom

Almost all surfaces in the bathroom had failing paint with large areas blistering, peeling and flaking on both walls and ceiling. However, the structure appeared in fair condition with a few exceptions. Over the window a large section of plaster/render had been lost from the underside of the lintel. There did not appear to be any structural damage associated with this.

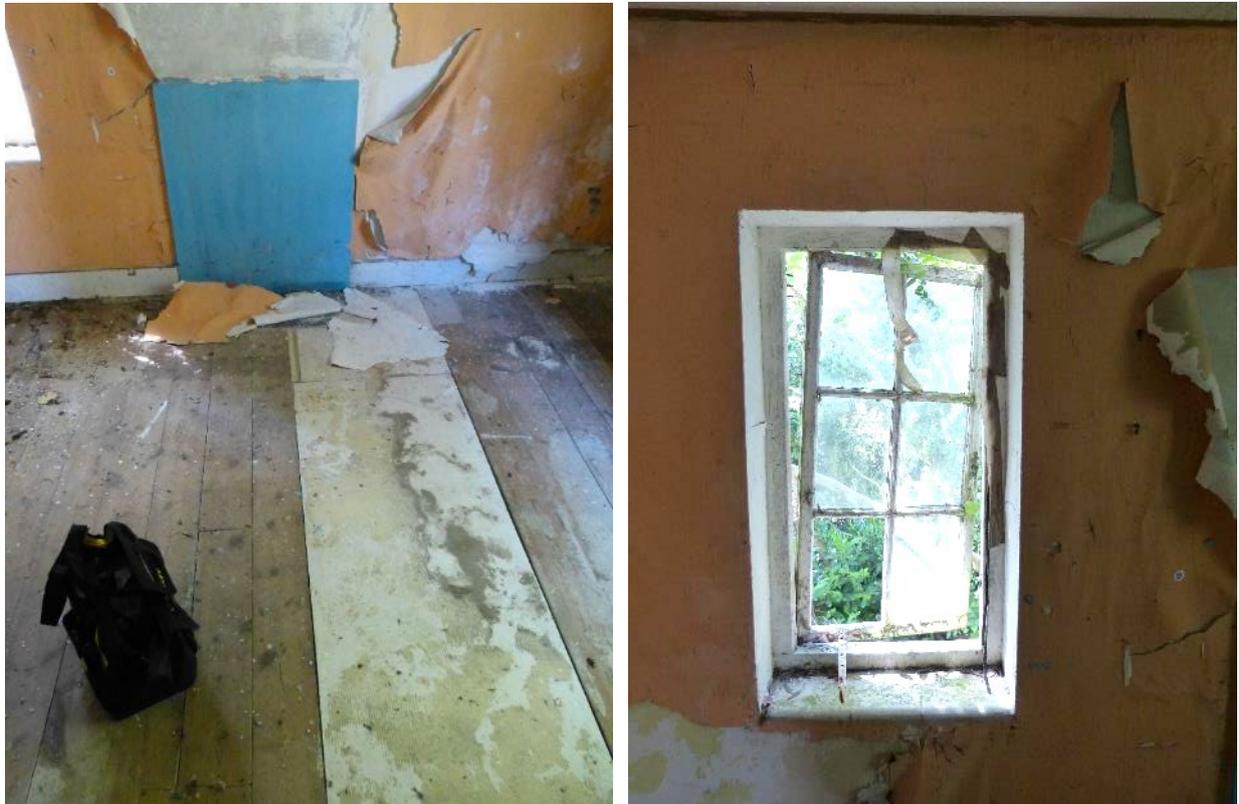
Figure 27 - Bedroom (South)

Ceiling, walls and floor all appeared structurally sound although with deteriorating finishes, again indicative of a high moisture content throughout the property. A section of floorboards had been replaced with sheet material, the reason for this is unknown. The South window was in a poor condition and hanging off its hinges.
