Lullings Cottage

Structural Assessment

Stantec UK Limited

6 August 2025

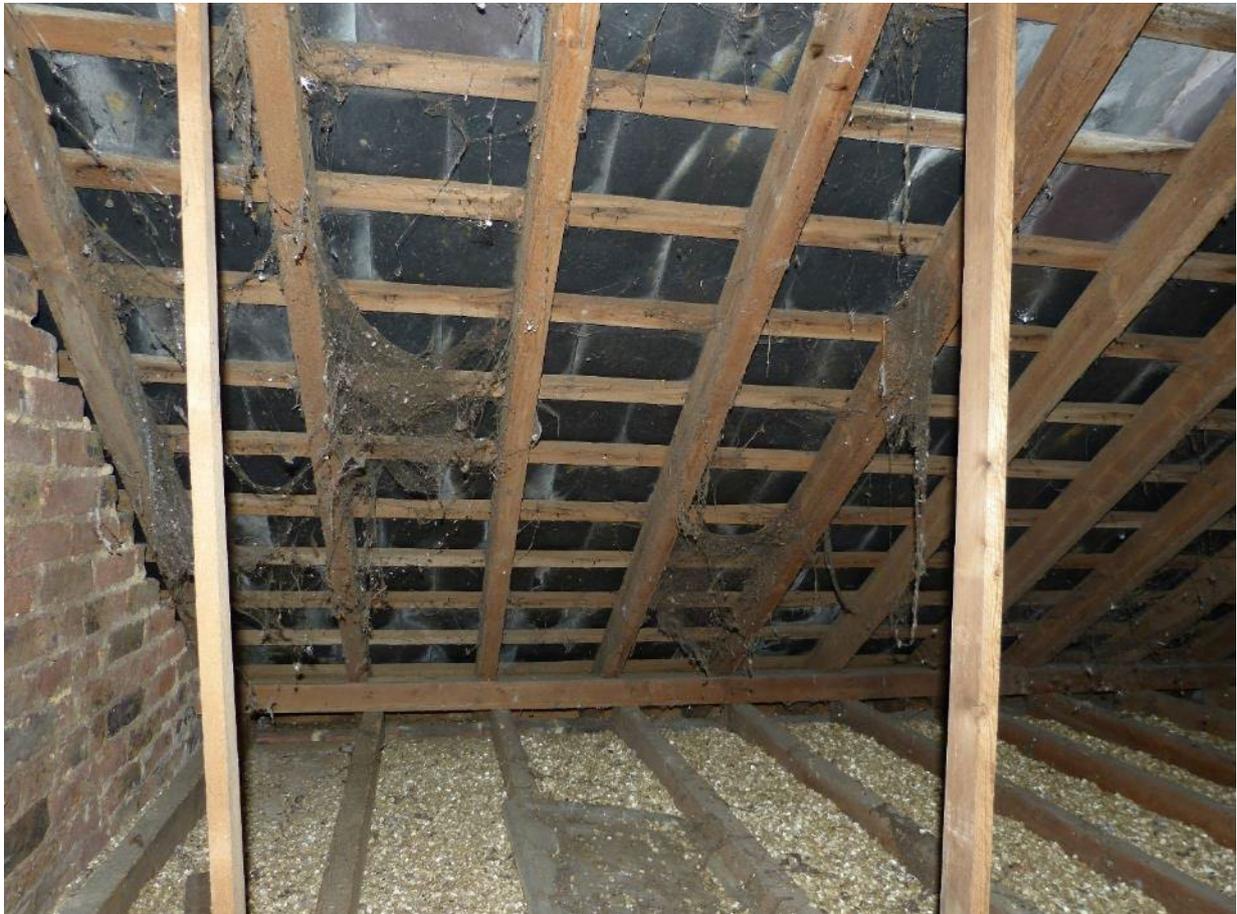
Figure 28 - Loft space

The roof structure comprised a simple A-frame of rafters and a ridge (without purlins, collars or diagonal members) supporting battens and slates. No sarking or roof felt was observed. Ceiling joists were suspended from the rafters with vertical timber hangers. All timbers generally appeared dry and in fair condition. No structural damage was observed from the access available.
