## TANYARD MANOR

Repair and Renewal of  
Roof Coverings

HERITAGE  
STATEMENT

July 2025  
v1

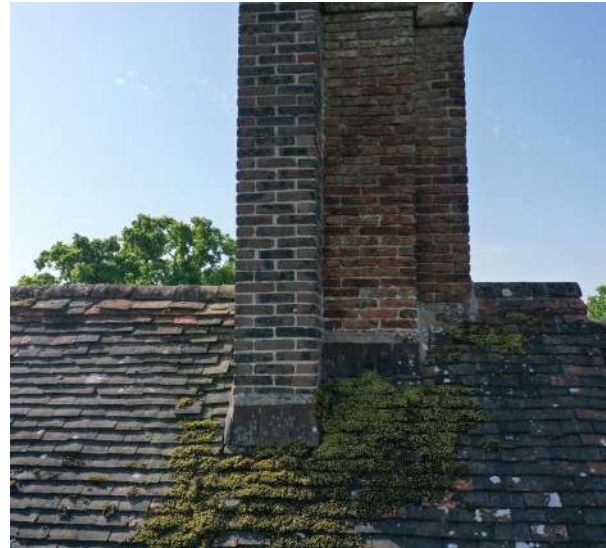
The north slope exhibits moss and lichen consistent with its shaded orientation and there is extensive evidence of spalling consistent with freeze thaw action due to water sitting on the relatively uncambered tiles, as well as cracked, broken, missing and slipped tiles. There is a missing ridge tile.

*clay peg tiles, tile and half to verges and mortar bedded abutments. Note moss and lichen growth and areas of consequent spalling*

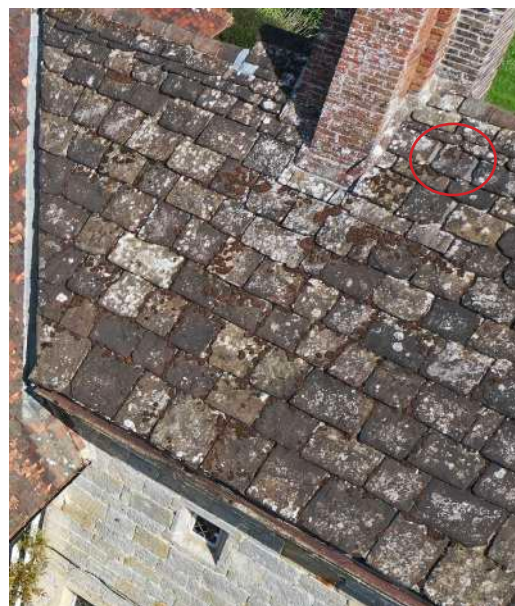
There is evidence of soakers in a contrasting material between the perpendicular joints. Conventionally this method of fixing alternated between Welsh slate soakers nailed to a narrow batten with the HSS nailed to a larger batten to ensure the soakers lie flat between the HSS course.

*evidence of soakers in contrasting material*

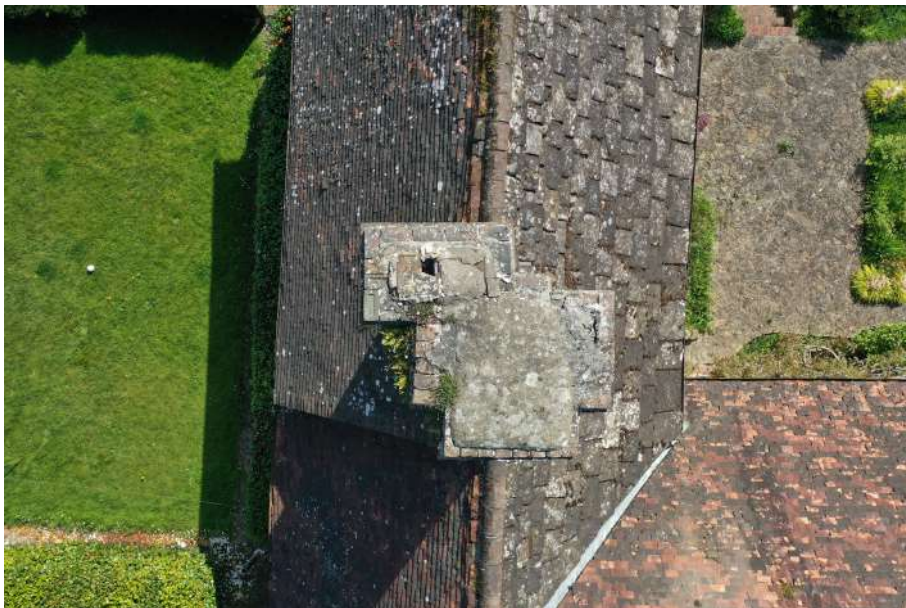
The chimney is set in the ridge line and multi-flued and appears to comprise an original 3 or possibly 4 flue rectangular stack stepped in planform with a series of corbelled courses to the head. The stack is constructed in soft red brick and has characteristics of a C17th stack. A second stack to the north west corner constructed in a darker brick of early-mid C20th appearance appears to serve the highly decorative 1st floor fireplace and may be as a result of the early C20th upgrading. Both stacks are capped with mortar.

*capped chimney*

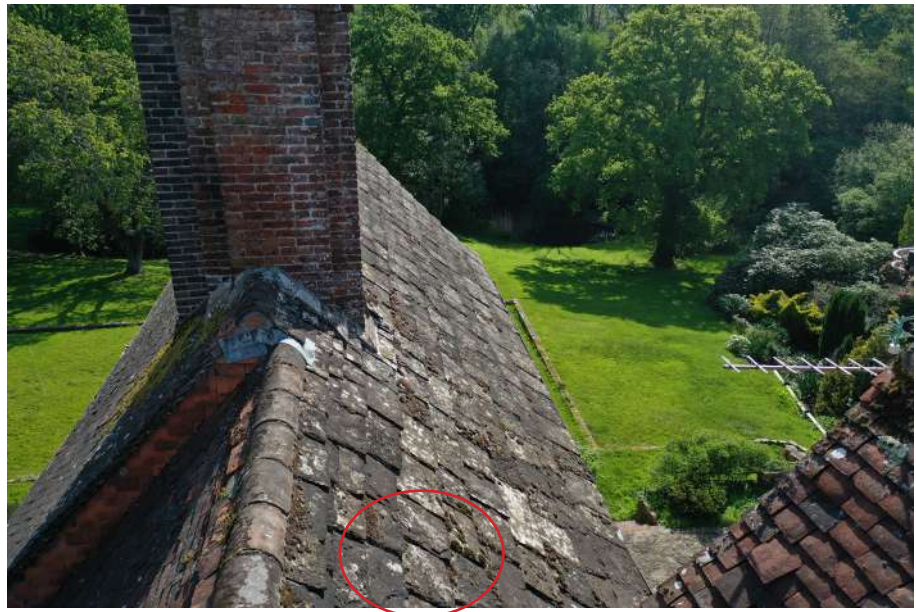
Defects are difficult to identify from external examination but there is some evidence of laminated, cracked, and chipped slates with some loss of bedding mortar at the ridge including a missing ridge tile. It is not possible to assess the bedding mortar of the slates and internal inspection is difficult without better access to determine if water ingress is apparent along joints indicative of mortar failure in fully bedded slates. Unfortunately it is difficult to assess individual slates for reuse or repair or to carry out localised repairs in situ particularly where the roof is single-lapped and alternating HSS and Welsh slate soaker courses are mortar bedded in and may only be possible once the HSS are removed and cleaned.

*evidence of laminated and cracked tiles*

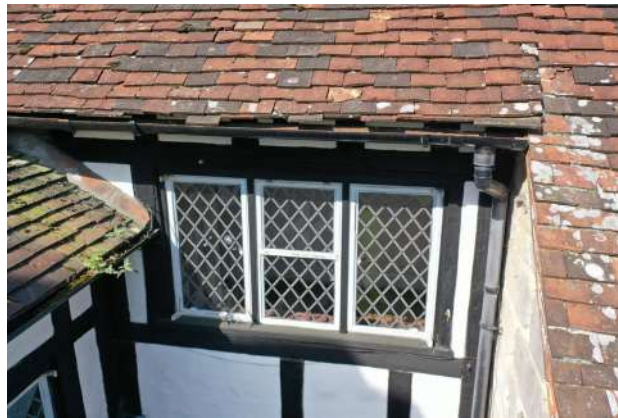
The usual defects are apparent including spalled, cracked, missing and slipped tiles, especially to the eaves suggestive of decayed tilt fillet due to failed rainwater goods. There is evidence of the loss of mortar beds to bonnet tiles and ridge tiles.

*slipped tiles to the eaves*
