**Tree Report**  
**Picus Testing – Very Mature Oak at Oak Lee, Compton Road,**  
**Hayward Heath RH16 2PF**

**1.1 Inspection date:** 19<sup>th</sup> November 2025 by Mr. Kim Gifford, undertaken in the area of test and at the time of inspection.

## **1.6 Oak (Quercus robur) Rear Garden by fence**

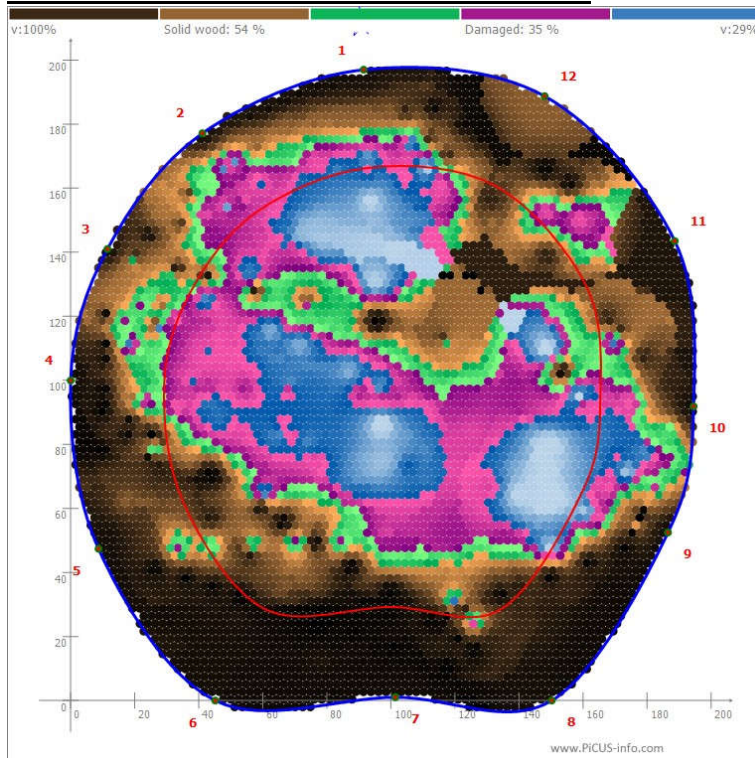
Test 1 @ level: 100cm approximately from ground level.

The measuring point readings give evidence of low velocities overall in the area of test representation showing decayed timber. The tomographic image shown above has a large percentage of 35% decayed timber. With reference to the 'colour chart see figure 2', the slower sonic speed of sound is represented by three bands of data representation blue/violet/white being the slowest altered/decayed timber, green being faster altered timber, brown being fast sonic-speeds solid timber.

The resulting Picus tests are of acceptable limits in relation to the altered timber. This ratio called a 'trunk ratio' TR (*reference Claus Mattheck*) has been calculated to be a guideline in terms of stability and rigidity of cylindrical structure. Although a debated theory in arboriculture in general terms the TR of 30% is an average.

The Picus test at the base shows decayed timber adjacent to the fungal brackets. It would be appropriate to reduce this specimen overall by to previous pruning points by 4 to 5m.

Crown reduce overall by 4-5m. Continue to monitor on an annual basis.
