## **CONDITION REPORT**

**MARLOW HOUSE  
107 HIGH STREET  
LINDFIELD  
WEST SUSSEX  
RH16 2HR**

**GH342**

**October 2022**

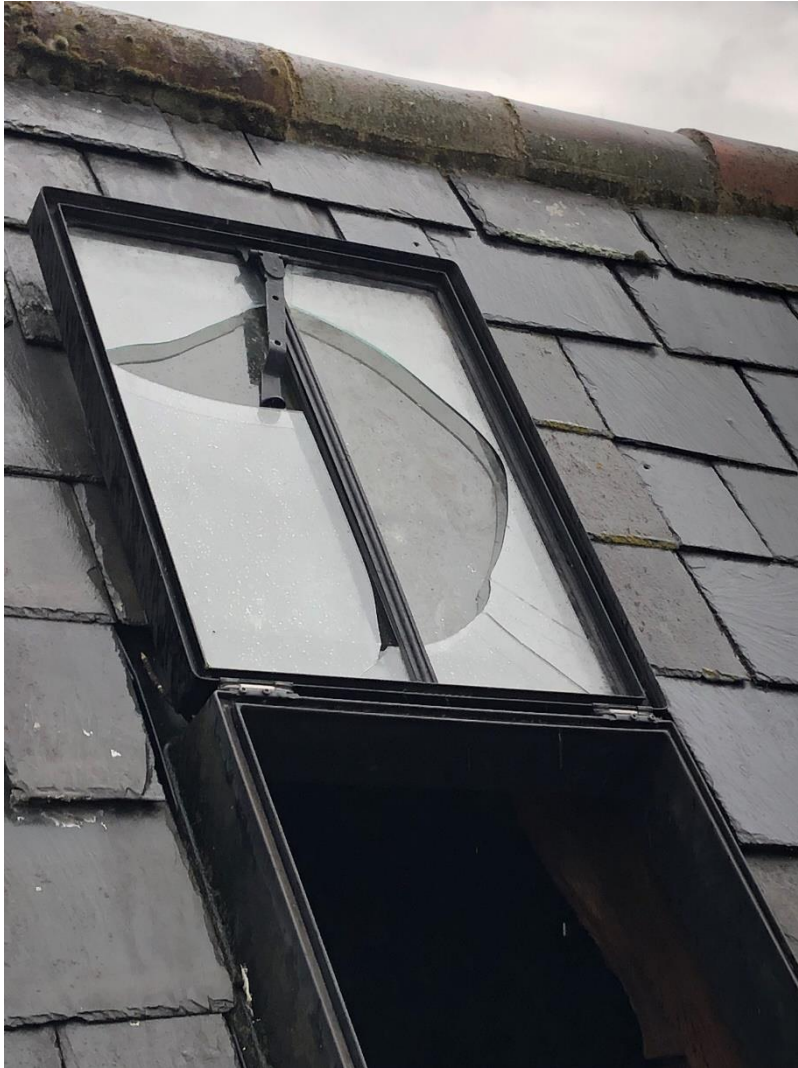
- 6. The rooflights generally appeared soiled but in a serviceable condition, with the exception of one. The inside pane of glass to the rooflight (which currently provides access to the roof) is broken. Subject to where the proposed rear extension roof adjoins the existing roof, allowances should be made to reglaze the damaged rooflight.

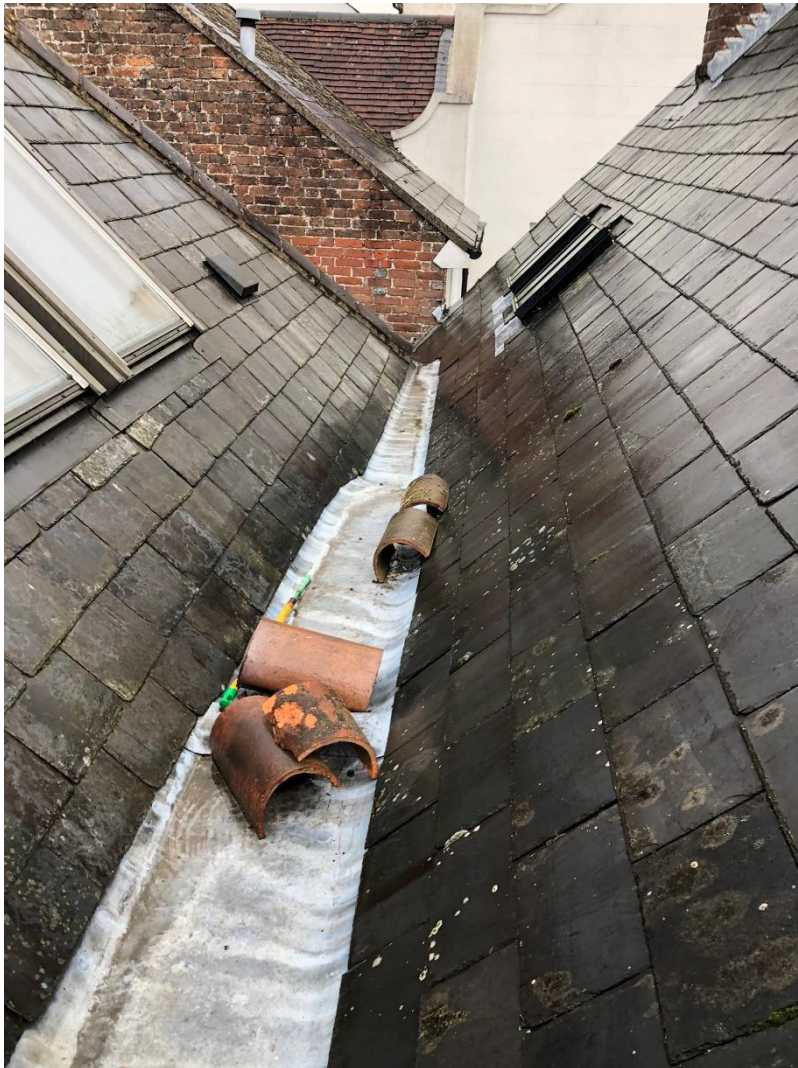
7. The lead valley gutter located between the main roof slope and adjoining roof to the rear, appeared in fair condition with no visible cracks or splits noted. We did note some bleaching of the lead to indicate it is nearing the end of its serviceable life expectancy.

8. We understand from discussions with the vendor that water ingress has occurred from the valley gutter, which may be a result of the rainwater outlet being blocked. It is noted that the valley gutter would be removed when forming the proposed rear extension. As such allowances should be made in the short term to check for any blockages and monitor the valley gutter for leaks before removing it at a later date.

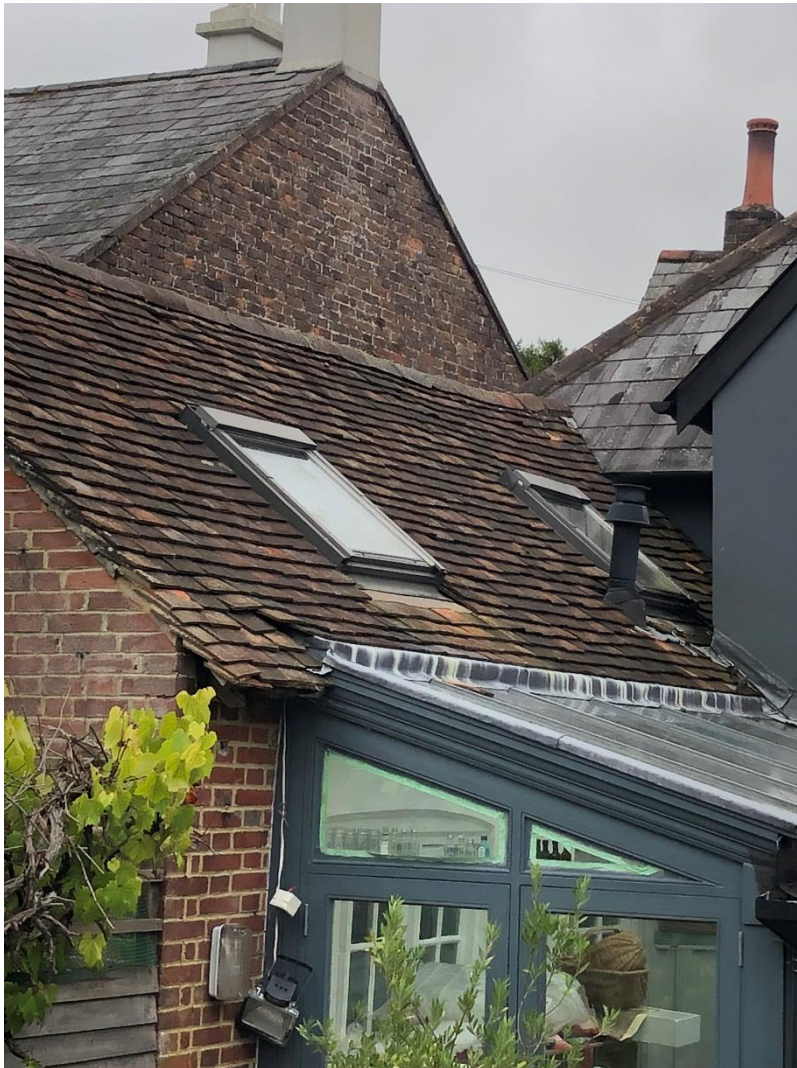
- 1.20 The roof slopes are covered with handmade plain clay tiles, with segmental tiles provided to the ridge.
- 1.21 The verge is comprised of mortar fillets without an undercloak.
- 1.22 Two Velux rooflights are provided to the south elevation roof slope.
- 1.23 The roof abuts the conservatory roof and wall of the two storey rear extension. The roof also abuts the brick party wall to the adjoining property, where a lead valley gutter is provided.
- 1.24 A vertical boiler flue penetrates the south facing roof slope.
- 1.25 The roof slopes were viewed from ground level and at high level from the adjacent valley gutter.
  - 1. The roof profiles generally appear to be even, with no significant undulations or unevenness, which would suggest that the roof structure has been adequately constructed.
  - 2. The ridge lines undulate slightly, but not seriously so.

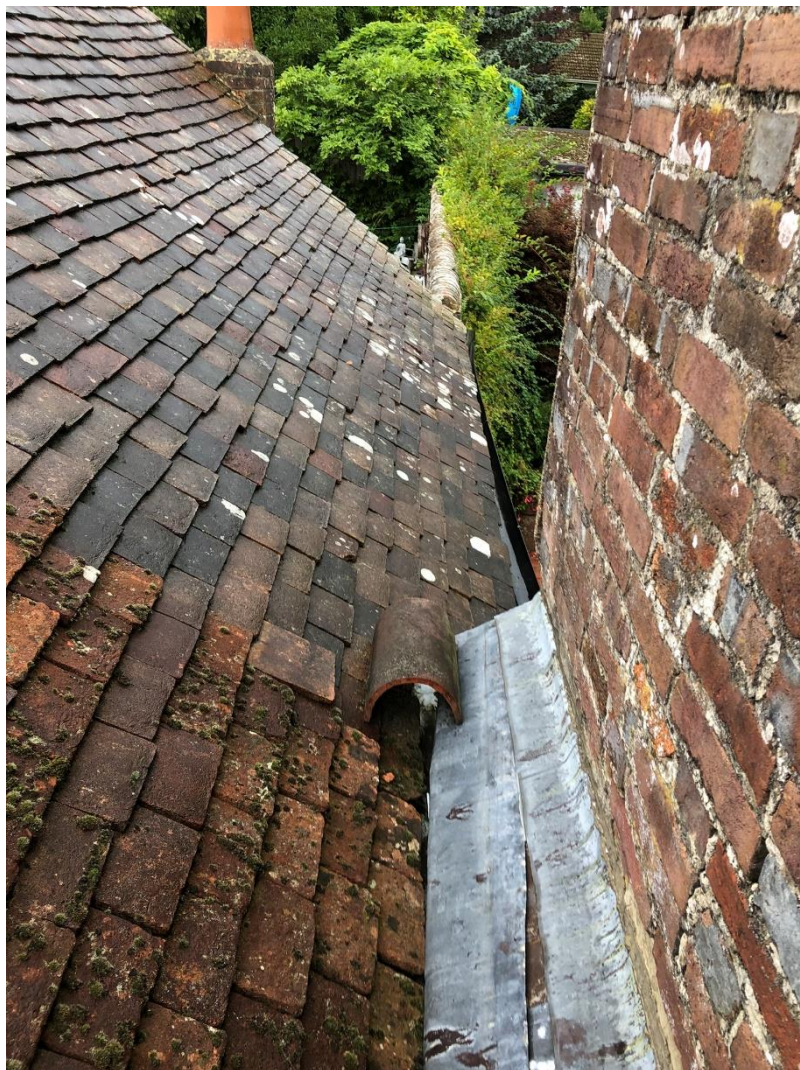
3. Where visible, the roof tiles generally appeared well fixed with cracked and slipped tiles noted to isolated areas.
4. The ridge tiles generally appear in serviceable condition with some surface spalling noted to areas.
5. The mortar fillet to the verges was in poor condition with cracks and missing sections noted. Allowances should be made to renew the mortar fillet.
6. The lead valley gutter did not appear to be suitably dressed beneath the roof tiles. It should be anticipated that the valley gutter will require renewal as part of the proposed extension and refurbishment works.

7. Following the proposed demolition of the adjacent two storey rear extension and conservatory, allowances will need to be made to carry out isolated repairs and infills to the roof as necessary to leave in a finished state.

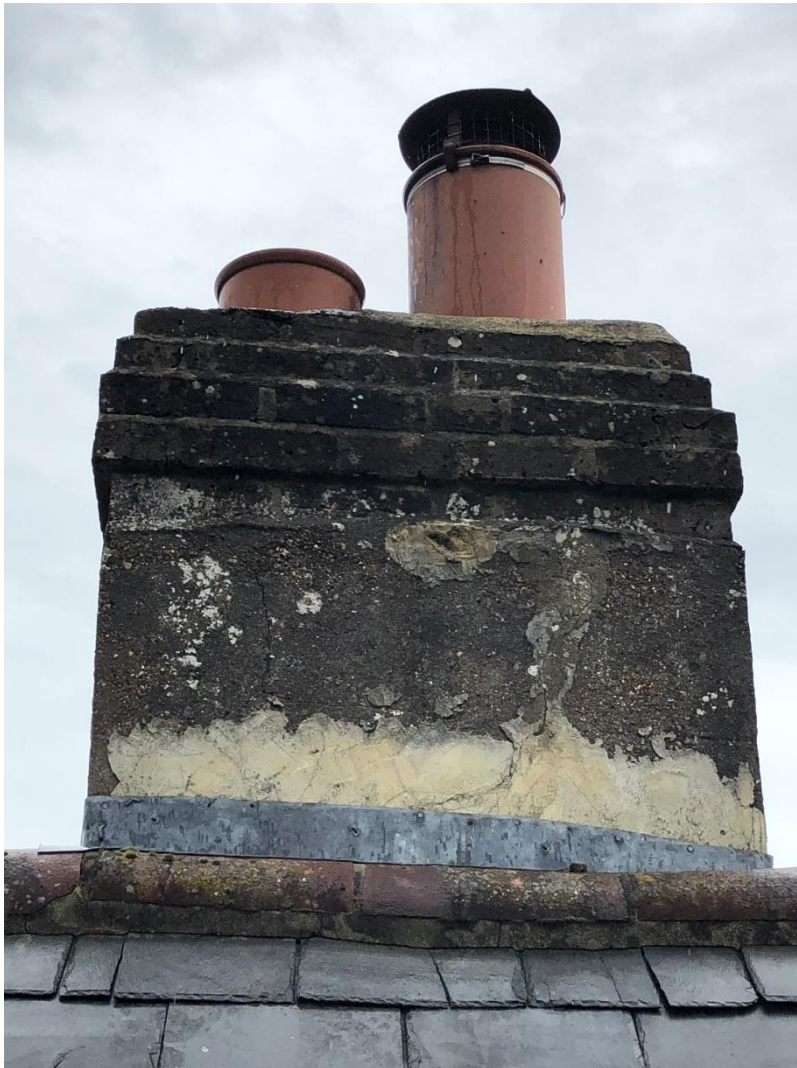
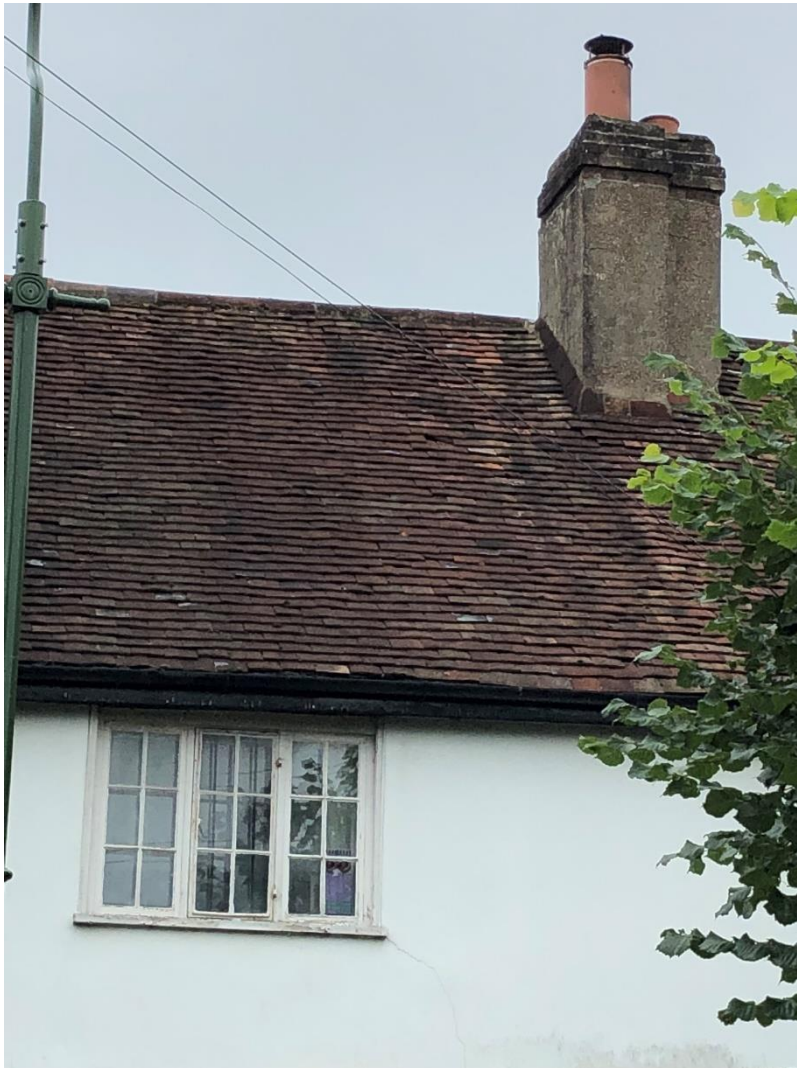
- 1.27 The stack is surmounted with two terracotta pots and is understood to serve the fireplace within the living room.
- 1.28 The junction with the main roof is weathered with a combination of tiled fillets (to the east elevation) and lead flashing (to the west elevation).
- 1.29 The following points were noted:
1. The stack remains upright and plumb.
  2. The render is cracked and in need of full replacement.
  3. The stack is not provided with a horizontal damp tray to mitigate vertical damp penetration.
  4. The back apron flashing is poorly weathered over the ridge tiles to the west elevation, presenting a poor weathering detail. Allowances should be made to replace the flashing, with a new suitably dressed lead flashing.
  5. Where visible the tiled fillet flashings appeared well fixed. We would recommend new lead flashing be provided to provide a superior weathertight junction.

6. We were unable to inspect the condition of the flaunching to the top of chimney stack. Allowances should be made to provide high level access for further inspection during the course of the proposed works to the property.
7. From our viewpoint, the chimney pots appeared in satisfactory condition, however further investigation is needed when the flaunching is inspected. .

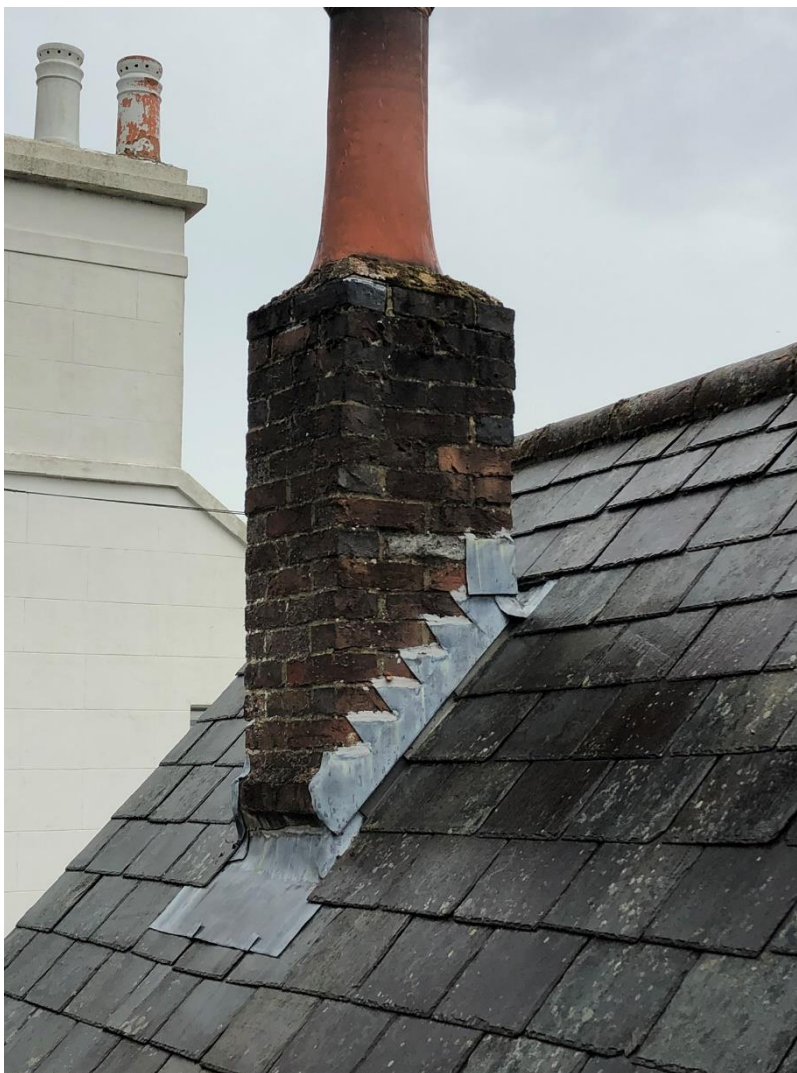
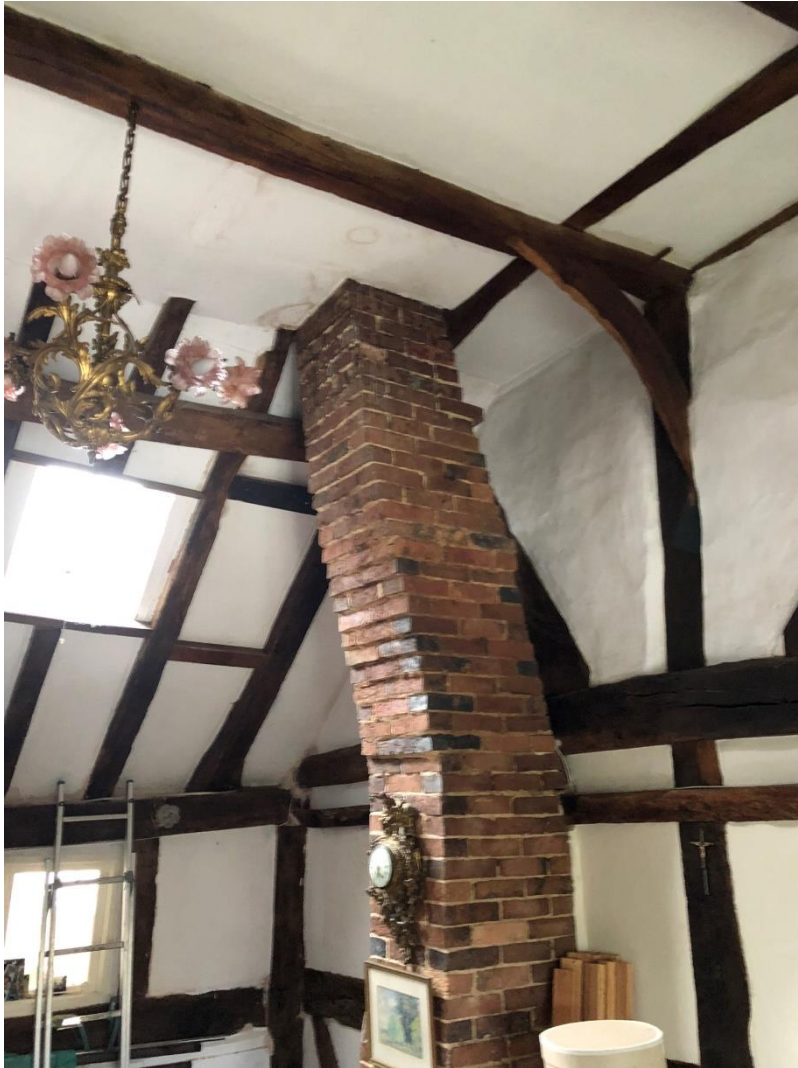
- 1.31 The stack is surmounted with a single terracotta chimney pot. It is unclear if the chimney is still in use. Further investigation is required to confirm this.
- 1.32 The following points were noted:
1. In general terms the stack remains reasonably upright and plumb, although it is noted that where it penetrates the master bedroom below, it is raked to an angle.

2. From our limited vantage point, the brickwork remains in satisfactory condition, with isolated areas of defective pointing noted, particularly at the top of the stack. Allowances should be made of limited repointing works.

3. The flaunching appears to be coming to the end of its useful life expectancy, with cracking and surface spalling noted. The flaunching should be renewed, with high level access provided to facilitate works.

4. The chimney pot appears to remain in satisfactory condition with some soot staining noted. When replacing the flaunching allowances should be made to replace the pot and cap if no longer in use.

5. The stack is not provided with a horizontal damp tray to mitigate vertical damp penetration.
6. The junction between the stack and roof slopes are weathered with lead flashing. From our vantage point the flashing appeared in serviceable condition, but the presence of damp staining internally would suggest current or historic damp penetration. Further investigation is required once high level access is provided but we would anticipate the flashing will require renewal.

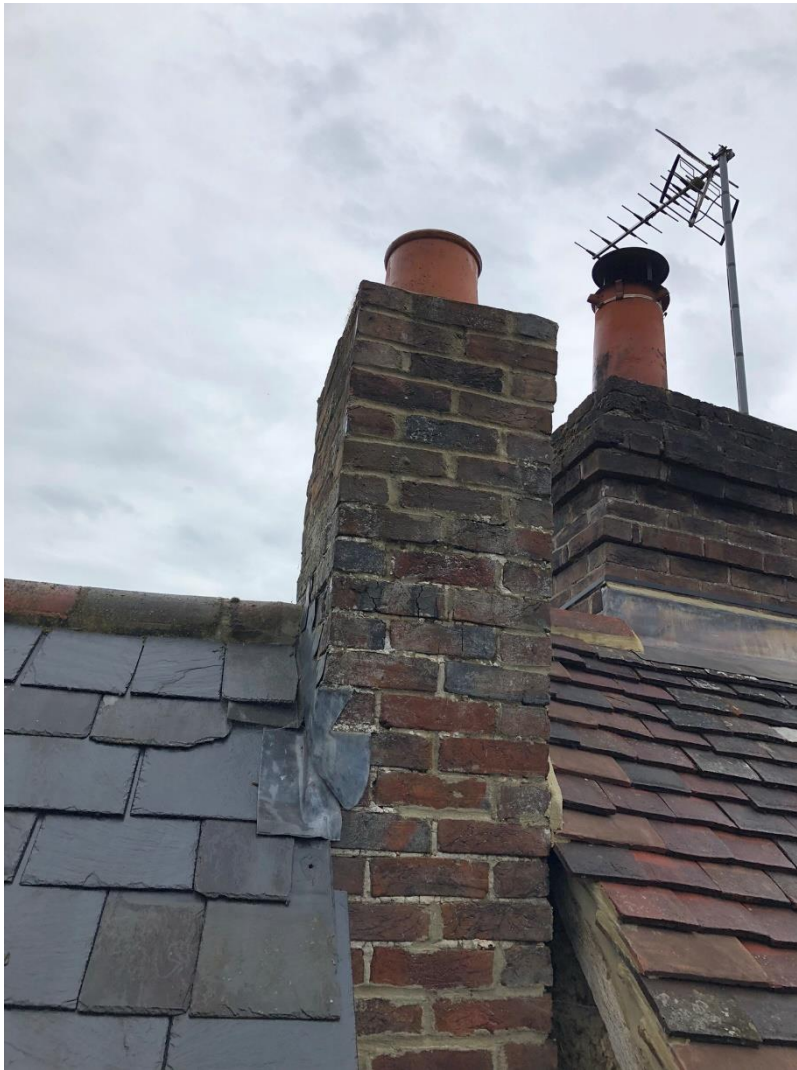
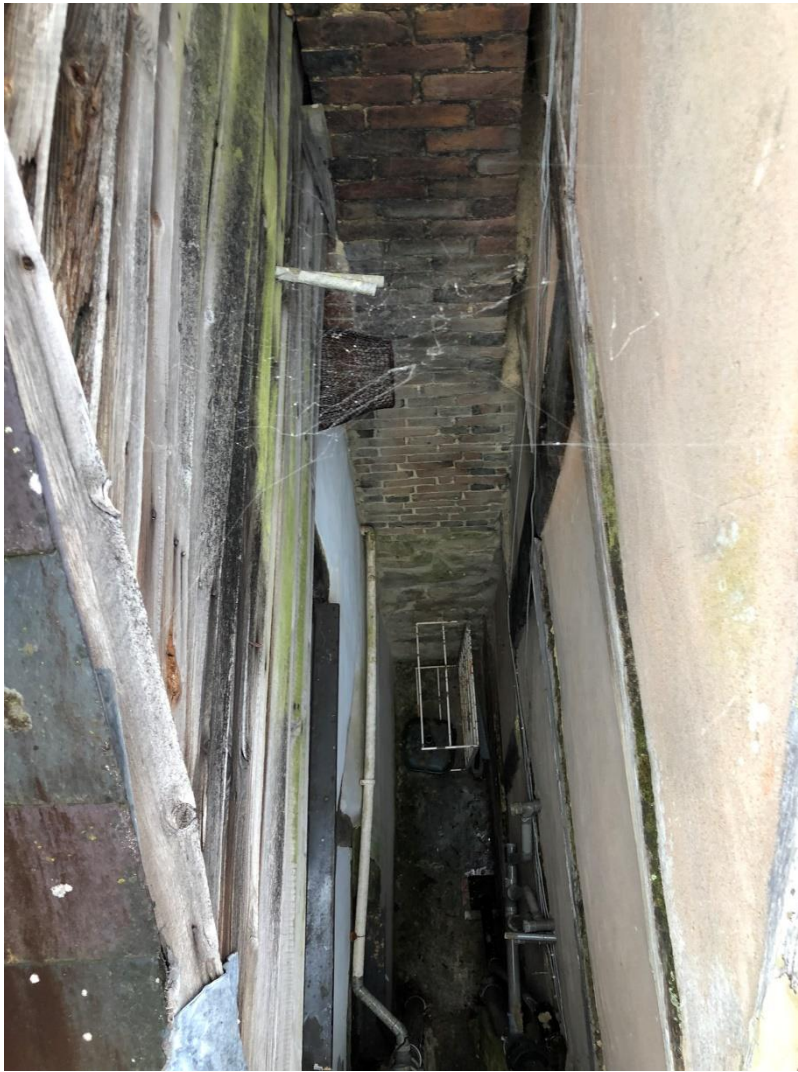
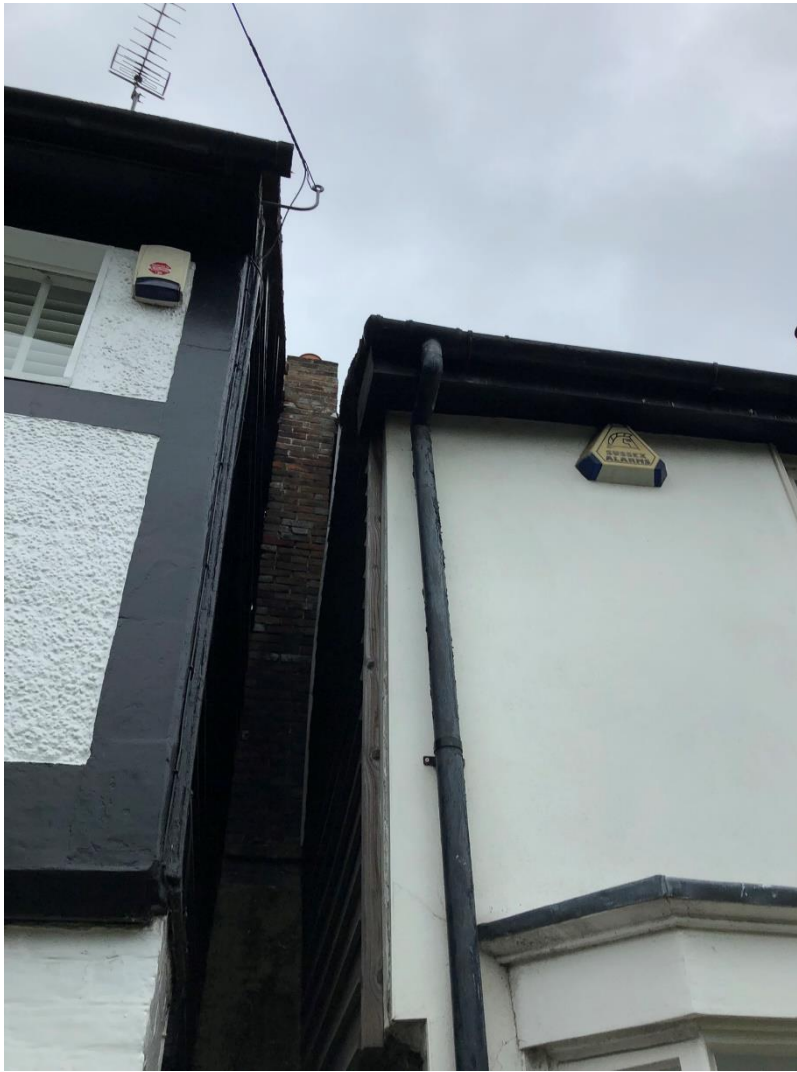
- 1.34 The stack is surmounted with two terracotta chimney pots. The chimney stack appears to serve the fireplaces within the old dining room and kitchen.
- 1.35 The following points were noted:
1. The stack generally remains reasonably upright and plumb.
  2. Where visible the brickwork generally remains in satisfactory condition, however we noted what appears to be a loose course of brickwork to the west elevation of the stack, as well as isolated areas of defective pointing to all visible elevations. Allowances should be made for isolated masonry repairs.

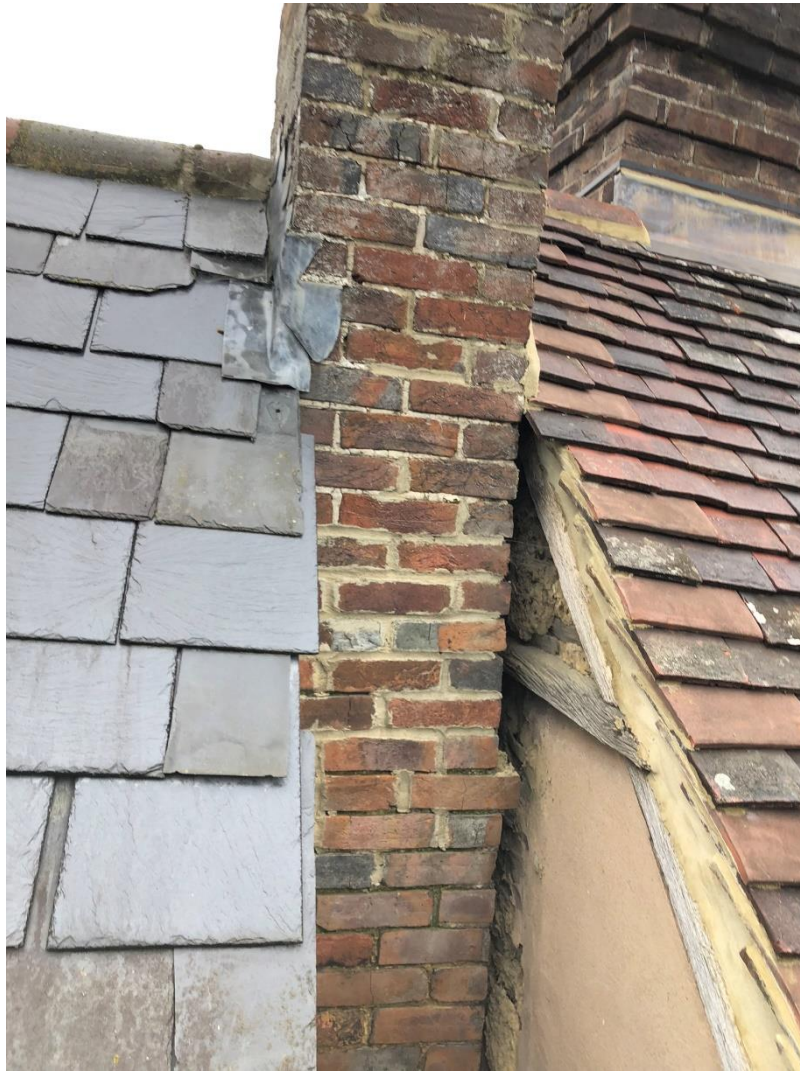
3. Where visible from our vantage point, the stack is weathered with a stepped lead flashing along its north elevation. The lead flashing appears to have been poorly fixed, and is incorrectly dressed over the adjoining slates. Ideally, allowances would be made to redress or replace the lead flashing.
4. To the south elevation of the stack, it appears to be weathered with a mortar fillet, however visibility was limited from our vantage point. To provide a superior weathertight detail, the mortar fillet should be replaced with a new stepped lead flashing, with the permission of the adjoining property owner.
5. When carrying out repairs to the stack, it should be noted that arranging safe high level access will be more challenging due to the restricted space available to work within.

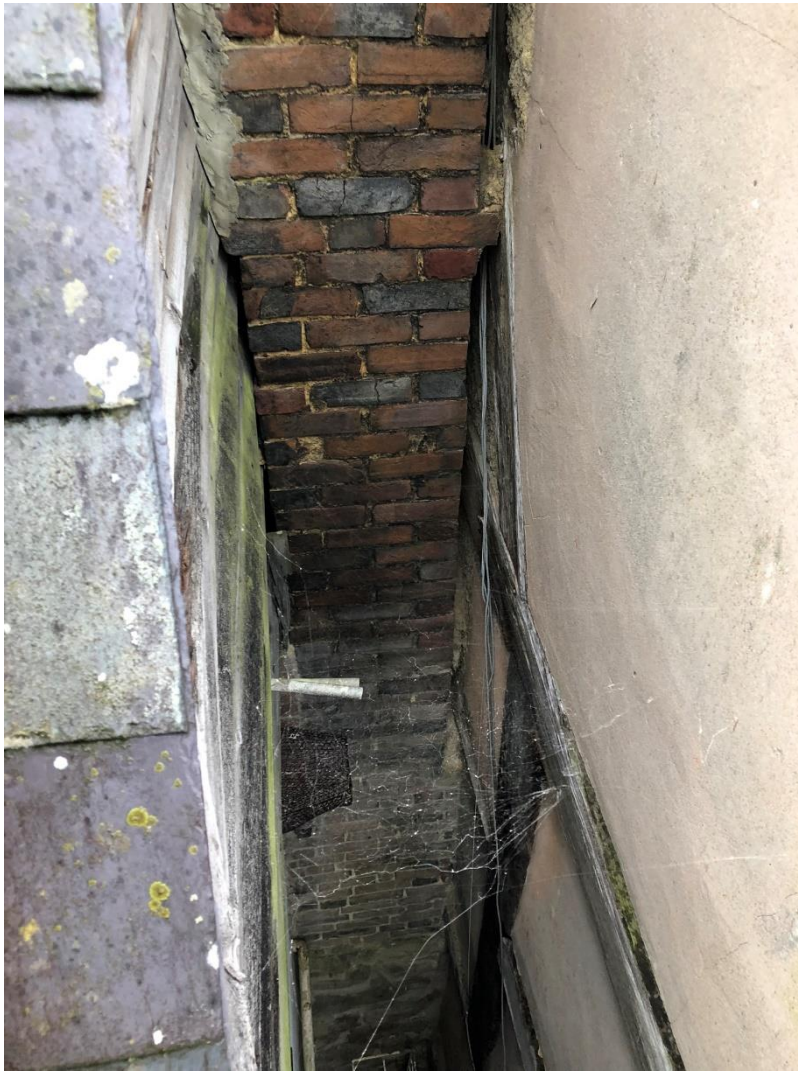
6. We were unable to carry out an inspection of the flaunching at the top of the chimney stack due to limited visibility. Allowances should be made to check its condition when high level access is next made available.
7. The same comments can be applied to the chimney pots.

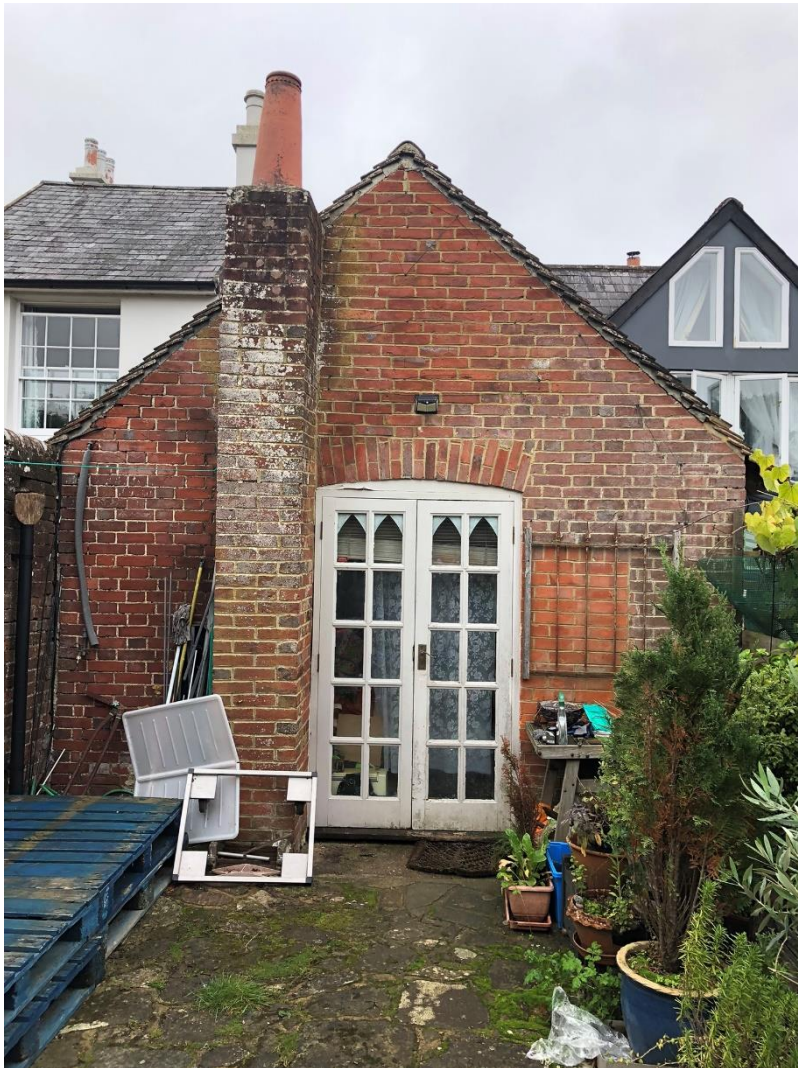
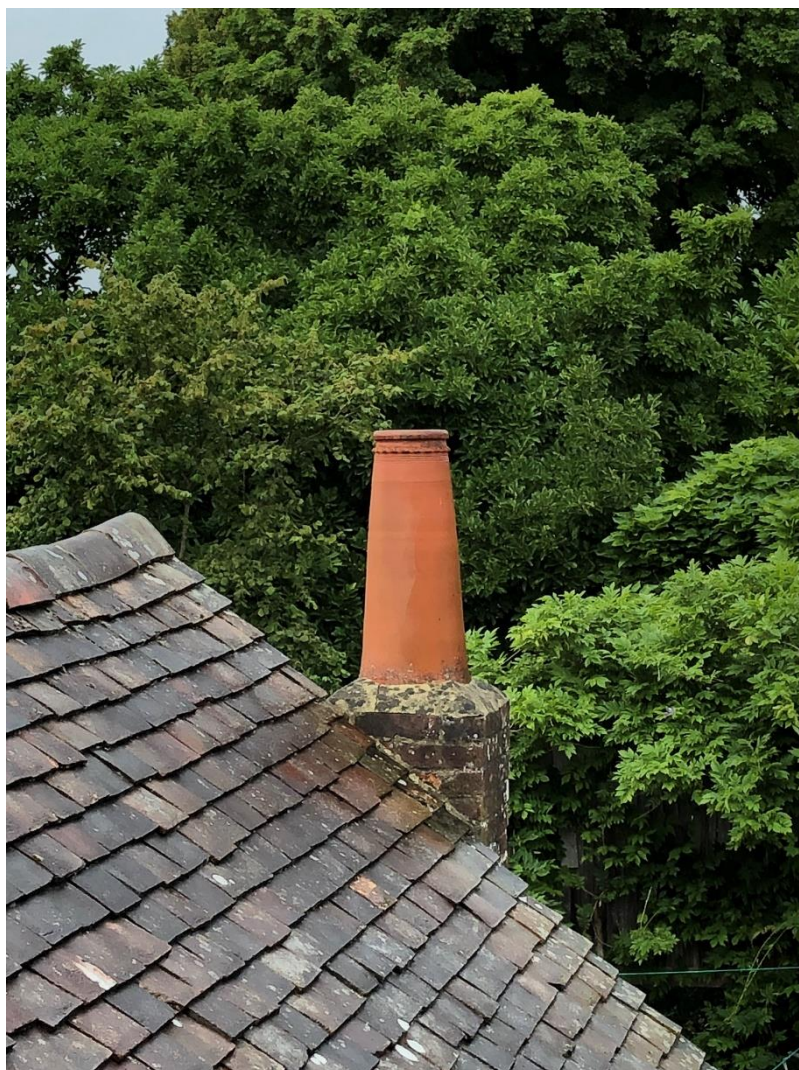
1. The stack generally remains reasonably upright and plumb.
2. The brickwork remains in satisfactory condition with isolated areas of defective pointing noted. Allowances should be made to repoint where required.
3. The junction between the chimney stack and bakehouse roof is not weathered with a lead flashing. Ideally this would be provided.
4. The flaunching is cracked and should be replaced.

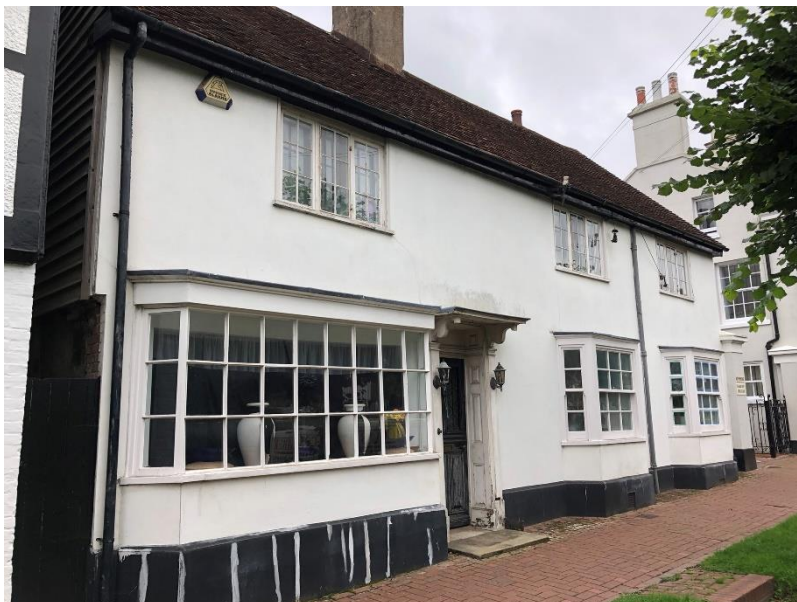
3. The exposed external walls of the original portion of the house, generally remain upright and plumb.
  4. The render to the front (east) elevation generally remained well fixed, despite evidence cracking noted. It should be anticipated that some localised render repairs will be required. It is evident that localised repairs have been carried out to the plinth on the front elevation.

5. The render to the north elevation, is a course render, with oversailing rendered gable at high level and sandstone plinth at low level. The render generally appears in satisfactory condition, with isolated areas of cracking and flaking render noted. As with the front, it should be anticipated that isolated repairs will be required following closer high level inspection.

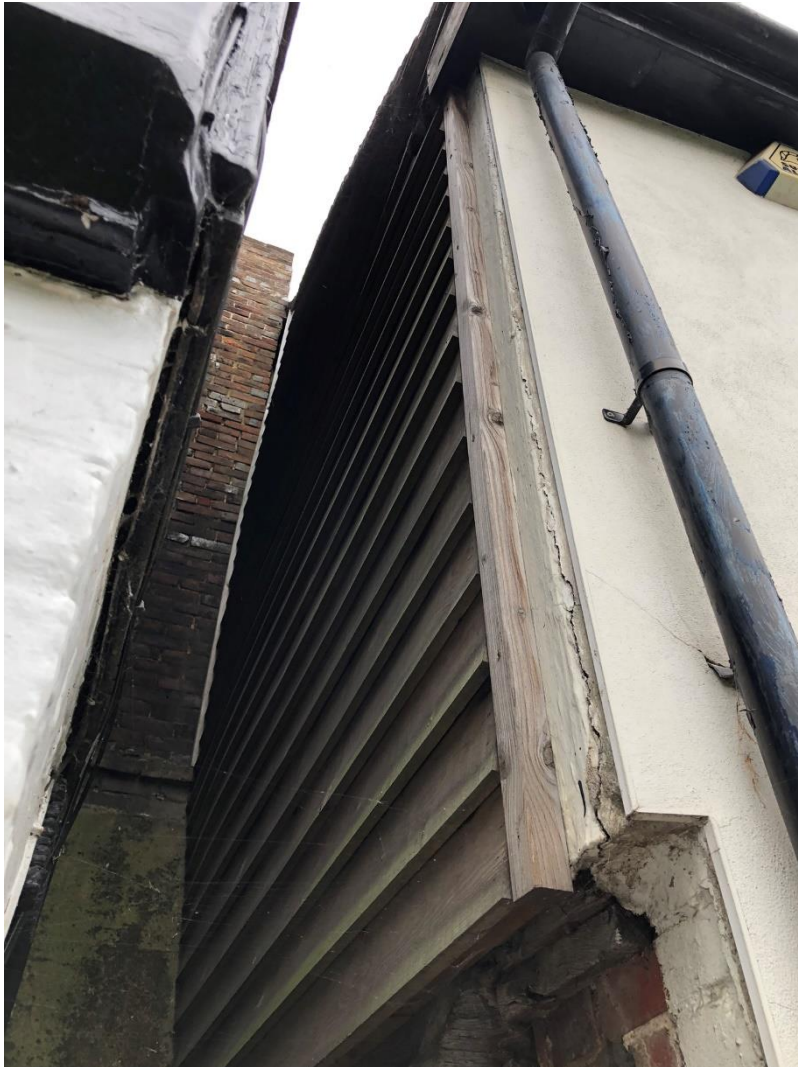
8. Exposed oak framing with render panelling is provided below the above weatherboarding. The oak framing is showing signs of historic wet rot, but generally appears in serviceable condition for its age.

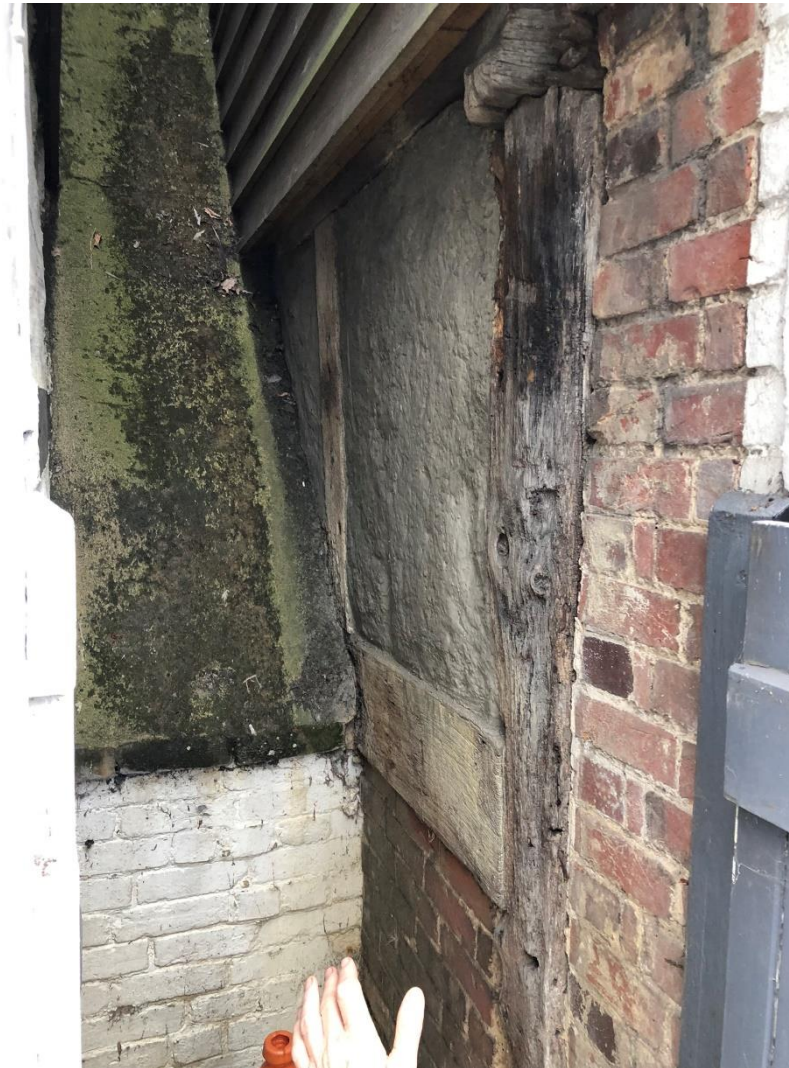
9. It's noted that the niche provides some weather protection to the exposed oak framing. To provide further protection, consideration should be given to extending the weatherboarding further down.
10. The weatherboarding visible from the north side of the south elevation, appeared in satisfactory condition from our vantage point, but renewal should be anticipated within the next 10 years.

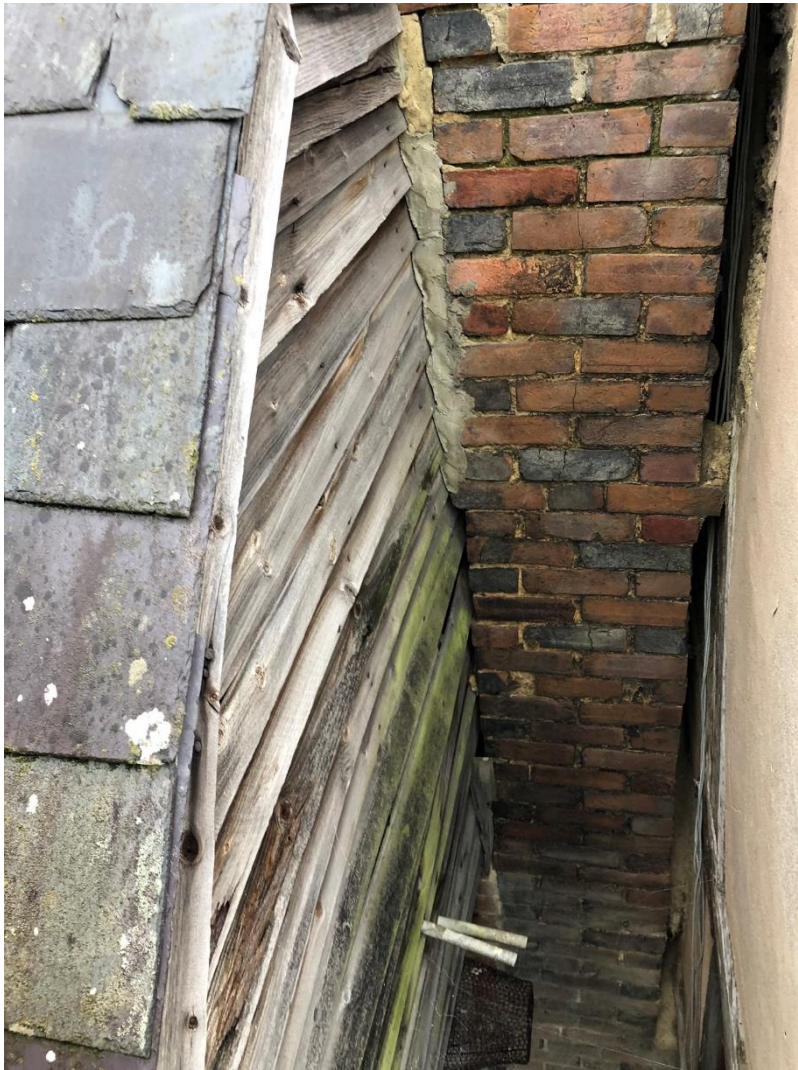
11. Exposed oak framing is also visible to the rear (west elevation) of the original house, at the junction with the rear extension roof slope. The junction is weathered with haphazardly fixed lead flashing and flash band repair tape. To provide improved weather protection to the original oak framing and prevent water ingress within the property, subject to the final detailing of the proposed extension, allowances should be made to provide improved weathering, with consideration given to applying weatherboarding.

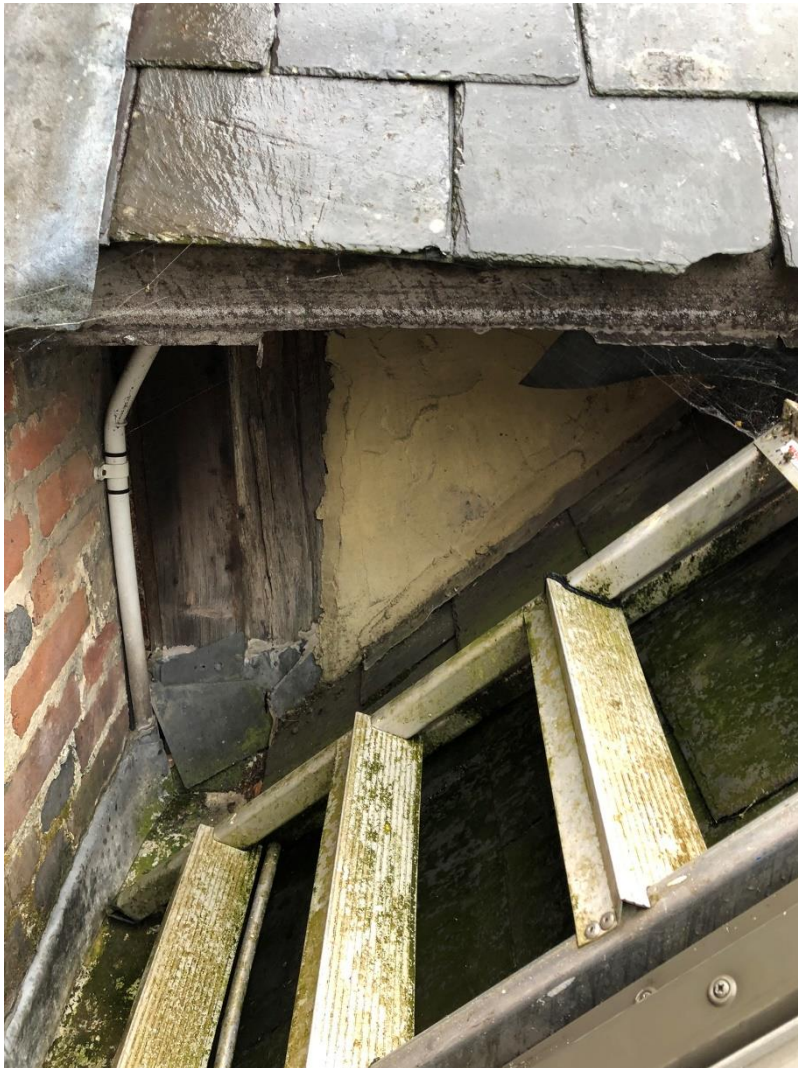
12. Access to inspect much of the oak framing was limited at the time of our inspection. We would anticipate that limited repairs will be required to replace any rot or woodworm affected timbers as is common with properties of this age and construction.

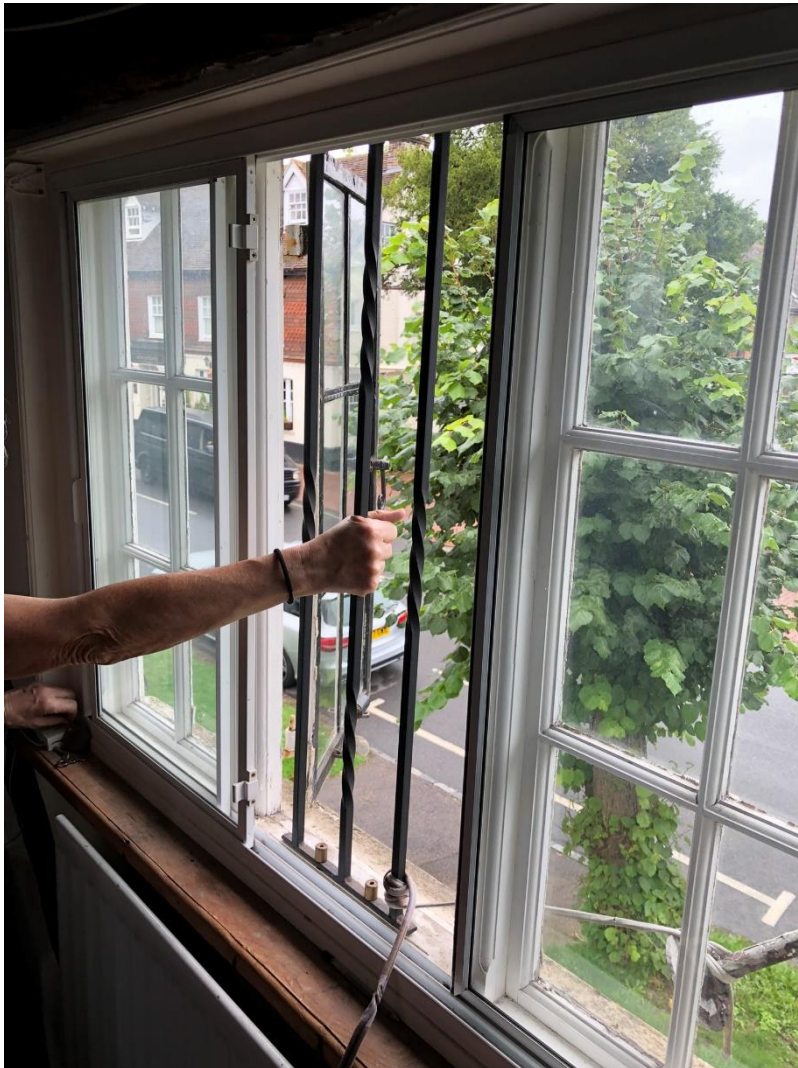
3. We noted one cracked window pane within bedroom 2. Allowances should be made to replace the glass.
4. Access to the bay windows with sash windows was limited to the external faces. The windows and timber subframes generally appeared in satisfactory condition with evidence of historic repairs noted. An overhaul of these windows should be anticipated to leave in full order.

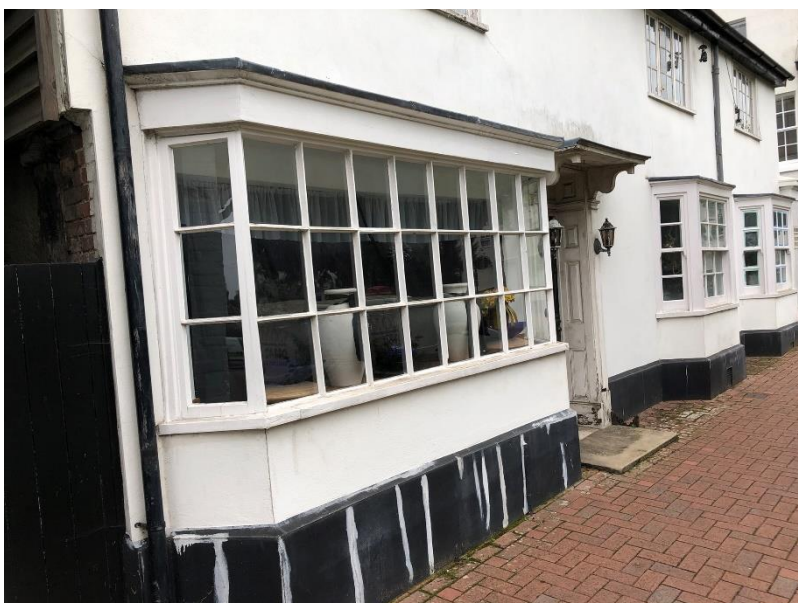
6. Some of the windows appeared to have been repainted recently, with decorator's tape left in place. This tape should be removed in advance of full external redecorations.
7. With timber windows such as these, it is reasonable to assume that following closer inspection, softened timber and defective ironmongery may be discovered. Allowances should be set aside for isolated repairs.
8. The front entrance door was found to be in working order but in a dilapidated condition, in need of redecoration and easing and adjusting. It is understood that this door was installed by the vendor, imported from France. You may wish to replace the door to suit your own requirements.

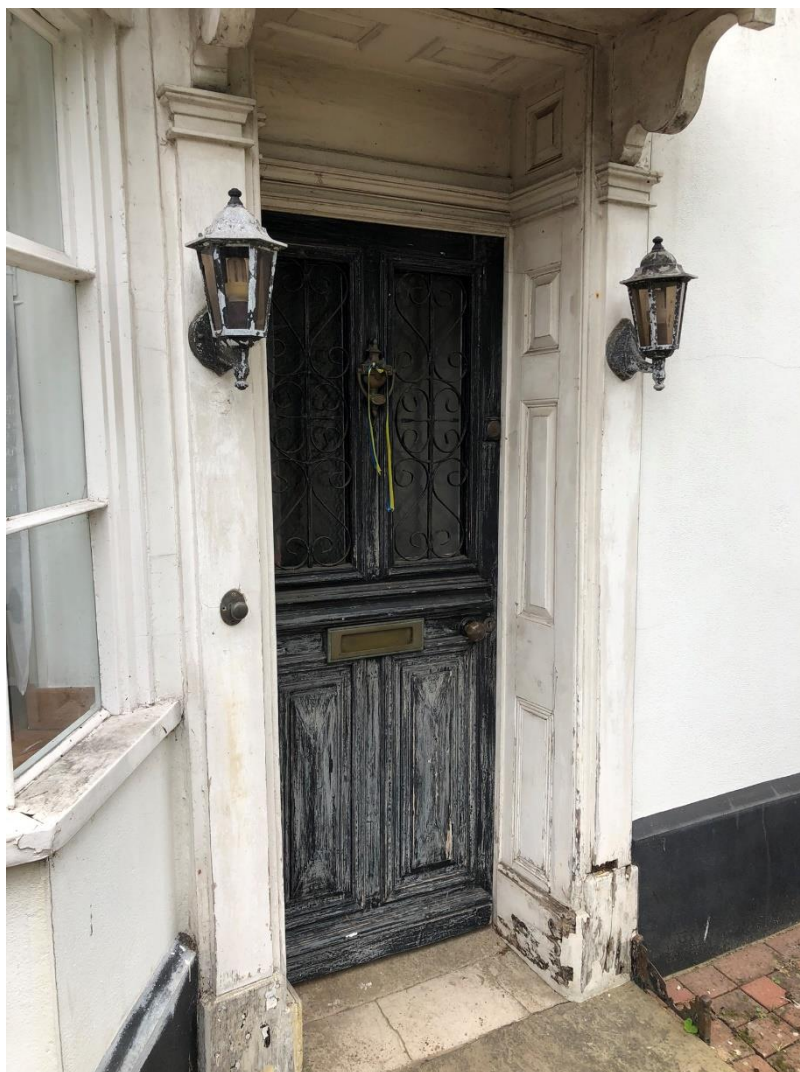
9. Softened timber was noted to the base of the moulded timber door reveals. It is anticipated that repairs will be required, to include removing rotten timber and replacing with new.
10. Where visible the lead coverings to the bay windows and entrance door hood, appeared in good condition.

11. The conservation style rooflights appeared in satisfactory condition with the exception of one, which was cracked. Subject to design aspirations for the roof void, allowances should be made to replace the glazing to the damaged roof light.
