## **CONDITION REPORT**

**MARLOW HOUSE  
107 HIGH STREET  
LINDFIELD  
WEST SUSSEX  
RH16 2HR**

**GH342**

**October 2022**

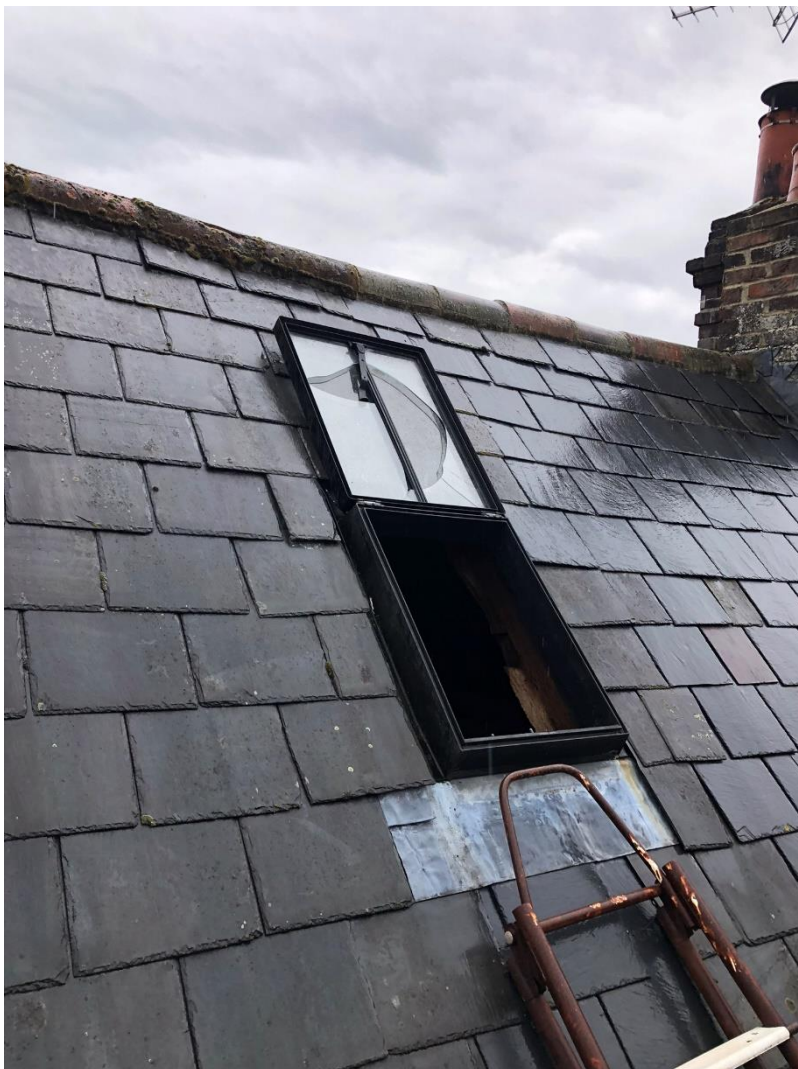
12. The flashing at the junctions between the rooflights and roof slope appeared in good order, however we noted evidence of damp penetration to the ceiling below. Allowances should be made for further investigation to ensure the rooflights are suitably weathertight.
13. We were unable to test the other three rooflights (on the original house) at the time of the inspection. Allowances should be made for further inspection and potentially a minor overhaul to leave in working order.
14. To the bakehouse, the patio doors appeared in serviceable condition, with some soiling noted to decorations. The rooflights provided to the south roof slope of the bakehouse appeared in satisfactory condition but were not tested at the time of the inspection.

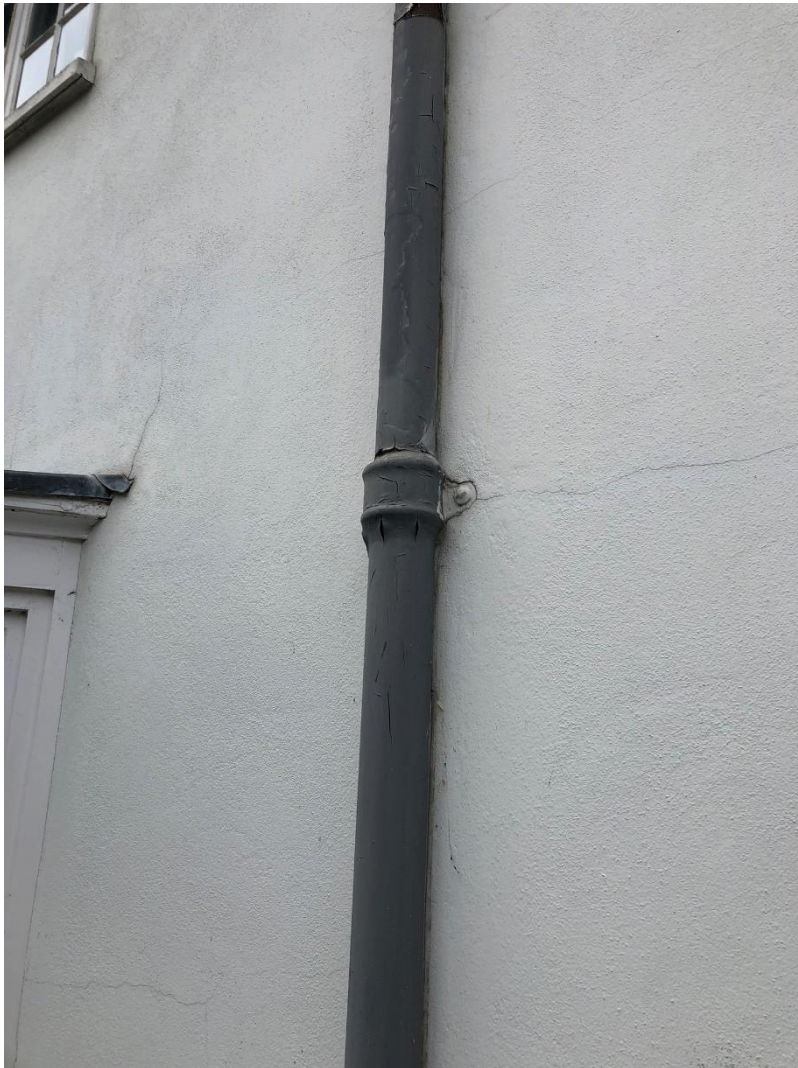
5. Ideally allowances should be made to replace the gutter and downpipes with new cast iron equivalents.
6. The lead valley gutter to the rear of the original house generally appeared in satisfactory condition, however we are advised by the vendor that issues with damp penetration have occurred in recent times, either by poor detailing, deterioration or via a fault with the internal rainwater outlet.
7. The lead valley gutter will require replacement as part of the proposals for the rear extension. When doing so, opportunities should be explored to avoid the requirement for an integral rainwater outlet, which can be prone to damp penetration internally.

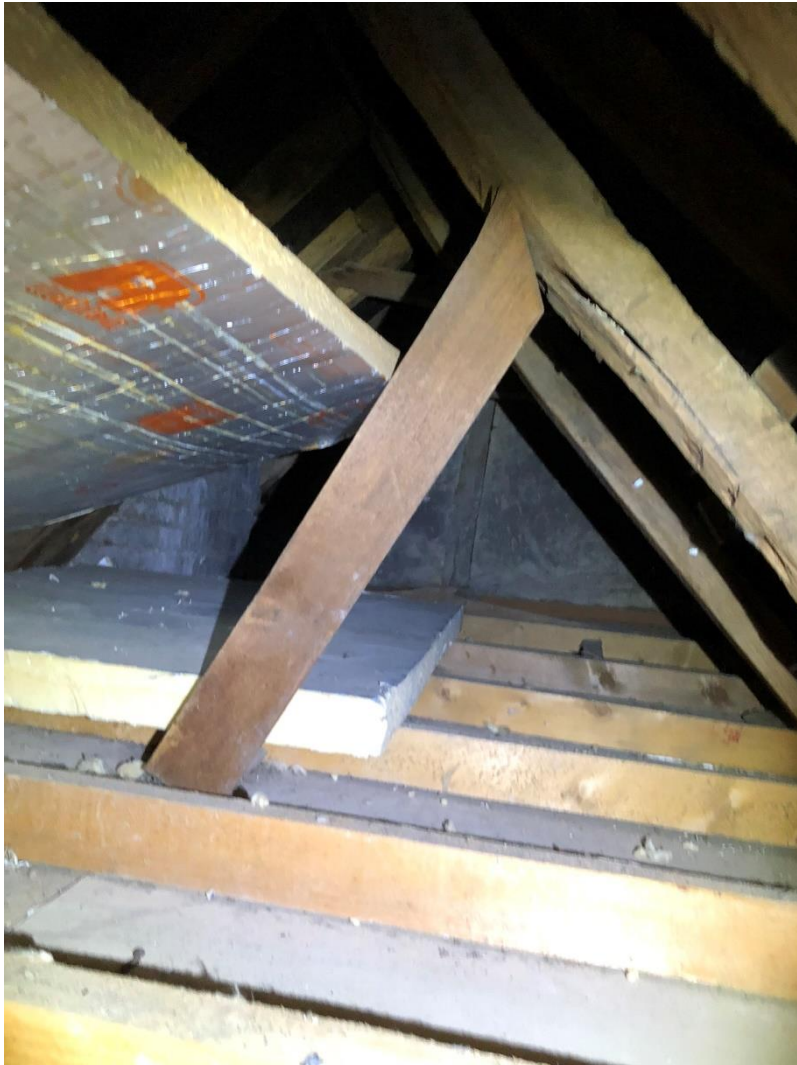
2. Purlins provide support to rafters at mid span and are supported by diagonal bracing within the roof void. Within the adjacent master bedroom, where purlins are not supported, some deflection was noted, however we did not note any signs to progressive structural movement, suggesting that the roof has reached a new equilibrium.

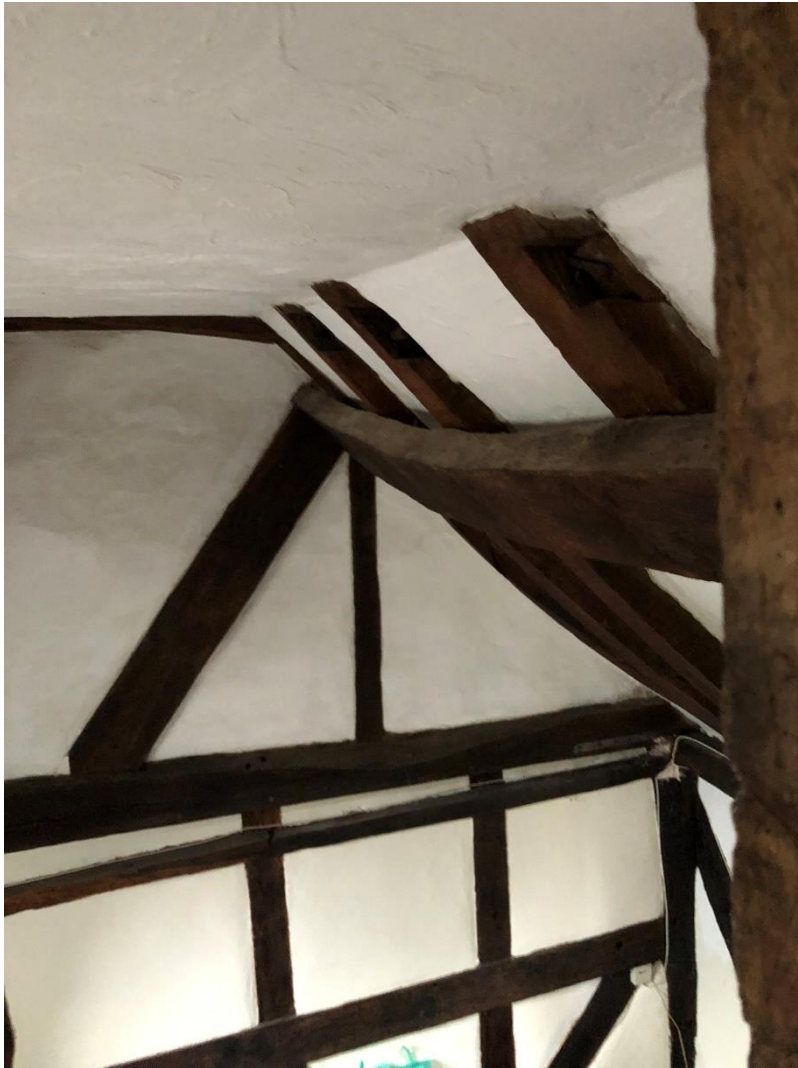
3. As is to be expected there was evidence of old common furniture and deathwatch beetle infestation to various exposed timbers.

4. We note from discussion with the vendor that woodworm treatment has been carried out in the past but the guarantee is no longer valid. We would recommend that you allow for the roof timbers to be treated against woodworm infestation by a specialist contractor.

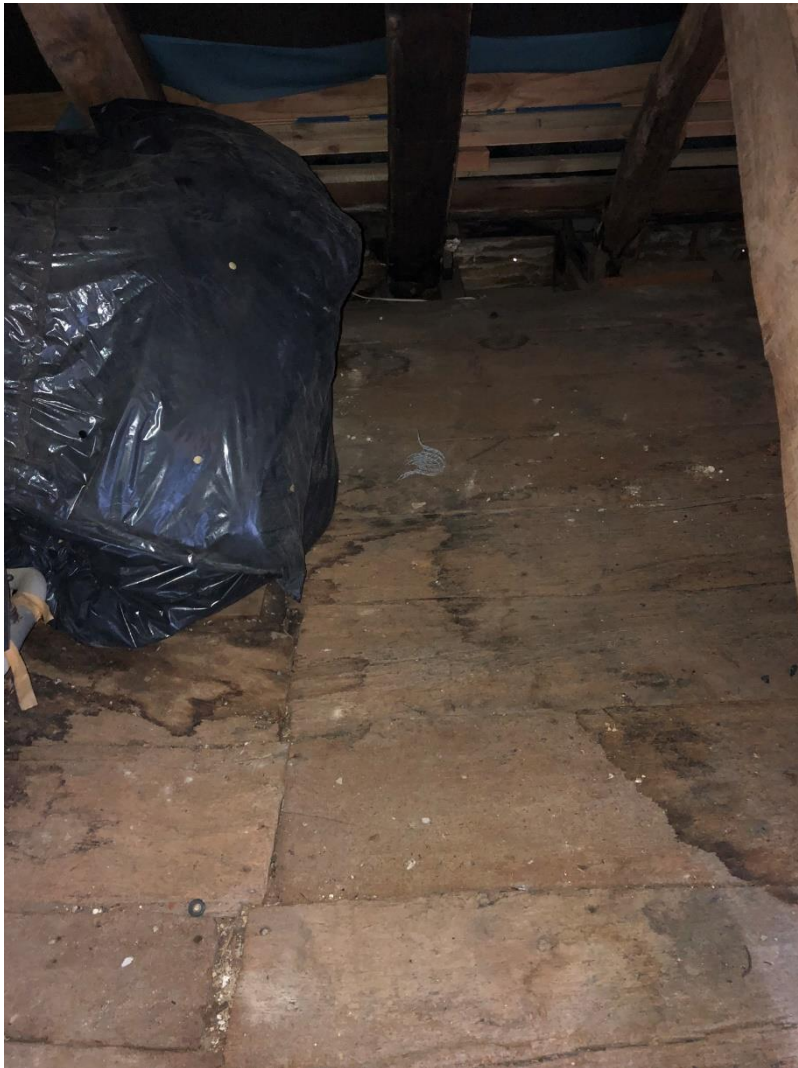
9. Evidence of rainwater ingress was noted to the surface of the render faced chimney stack in the roof void, as evidenced by staining and cracking to the render and abutting timbers. As detailed elsewhere, we recommend that the flashing around the chimney stack be renewed to provide a weathertight seal around the stack.

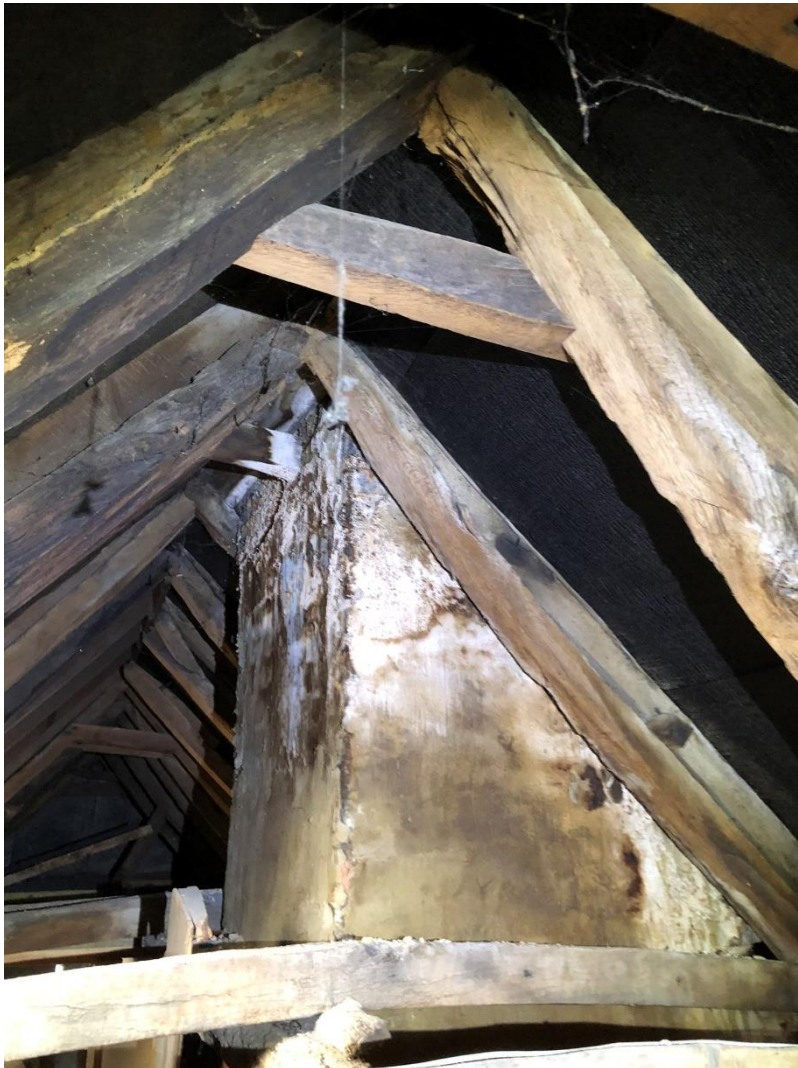
10. A second chimney stack extends full height within the master bedroom, adjacent to the roof void. The chimney stack rakes diagonally towards the rear roof slope. Despite its raking form, the chimney stack appears to be in satisfactory structural condition, with no evidence of ongoing progressive movement.

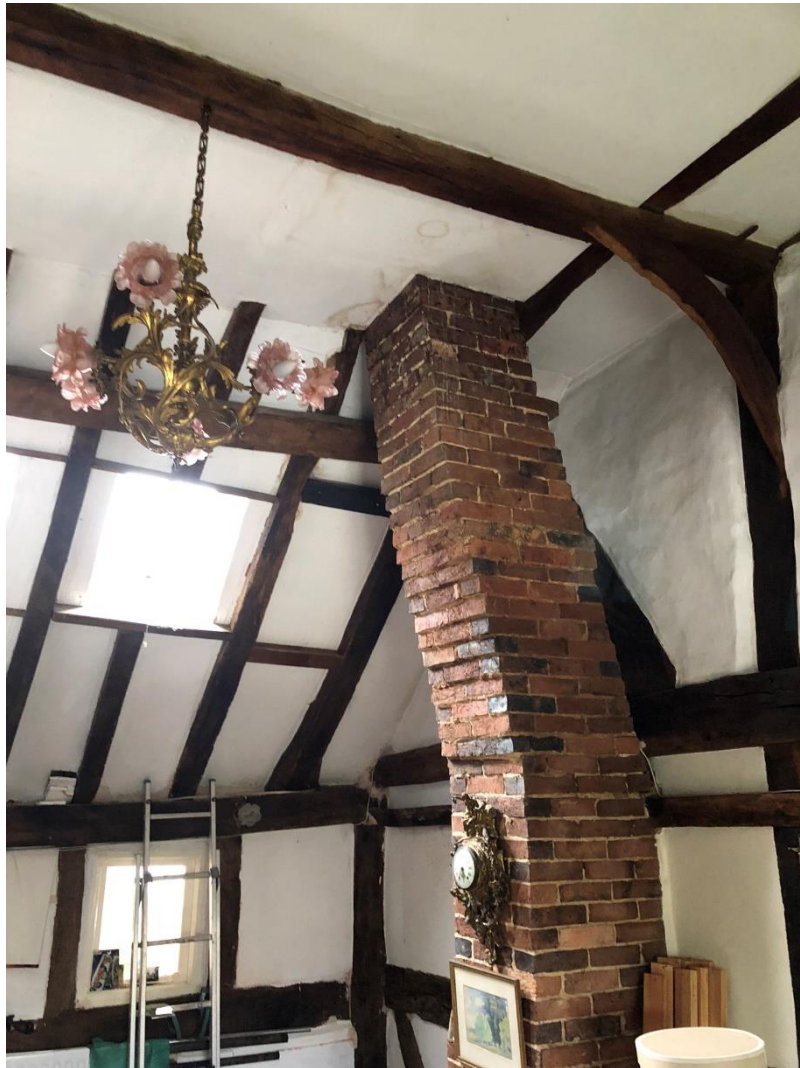
11. As noted previously in the report, evidence of damp penetration was noted to the ceiling adjacent the chimney stack. Our recommendation is to renew the flashing to provide a weathertight detail.
12. Some sections of original wattle and daub panels are visible within the roof void, on the south facing gable end. The panels remain reasonably well fixed but with some deterioration noted, with evidence of poorly applied expanding foam repairs present. Allowances should be made for isolated repairs.

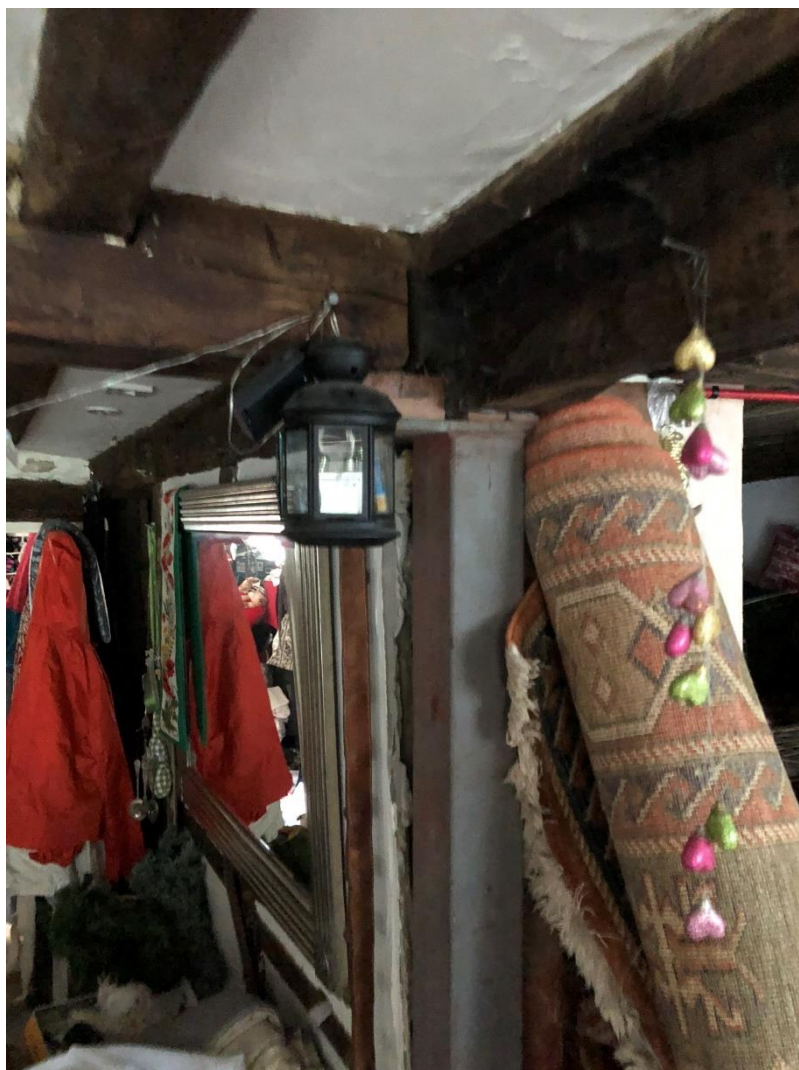
1. The large oak bressummers are generally in fair condition for their age and with the provision of additional support, provided by a steel post, appear to provide adequate support for ancillary oak joists.
2. Subject to the proposed internal layout and structural engineer's recommendations, you may to replace the post with an oak equivalent or conceal within boxing or stud walling.
3. It was evident that many of the oak joists and bressummers have been affected in the past with both common furniture and deathwatch beetle infestation. We were unable to ascertain whether the infestation was active at the time of our inspection and a specialist contractor is recommended to make a more detailed inspection in May/June 2022 when the woodworm becomes active.

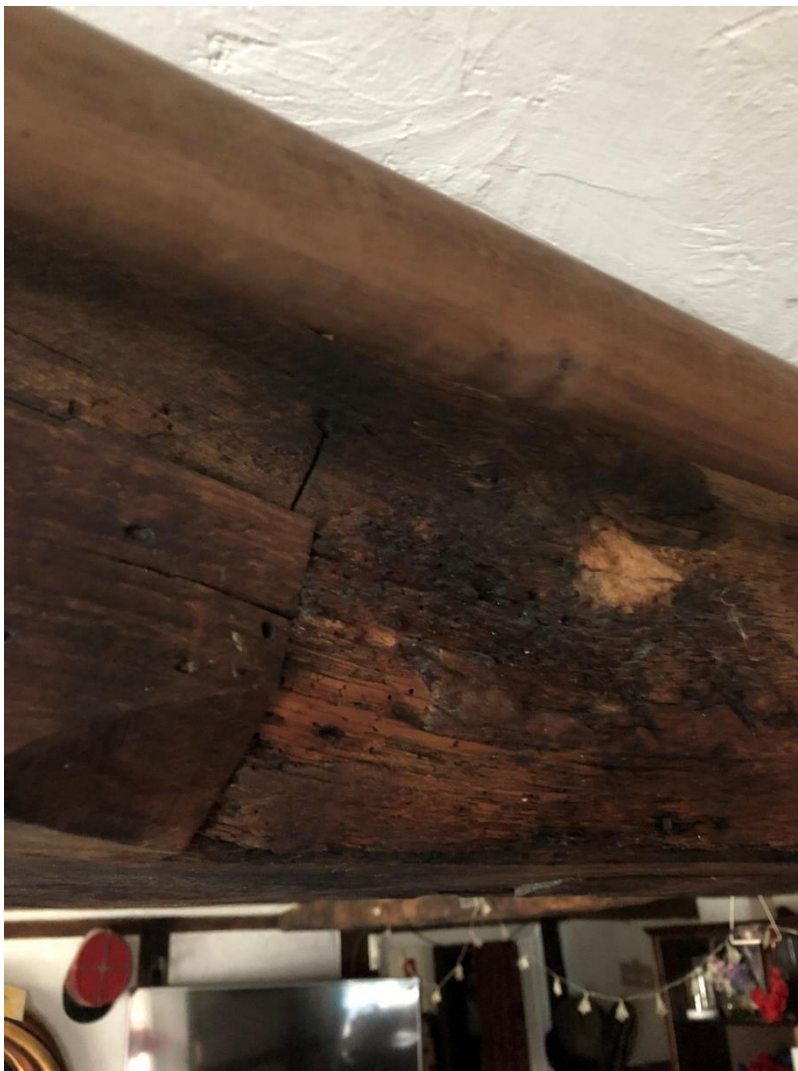
4. Many of the oak joists and bressummers have been oiled, and some have not. To provide a consistent appearance, allowance should be made to complete oiling to all exposed oak timbers.
5. Isolated areas of damaged ceiling plaster were noted. You may wish to replace the hardboard ceilings throughout with new skimmed plasterboard equivalents.
6. Replacement plasterboard ceiling with an emulsion paint finish are provided within the old dining and kitchen area. These ceilings appeared in good condition with some shrinkage noted at wall junctions. The shrinkage cracking can easily be made good during the next course of internal redecorations.

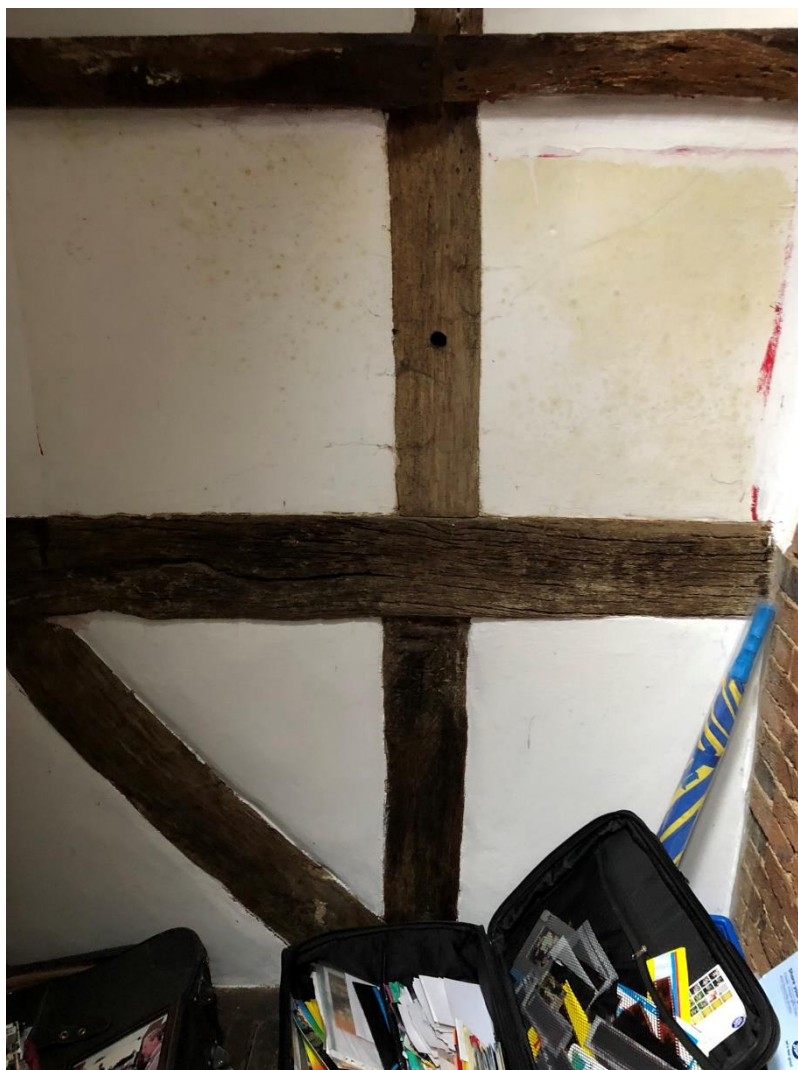
2. Some of the plaster infill panels are uneven with some hairline cracking noted, but generally remain intact and well preserved.
3. As has been reported in relation to some of the ceiling joists / bressummers, some of the exposed framing has been affected over the years by deathwatch beetle and common furniture infestation. Allowances should be made for woodworm treatment.
4. The drylined stud walling appeared in satisfactory condition, with some shrinkage cracking noted to areas. Isolated areas of replastering should be anticipated as part of the proposed internal refurbishment works.

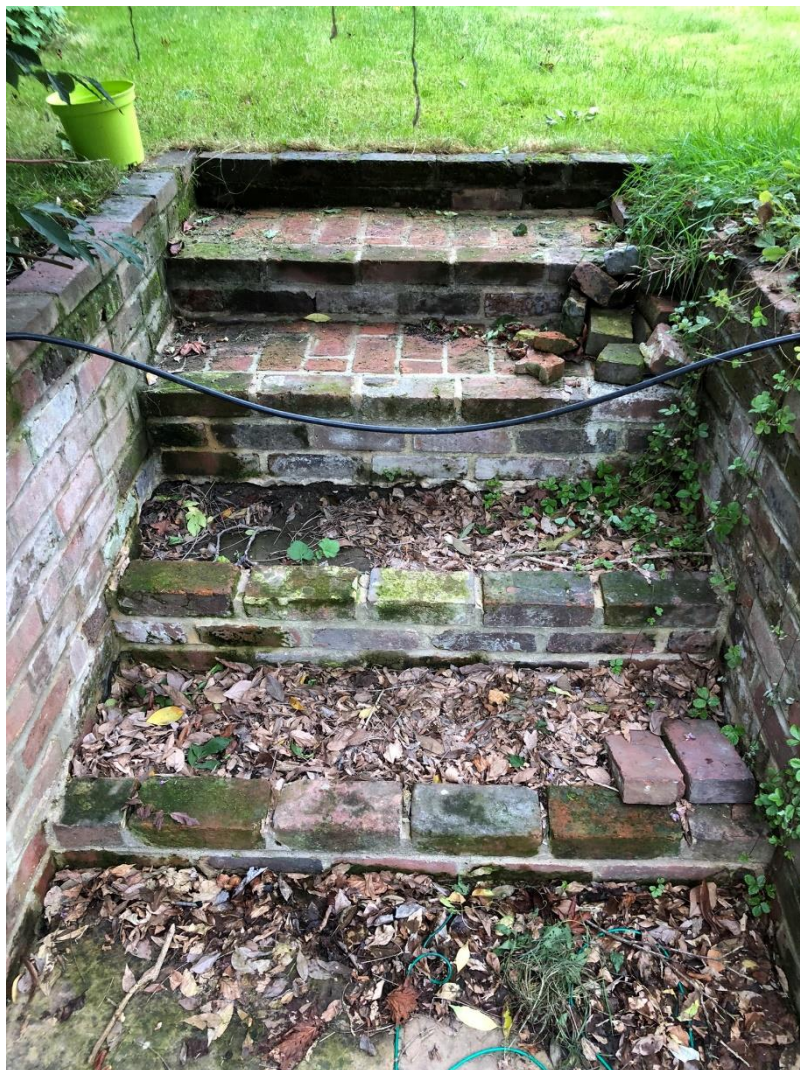
3. The brick paved pathways appeared in serviceable condition but largely obscured by sand and mud.

4. Where visible, the boundary walls appeared in fair condition with isolated areas of defective pointing and brickwork noted. Allowances should be made for isolated repairs.

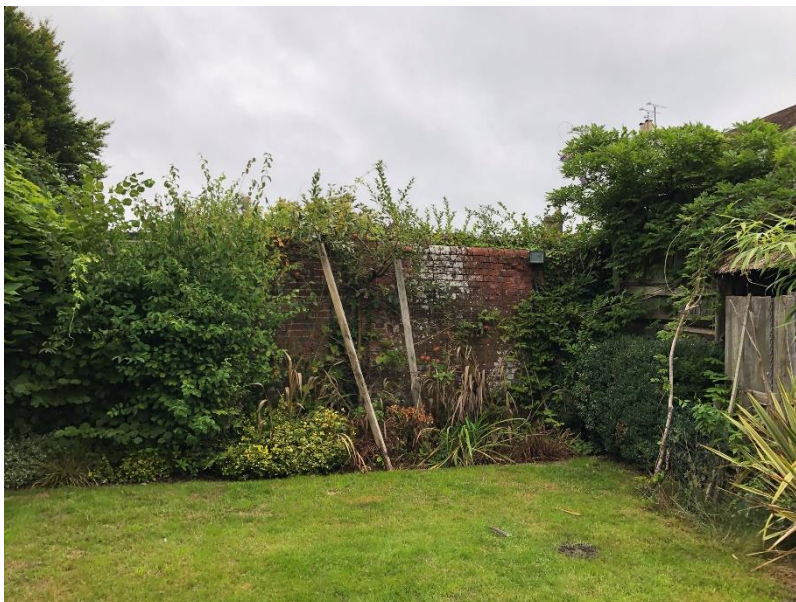
5. The fencing was largely obscured. We would anticipate repairs being required to replace any rotted sections. Alternatively you may wish to replace entirely to provide a consistent appearance in accordance with any requirements you may have for external landscaping.
