## **Observation Report: Surface Water Infrastructure**

**Subject site: Courthouse Farm Copthorne Common Road, Copthorne West Sussex**  
**Planning application: DM/25/3021 and DM/25/3020**

Date: 14 May 2026  
Prepared by: Matt Etheridge MBA MSc MCIOB  
Version No. 01

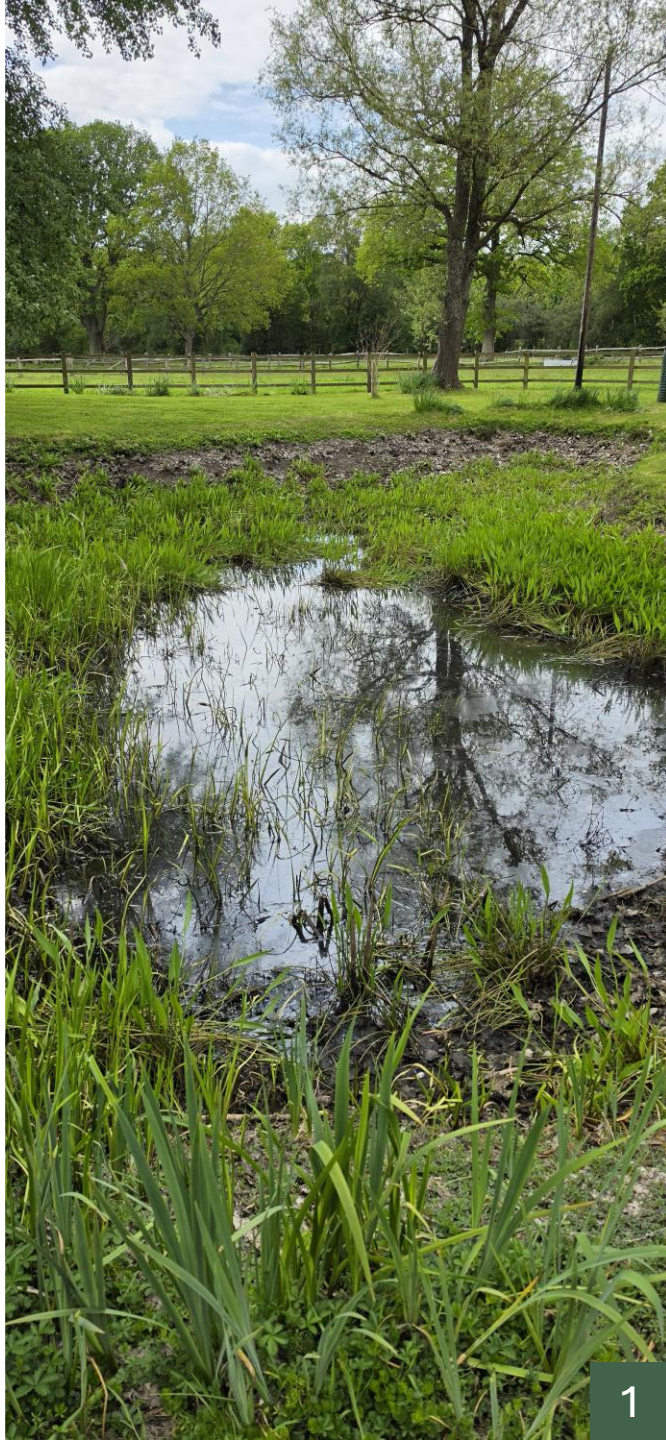
| Ref | Location | Observation |
|---|---|---|
| 1 | Existing pond south of application site | View looking north-west across upstream pond. No observable water movement visible at time of inspection. |

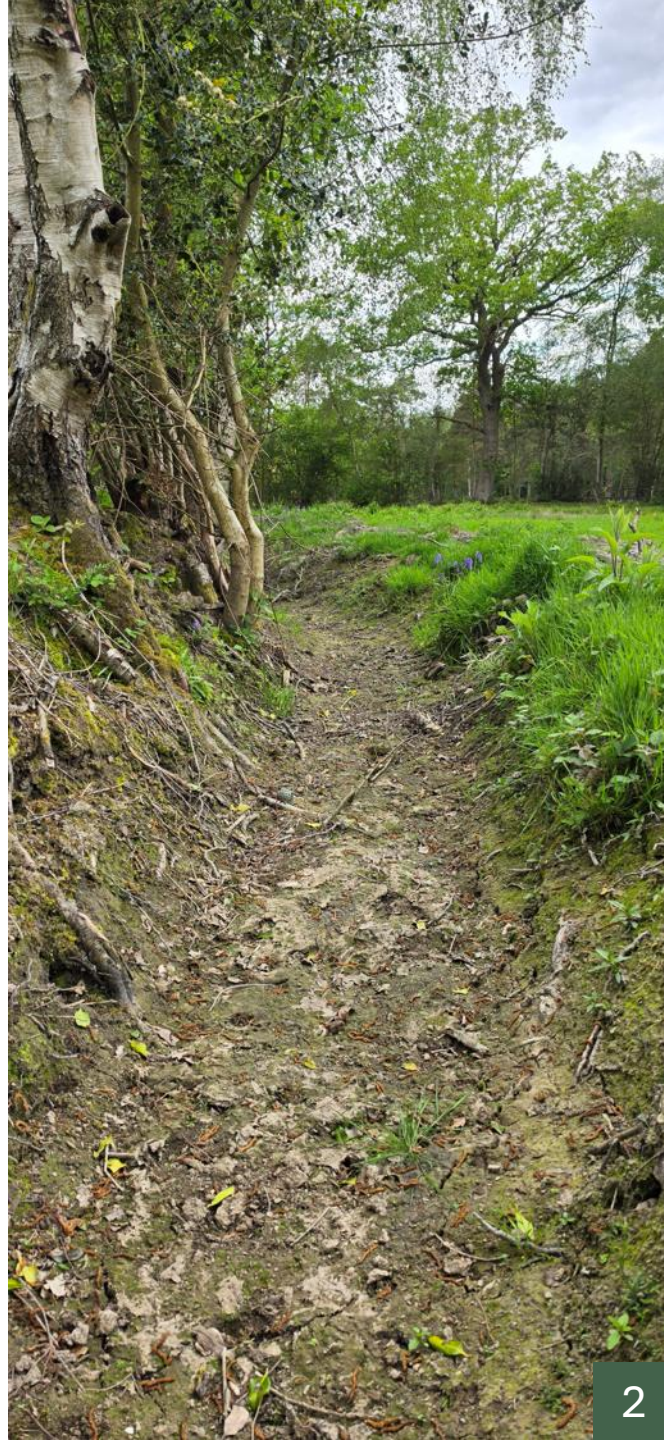
| Ref | Location | Observation |
|---|---|---|
| 2 | Drainage ditch | View looking westward along drainage ditch corridor. |

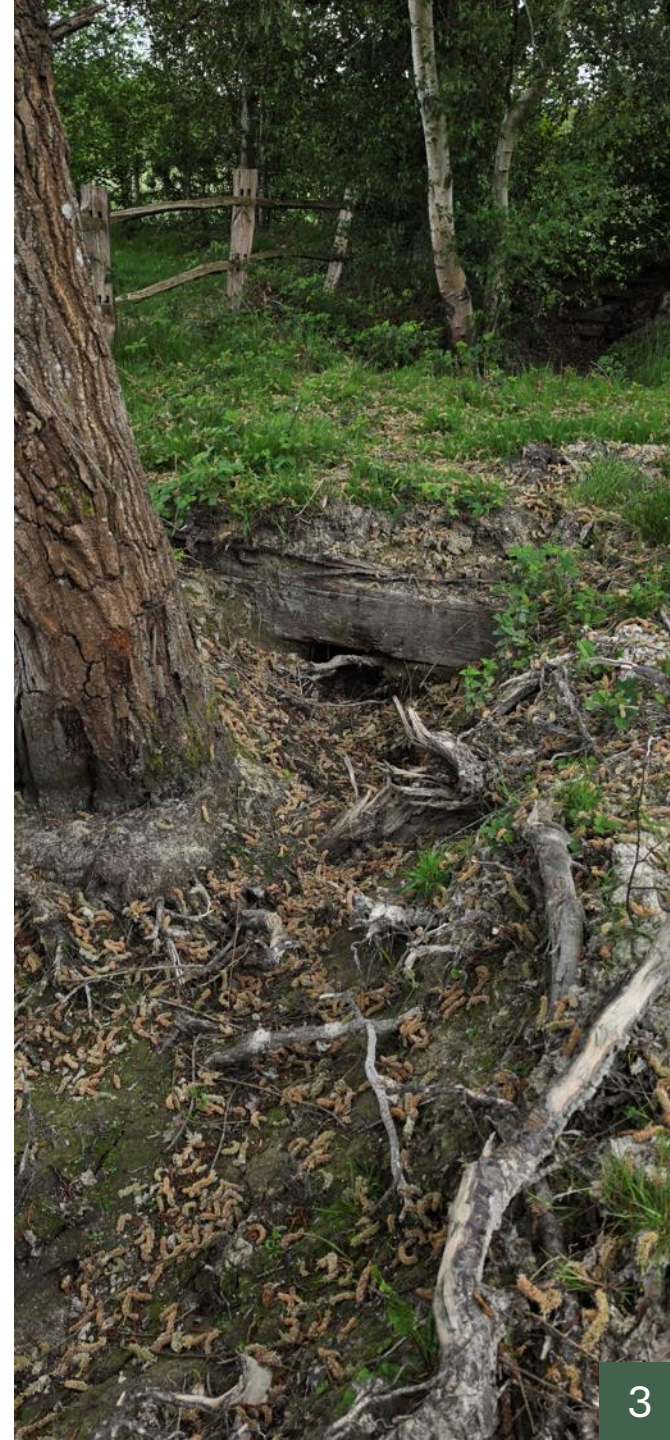
| Ref | Location | Observation |
|---|---|---|
| 3 | Drainage ditch adjacent golf course boundary | View looking westward along drainage ditch adjacent golf course boundary. |

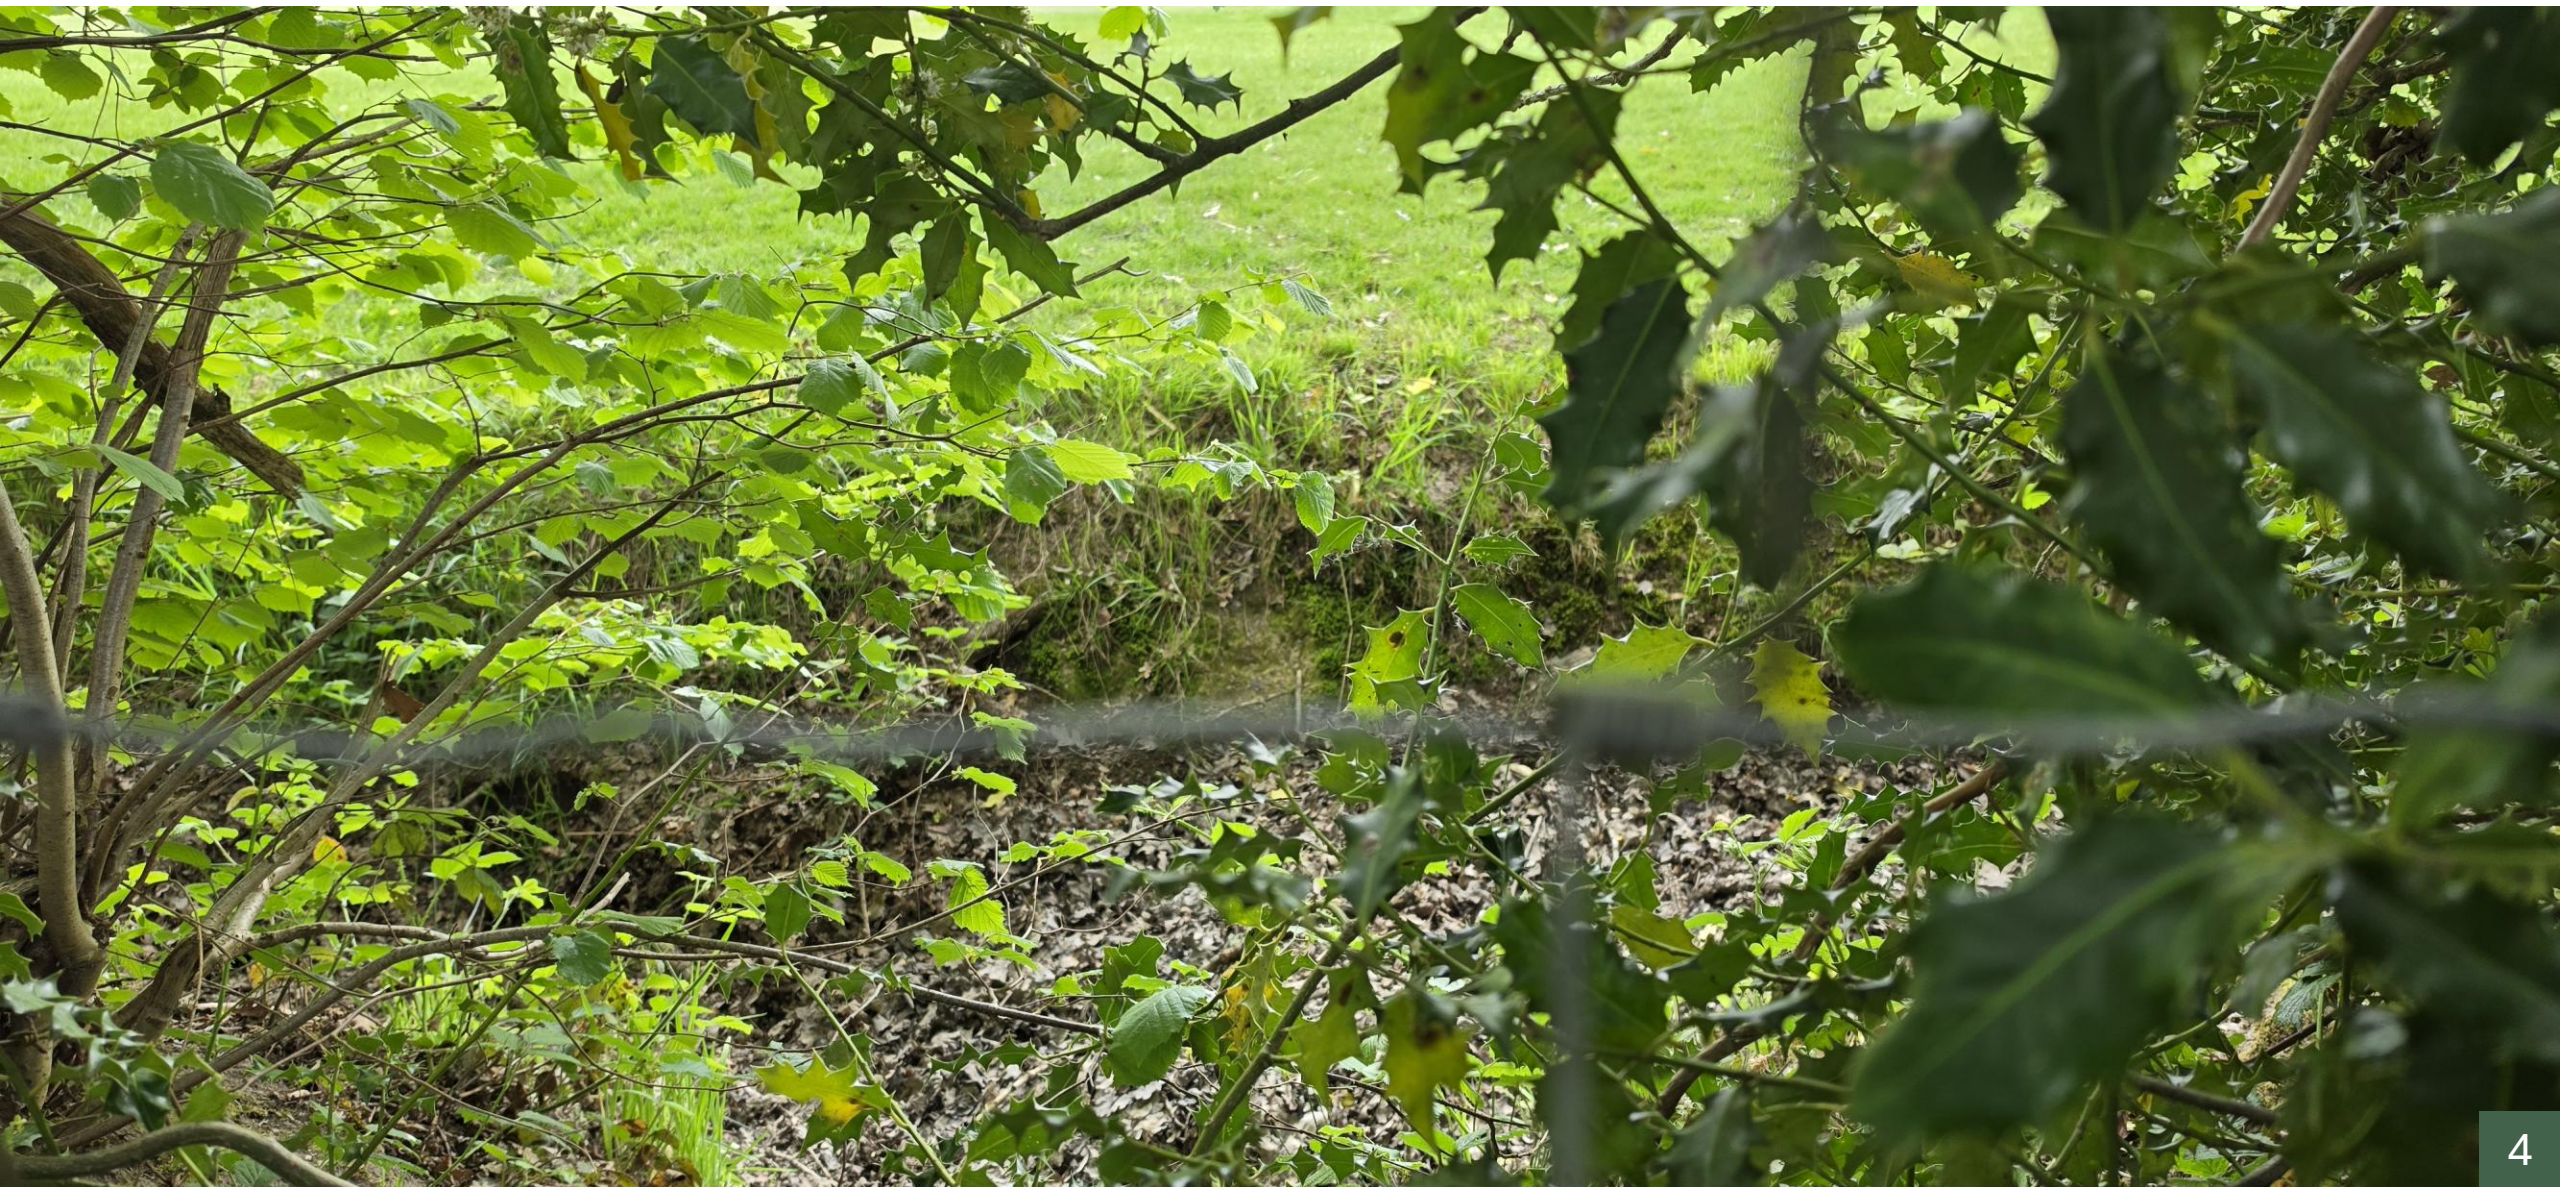
| Ref | Location | Observation |
|---|---|---|
| 4 | Drainage corridor between golf course and application site | View looking westward. Drainage corridor partially obscured by vegetation. |

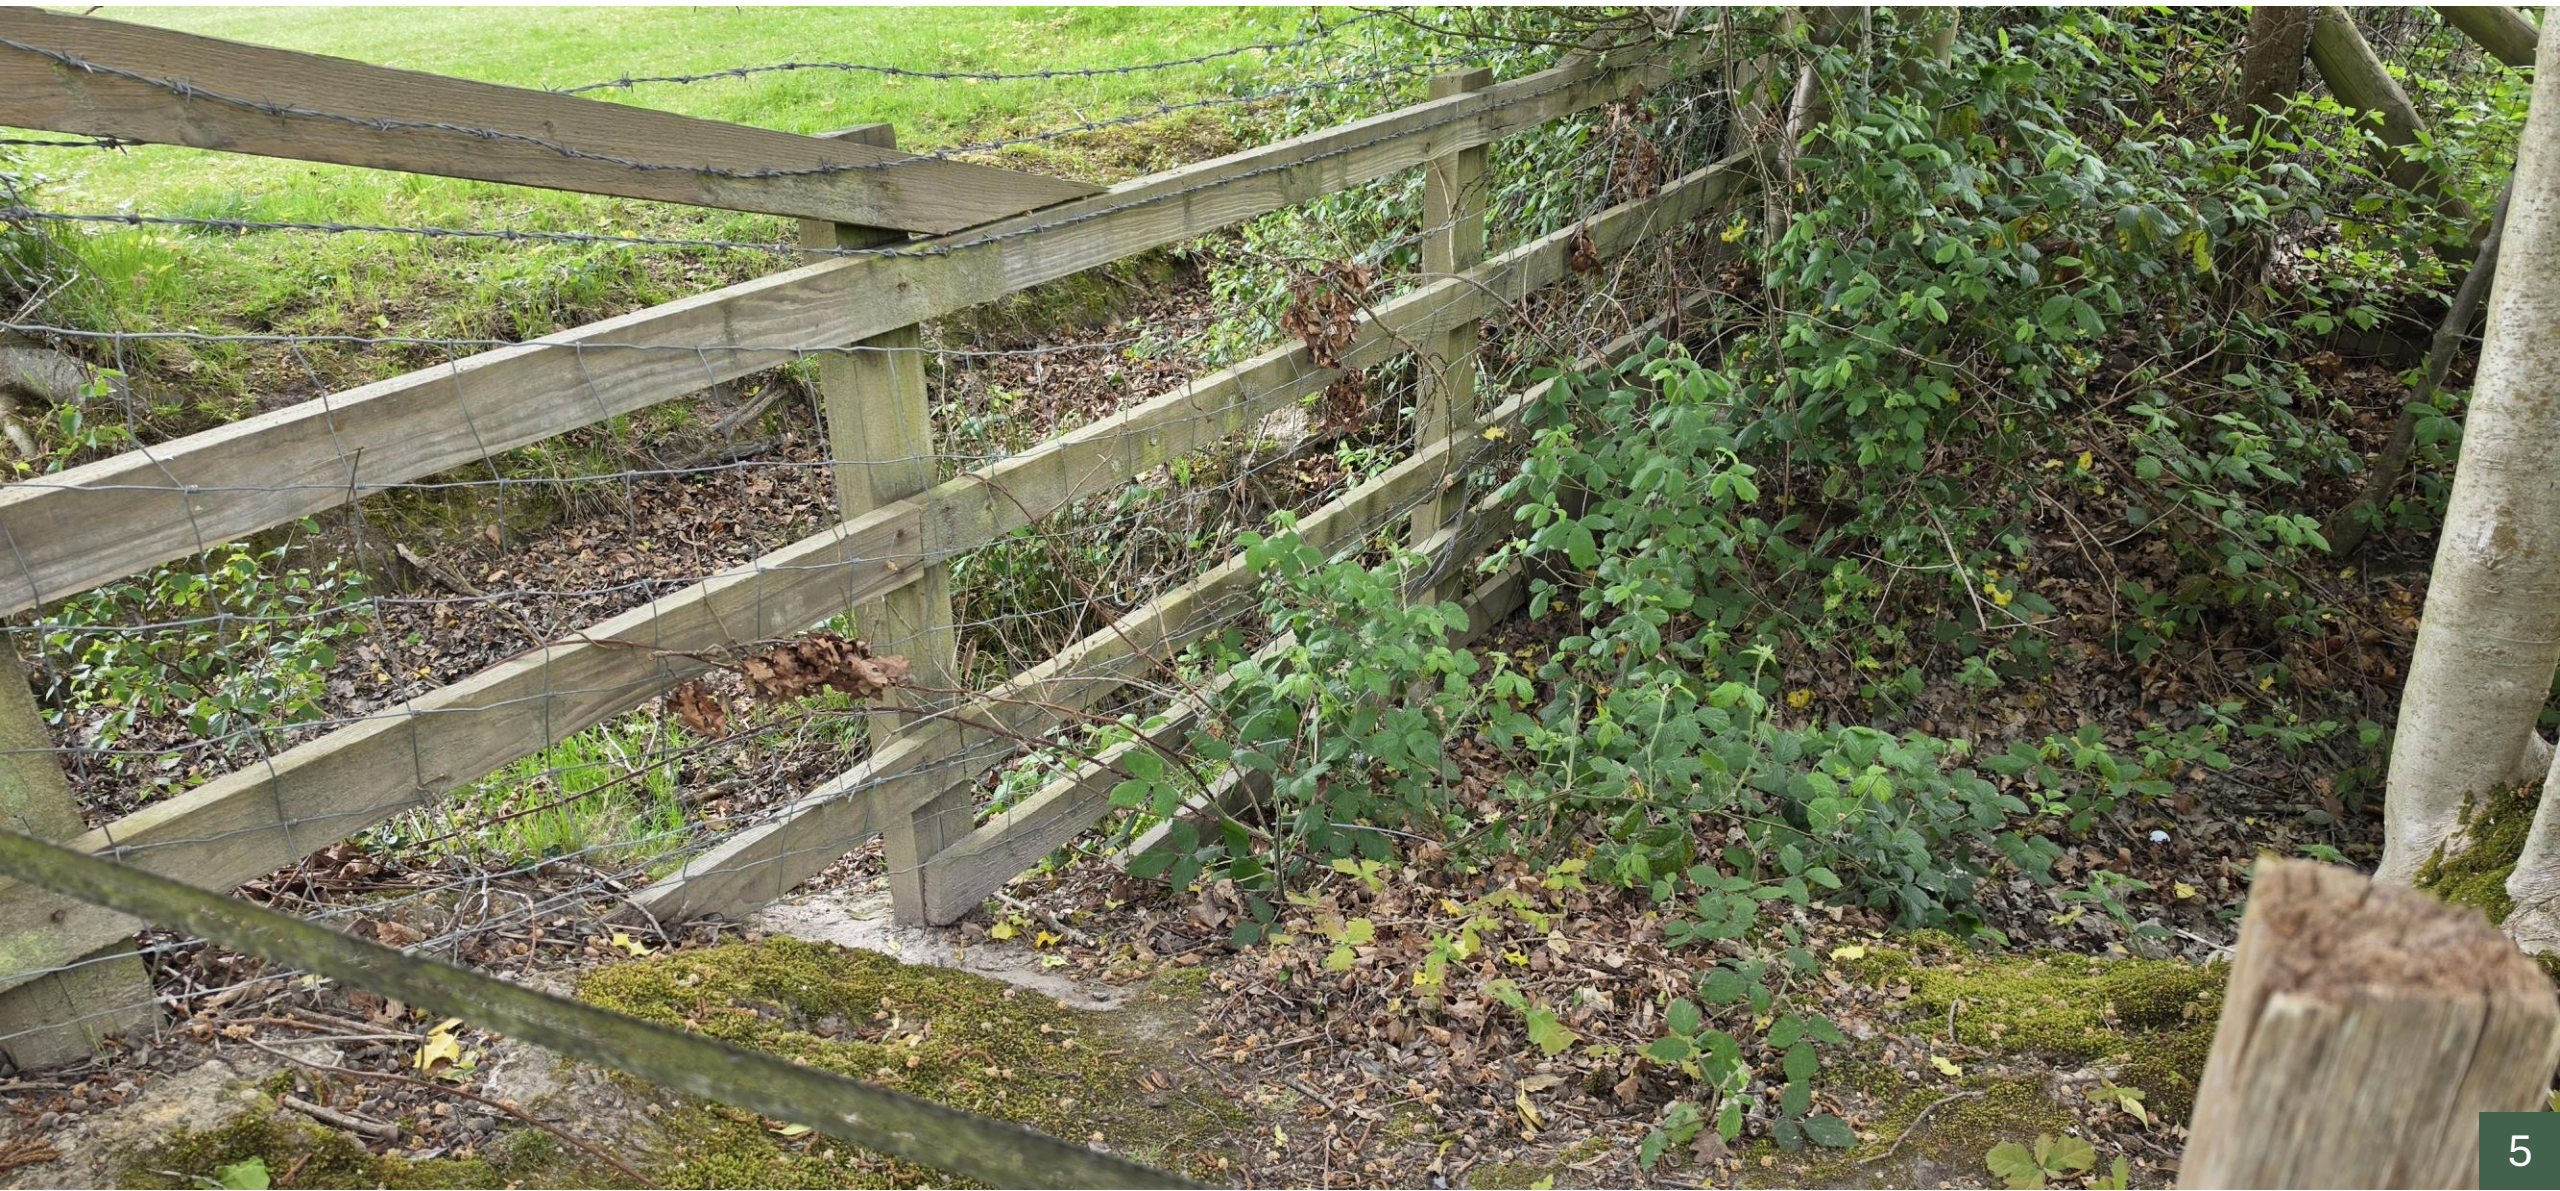
| Ref | Location | Observation |
|---|---|---|
| 5 | Northern connection to off-site drainage network | View looking north-west toward northern drainage connection and wider off-site network. |

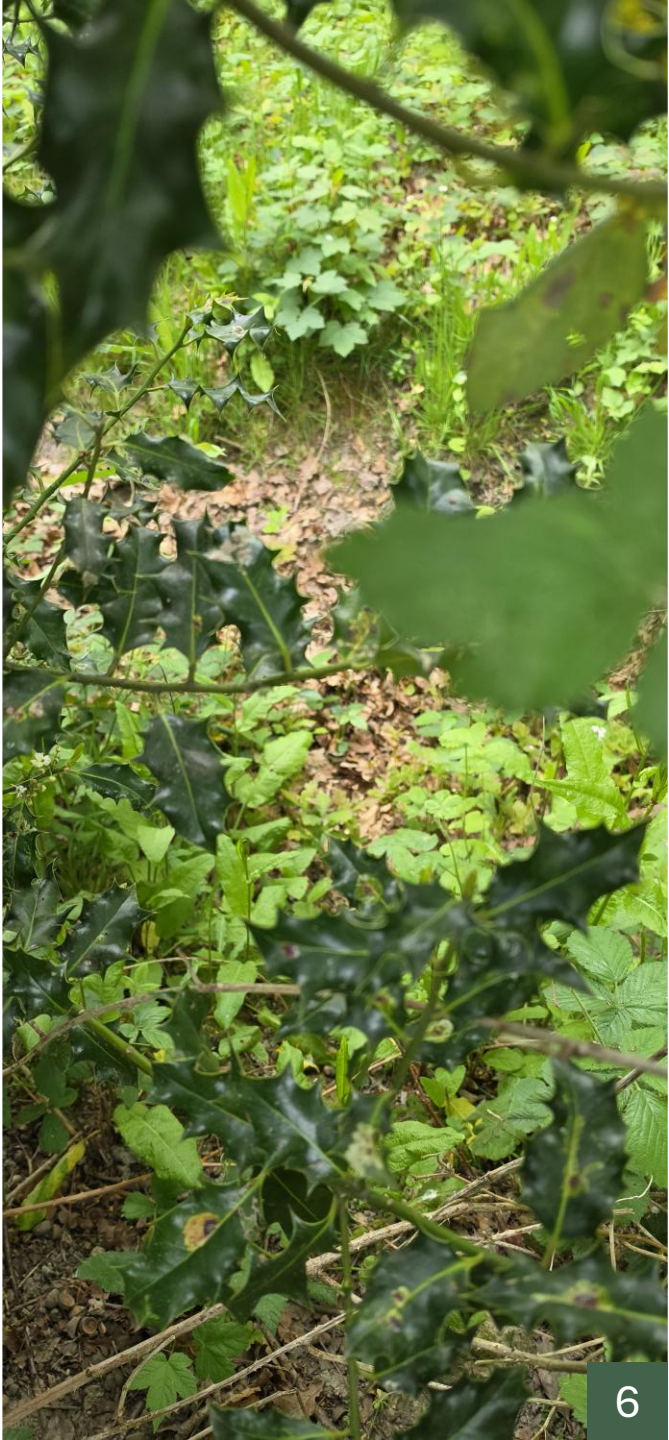
| Ref | Location | Observation |
|---|---|---|
| 6 | North-western drainage corridor | View looking north-west along drainage corridor. Sections partially obscured by vegetation. |

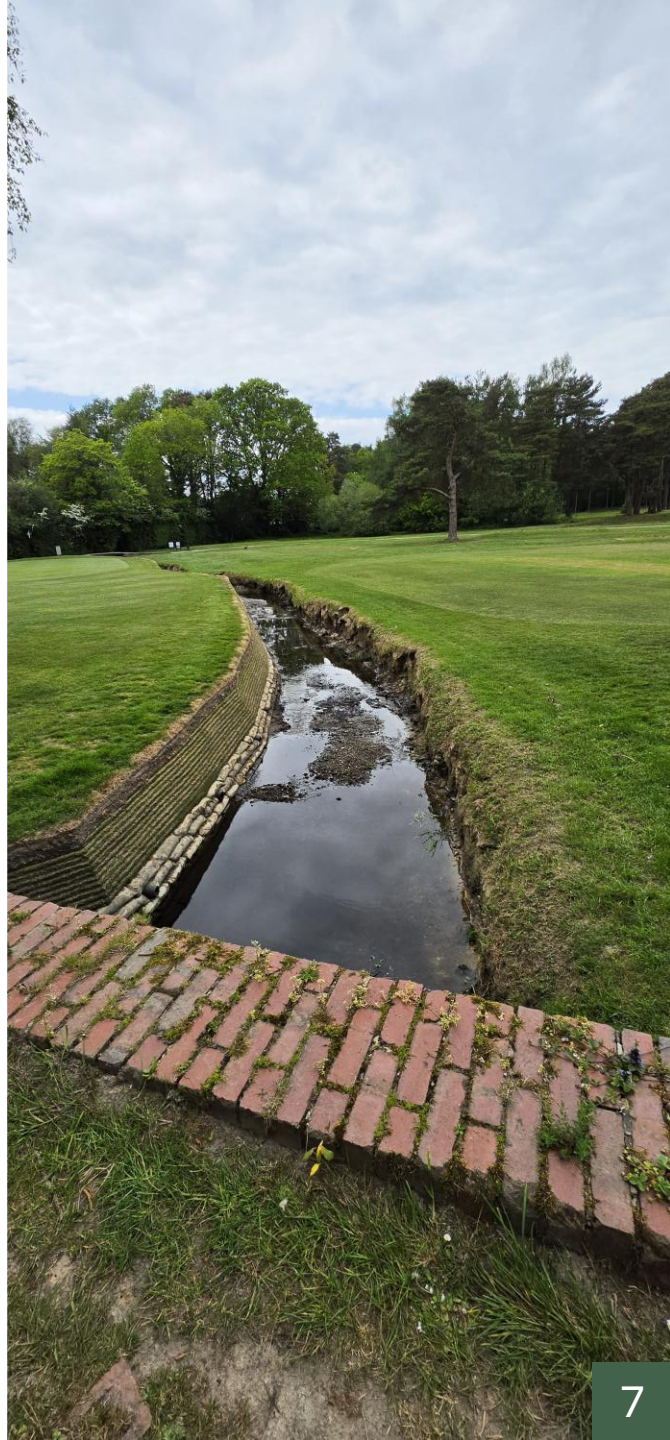
| Ref | Location | Observation |
|---|---|---|
| 7 | Drainage network across golf course | View looking north-west from PROW across observable drainage route within golf course. |
