The external foul drainage system (underground) is mostly constructed of cast iron, with existing connections from the main house connected via "Burns Chambers", these are enclosed chambers with cast iron plates bolted on-top. These bolts remain in place and are likely to be seized due to corrosion. As a result, some connections could not be accessed and surveyed.

Project Pictures:

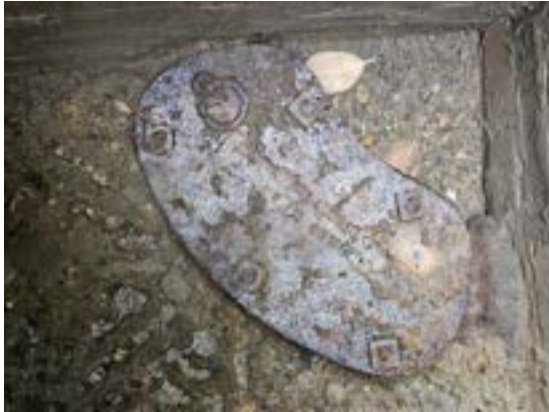
Burns Plate

- All burns covers should be made accessible for maintenance and unblocking.
- All cast iron pipework should be de-scaled using milling machine.
- IC1 – IC2: Root cutting
- IC5 – BR3: Patch repair due to fracture.
- IC14 – IC12: Root cutting and patch repair.
- Catch-pit-3 – Lake: Jetting & Root cutting to restore full flow.

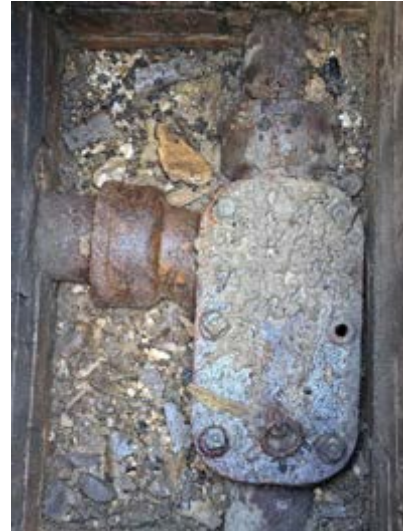
Burns Plate

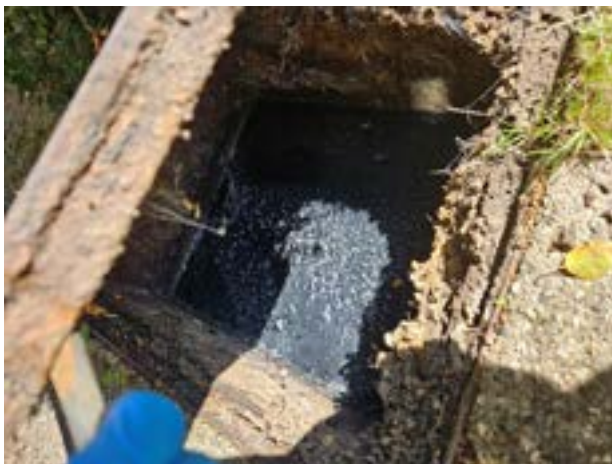
Blocked drains on arrival

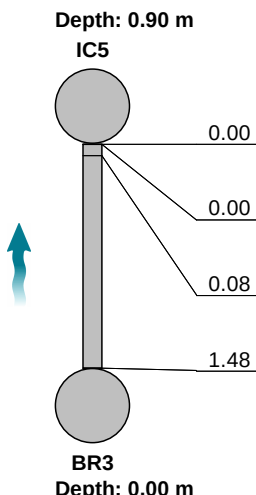
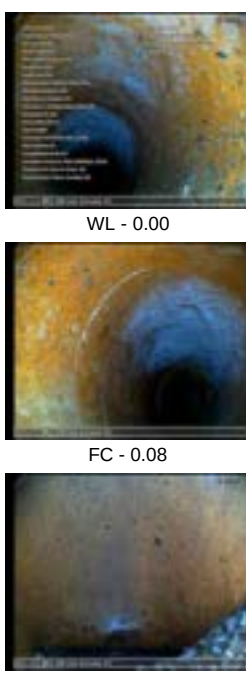
| Scale: 1:50 | Position [m] | Code | Observation | Grade |
|---|---|---|---|---|
| | 0.08 | FC | Fracture, circumferential from 1 o'clock to 12 o'clock | 3 / 2 |

| STR No. Def | STR Peak | STR Mean | STR Total | STR Grade | SER No. Def | SER Peak | SER Mean | SER Total | SER Grade |
|---|---|---|---|---|---|---|---|---|---|
| 1 | 40.0 | 27.0 | 40.0 | 3.0 | 1 | 1.0 | 0.7 | 1.0 | 2.0 |
