**Phase 1 Land Contamination  
Risk Assessment**

**Proposed Conversion of Barn to  
Residential Use to Create a Single 2 No.  
Bedroomed Dwelling with Removal of  
Existing Hardstanding & Landscaping**

**Slaugham Garden Nursery,  
Staplefield Road, Slaugham  
RH17 6AL**

4312D P1 Lenmark – Slaugham RH17 6AL

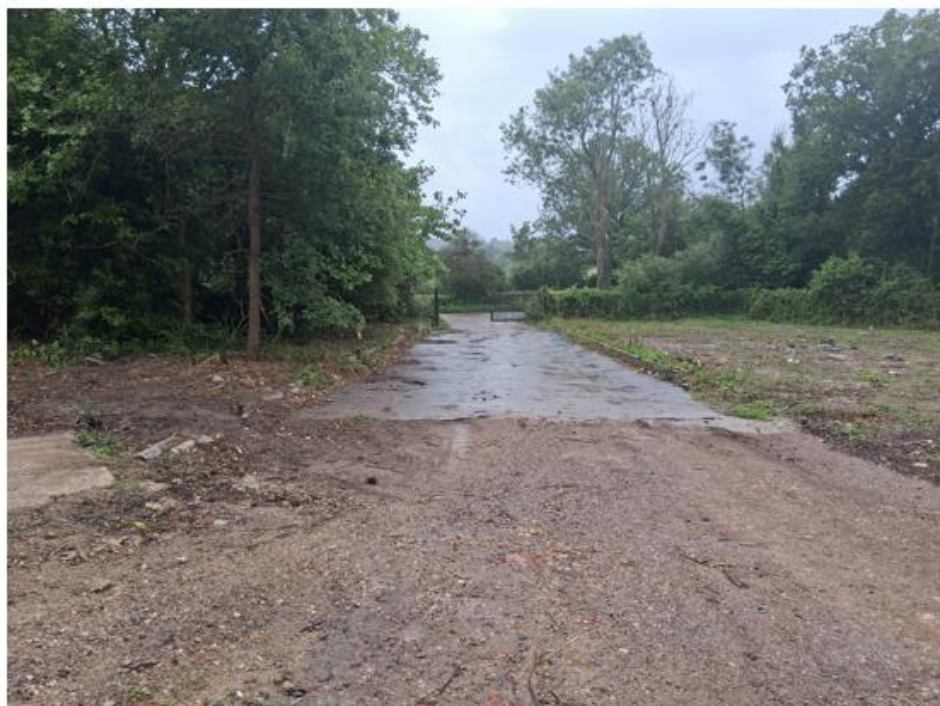
**Photo No.1: Facing south showing the concreted, sloped access route leading north and up to site**

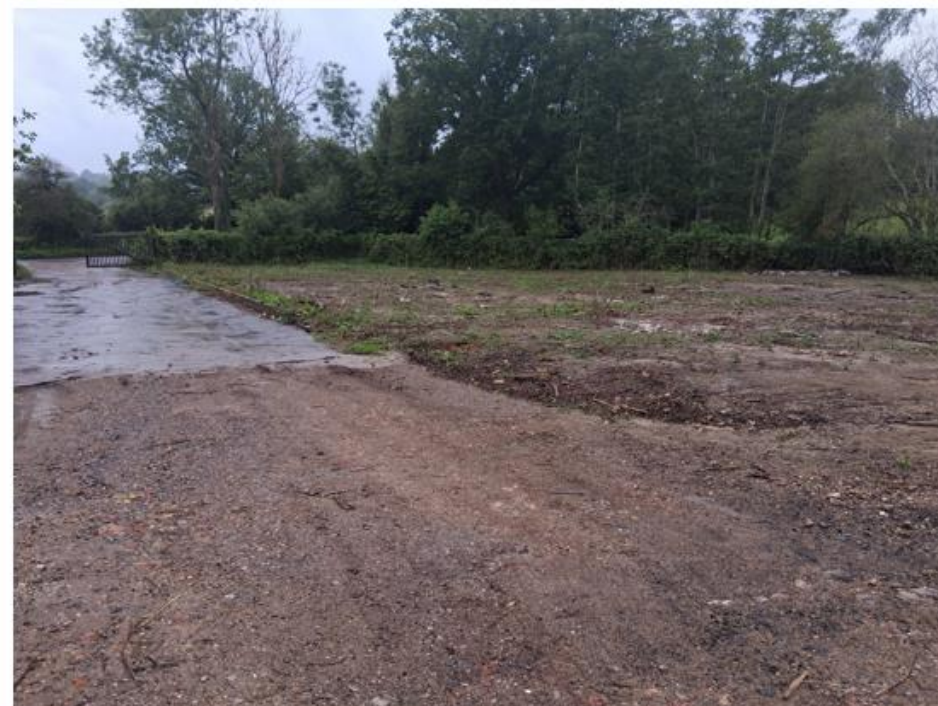
**Photo No.2: Facing slightly SW showing the former nursery area located directly west of site**

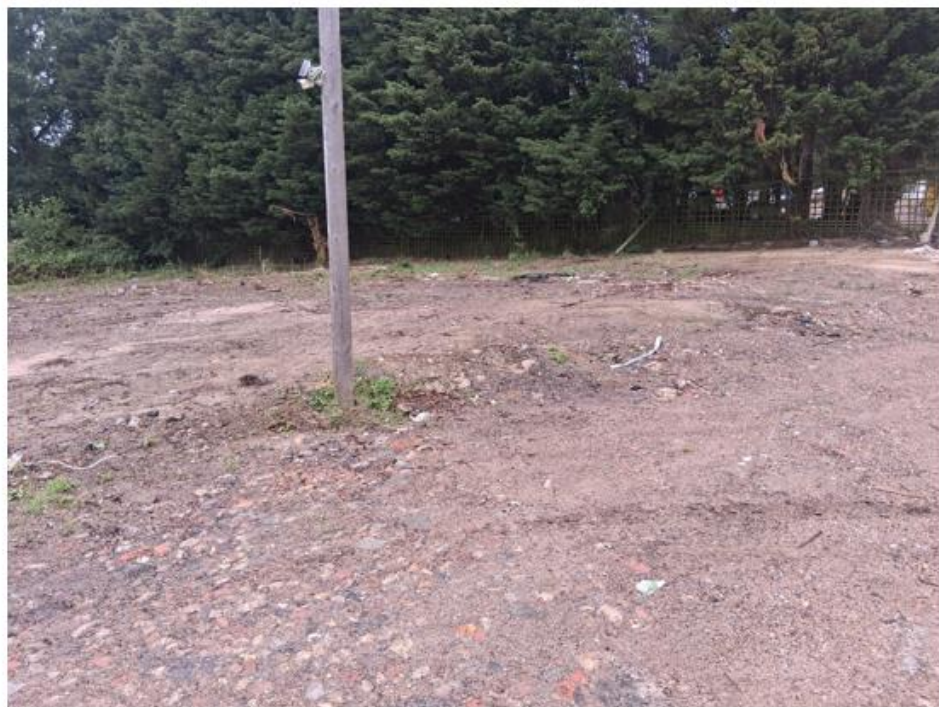
**Photo No.3: Facing west from atop the site access route showing now removed former nursery area adj. to site**

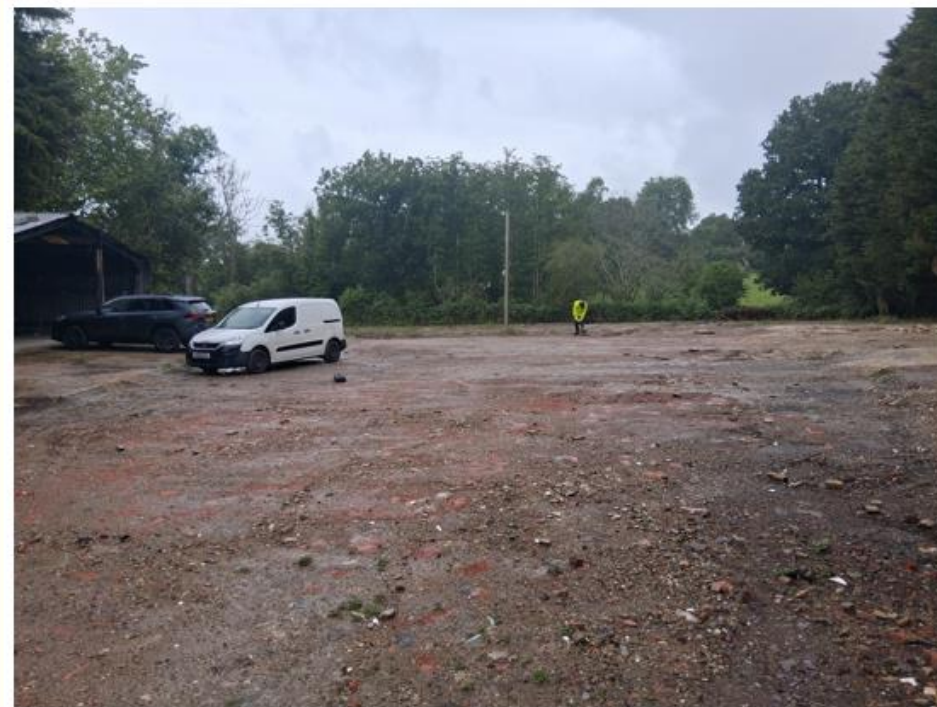
**Photo No.4: Facing SW from the NE extent of site with onsite barn located to left of photograph**

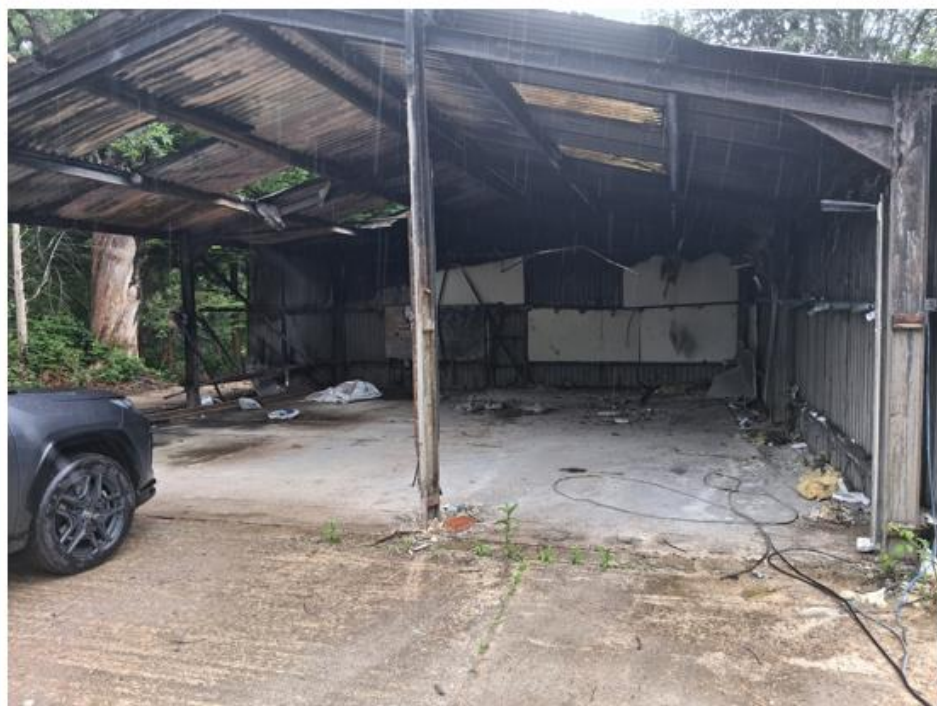
**Photo No.5: Facing SE showing the burnt-out barn**

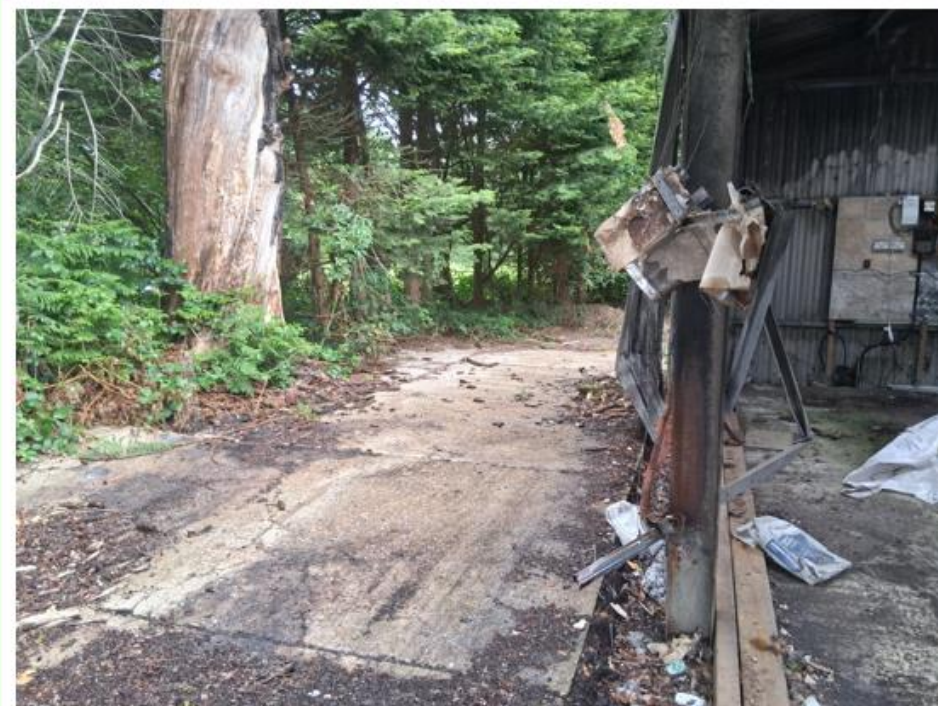
**Photo No.6: Facing SE showing the NE face of barn and the  
hardstanding area adj. to this face of the barn**

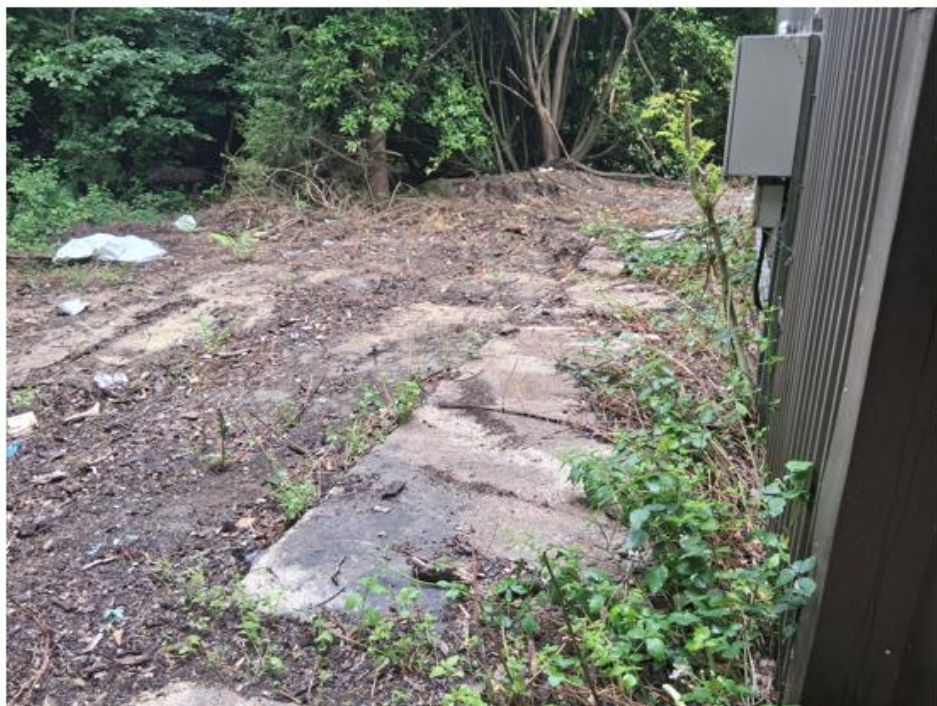
**Photo No.7: Facing SW showing the area to the rear (south) of the burnt-out barn, some debris removed from site**

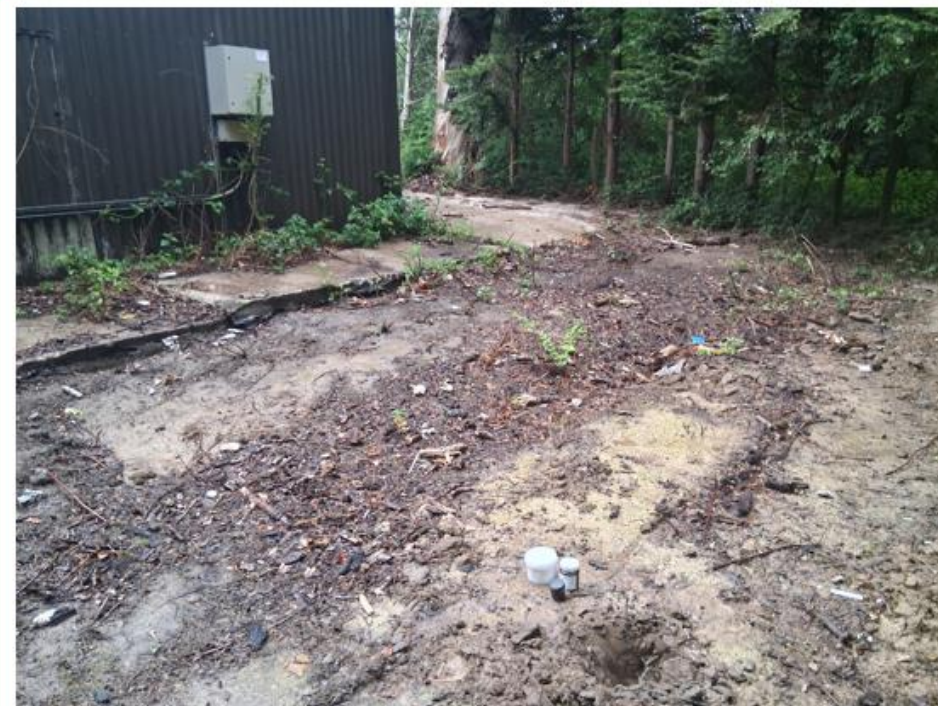
**Photo No.8: Facing north showing the area to the rear (south) of the burnt-out barn, some debris removed from site**

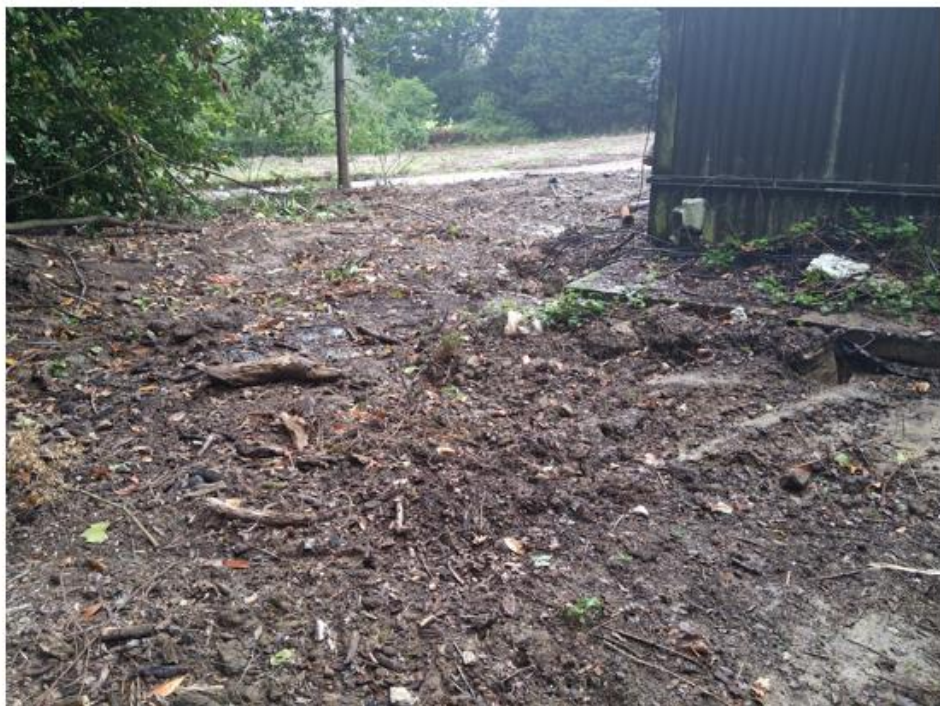
**Photo No.9: Facing NW outside the rear of the barn showing further areas where material had been removed**

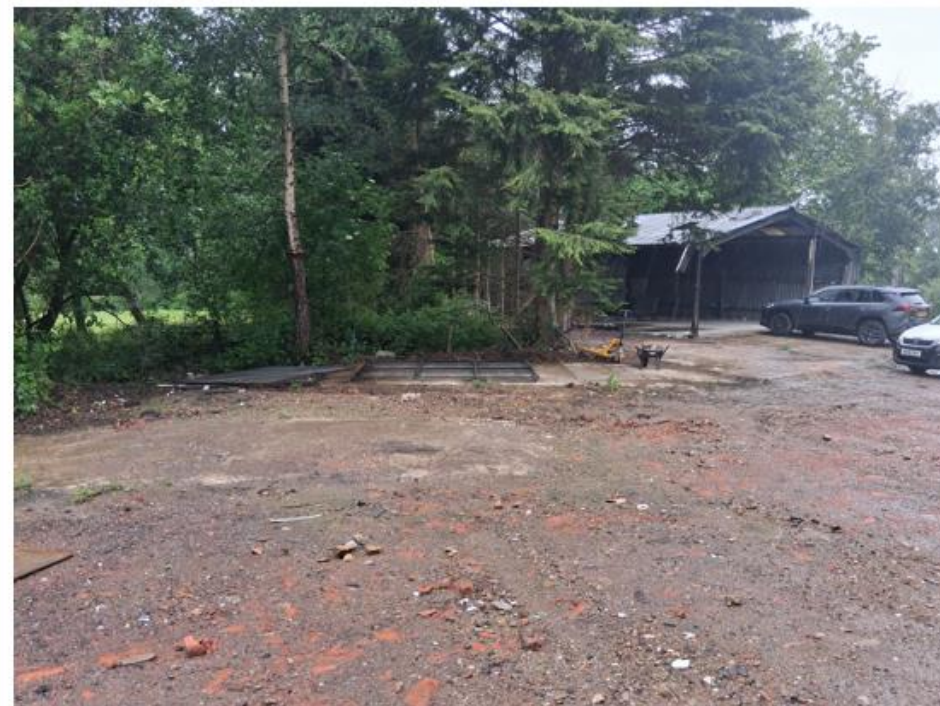
**Photo No.10: Facing south from the far northern extent of site**

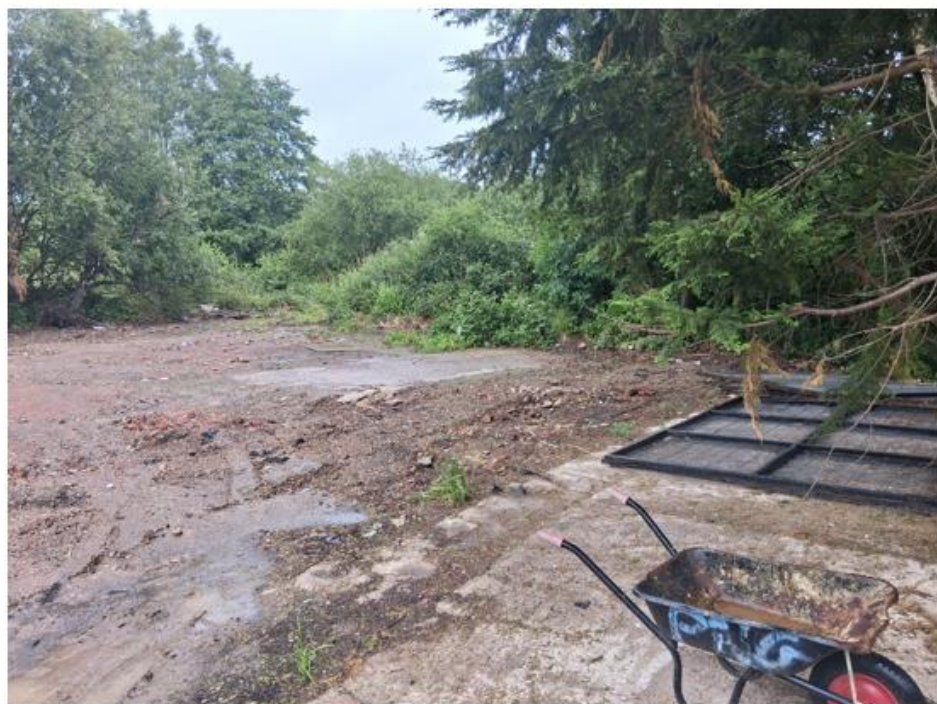
**Photo No.11: Facing north from adj. to the barn showing the northern extent of site and only area of soft-landscaping**

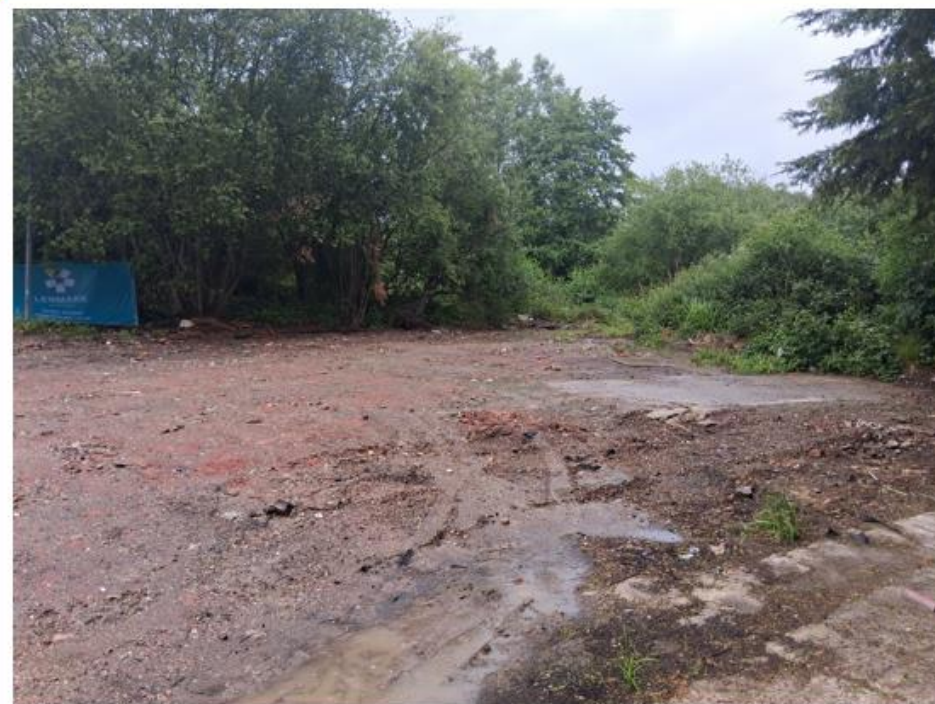
**Photo No.12: Facing NW from adj. to the barn showing the northern extent of site and only area of soft-landscaping**

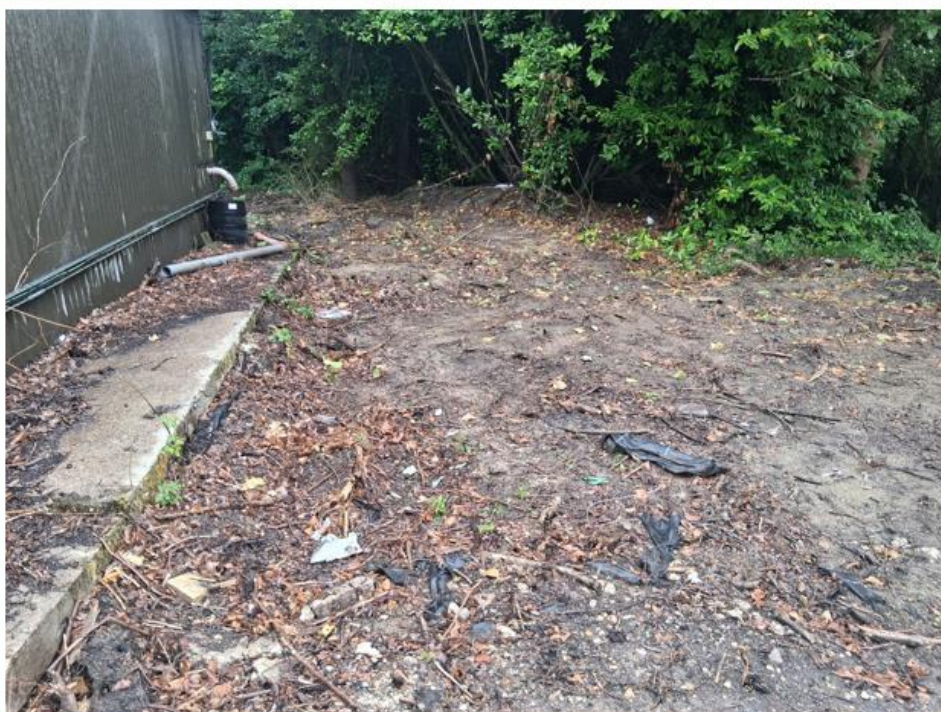
**Photo No.1: IP01 formed directly SW of the burnt-out barn**

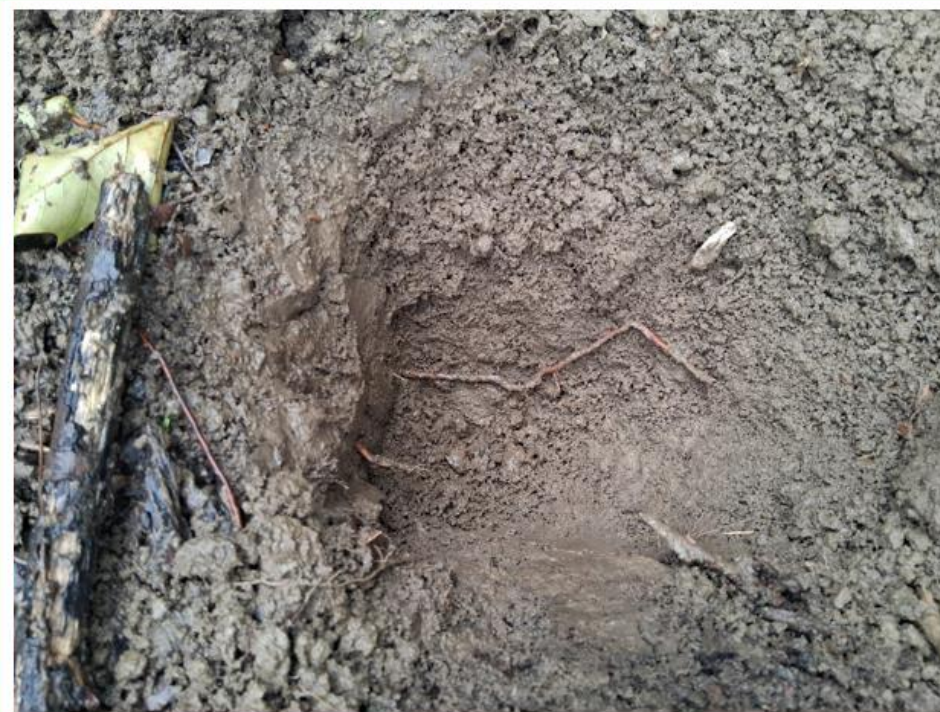
**Photo No.2: IP01 showing natural deposits**

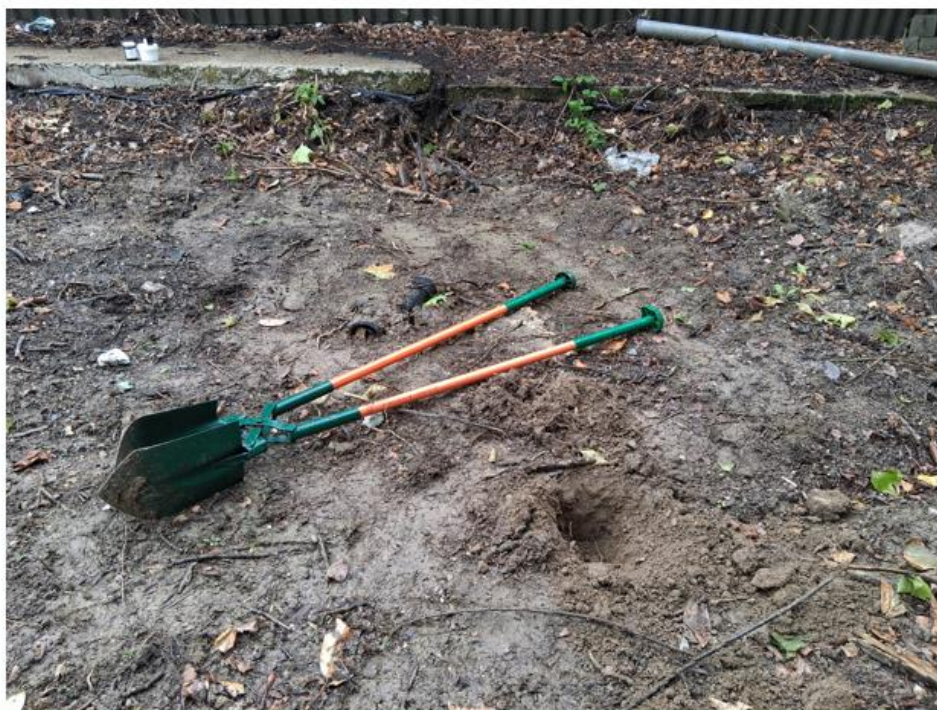
**Photo No.3: IP02 formed directly SE of the burnt-out barn**

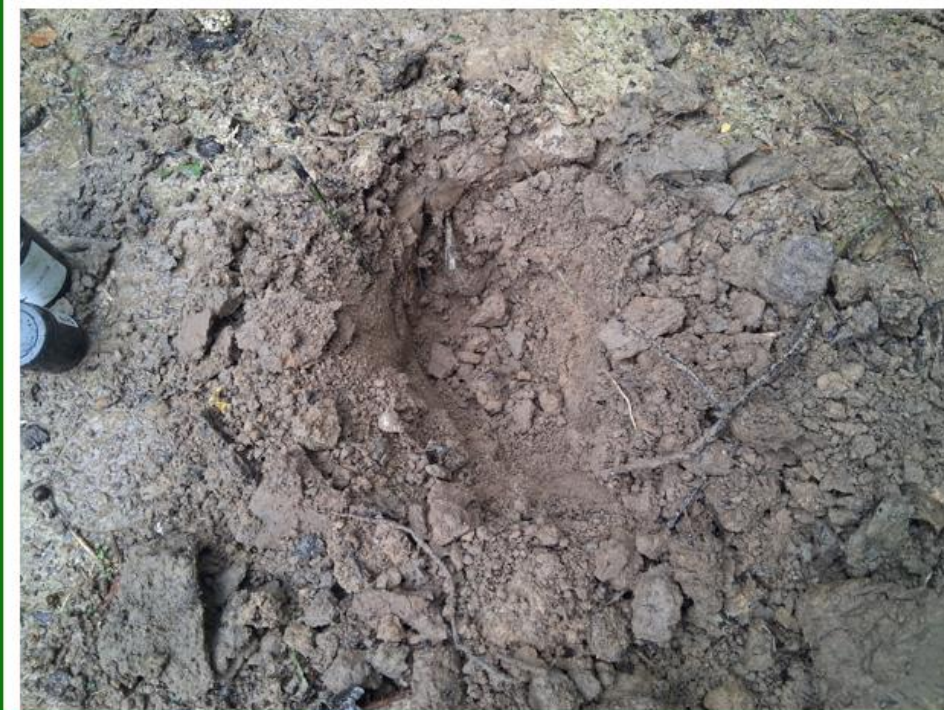
**Photo No.4: IP02 showing natural deposits**

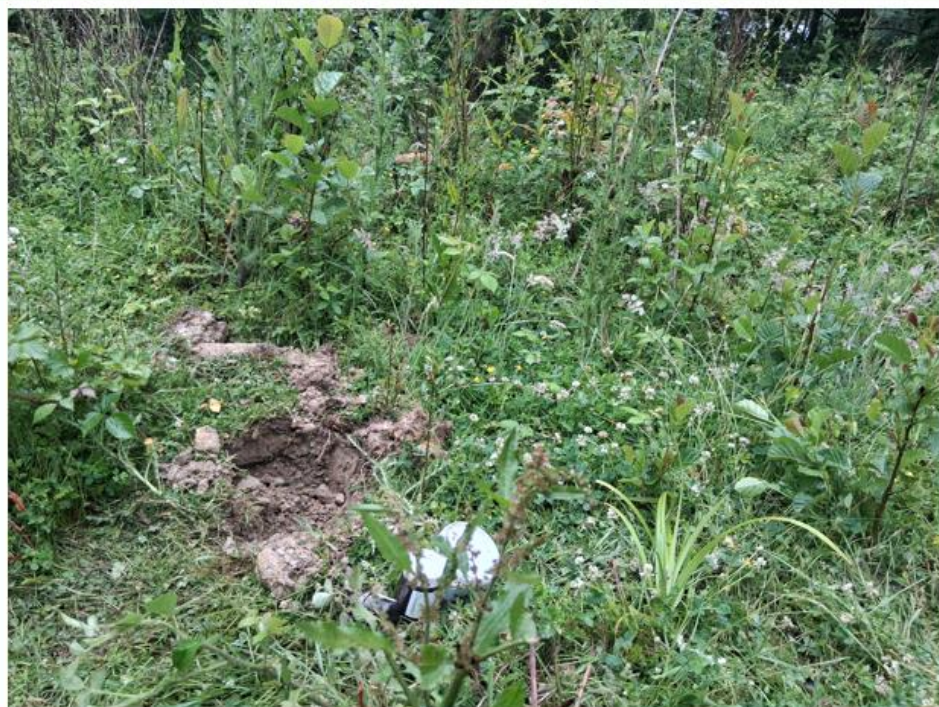
**Photo No.5: IP03 formed in the limited area of soft-landscaping in the north of site**

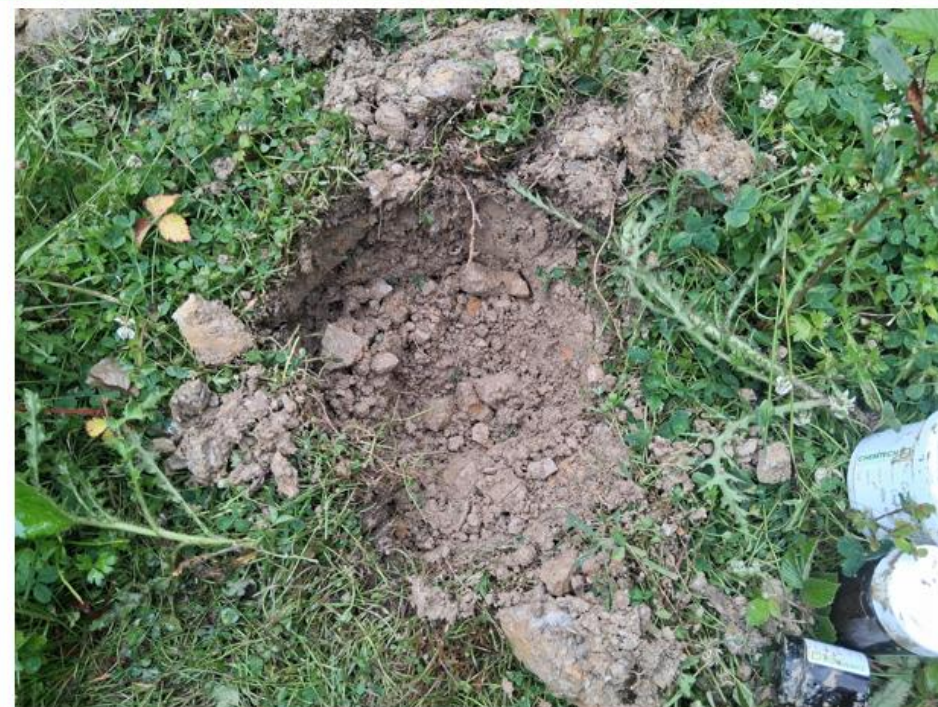
**Photo No.6: IP03 showing natural deposits**

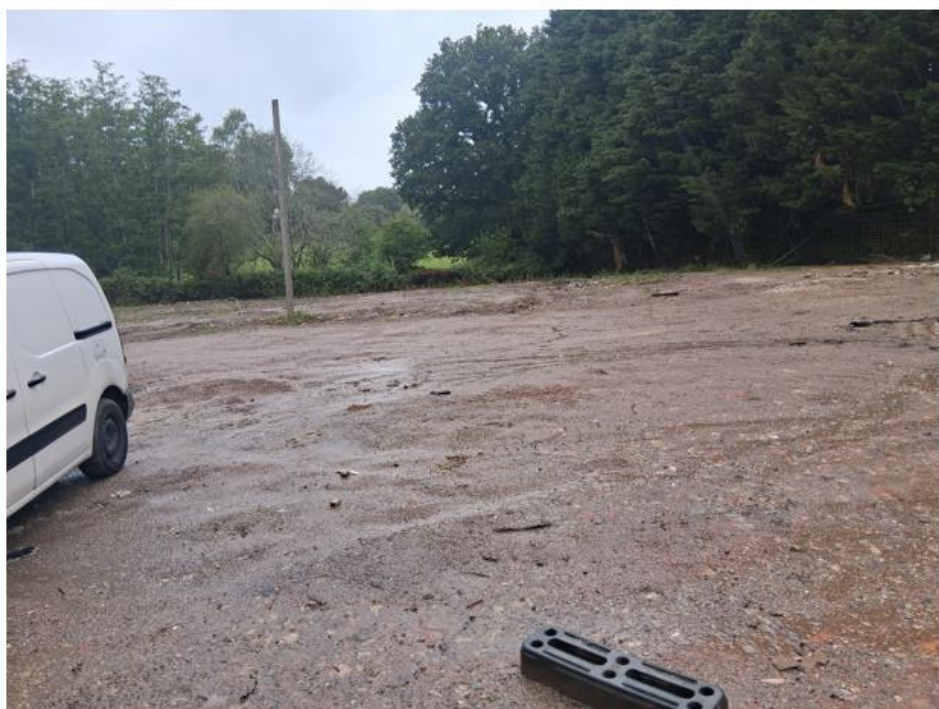
**Photo No.7: IP04 formed on the western boundary of site, adj. to the former nursery area (now removed)**

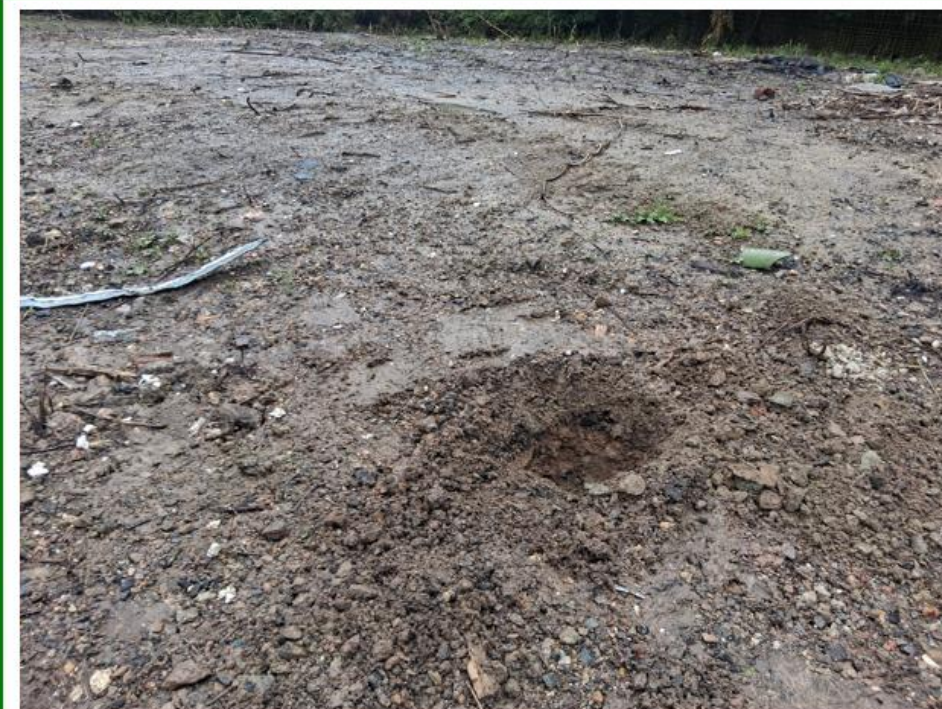
Made ground was encountered at only at IP04 and consisted of a dark brown, gravelly, silty clay within which fragments of flint, brick, wire and felt were noted.

**Photo No.8: IP04 showing made ground deposits associated with the former nursery usage adj. to site**
