# Flood Risk Assessment

Furlong House, Pitt Lane, Furlong House, Pitt Lane,  
Hurstpierpoint BN6 9QA

**Ref:** 10517

**Date:** September 2026

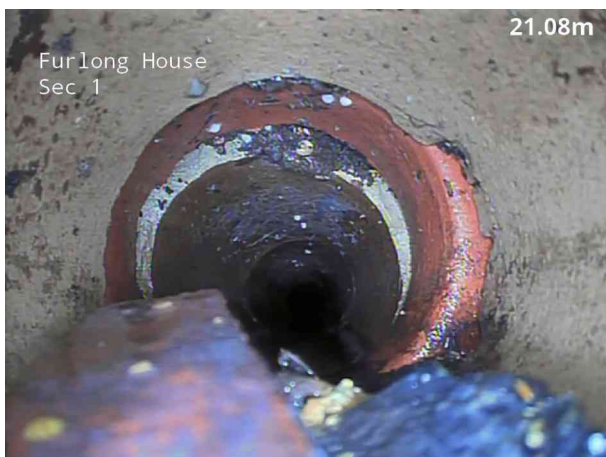
4, 00:03:19, 18.60 m  
Other obstacles, brick or masonry in invert at 5 o'clock, 5% cross-sectional area loss

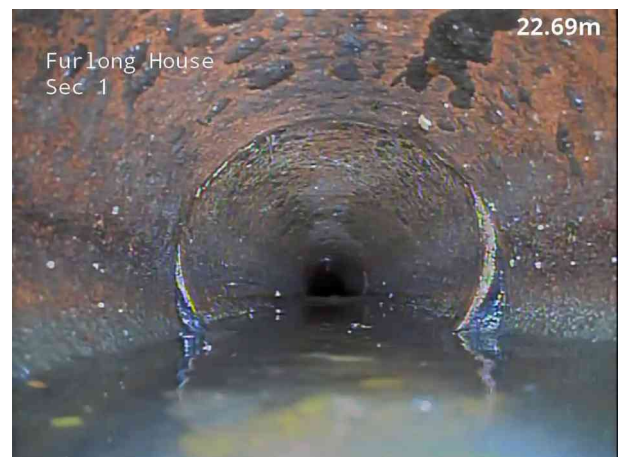
5, 00:03:57, 21.20 m  
Hole in drain or sewer from 11 o'clock to 1 o'clock

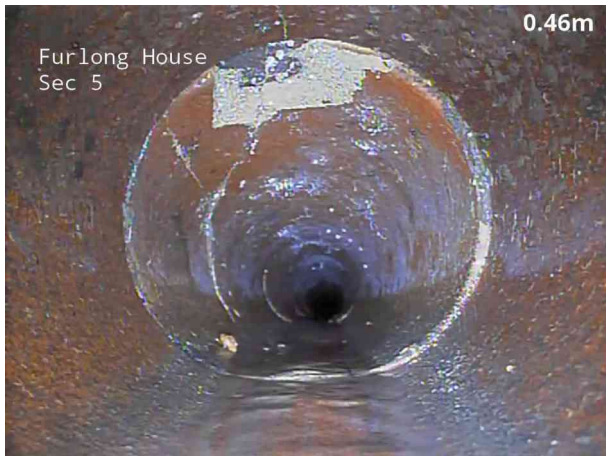
| No. | m+ | Code | Observation |
|---|---|---|---|
| 3 | 0.60 | FC | Fracture, circumferential from 7 o'clock to 12 o'clock |

2, 00:00:12, 0.60 m  
Fracture, circumferential from 7 o'clock to 12 o'clock

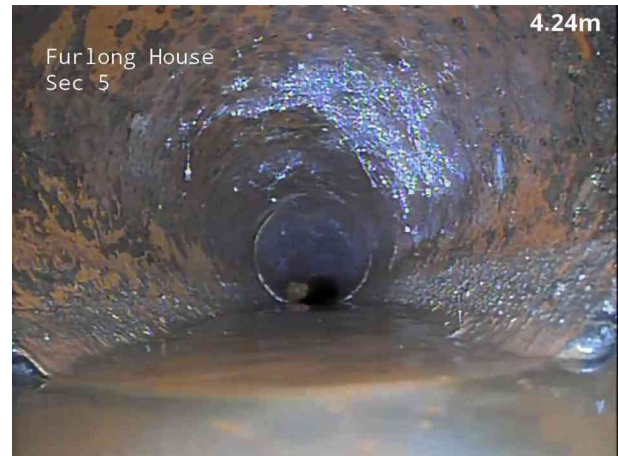
| No. | m+ | Code | Observation |
|---|---|---|---|
| 4 | 0.60 | BJ | Broken pipe at joint from 11 o'clock to 12 o'clock |

3, 00:00:12, 0.60 m  
Broken pipe at joint from 11 o'clock to 12 o'clock

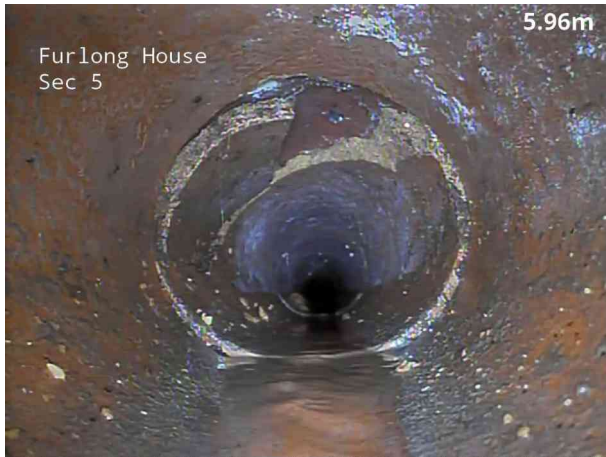
| No. | m+ | Code | Observation |
|---|---|---|---|
| 8 | 6.10 | FLJ | Fracture, longitudinal at joint at 9 o'clock |

7, 00:00:57, 6.10 m  
Fracture, longitudinal at joint at 9 o'clock

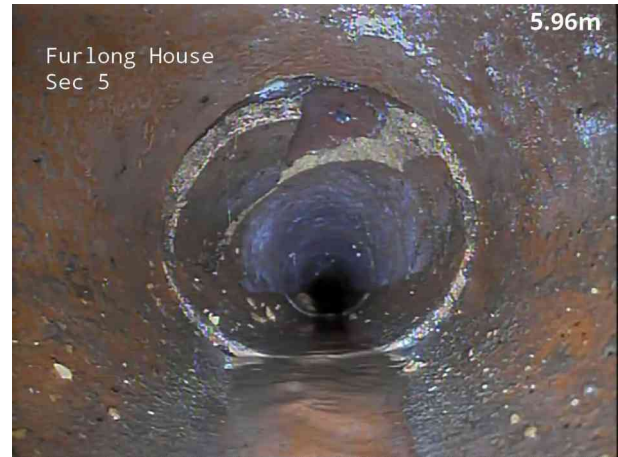
| No. | m+ | Code | Observation |
|---|---|---|---|
| 9 | 6.10 | BJ | Broken pipe at joint from 9 o'clock to 12 o'clock |

8, 00:00:57, 6.10 m  
Broken pipe at joint from 9 o'clock to 12 o'clock

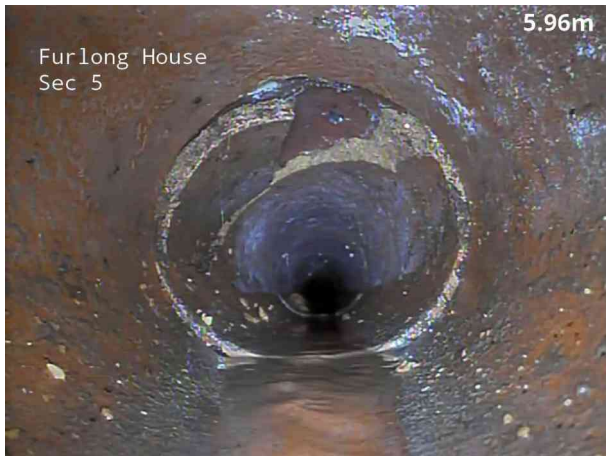
9, 00:00:57, 6.10 m  
Hole in drain or sewer from 12 o'clock to 1 o'clock

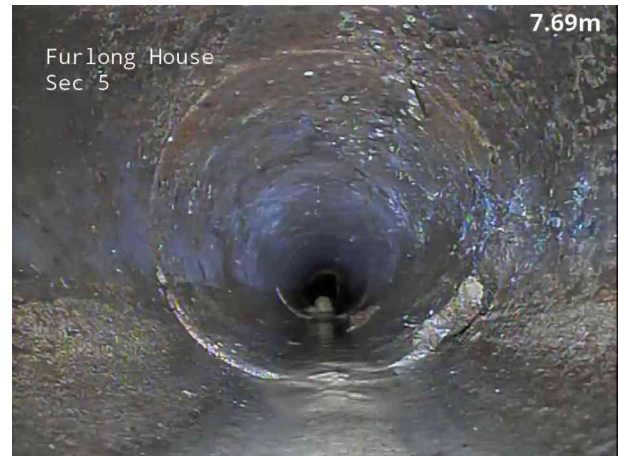
10, 00:01:21, 7.85 m  
Hole in drain or sewer from 4 o'clock to 5 o'clock

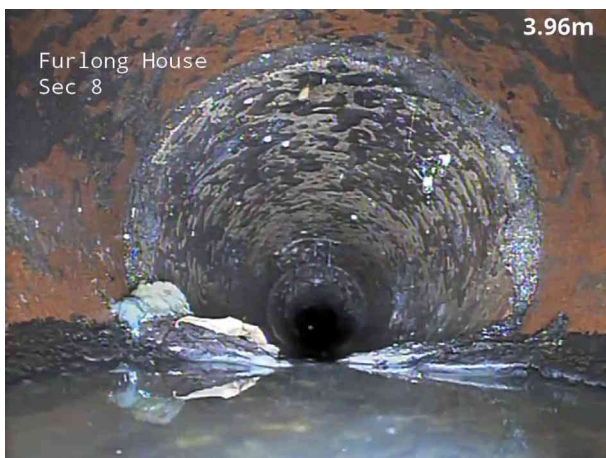
2, 00:00:41, 4.00 m  
Attached deposits, encrustation at joint from 4 o'clock to 8 o'clock, 5% cross-sectional area loss

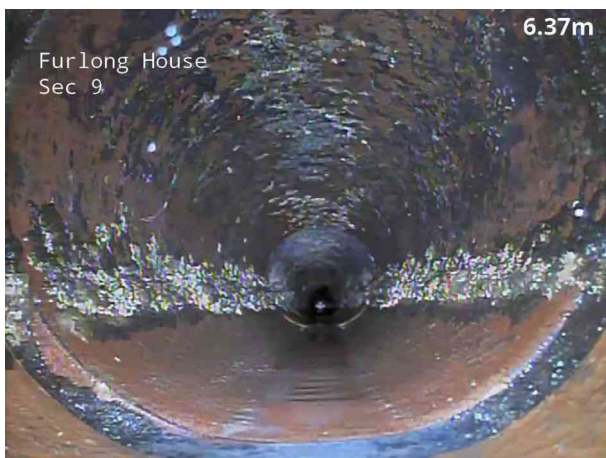
2, 00:00:50, 6.37 m  
Attached deposits, grease at 9 o'clock, 5% cross-sectional area loss, start

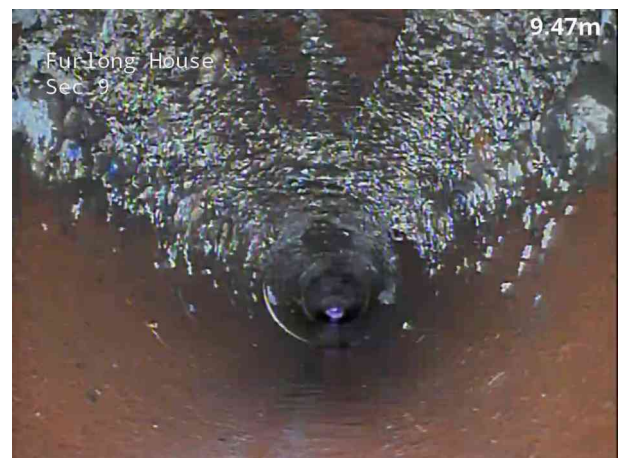
3, 00:00:50, 6.37 m  
Attached deposits, grease at 3 o'clock, 5% cross-sectional area loss, start

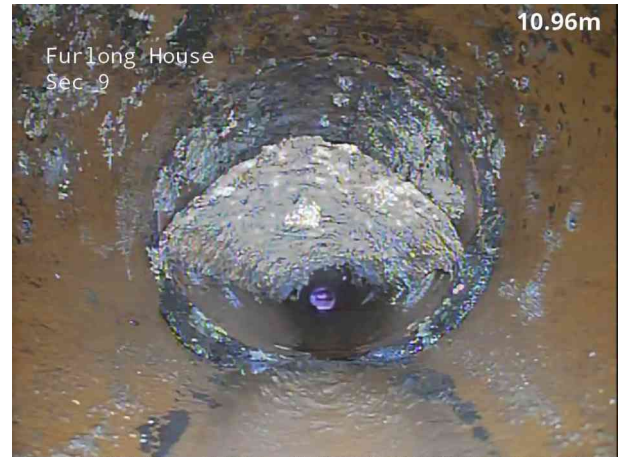
8, 00:01:30, 10.96 m  
Attached deposits, grease from 8 o'clock to 4 o'clock, 70%  
cross-sectional area loss, start

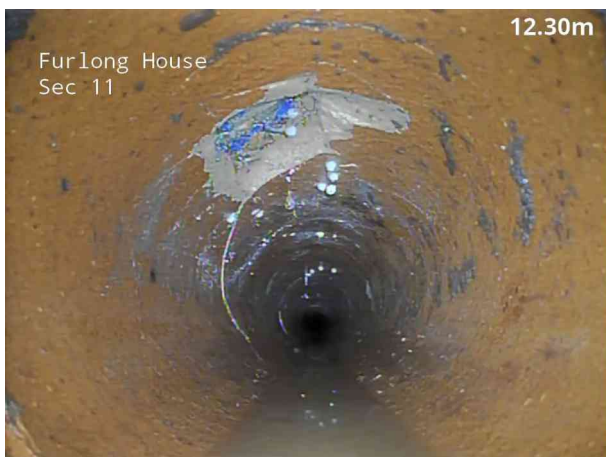
4, 00:01:31, 12.30 m  
Hole in drain or sewer at 11 o'clock
