## **Sunte House & Outbuildings: Initial Structural Assessment**

22 11 24 .V1

Prepared By: Elizabeth Cattle MEng GMICE  
Checked By: Steve Atkinson BEng CEngMIStructE

**BUILT ENGINEERS**

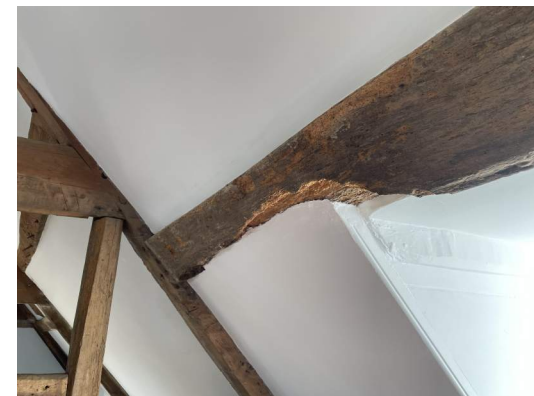
9 Areas of excessive decay and infestation particularly to sap wood sections of timbers detailed condition survey of attic timbers required by infestation specialist!

Full detailed condition survey of attic timbers required by conservation timber decay and infestation specialist.

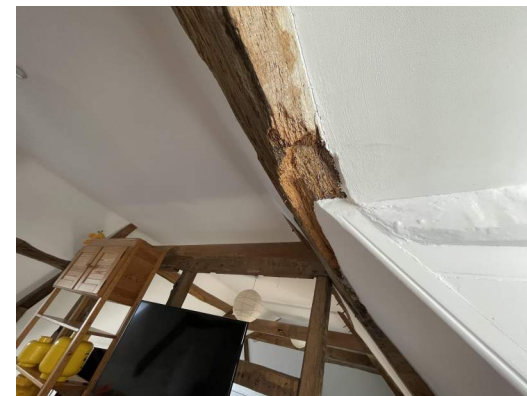
10 Underside view of severely depleted timber section

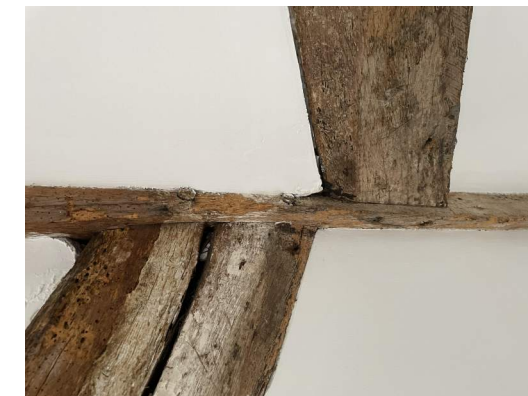
11 Illustrating varied surface conditions of timber elements, signs of natural drying splits, decay and infestation

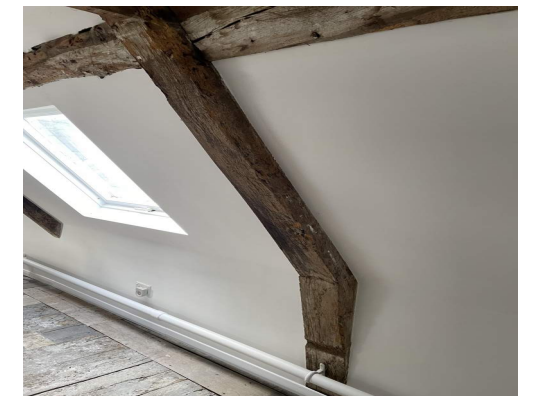
12 Full timber sections not visible, ideally during works all plaster soffits to be fully stripped to allow full inspection & treatment / repair of all primary framing

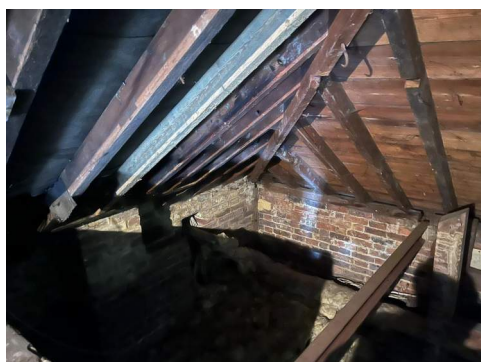
13 C19th central roof in good condition

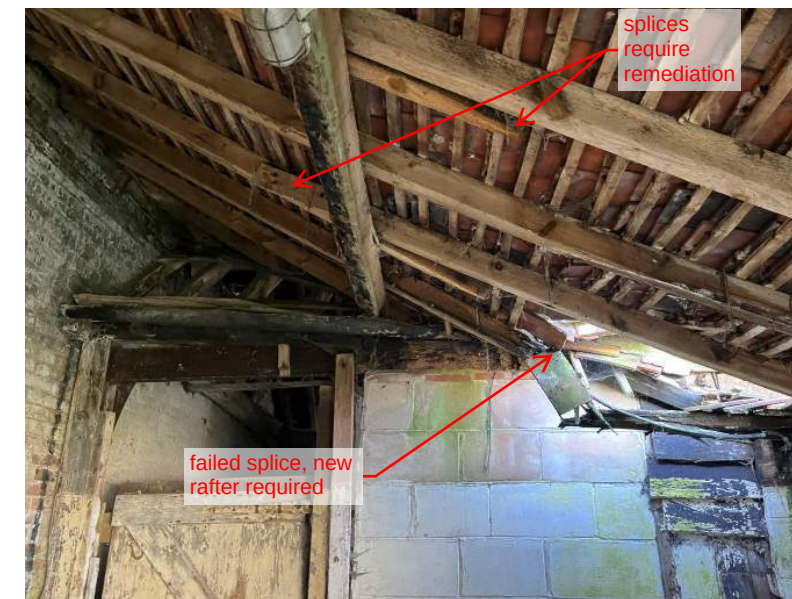
7 Wall to cow shed & collapsed roof

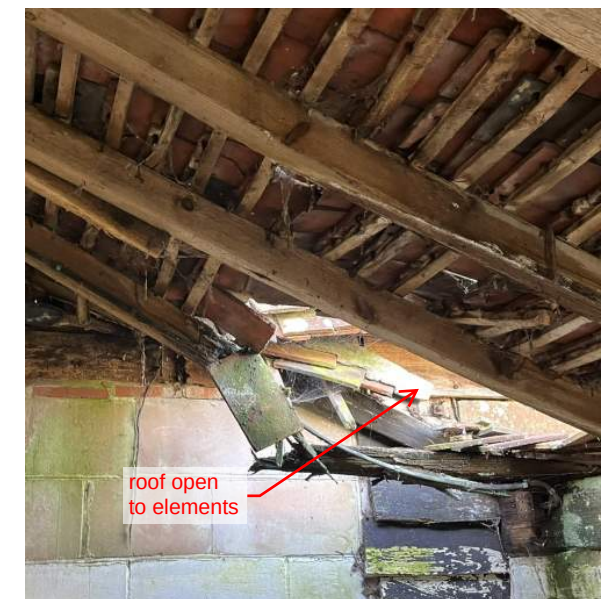
8 Failed rafter splices

due to decayed state of timber columns and failed rafter splices, existing vertical load paths are impaired, load transfers through blockwork infill in places

- hole in roof at end adjacent cow shed where rafter splice has failed, water ingress causing accelerated building decay, roof needs to be made weather proof as a matter of urgency
- infestations of damp and wood worm to be surveyed by conservation specialist
- areas of vegetation also invading roof harbouring damp and causing physical damage along rear wall, needs to be carefully cut back and managed as a matter of urgency
- widespread areas of timber element repair and replacement will be required (including where previous rafter splices have failed and rafters may be undersized for proposed loading) using sympathetic conservation repair methods maximising retained fabric where possible; using reversible repairs with mechanical fasteners with matching quality material eg solid seasoned oak and stainless steel hardware

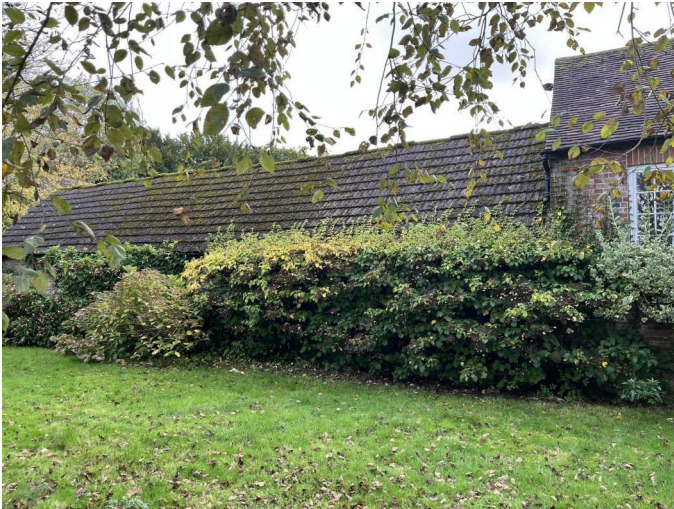
1 Northern elevation abutting stables, vegetation has grown excessively & is on brink of causing damage to roof eaves

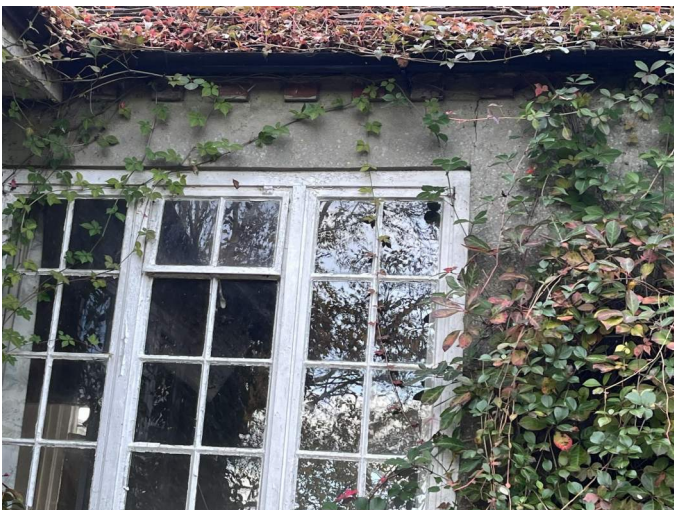
5 Cracked render

solid 225mm bricks in Flemish bond to original cottage, extension in assumed cavity stretcher bond (shown in yellow), visible cracks (**C**) in the render around the corner at the wall head on original NW corner of the cottage and above window, render to be removed to reveal masonry, local brick stitching repair may be required

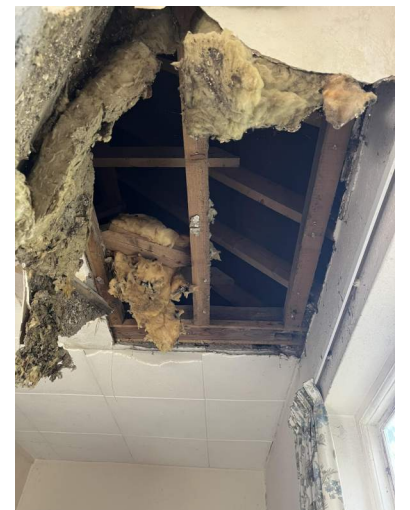
8 Damaged ceiling

- ceiling joists generally span longitudinally between ceiling beams on position of primary roof frames - an area of severely water damaged ceiling to be repaired locally

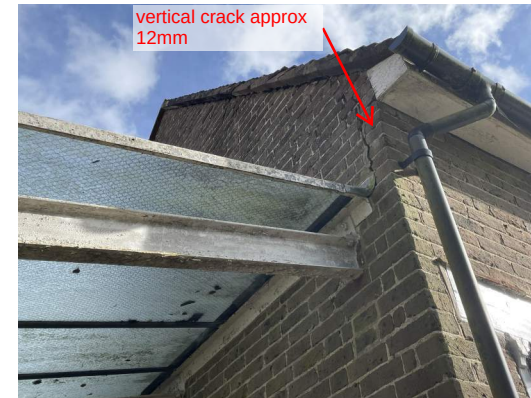
3 External cracking

localised brick stitching where cracking (C) in retained brickwork, visually sagging lintel to front elevation to be replaced with localised brick repairs above

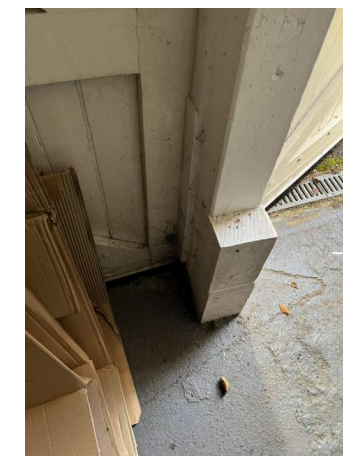
8 Repair splice to base of timber post

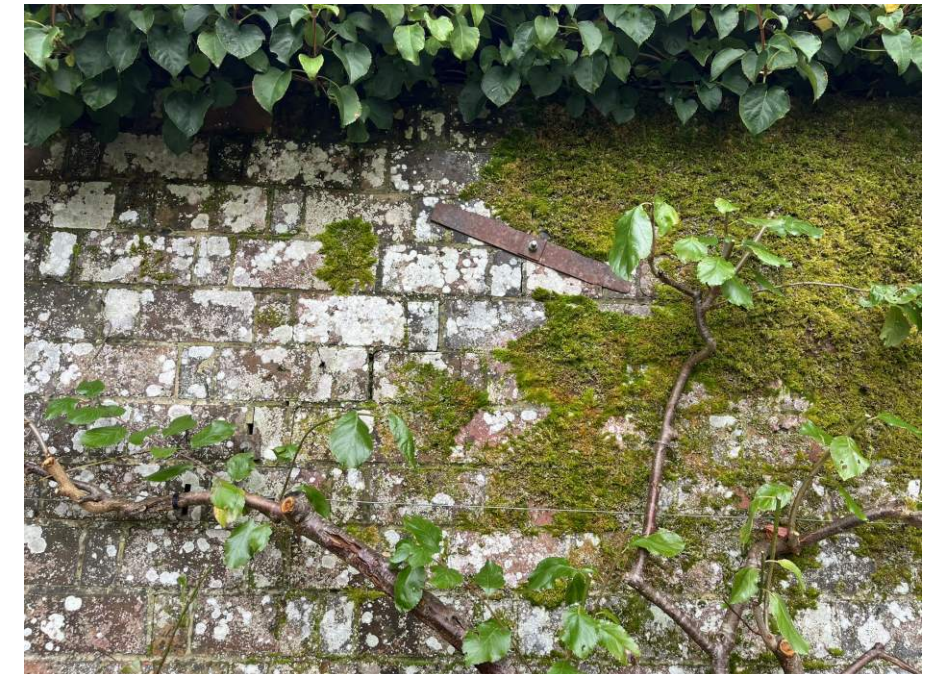
4 2no. ties / pattress plates in wall

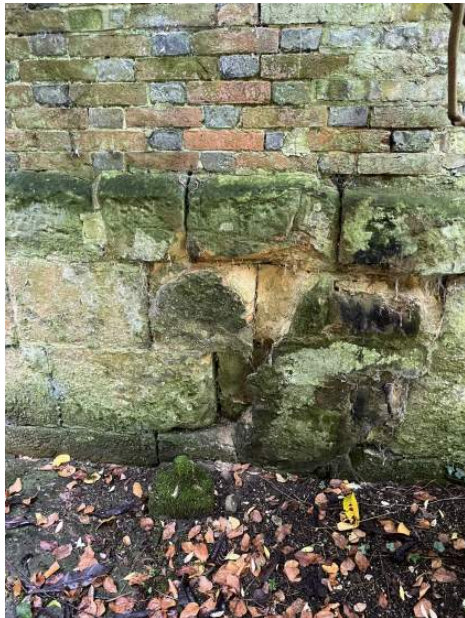
1.1 Severe defect in the stone base to the wall

- heavily spalled and weathered sandstone base to wall with severe defect as indicated
- localised brick stitching where cracking (C) in retained brickwork

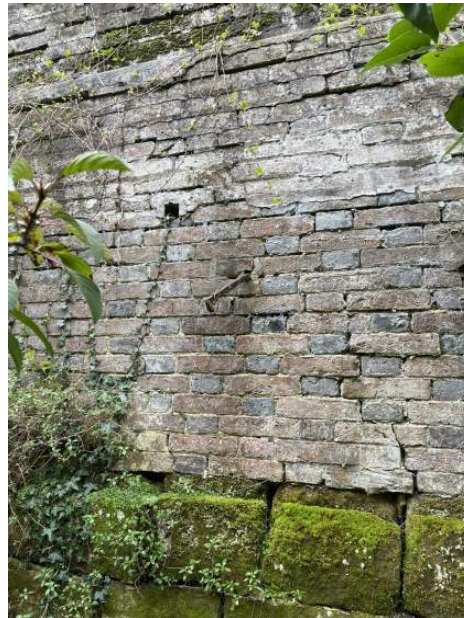
1.2 Multiple cracks in the brick wall above the stone base

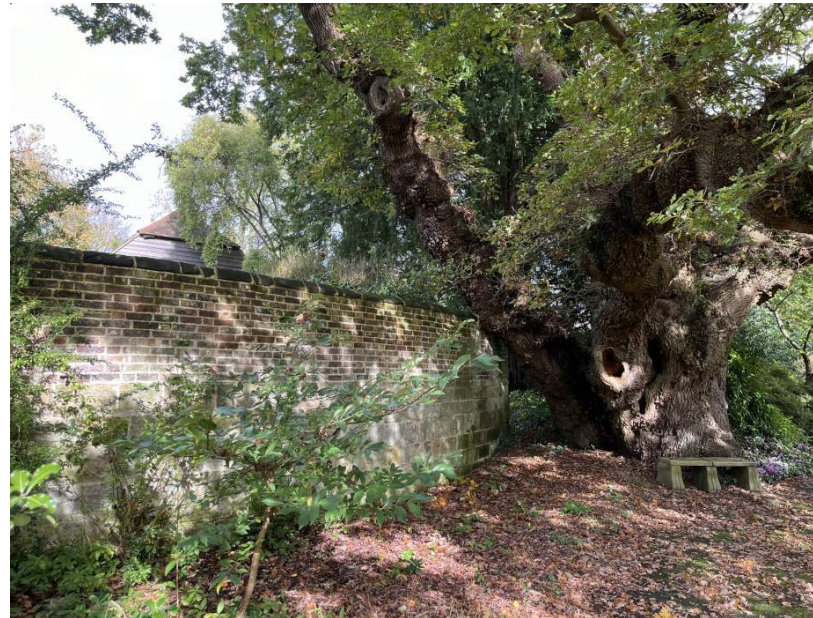
2.1 Large 3-stem oak tree at wall end, extended sandstone base

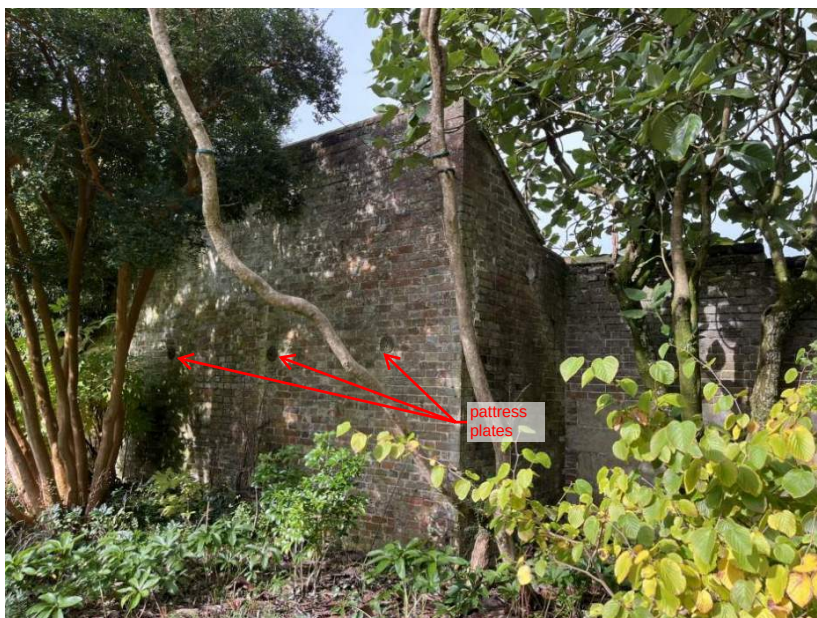
3.1 Pattress plates visible on external southern wall of Garden Store

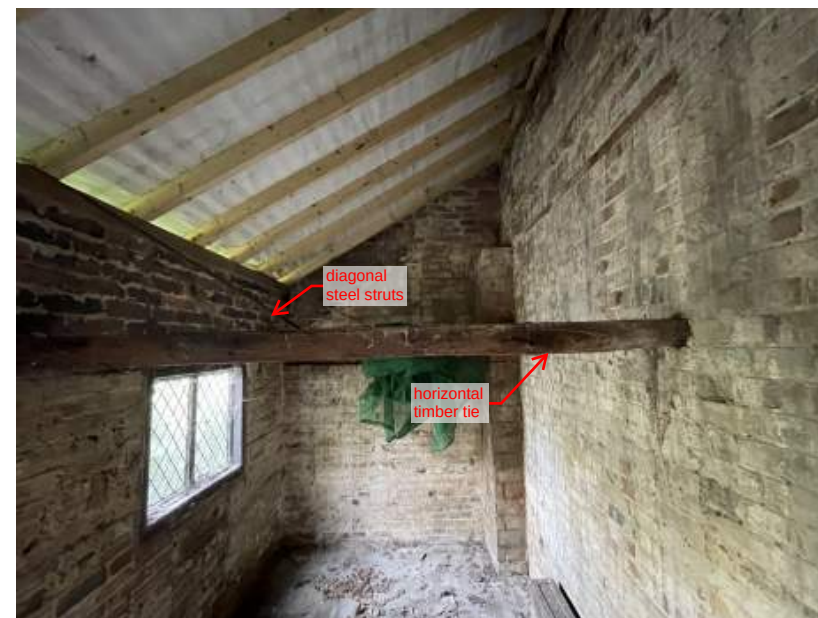
3.2 Garden store with struts from wall head to timber beams
