STAR GARAGES (BRIGHTON) LTD

NATIONAL TYRES, 60 KEYMER ROAD, HASSOCKS,
WEST SUSSEX BN6 8AR

Preliminary Contamination Risk Assessment

March 2021

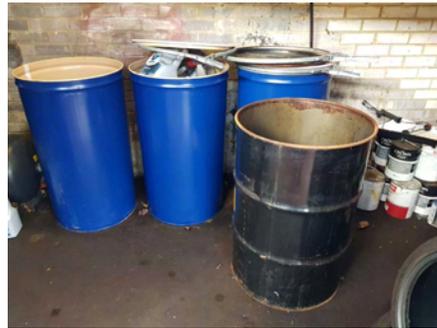
Photograph 2: Open drums used for waste storage, paint cans on floor.

- 10.1 Potentially contaminative fluids and waste items associated with the current garage will need to be removed from the site prior to demolition and ground works.

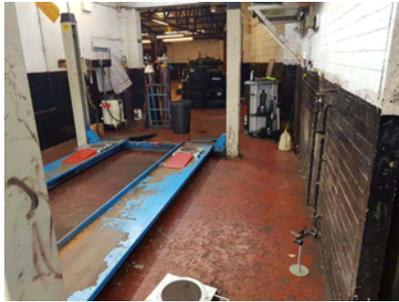
Photograph 3: Lift equipment.

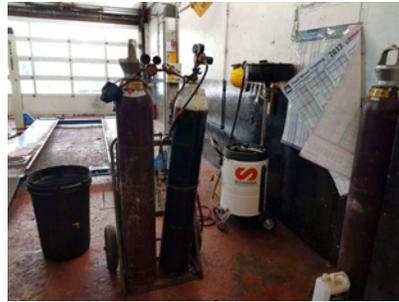
Photograph 4: Compressed oxygen, and mobile waste oil collection.

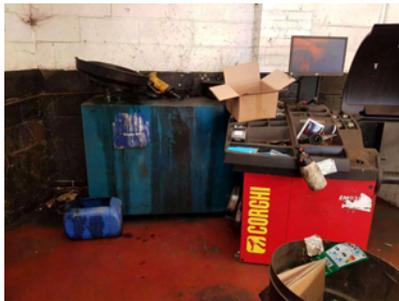
- 5.6 A waste oil tank is located within the southwest corner of the building. Waste batteries are stored on the concrete floor of the workshop prior to collection for offsite disposal. There is no dedicated waste battery storage bin.

Photograph 5: Waste oil collection tank.

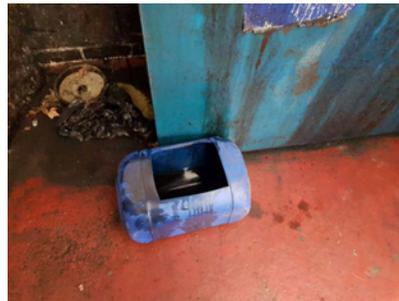
Photograph 6: Waste oil storage.

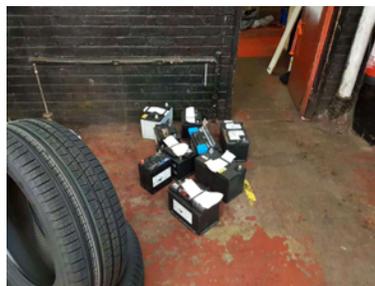
Photograph 8: Waste batteries stored directly on concrete floor

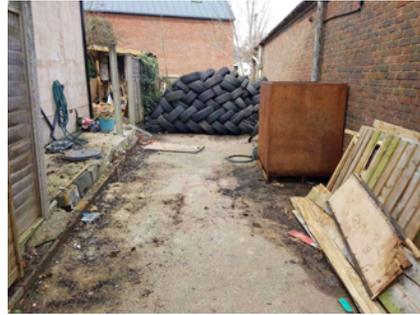
5.3 The external hard standing is used for access and parking (and a monthly local market). The strip of land along the southern boundary of the site includes a large waste tyre pile, an old tank (with a few miscellaneous items of waste including spray cans) and wooden fencing panels (taken from the boundary with the adjacent residential dwelling, which is having a rear extension). Behind the pile of tyres is some mixed waste overgrown by brambles, a waste bin and car bumper can also be identified. The remaining external areas are free from waste and any other notable features.

Photograph 10: Storage of used tyres to the rear of the building.

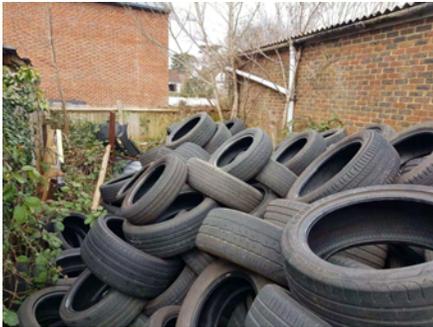
Photograph 11: Storage of used tyres to the rear of the building.

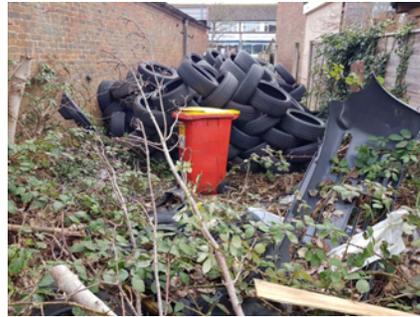
Photograph 12: Scrub adjacent to tyre storage.

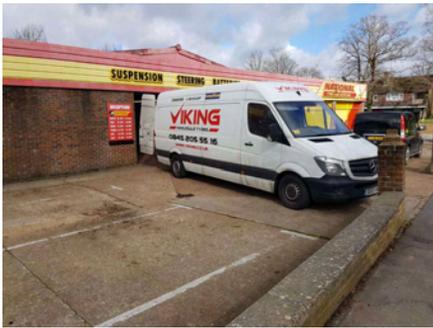
Photograph 13: Forecourt to the east.

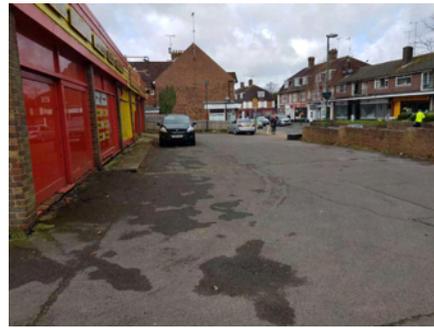
Photograph 14: Forecourt to the north.
