## Preliminary Roost Assessment

12 & 14 Eastern Road, Haywards Heath, West Sussex RH16 3NN

Proposed demolition of existing lean to stores at the rear of each house and erection of two storey rear and side extensions with recessed balconies in order to enlarge the existing 4x flats. Loft conversions and roof extensions that include front dormers and rooflights. New dropped kerb and parking area to the front for 5 cars.

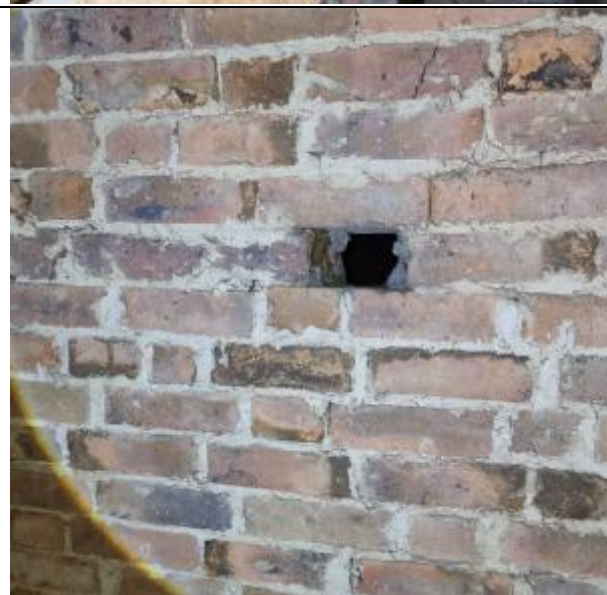
Missing bricks in dividing wall

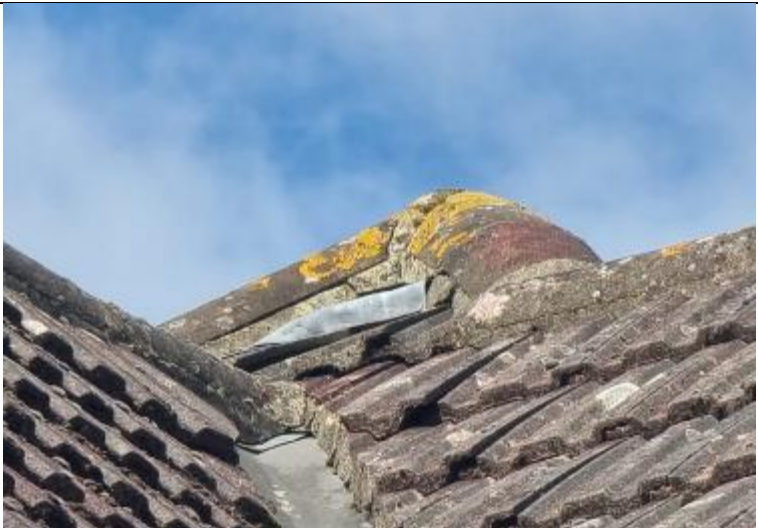
The roof is covered with interlocking concrete tiles which are in good condition and offer no roosting opportunities for crevice-dwelling species. The only exception to this is an area of the central roof where the cross-ridges meet. There is an area of raised tiles and flashing approximately four feet long under the apex which provides roosting opportunity for crevice-dwelling species.

| <p>Area of raised tiles/flashing at apex where bat access is possible to the space under tiles and between tiles and lining</p> | | |

Two dusk emergence surveys will be required to identify and characterise any roosts within this building. These surveys will be conducted in the optimal bat season (Mid-May to August) with a minimum of three weeks between them. If the two visits indicate that bats are roosting on site, or if a higher level of activity than expected is recorded, a third survey will be required.

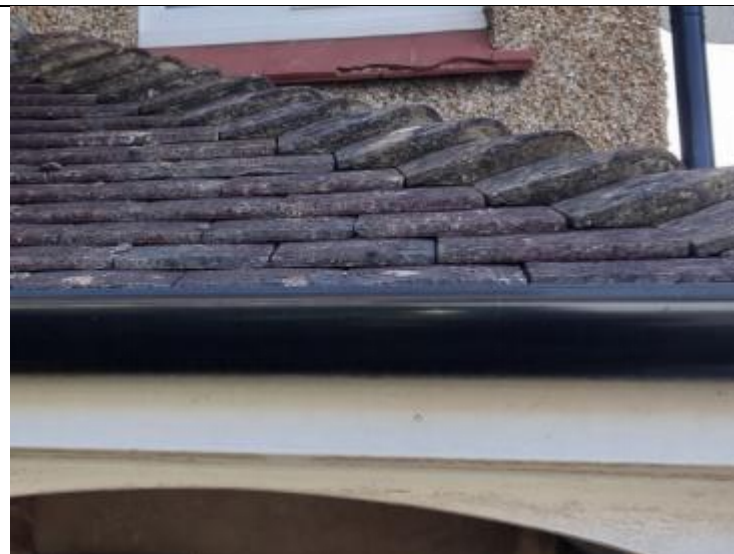
In addition, there is a porch on the north-western elevation covered in clay tiles, and suitable gaps under these tiles for crevice-dwelling species.

Porch tiles with gaps suitable for bat access

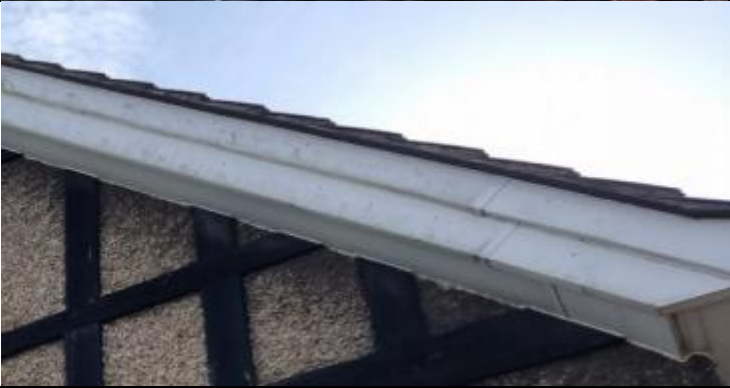
The mortar in the roof verges is in excellent condition with no gaps that could enable bat-access.

| <p>Sealed verges</p> | |

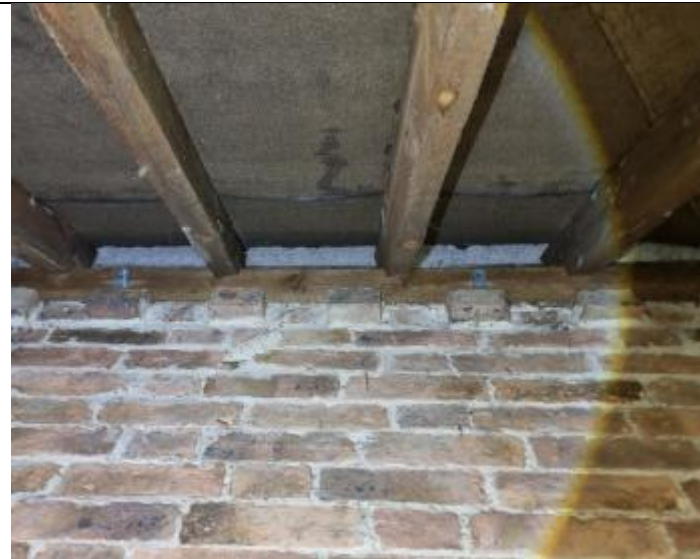
Sealed eaves of dividing wall

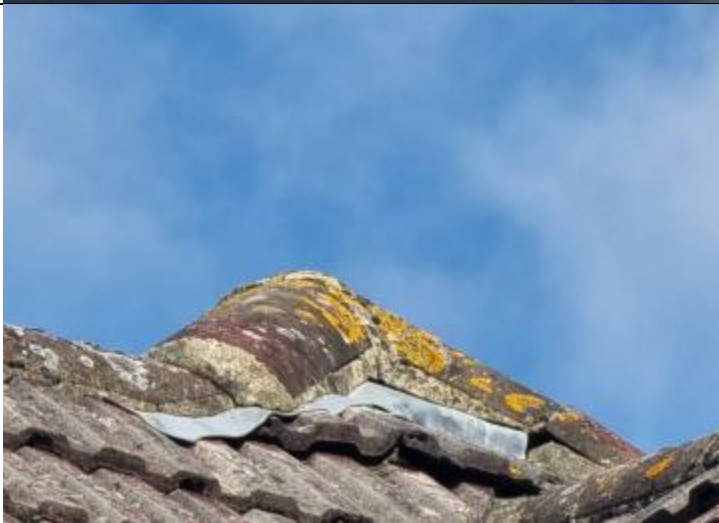
There is an area of the central roof where the cross-ridges meet with an area of raised tiles and flashing approximately four feet long under the apex which provides roosting opportunity for crevice-dwelling species. There is also an area of damaged interlocking tiles on the SE sub-roof which has created gaps suitable for use by crevice-dwelling bats.

| <p>Area of raised tiles/flashing at apex where bats could access under tiles and between tiles and felt</p> | |

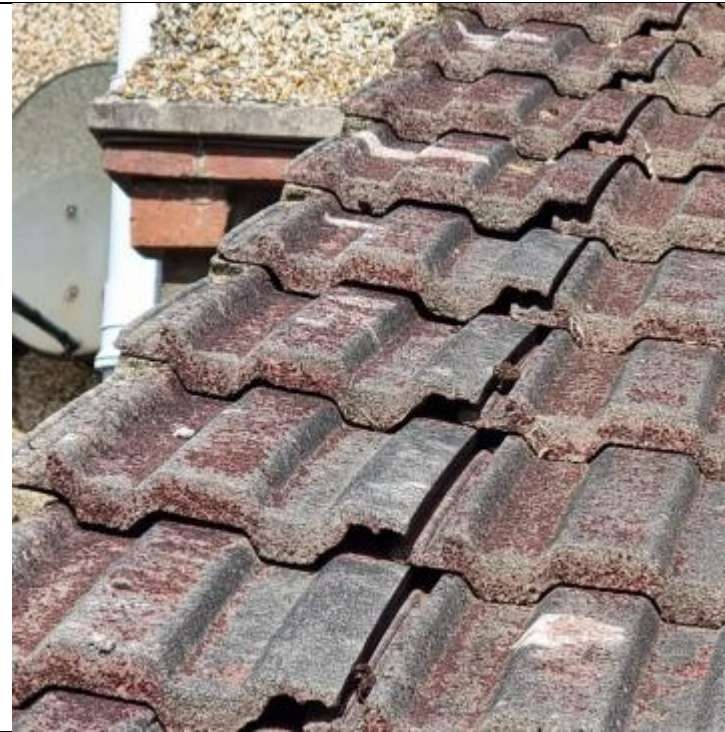
Damaged tiles on sub-roof where bats could access under tiles and between tiles and felt

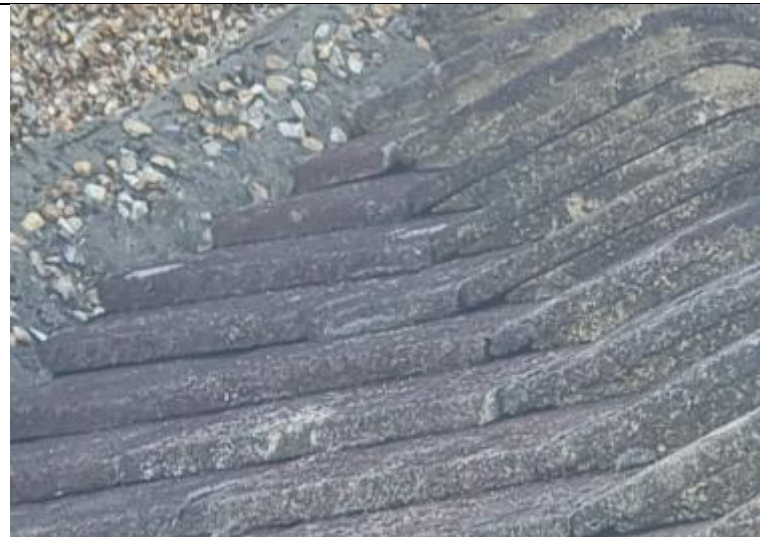
In addition, there is a porch on the north-western elevation covered in clay tiles, and suitable gaps under these tiles for crevice-dwelling species.

Porch tiles with gaps where bats could access under tiles and between tiles and felt

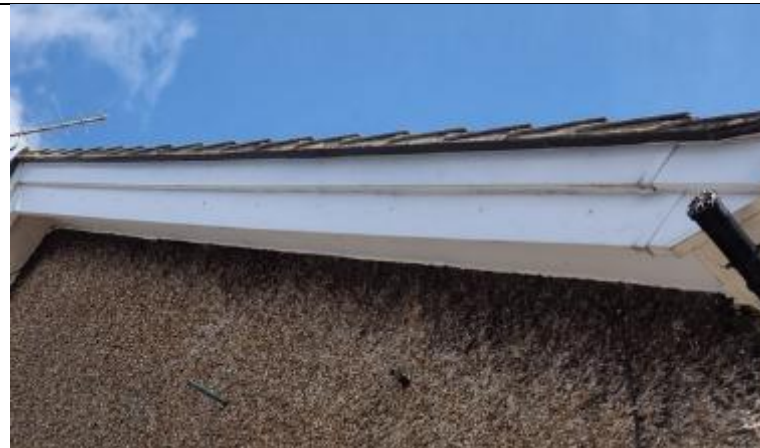
The mortar in the roof verges is in excellent condition with no gaps that could enable bat-access.

Verges

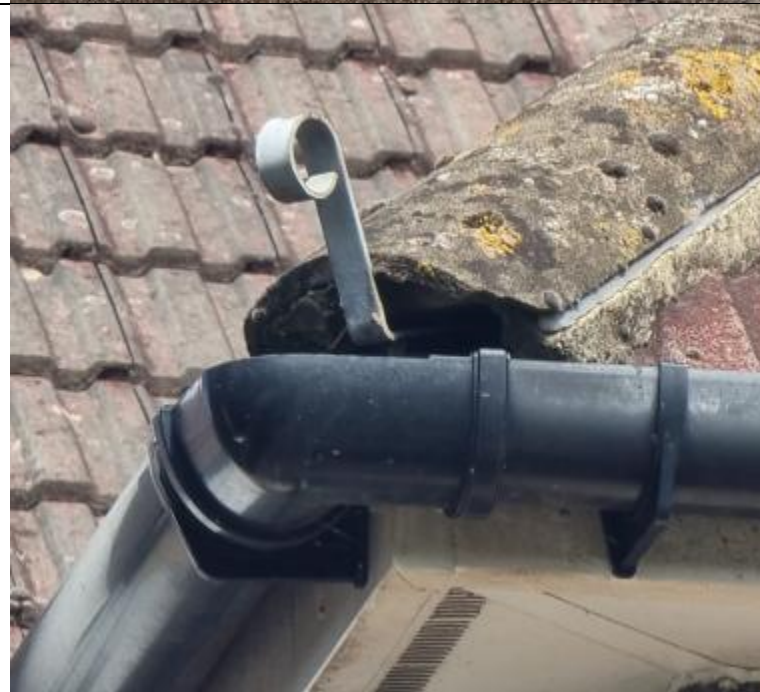
There is a single area at the bottom of the roof hip on the south-eastern corner of the main roof where some mortar is missing, but this is being used by nesting blue-tits, which were seen coming and going from the hole during the survey.

Gap in mortar SE corner being used by blue tits

| Nesting Birds | |
|---|---|
| <i>Summary of Survey Findings</i> | Nesting blue-tits were observed using a hole in the mortar at the south-east hip corner. |

| Nesting Birds | |
|---|---|
| <i>Recommendations</i> | Any works to B1 should be undertaken outside the period 1st March to 31st August. If this time period cannot be avoided, a close inspection of the building should be undertaken immediately prior to the start of works by a qualified ecologist. All active nests will need to be retained with a 5m buffer until the young have fledged. |
