## Arboricultural Report

Date: 18/03/2025

Site Address: 14 Lucastes Road, Haywards Heath

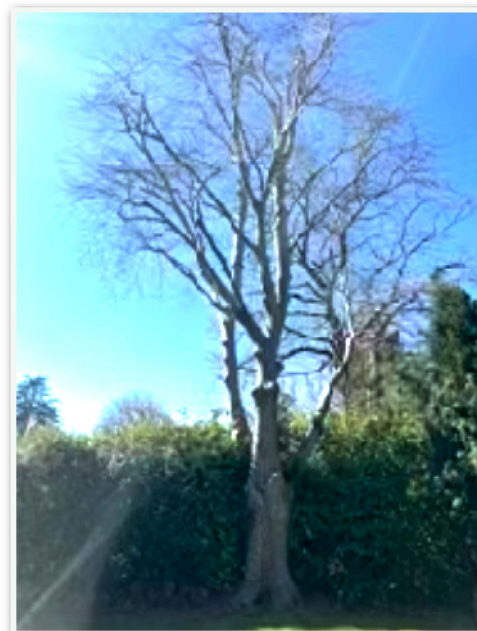
An open cavity is present on the North of stem at 0.5m. I was able to insert probe to full extent here 750mm. This also extends upwards 500mm. Cavity appears to extend the full width of the stem North-South. Use of a sounding mallet reveals noticeable tonal differences in both stem and several major buttress roots.

*Cavity in North of stem*

**I therefore recommend that the tree is felled within 6 months.**

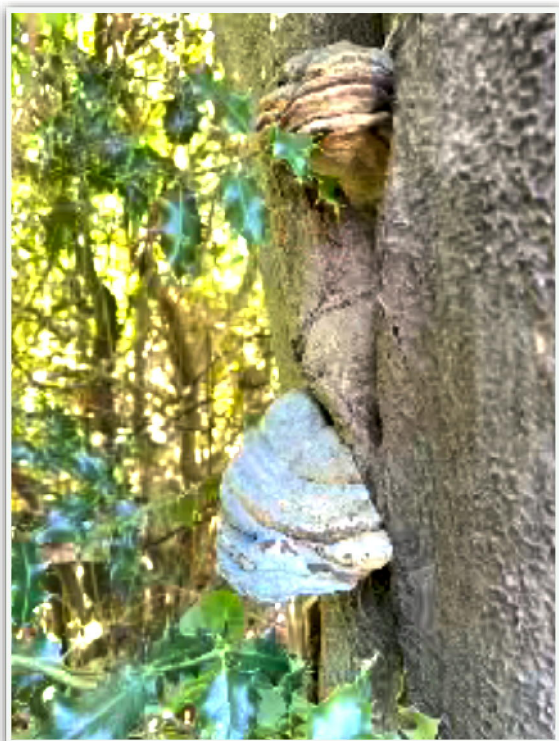
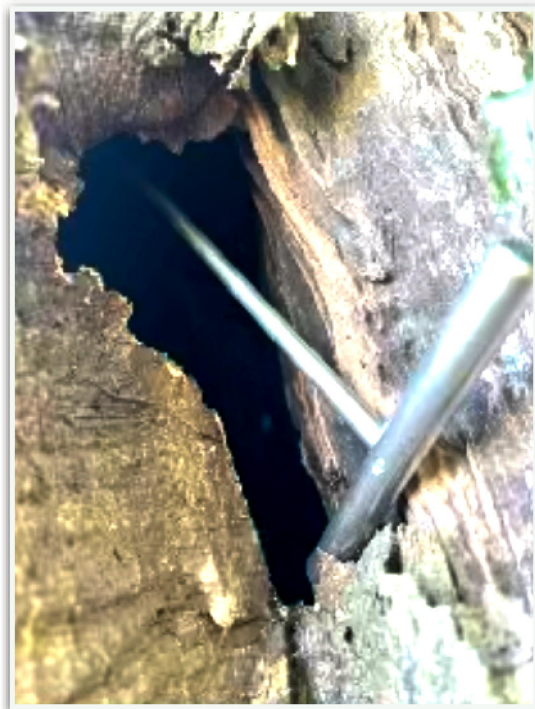
There are numerous *Ganoderma* spp. fungal fruiting bodies around entirety of the stem (pictured). Notably in the large union joining the two major stems of the tree (assumably the initial reason for the bracing work).

*Ganoderma ssp. fungal fruiting bodies.*

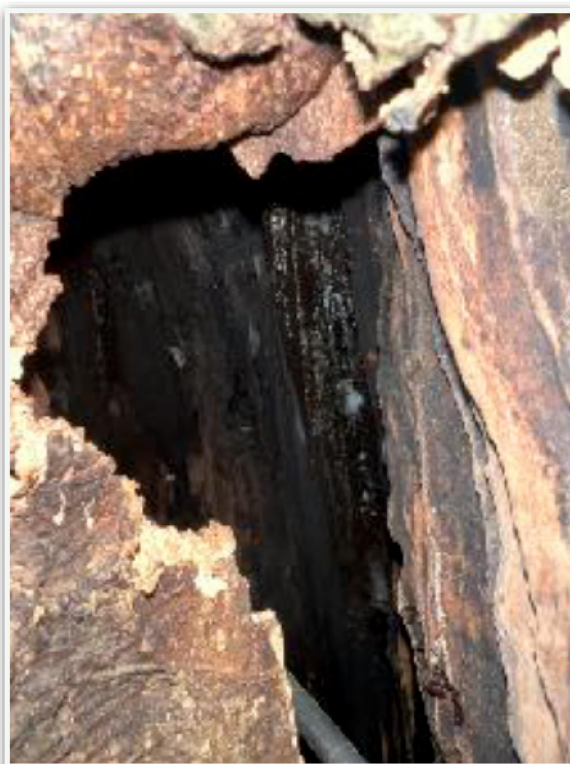
*Image showing open cavity.*

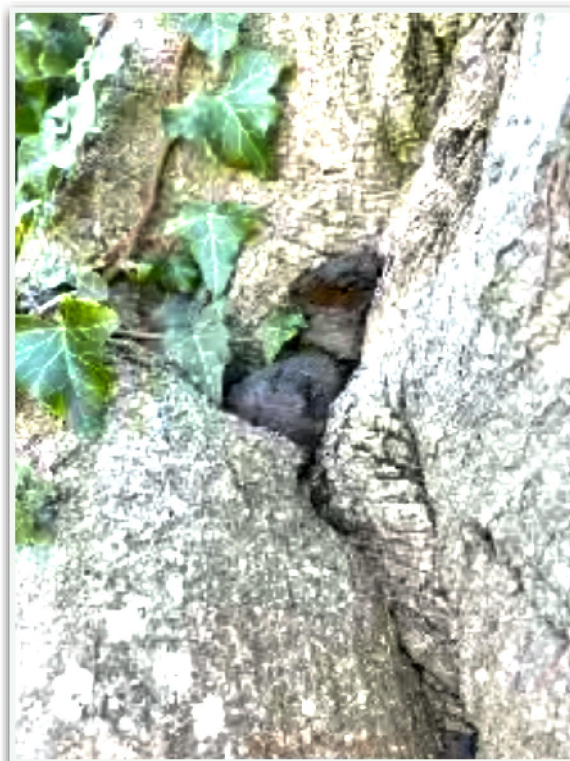
There are also some areas of *Kretschmeria deusta* present at base/rootplate and on the stem at 2.5m, a fungi particularly associated with failure in Beech trees.

*Kretschmeria fungi at 2.5m*
