Project No.	GE23384
Name	Land south of Bolney Road, Ansty
Client	Devine Homes
Location	Ansty
Date	22/09/2025, 09:44
Version	1

Site Overview Photographs 1 record

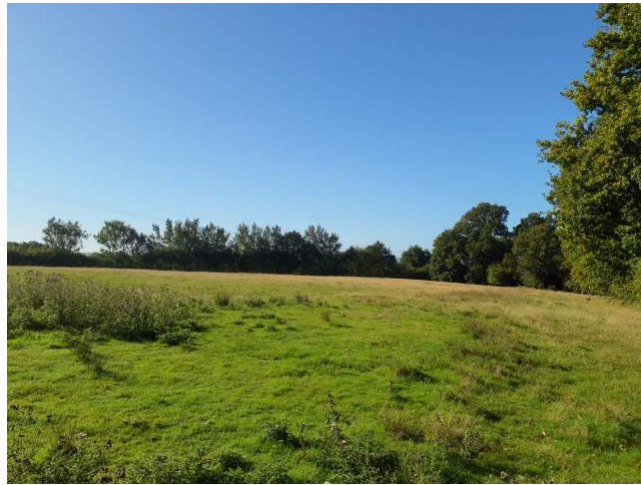
View from North facing South

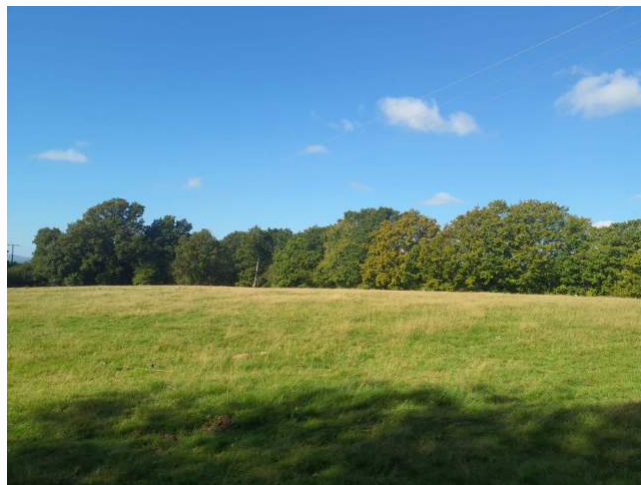
View from East facing West

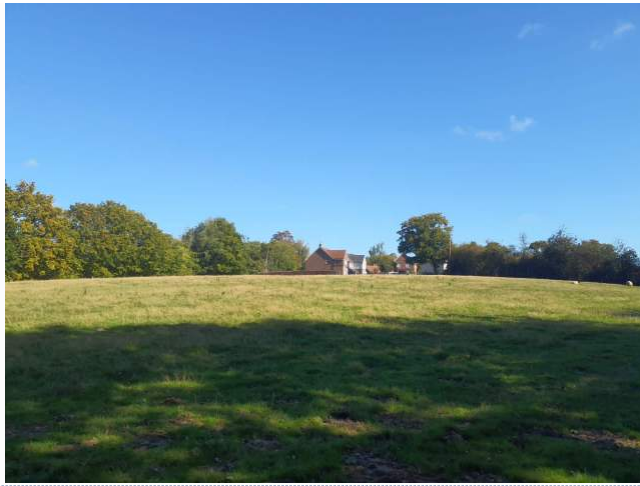
View from South facing North

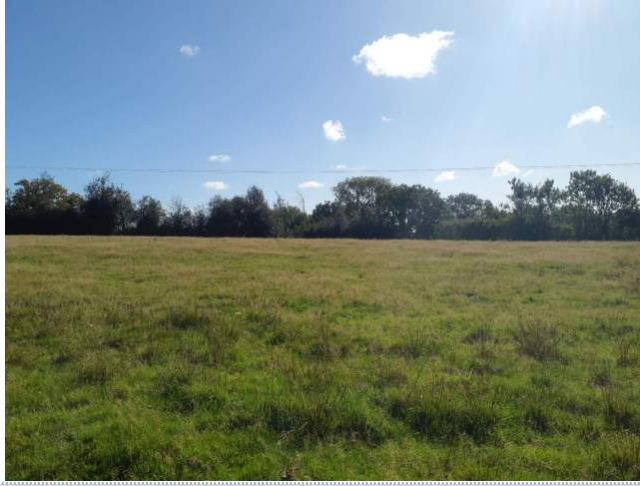
View from West facing East

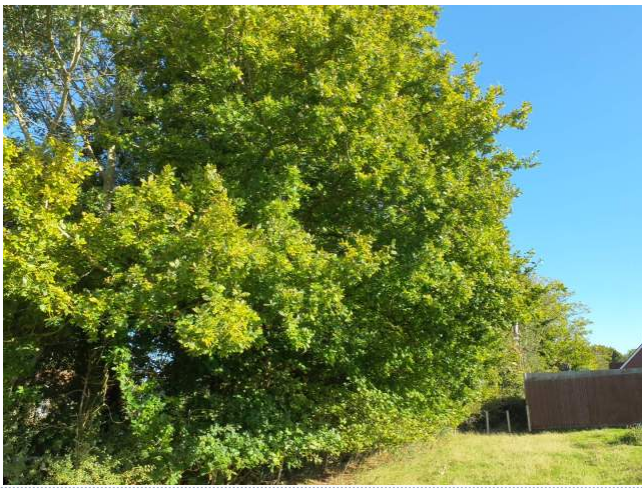
Description	Trees along northwest border looking north past access.
Photo

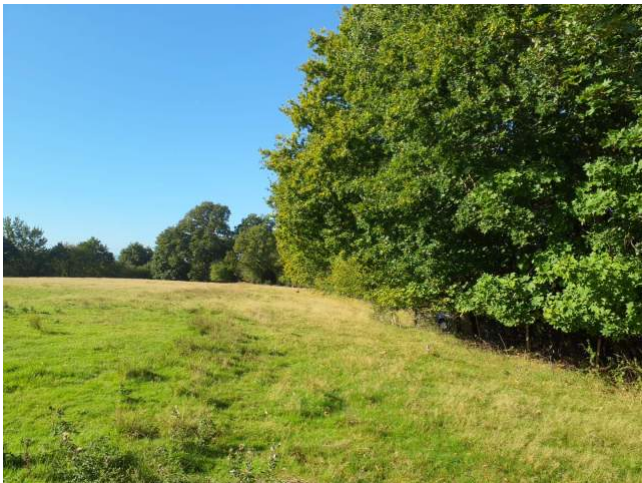
Description Trees along NW boundary looking SW. Trees are semi mature c.6.5 to 10m in height.

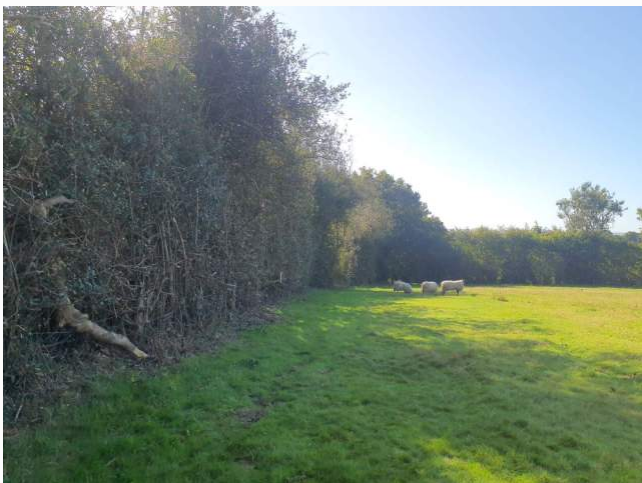
Description East boundary looking south. Hedgerows and semi mature trees.

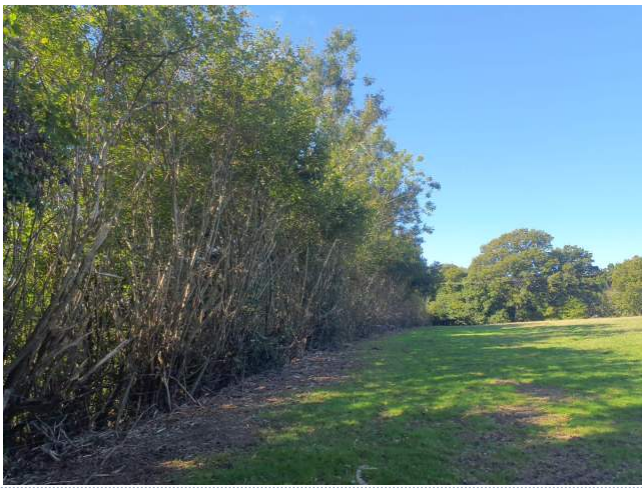
Description Southern boundary trees semi mature c.6 to 8 m.

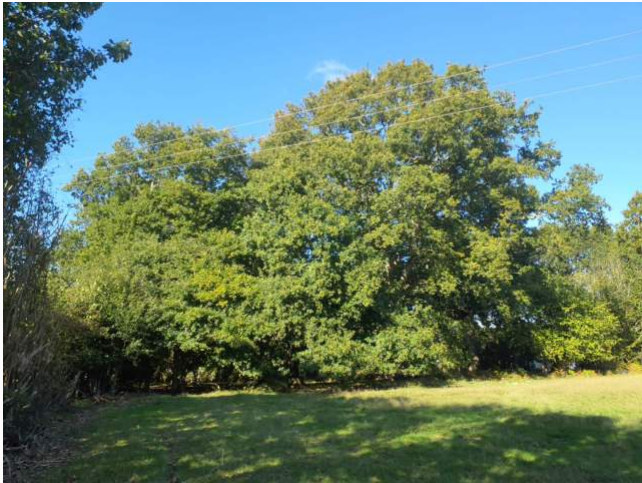
Description Wooded area southwest corner of site trees c.10-15m.

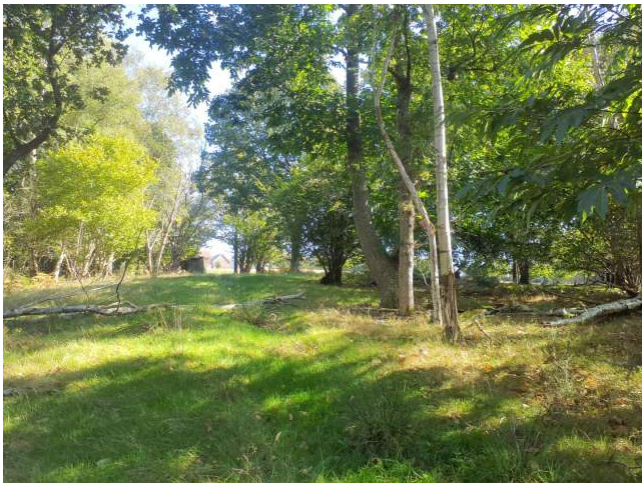
Description Woodland area where felled trees are present.

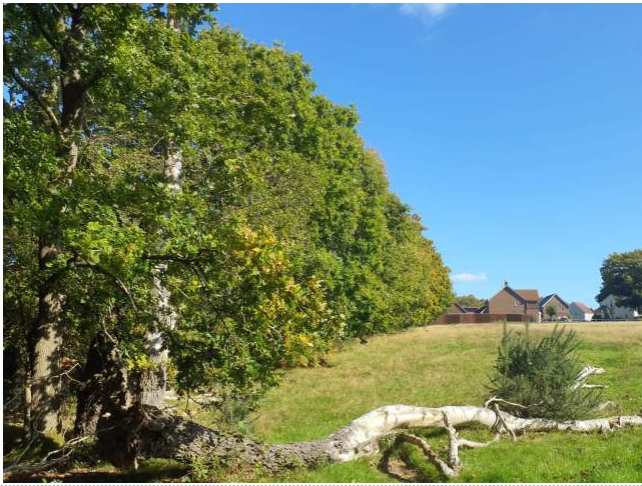
Description north west boundary mature trees c.10m.

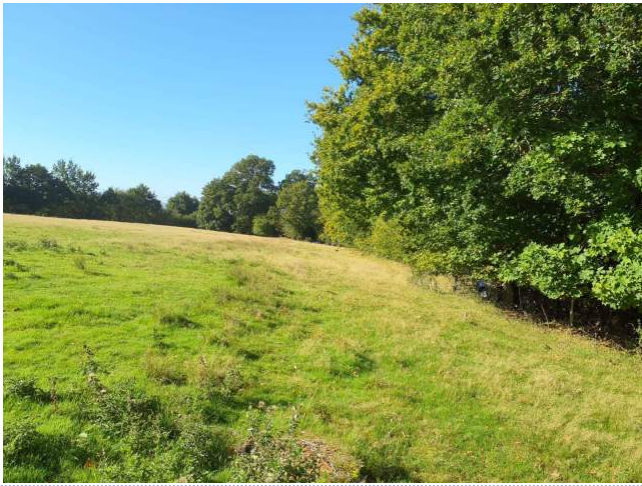
Soft Landscaping	1
Description	Grassland from north facing SE.
Photo(s)

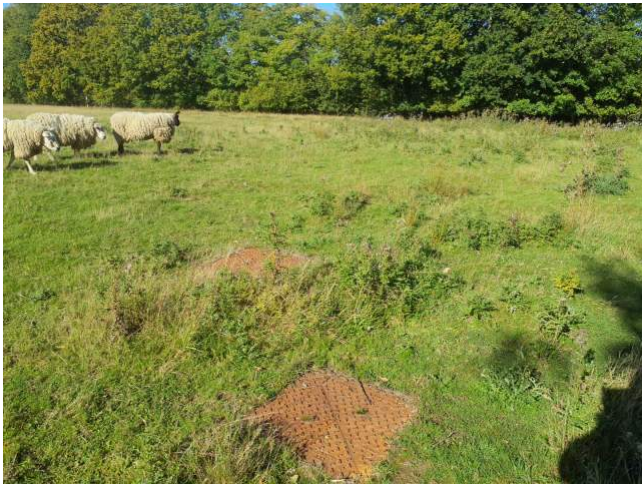
2

Buried service covers in line with previous along NE. Boundary.

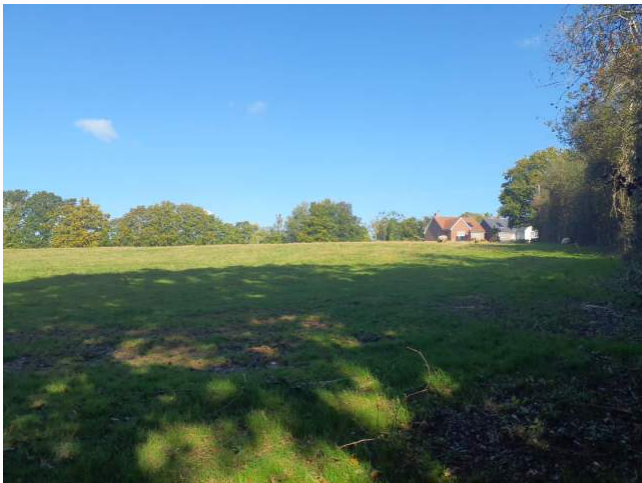
3

Southeast corner looking north.

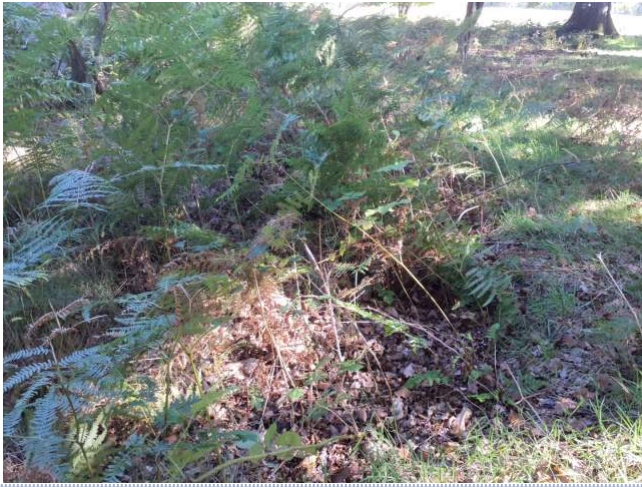
4

Slight surface depression in wooded area covered by foliage.

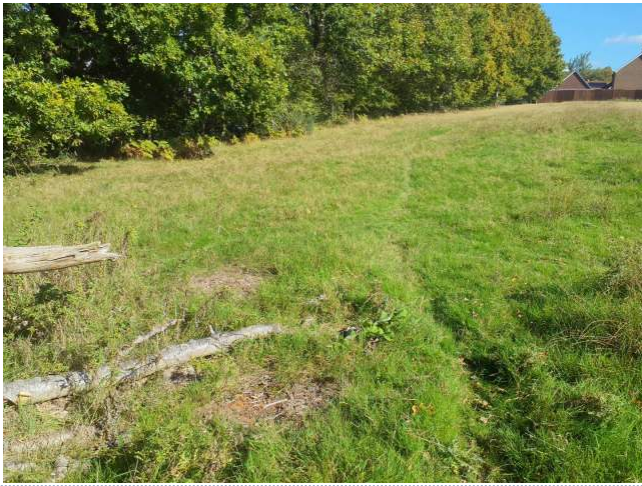
Buried Services	1
Description	Buried service covers in north corner of site..
Photo(s)	A photograph of a grassy field with a brown, textured mat or cover in the foreground. The field is green and appears to be a natural area. In the background, there is a line of trees under a clear blue sky.
Buried Services	2
Description	Buried service north western border in line with other buried services.
Photo(s)

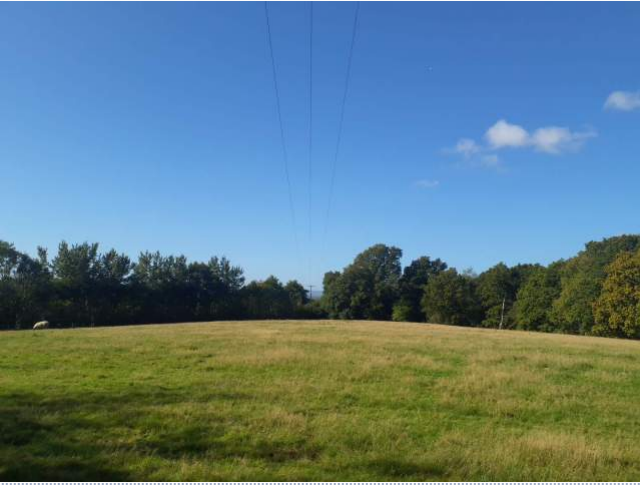
OverheadServices	3
Description	Overhead services at NE , East corner running south.
Photo(s)

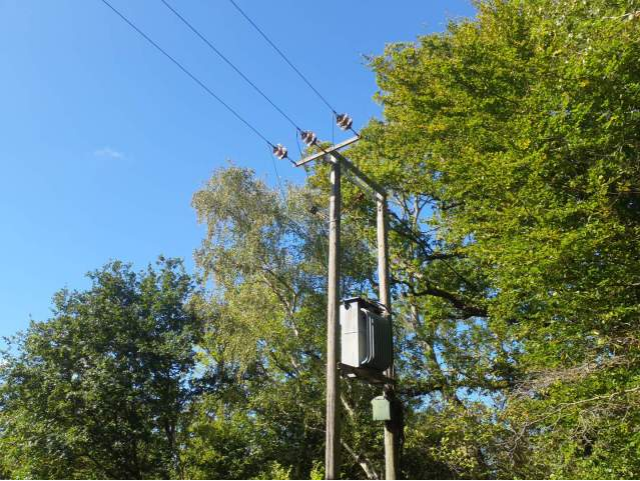
OverheadServices	4
Description	Overhead service southwest corner running along southern boundary appears to connect to other overhead service.
Photo(s)

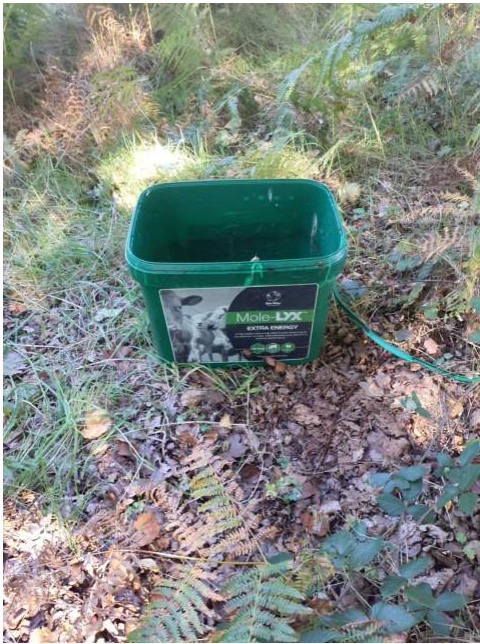
Fly Tipping	1
Description	Bucket in wooded area. Labelled as mole-lyx.
Photo(s)

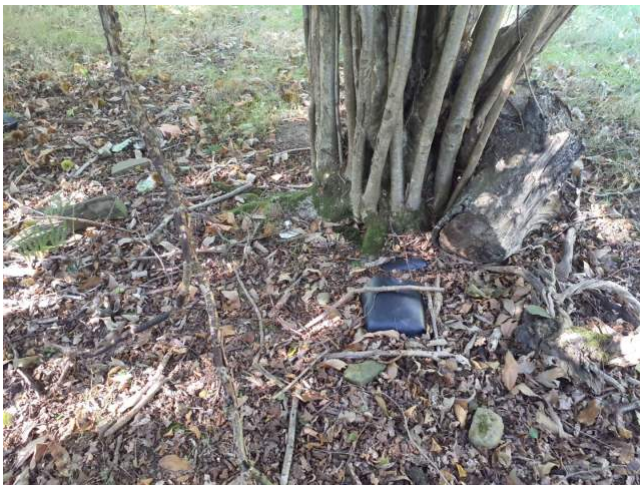
2

Plastic at base of tree.

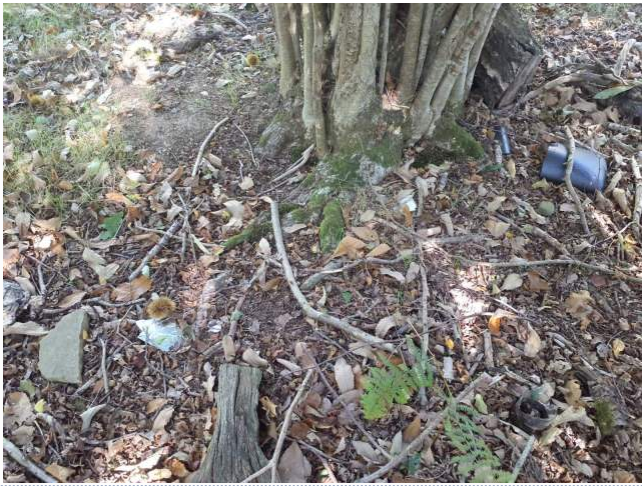
3

Further glass and plastic at base of tree in wooded area.

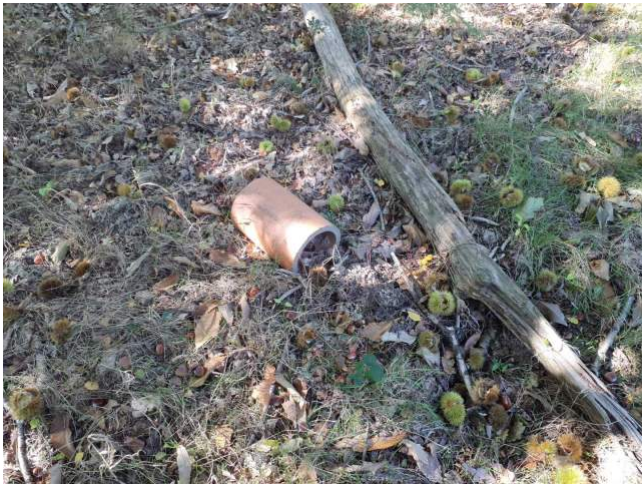
Fly Tipping 4

Description Terracotta pipework.

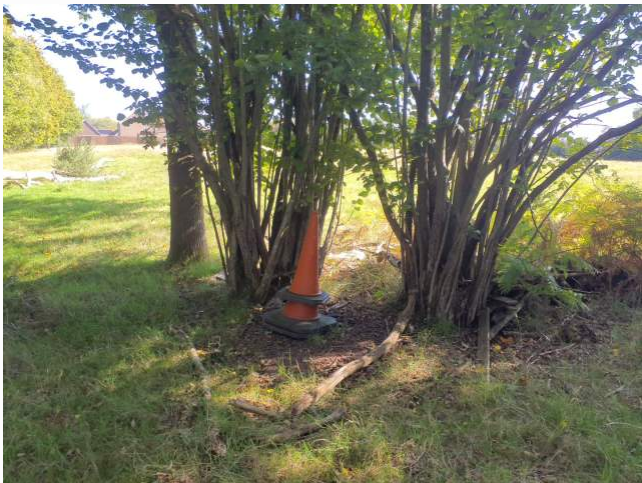
Fly Tipping 5

Description Traffic cones.

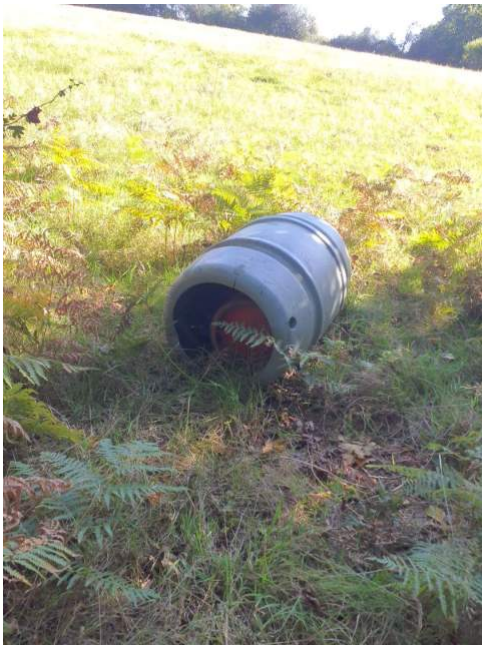
Fly Tipping 6

Description Water butt containing propane gas canister.

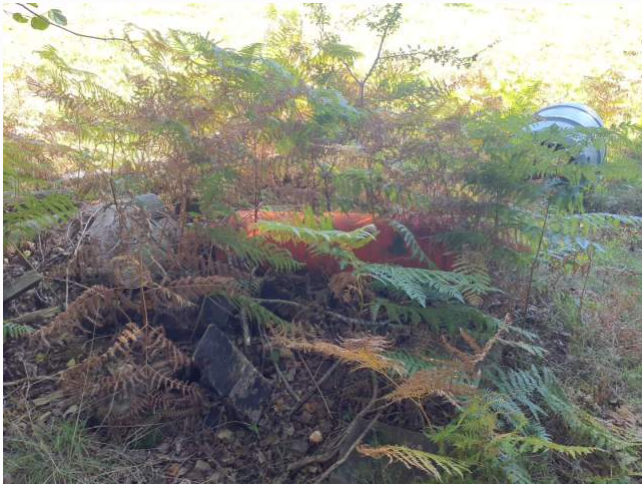
7

Propane tank.

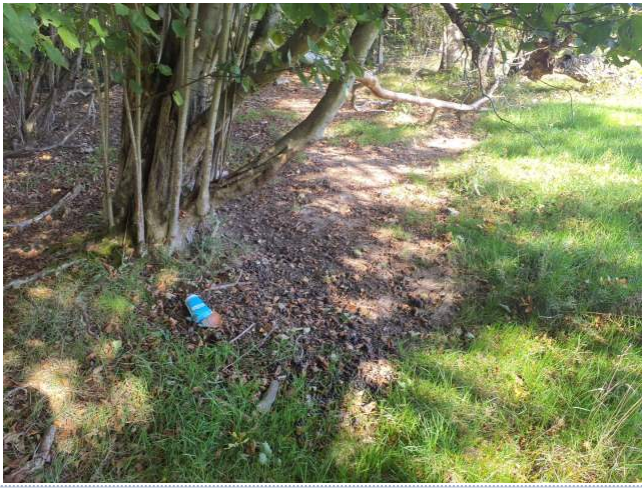
8

Line marking aerosol can.
