| Date: 29 October 2022 | Title: Windows |
| Project & Version: Grove Cottage Windows | |

**ELIZABETH BEE**  
creative interior design

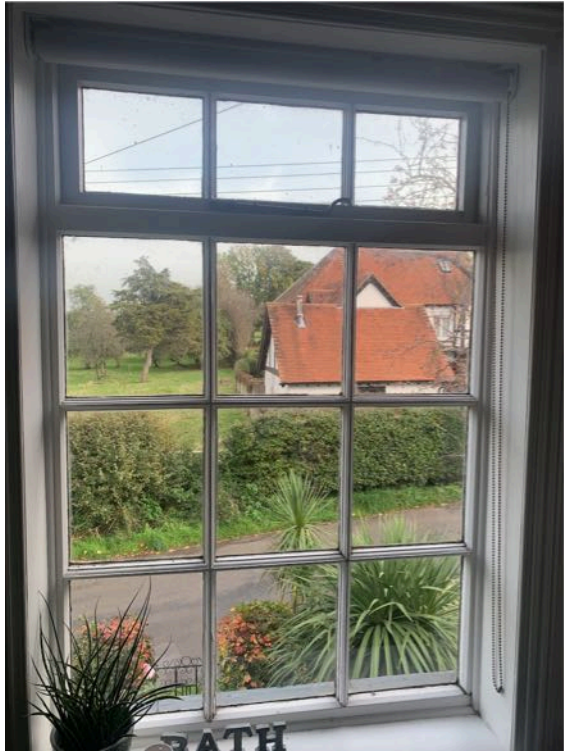
WINDOW B1: 1/4 X 3/4 Single glazed unit  
This is a bathroom window & gets very moldy & the paint peels off very year

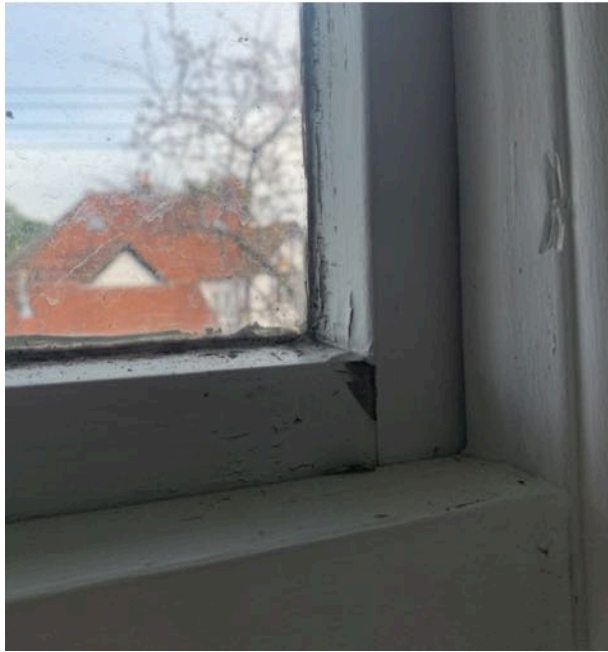
WINDOW B1: This window was renovated in 2021 and this is a detail picture which shows the paint already peeling off, due to condensation on the single glazed window

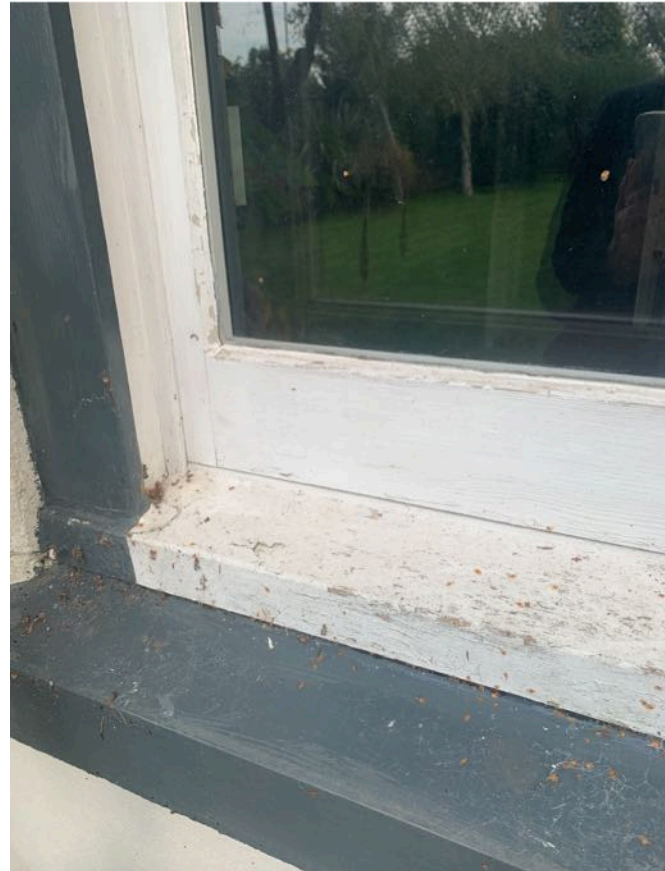
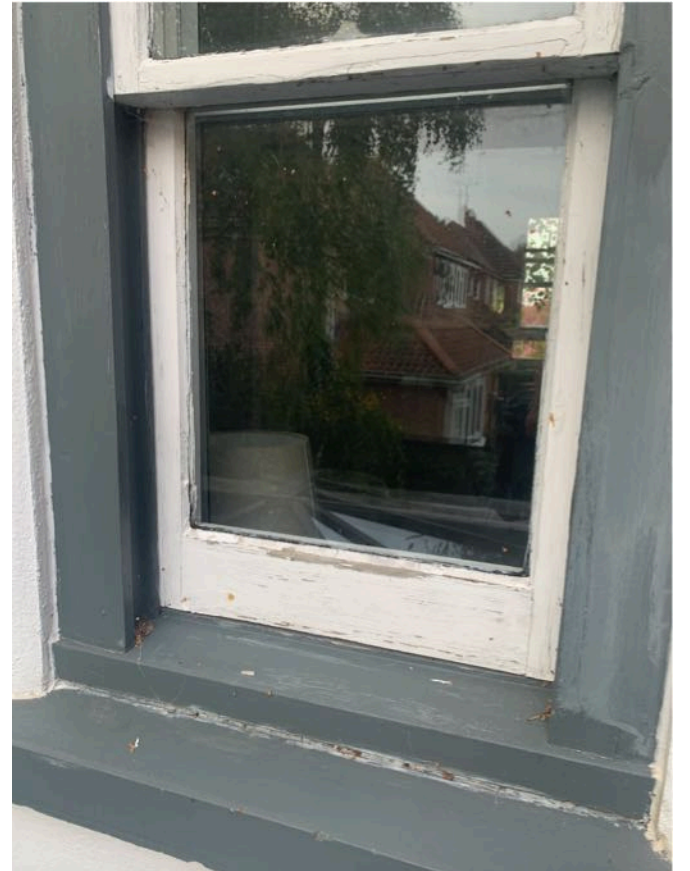
WINDOWS E1 - E9: New single glazed centre bar sash windows. These are renovated almost yearly, but because they are such poor quality soft wood, the paint is constantly cracking and they need regular maintenance.

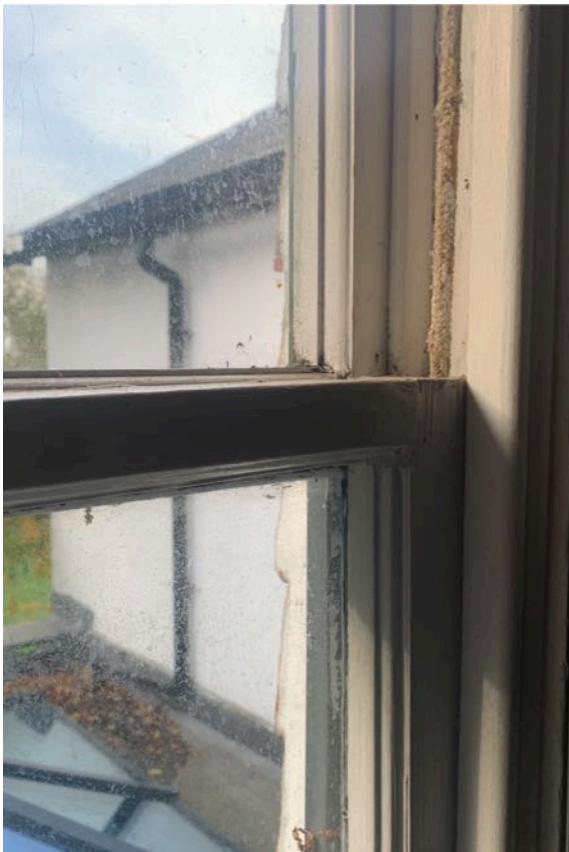
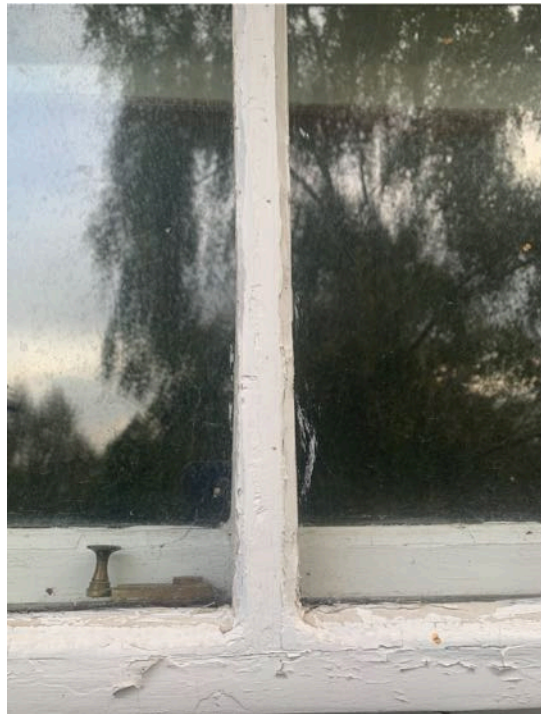
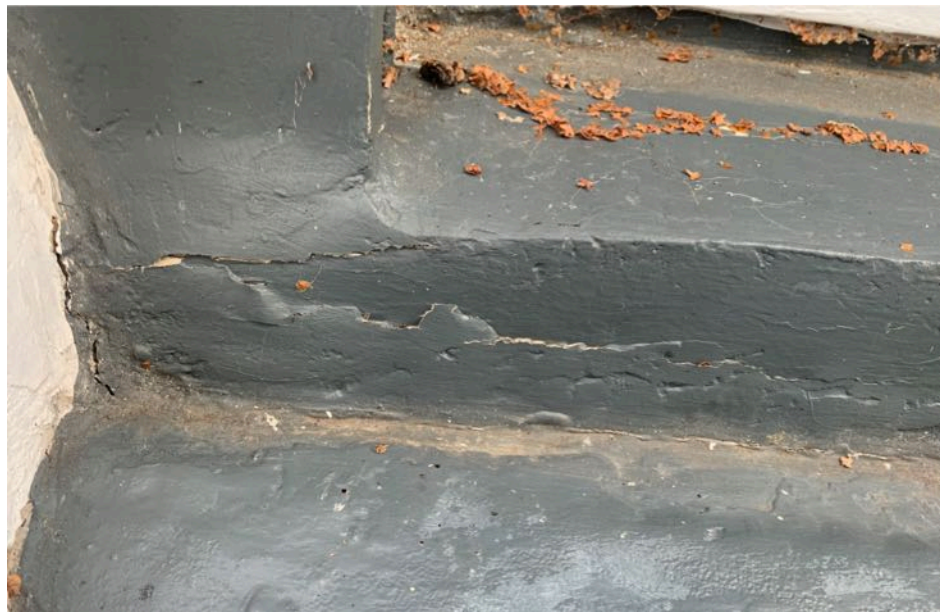
WINDOWS C1 - C3: Single glazed central bar sash windows with secondary glazing

These are the oldest windows are are mainly held together with filler. They have been renovated over the years, but it is not possible to repair them further. They are never opened as they are so fragile
