#### **REPORT ON WINDOWS**

**Property Address:** Grove Cottage, 122 College Lane, Hurstpierpoint, Hassocks, West Sussex, BN6 9AJ

**Inspection Date:** 14<sup>th</sup> March 2023

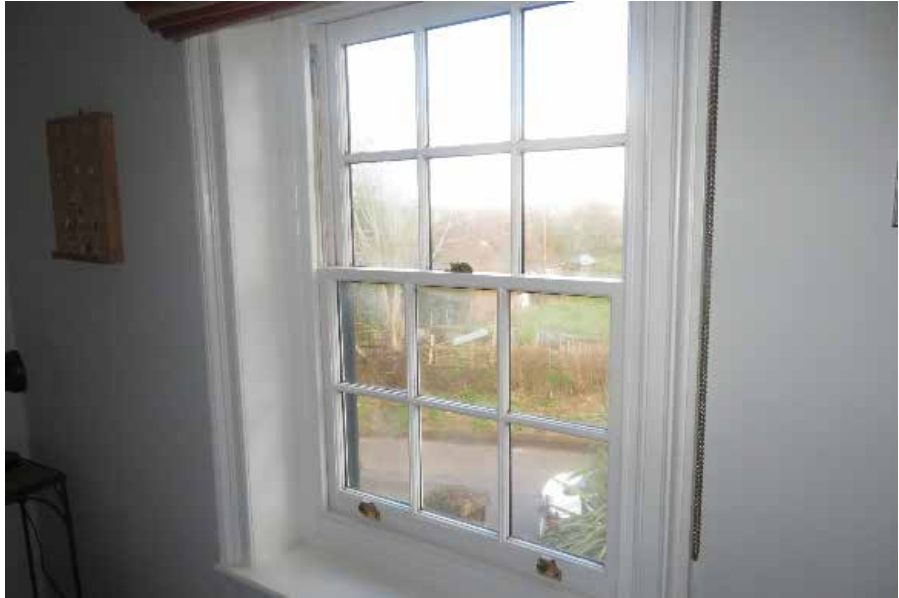
| A1 | 12 panel double hung bedroom sash probably late 20 <sup>th</sup> century, sealed unit glass. | Joinery adequate, all sealed units have failed.<br> |

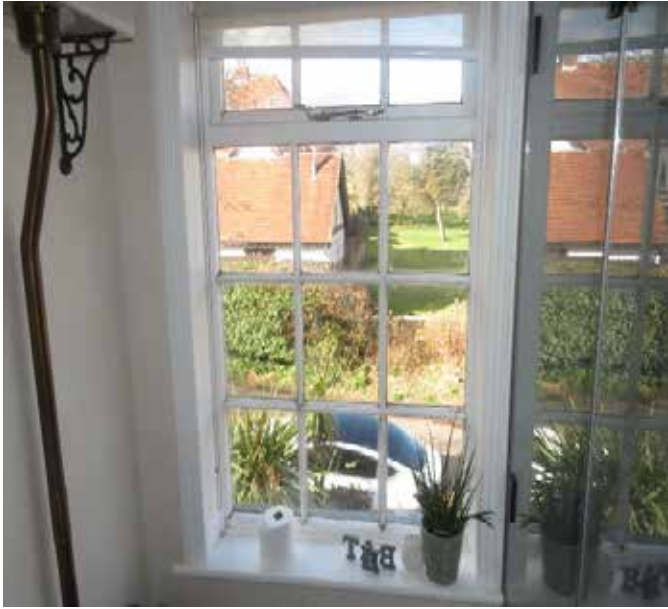
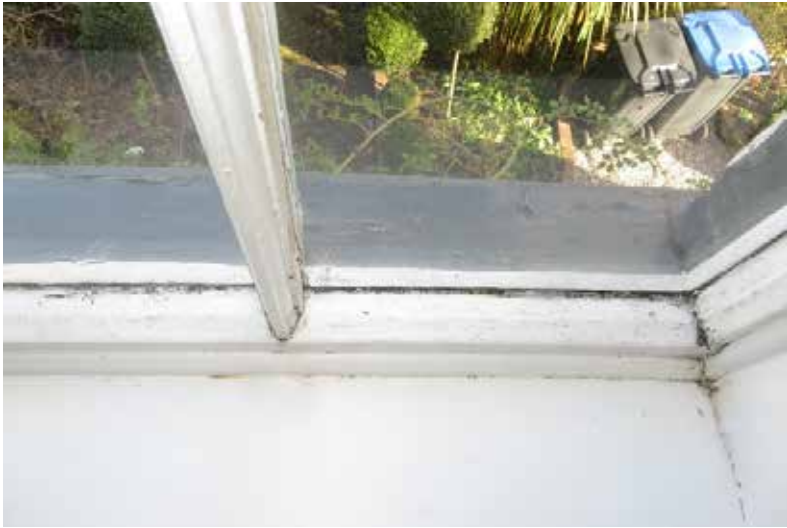
| B1 | <p>Twelve panel timber single glazed front bathroom window with glazing bars, fixed but with top hung light. Probably 1960s or 70s.</p> | <p>Poor quality replacement window susceptible to condensation and mould creating potentially unhealthy conditions, despite installation of operational extractor fan, exacerbated by east facing aspect and water vapour rising from other parts of the house all causing decorative damage and softening of joinery on the inside face. There is noticeable water damage to the timber sill and timber frame of the window, which has been caused by the condensation pooling on the sill and frame.</p> <p>Provision of secondary glazing would hamper ventilation further, increasing risk of mould in other parts of the room.</p> |

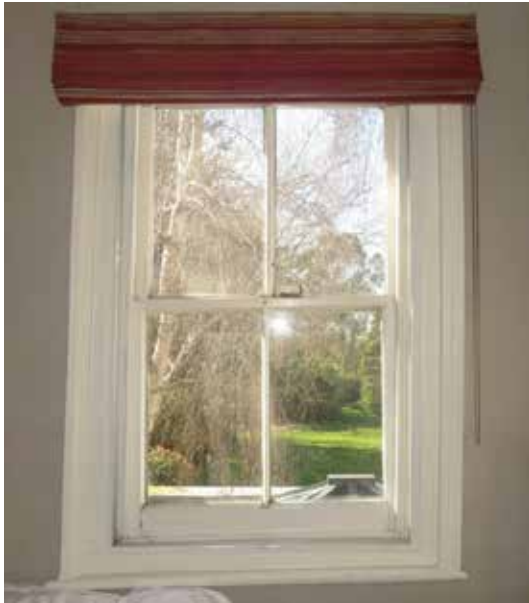
C3

Poor, rotten sill, ill fitting, upper and lower sash glazing bar thicknesses do not match, which would suggest a replacement.

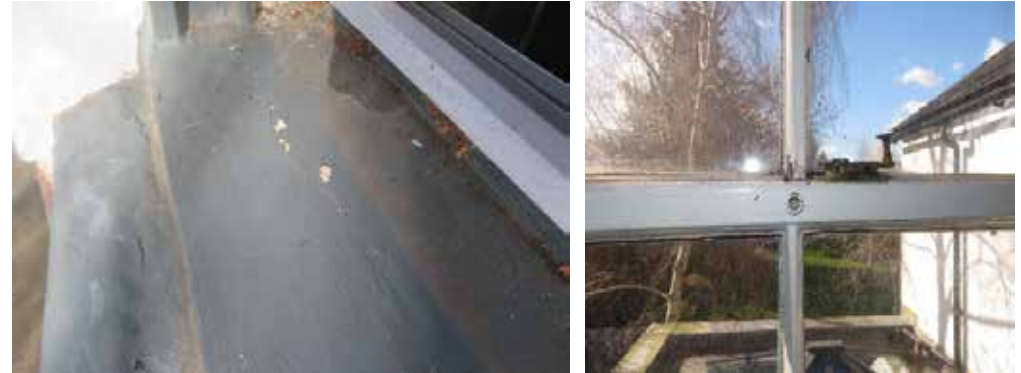
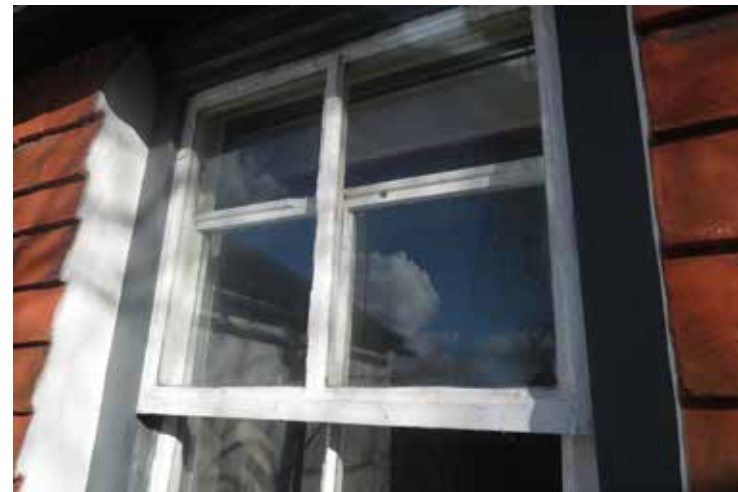
Top sash poorly formed and putty crudely applied. This top sash is possibly a later 20<sup>th</sup> century addition as the glazing bar is thicker than the lower sash and the internal moulding around the frame is clearer. There is no moulding or detailing on the external frame. Clumsy secondary glazing hampers operation of this window and was removed for inspection.

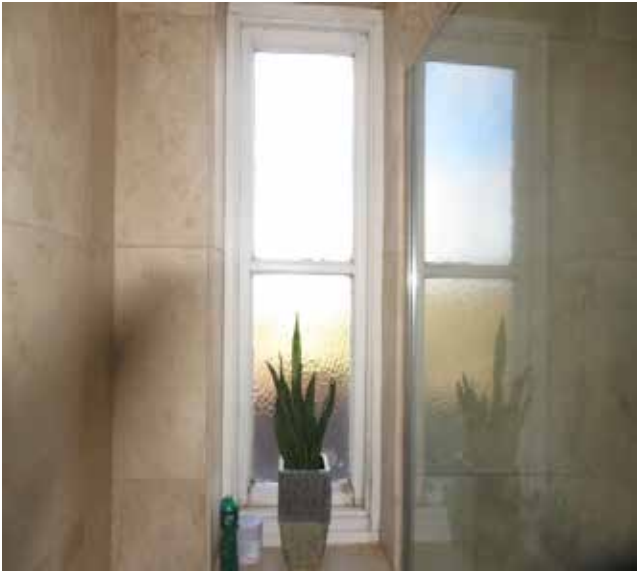
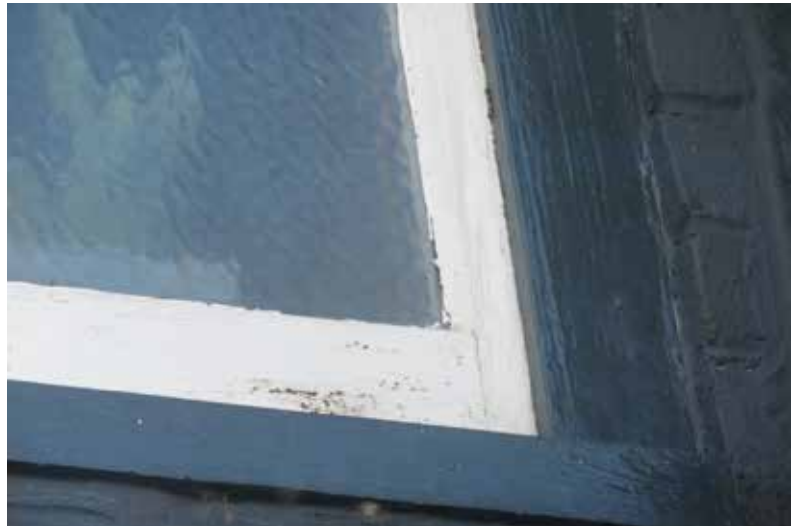
| E1 | <p>Narrow two panel fixed 21<sup>st</sup> century north facing shower room single glazed window with 21<sup>st</sup> century obscured glass.</p> | <p>Poor, rotten frame, window fixed, window providing no natural source of ventilation, susceptible to condensation on this north facing elevation causing unhealthy development of mould. A modern extractor fan is fitted in this bathroom. Black mould caused from this bathroom is visible in the adjoining bedroom to the ceiling area and on the secondary glazing.</p> <p>Provision of secondary glazing in this bathroom would hamper ventilation further, increasing risk of mould to other parts of the room and adjoining bedroom.</p> |

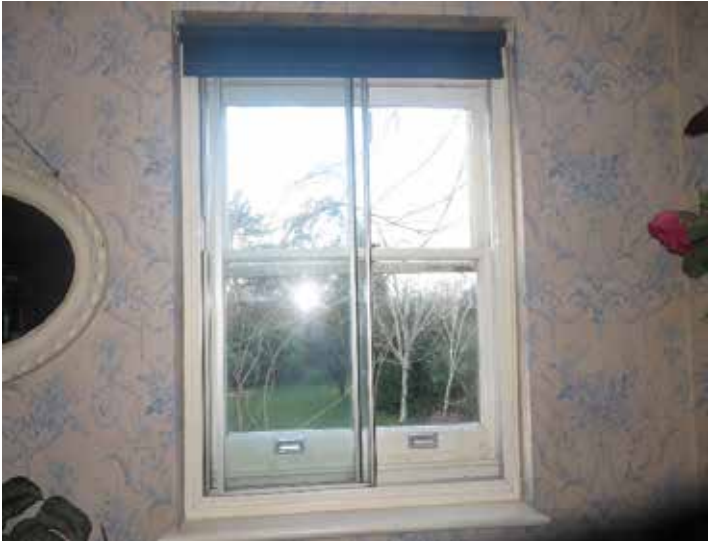
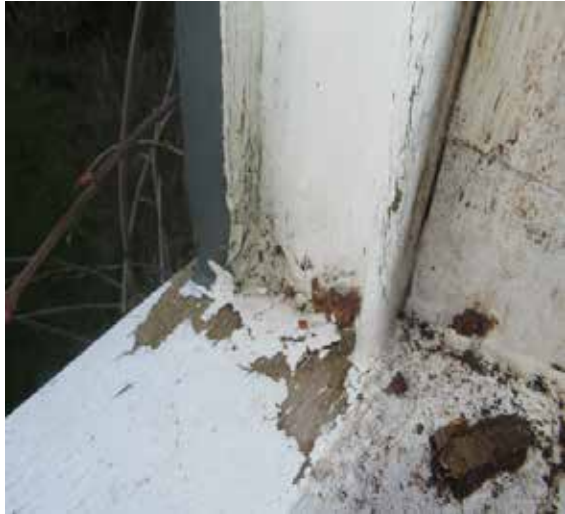
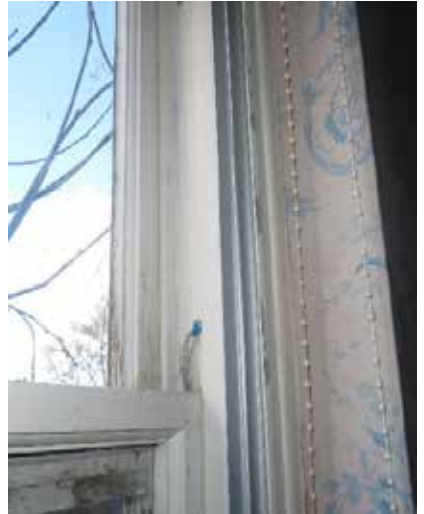
| E4 | <p>Four panel 21<sup>st</sup>-century single glazed double hung sash.</p> | <p>Sill/box frame joint rotting, sash cord broken.</p> |

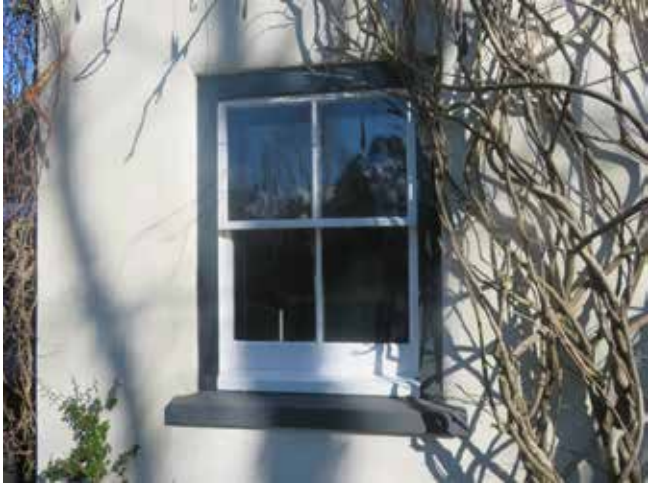
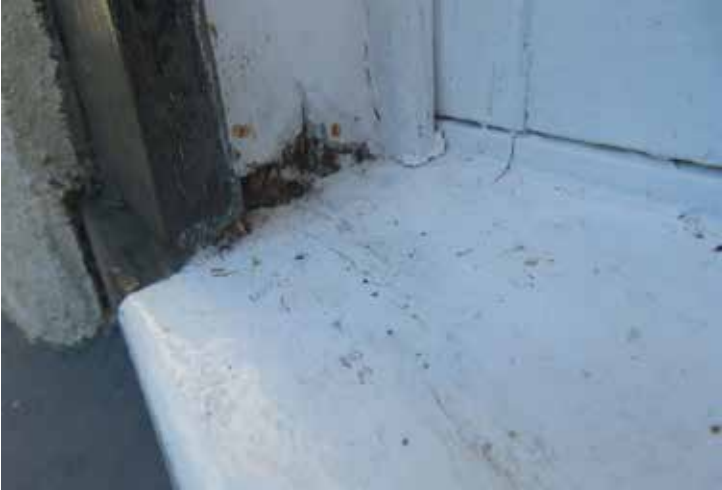
| E6 | <p data-bbox="286 193 1016 225">Four panel 21<sup>st</sup>-century single glazed double hung sash.</p> | <p data-bbox="1070 193 1435 225">Decay at sill/box frame joint.</p> |

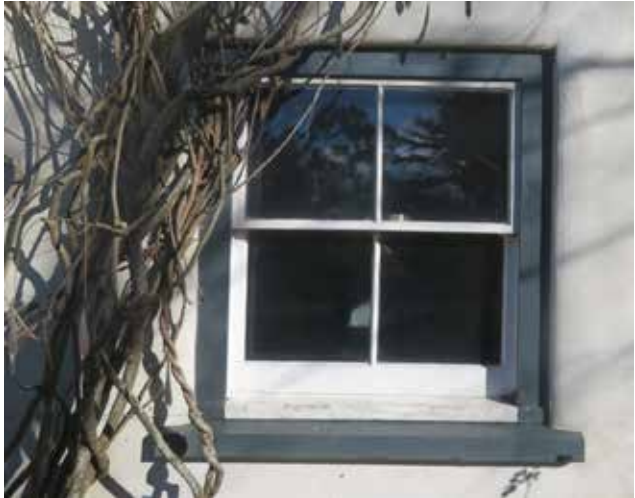
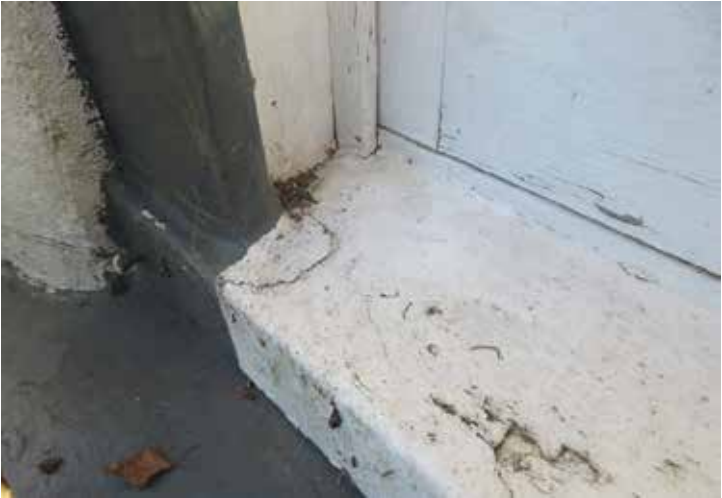
| E7 | <p data-bbox="286 815 1016 847">Four panel 21<sup>st</sup>-century single glazed double hung sash.</p> | <p data-bbox="1070 815 1435 847">Decay at sill/box frame joint.</p> |

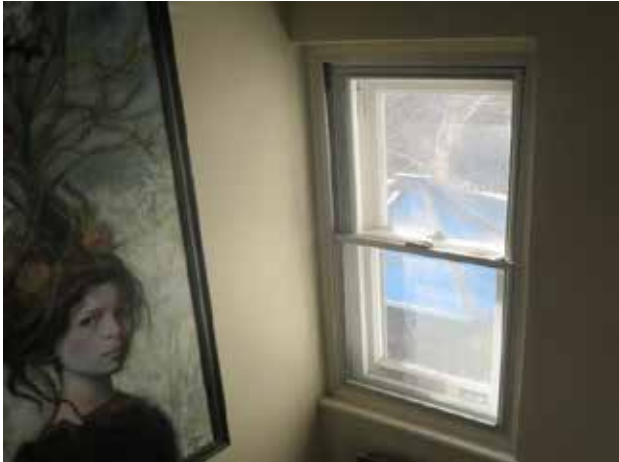
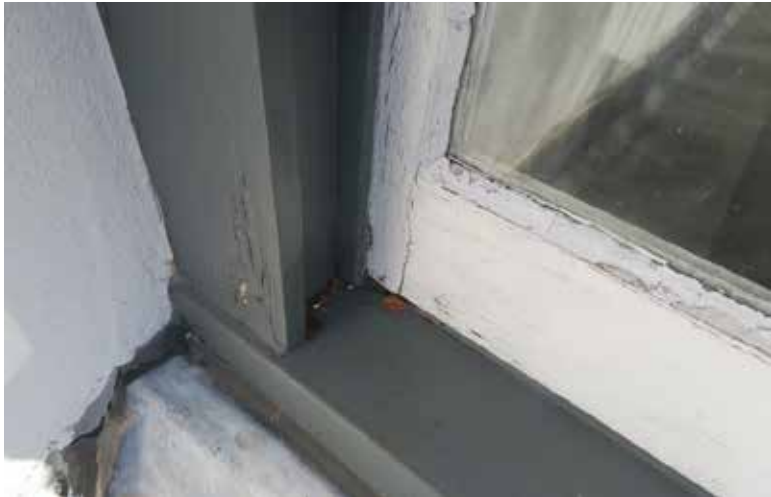
| <p>E8</p> | <p>Narrow single glazed two panel 21<sup>st</sup>-century single glazed double hung sash.</p> | <p>Decay at sill/box frame joint. Window creates a downdraught in the stairwell.</p> |

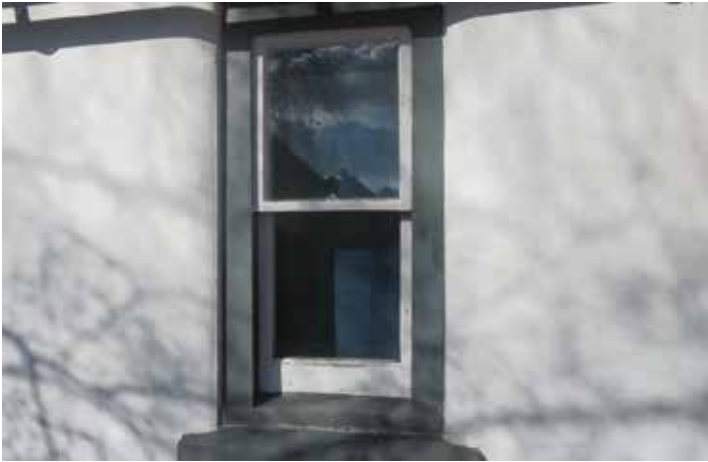
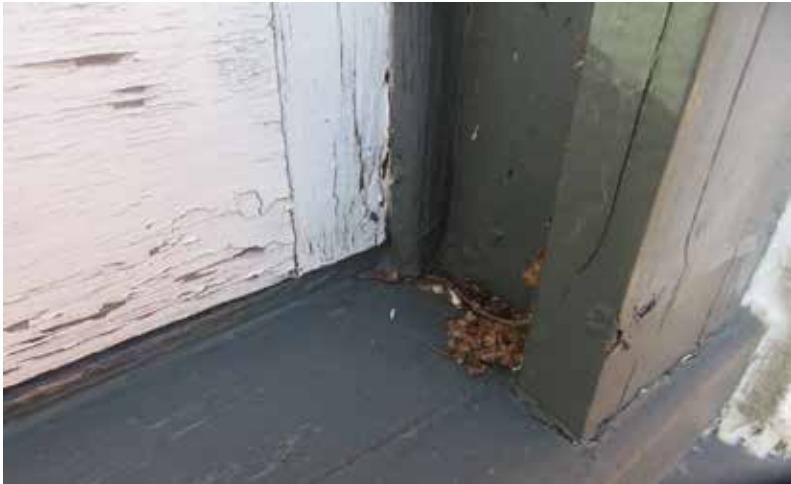
| <p>E9</p> | <p>Narrow single glazed two panel 21<sup>st</sup>-century single glazed double hung sash.</p> | <p>Decay to bottom rail and sill/box frame joint.</p> |

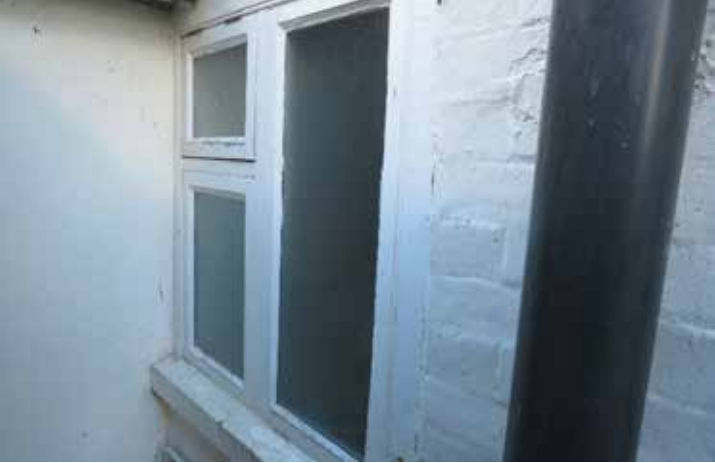
| F11 | <p data-bbox="286 196 1039 260">Late 20<sup>th</sup> century casement in all the subframe, obscured sealed unit double glazed glass.</p> | <p data-bbox="1070 196 1666 228">Top hung light frame softening, hinges rusted.</p> |

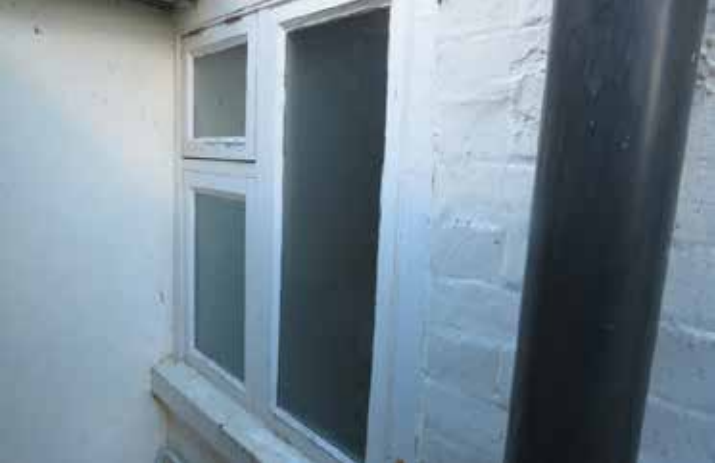
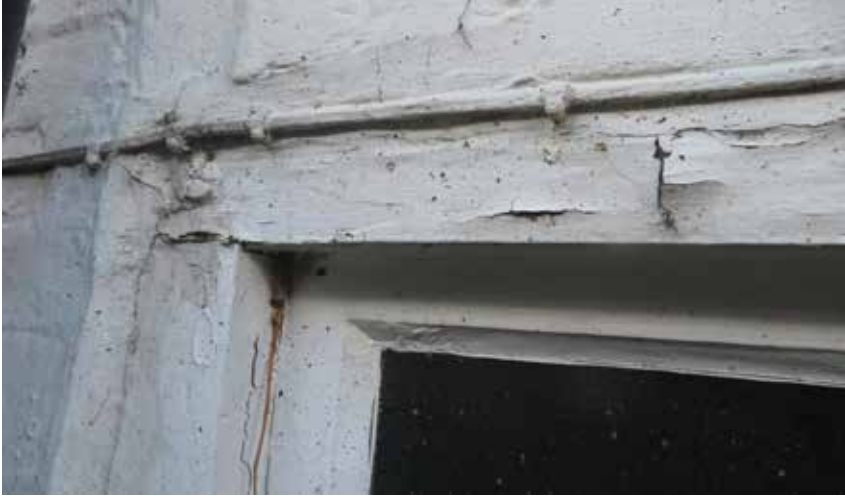
| F12 | <p data-bbox="286 834 1039 898">Late 20<sup>th</sup> Century casement in all the subframe, obscured double glazed sealed unit glass.</p> | <p data-bbox="1070 834 1525 866">Paint stuck, rotten out of subframe.</p> |
