# **THE OLD RECTORY, CHURCH LANE,** **TWINEHAM**

## **WINDOW CONDITION SURVEY**

Property: The Old Rectory, Church Lane, Twineham, West Sussex, RH17 5NR

Date of Survey: Monday 22<sup>nd</sup> June 2026

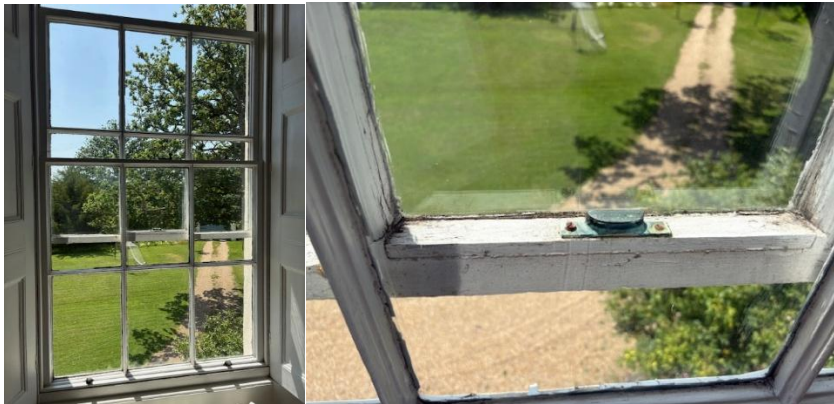
Label - Window 1

- Timber sash
- Approximate dimensions – 101cm x 193cm
- Number of panes - 12
- Historic interest – Appears original but with no historic glass. Cords visible and original shutters.

- ☐ Good
- ☐ Fair
- ☒ Poor

- ☒ Rot
- ☐ Soft timber
- ☐ Open joints
- ☐ Failed putty
- ☒ Distorted frame
- ☐ Water ingress
- ☒ Paint failure
- ☐ Broken glazing
- ☐ Other

- ☒ Opens and closes correctly
- ☐ Difficult to operate
- ☐ Does not operate correctly
- ☐ Painted shut

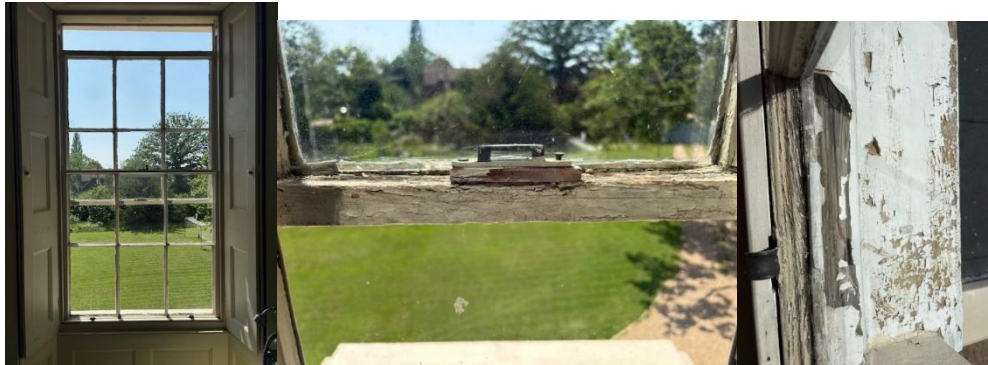
Label - Window 2

- Timber sash
- Approximate dimensions - 101cm x 193cm
- Number of panes - 12
- Historic interest – Appears original but with no historic glass. Cords visible and original shutters.

- ☐ Good
- ☐ Fair
- ☒ Poor

- ☐ Rot
- ☒ Soft timber
- ☒ Open joints
- ☐ Failed putty
- ☒ Distorted frame
- ☒ Water ingress
- ☒ Paint failure
- ☐ Broken glazing
- ☐ Other

- ☐ Opens and closes correctly
- ☒ Difficult to operate
- ☐ Does not operate correctly
- ☐ Painted shut

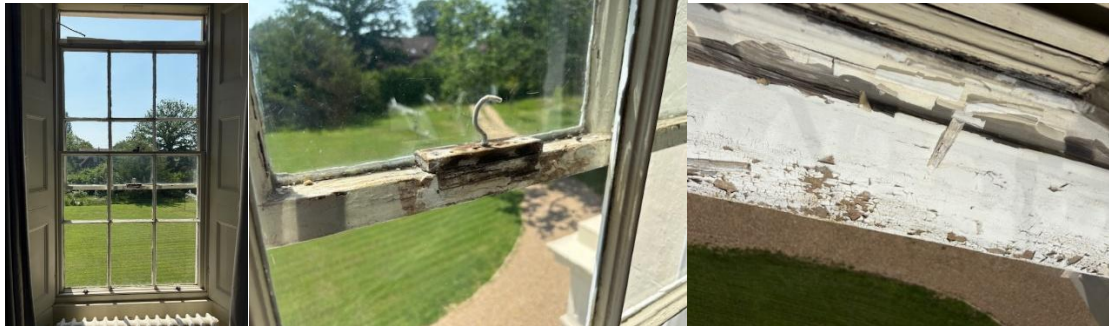
Location - South Elevation, 1<sup>st</sup> floor  
Label - Window 3

- Timber sash
- Approximate dimensions - 101cm x 193cm
- Number of panes - 12
- Historic interest – Appears original but with no historic glass. Cords visible and original shutters.

- ☐ Good
- ☐ Fair
- ☒ Poor

- ☒ Rot
- ☒ Soft timber
- ☒ Open joints
- ☐ Failed putty
- ☒ Distorted frame
- ☒ Water ingress
- ☒ Paint failure
- ☐ Broken glazing
- ☐ Other

- ☐ Opens and closes correctly
- ☐ Difficult to operate
- ☒ Does not operate correctly
- ☐ Painted shut

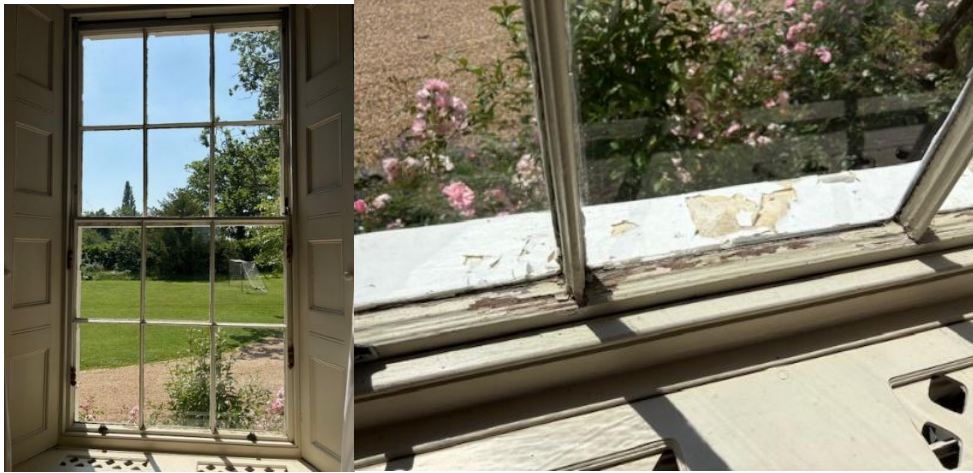
Location - South Elevation, Ground floor  
Label - Window 4

- Timber sash
- Approximate dimensions - 101cm x 193cm
- Number of panes - 12
- Historic interest – Appears original but with no historic glass. Cords visible and original shutters.

- ☐ Good
- ☒ Fair
- ☐ Poor

- ☐ Rot
- ☐ Soft timber
- ☒ Open joints
- ☐ Failed putty
- ☐ Distorted frame
- ☒ Water ingress
- ☒ Paint failure
- ☐ Broken glazing
- ☐ Other

- ☐ Opens and closes correctly
- ☒ Difficult to operate
- ☐ Does not operate correctly
- ☐ Painted shut

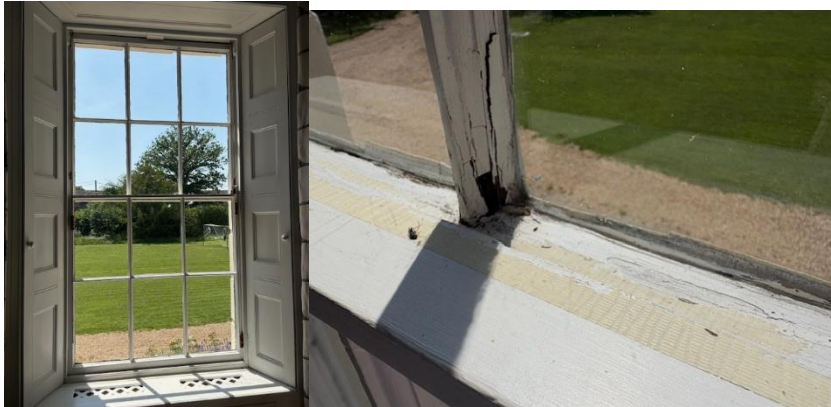
Location - South Elevation, Ground floor  
Label - Window 5

- Timber sash
- Approximate dimensions - 101cm x 193cm
- Number of panes - 12
- Historic interest – Appears original but with no historic glass. Cords visible and original shutters.

- ☐ Good
- ☒ Fair
- ☐ Poor

- ☐ Good
- ☐ Fair
- ☒ Poor

- ☒ Rot
- ☐ Soft timber
- ☐ Open joints
- ☐ Failed putty
- ☐ Distorted frame
- ☒ Water ingress
- ☒ Paint failure
- ☐ Broken glazing
- ☐ Other

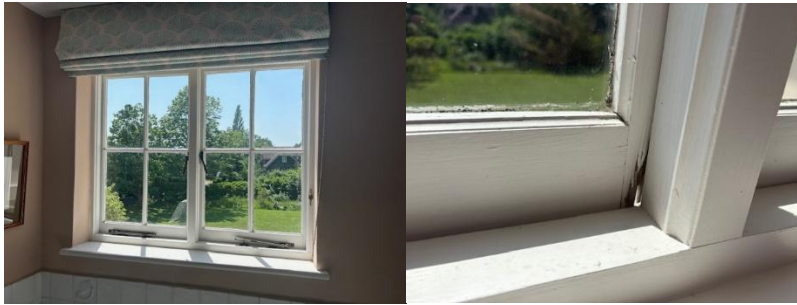
Location - South Elevation, 1<sup>st</sup> floor  
Label - Window 6

- Casement window – double
- Approximate dimensions – 112cm x 90cm
- Number of panes - 8
- Historic interest – None, ancillary extension.

- ☐ Good
- ☐ Fair
- ☒ Poor

- ☒ Rot
- ☒ Soft timber
- ☒ Open joints
- ☐ Failed putty
- ☐ Distorted frame
- ☒ Water ingress
- ☒ Paint failure
- ☐ Broken glazing
- ☐ Other

- ☐ Opens and closes correctly
- ☐ Difficult to operate
- ☒ Does not operate correctly
- ☐ Painted shut

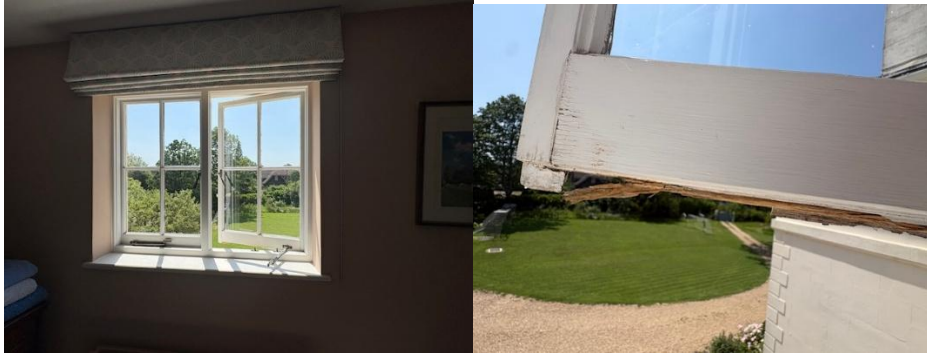
**Label - Window 7**

- Casement window – double
- Approximate dimensions – 112cm x 90cm
- Number of panes - 8
- Historic interest – None, ancillary extension.

- ☐ Good
- ☐ Fair
- ☒ Poor

- ☒ Rot
- ☐ Soft timber
- ☒ Open joints
- ☐ Failed putty
- ☒ Distorted frame
- ☒ Water ingress
- ☒ Paint failure
- ☐ Broken glazing
- ☐ Other

- ☐ Opens and closes correctly
- ☐ Difficult to operate
- ☒ Does not operate correctly
- ☐ Painted shut

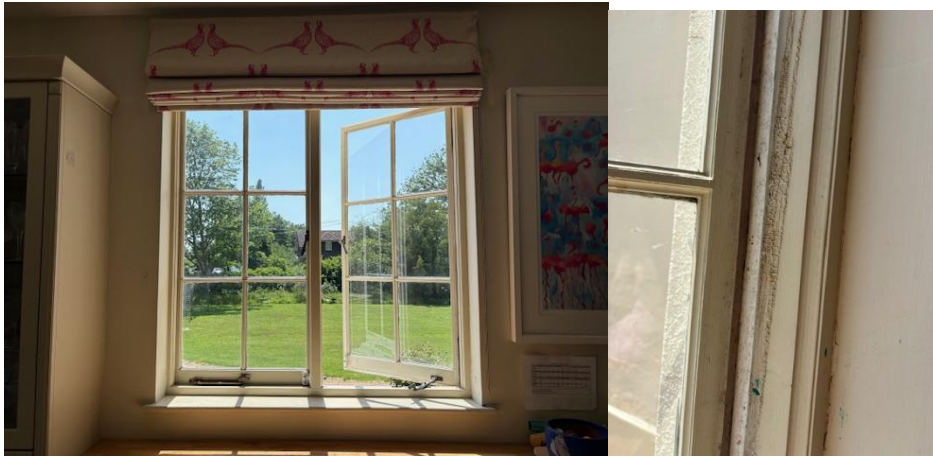
**Location - South Elevation, Ground floor**  
**Label - Window 8**

- Casement window – double
- Approximate dimensions – 130cm x 137cm
- Number of panes - 12
- Historic interest – None, ancillary extension.

- ☐ Good
- ☒ Fair
- ☐ Poor

- ☐ Good
- ☐ Fair
- ☒ Poor

- ☒ Rot
- ☐ Soft timber
- ☐ Open joints
- ☐ Failed putty
- ☐ Distorted frame
- ☐ Water ingress
- ☒ Paint failure
- ☐ Broken glazing
- ☐ Other

- ☐ Opens and closes correctly
- ☒ Difficult to operate
- ☐ Does not operate correctly
- ☐ Painted shut

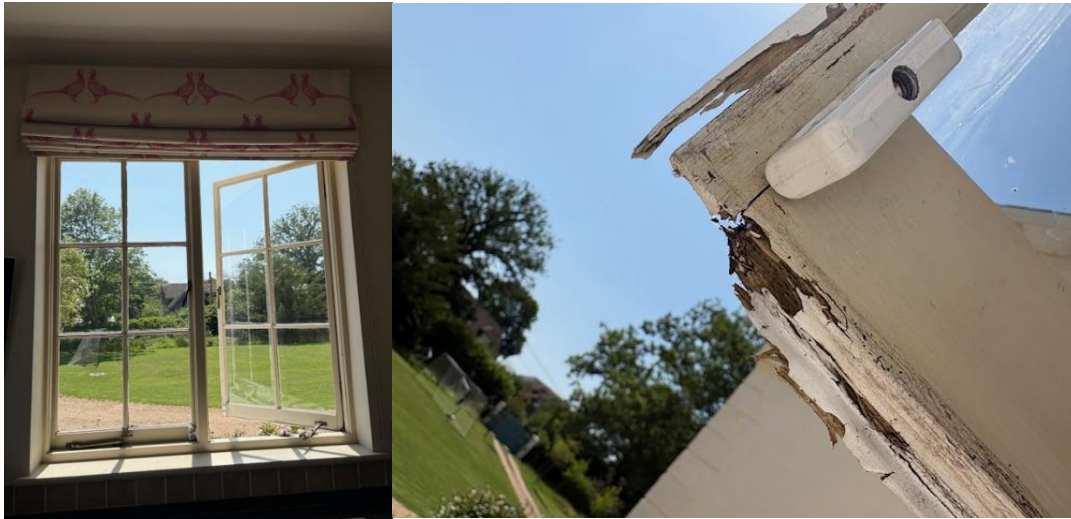
Location - South Elevation, Ground floor  
Label - Window 9

- Casement window – double
- Approximate dimensions – 130cm x 137cm
- Number of panes - 12
- Historic interest – None, ancillary extension.

- ☐ Good
- ☐ Fair
- ☒ Poor

- ☒ Rot
- ☒ Soft timber
- ☒ Open joints
- ☐ Failed putty
- ☒ Distorted frame
- ☒ Water ingress
- ☒ Paint failure
- ☐ Broken glazing
- ☐ Other

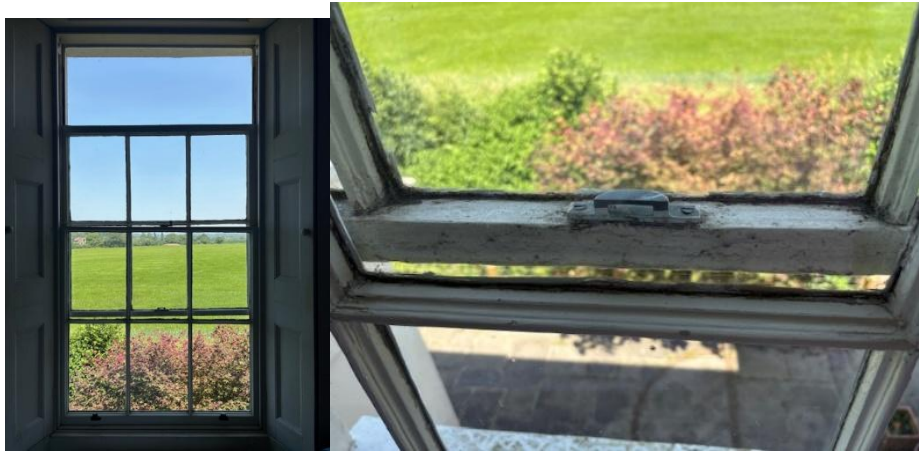
Location – North Elevation, 1<sup>st</sup> floor  
Label - Window 1

- Timber sash
- Approximate dimensions - 101cm x 193cm
- Number of panes - 12
- Historic interest – Appears original but with no historic glass. Cords visible and original shutters.

- ☐ Good
- ☐ Fair
- ☒ Poor

- ☐ Good
- ☒ Fair
- ☐ Poor

- ☐ Rot
- ☒ Soft timber
- ☒ Open joints
- ☐ Failed putty
- ☐ Distorted frame
- ☒ Water ingress
- ☒ Paint failure
- ☐ Broken glazing
- ☐ Other

- ☐ Opens and closes correctly
- ☒ Difficult to operate
- ☐ Does not operate correctly
- ☐ Painted shut

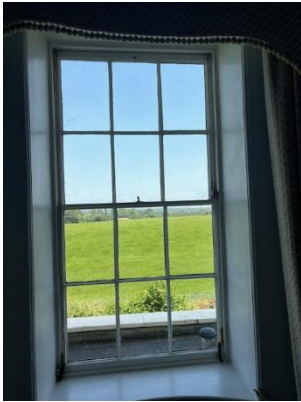
Label - Window 2

- Timber sash
- Approximate dimensions - 101cm x 193cm
- Number of panes - 12
- Historic interest – Appears original but with no historic glass. Cords visible and original shutters.

- ☐ Good
- ☒ Fair
- ☐ Poor

- ☐ Rot
- ☒ Soft timber
- ☐ Open joints
- ☐ Failed putty
- ☐ Distorted frame
- ☒ Water ingress
- ☐ Paint failure
- ☐ Broken glazing
- ☐ Other

- ☐ Opens and closes correctly
- ☐ Difficult to operate
- ☐ Does not operate correctly
- ☒ Painted shut

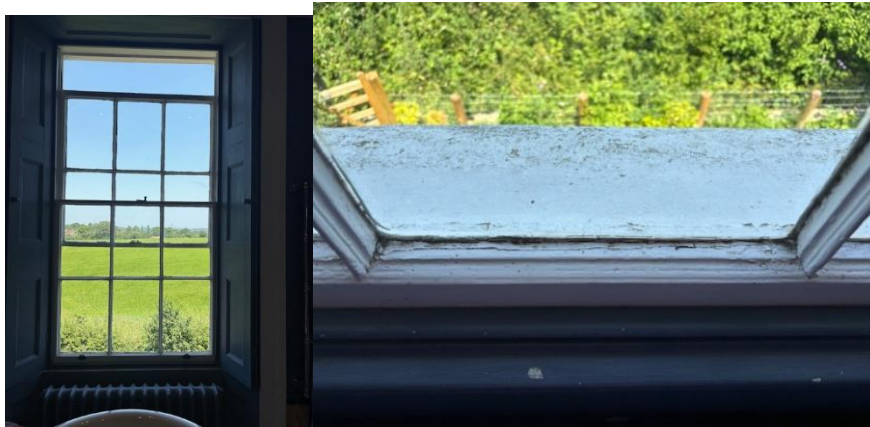
Label - Window 3

- Timber sash
- Approximate dimensions - 101cm x 193cm
- Number of panes - 12
- Historic interest – Appears original but with no historic glass. Cords visible and original shutters.

- ☐ Good
- ☐ Fair
- ☒ Poor

- ☐ Rot
- ☒ Soft timber
- ☒ Open joints
- ☐ Failed putty
- ☐ Distorted frame
- ☒ Water ingress
- ☒ Paint failure
- ☐ Broken glazing
- ☐ Other

- ☐ Opens and closes correctly
- ☒ Difficult to operate
- ☐ Does not operate correctly
- ☐ Painted shut

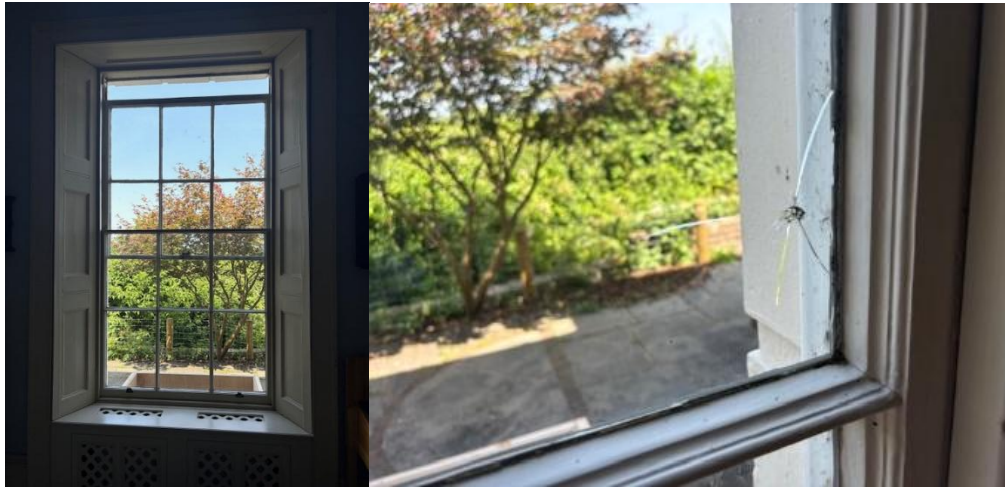
Location - North Elevation, Ground floor  
Label - Window 4

- Timber sash
- Approximate dimensions - 101cm x 193cm
- Number of panes - 12
- Historic interest – Appears original but with no historic glass. Cords visible and original shutters.

- ☐ Good
- ☐ Fair
- ☒ Poor

- ☐ Good
- ☒ Fair
- ☐ Poor

- ☐ Rot
- ☒ Soft timber
- ☒ Open joints
- ☐ Failed putty
- ☐ Distorted frame
- ☒ Water ingress
- ☒ Paint failure
- ☒ Broken glazing
- ☐ Other

- ☐ Opens and closes correctly
- ☒ Difficult to operate
- ☐ Does not operate correctly
- ☐ Painted shut

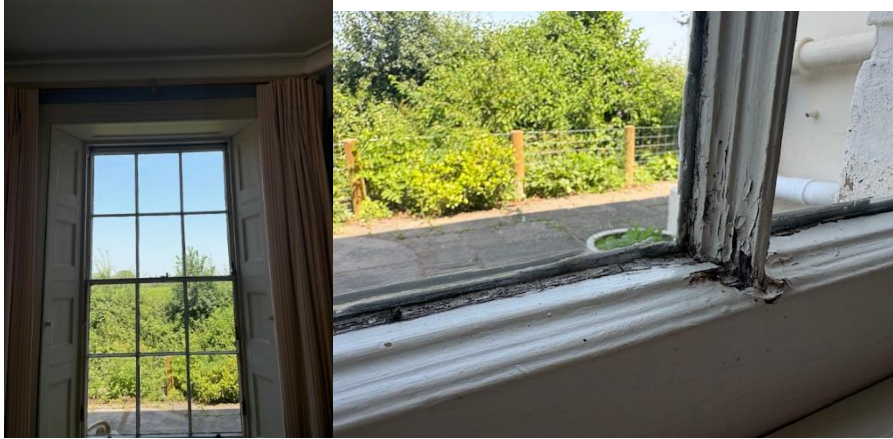
Location - North Elevation, Ground floor  
Label - Window 5

- Timber sash
- Approximate dimensions - 101cm x 193cm
- Number of panes - 12
- Historic interest – Appears original but with no historic glass. Cords visible and original shutters.

- ☐ Good
- ☐ Fair
- ☒ Poor

- ☐ Good
- ☒ Fair
- ☐ Poor

- ☐ Rot
- ☒ Soft timber
- ☒ Open joints
- ☐ Failed putty
- ☐ Distorted frame
- ☒ Water ingress
- ☒ Paint failure
- ☐ Broken glazing
- ☐ Other

- ☐ Opens and closes correctly
- ☒ Difficult to operate
- ☐ Does not operate correctly
- ☐ Painted shut

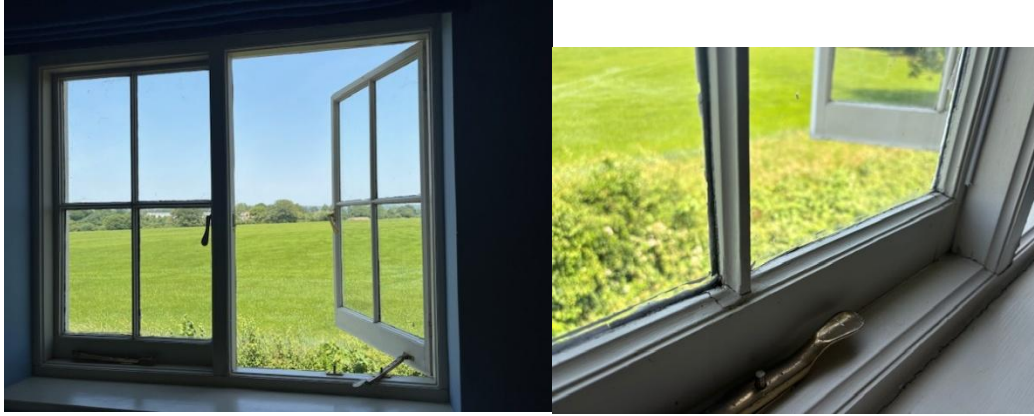
Location - North Elevation, 1<sup>st</sup> floor  
Label - Window 6

- Casement window – double
- Approximate dimensions – 112cm x 90cm
- Number of panes - 8
- Historic interest – None, ancillary extension.

- ☐ Good
- ☐ Fair
- ☒ Poor

- ☐ Good
- ☒ Fair
- ☐ Poor

- ☐ Rot
- ☒ Soft timber
- ☒ Open joints
- ☐ Failed putty
- ☒ Distorted frame
- ☒ Water ingress
- ☒ Paint failure
- ☐ Broken glazing
- ☐ Other

- ☐ Opens and closes correctly
- ☒ Difficult to operate
- ☐ Does not operate correctly
- ☐ Painted shut

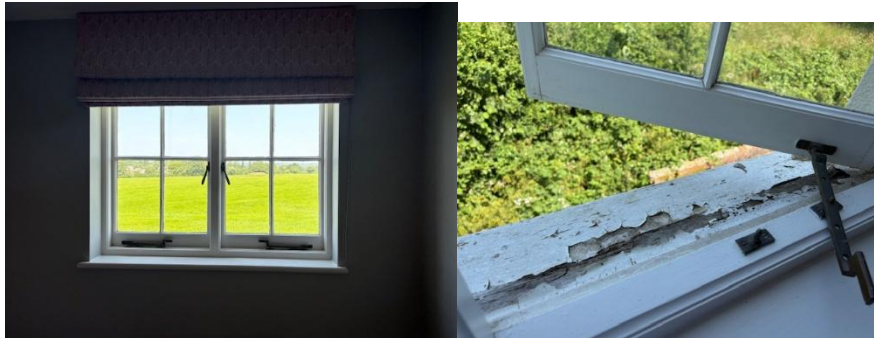
Location – North Elevation, 1<sup>st</sup> floor  
Label - Window 7

- Casement window – double
- Approximate dimensions – 112cm x 90cm
- Number of panes - 8
- Historic interest – None, ancillary extension.

- ☐ Good
- ☐ Fair
- ☒ Poor

- ☐ Rot
- ☒ Soft timber
- ☒ Open joints
- ☐ Failed putty
- ☐ Distorted frame
- ☒ Water ingress
- ☒ Paint failure
- ☐ Broken glazing
- ☐ Other

- ☐ Opens and closes correctly
- ☒ Difficult to operate
- ☐ Does not operate correctly
- ☐ Painted shut

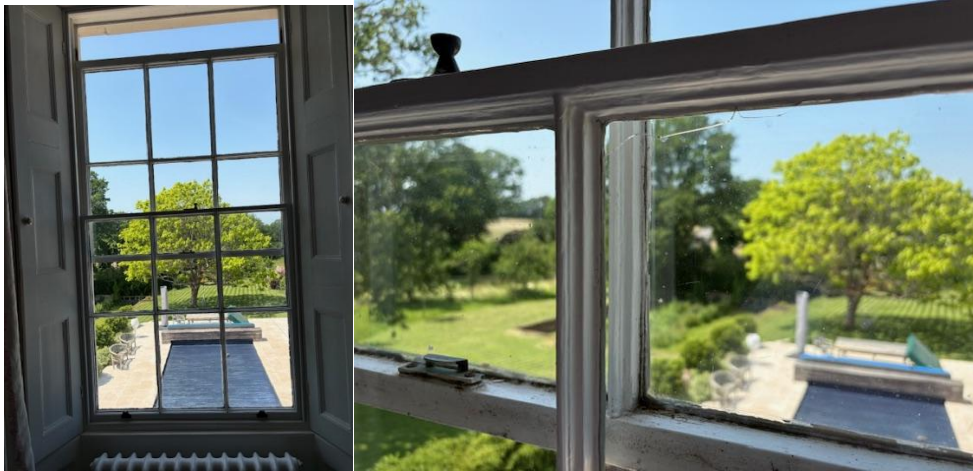
Location - West Elevation, 1<sup>st</sup> floor  
Label - Window 1

- Timber sash
- Approximate dimensions - 101cm x 193cm
- Number of panes - 12
- Historic interest – Appears original but with no historic glass. Cords visible and original shutters.

- ☐ Good
- ☐ Fair
- ☒ Poor

- ☐ Good
- ☒ Fair
- ☐ Poor

- ☐ Rot
- ☒ Soft timber
- ☒ Open joints
- ☐ Failed putty
- ☐ Distorted frame
- ☒ Water ingress
- ☒ Paint failure
- ☐ Broken glazing
- ☐ Other

- ☐ Opens and closes correctly
- ☒ Difficult to operate
- ☐ Does not operate correctly
- ☐ Painted shut

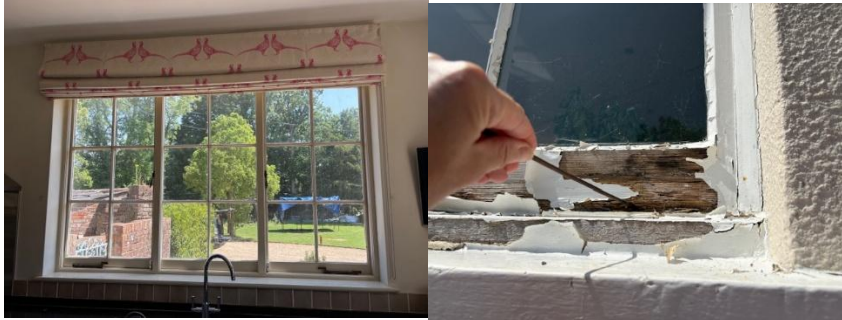
Location - East Elevation, Ground floor  
Label - Window 1

- Timber sash
- Approximate dimensions - 224cm x 137cm
- Number of panes - 18
- Historic interest – None, ancillary extension.

- ☐ Good
- ☐ Fair
- ☒ Poor

- ☒ Rot
- ☒ Soft timber
- ☒ Open joints
- ☐ Failed putty
- ☒ Distorted frame
- ☒ Water ingress
- ☒ Paint failure
- ☐ Broken glazing
- ☐ Other

- ☐ Opens and closes correctly
- ☒ Difficult to operate
- ☐ Does not operate correctly
- ☐ Painted shut
