Supporting Statement for Applications  
[refs. DM/25/2654 and 2655]  
**Wykehurst House, nr Bolney RH17 5QQ**

### **Introduction**

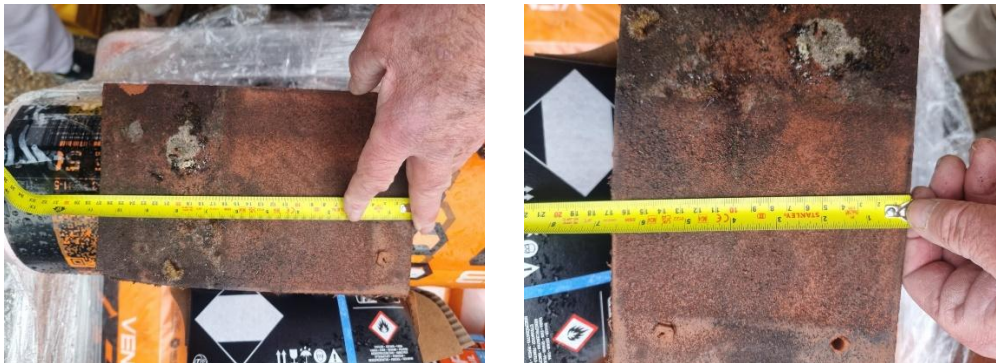
The original tiles are a variable, handmade red/brown sand faced plain clay tile, 165/170 by 270mm in size – see images of salvaged tiles below.

As a principle of repair, ALL sound tiles will be salvaged and re-used on the SAME roof area. New tiles will be as follows, seeking to create a best match with the preserved originals:

The proposed tiles are of best colour match, with matching size and finish. These are necessarily sourced, as reclaimed tiles, from numerous stockists to meet the above conditions.

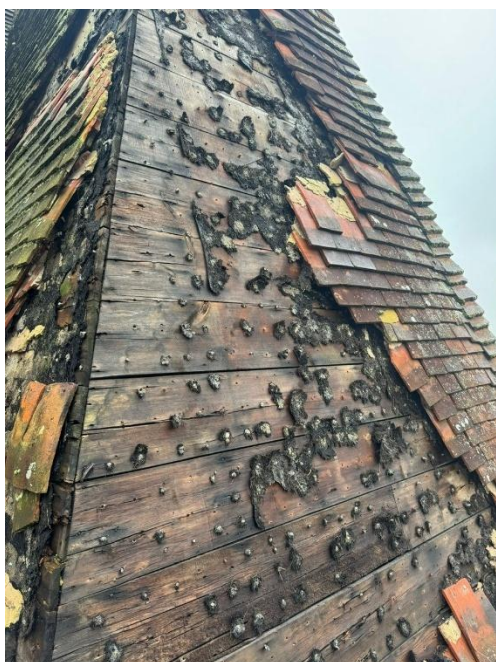
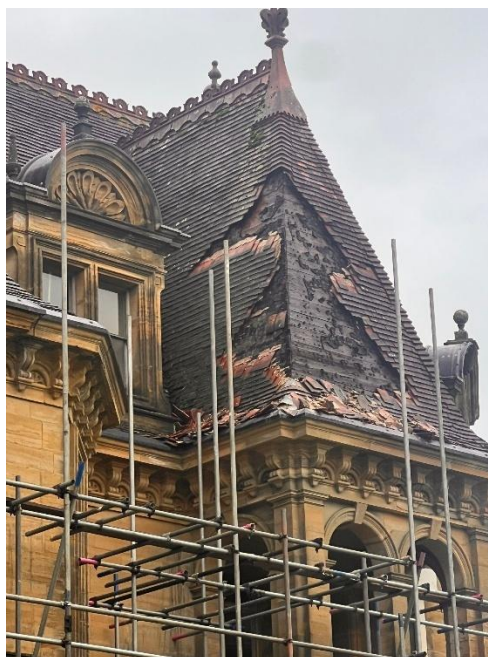
On the steeper pitched roof parts, we see that a vertical tile hanging, or weather tiling, method has been used. Here tiles are fixed through a sarking felt, to sarking boards behind, with a mortar bed at the head of the tile (torching). However, as tile fixing anchorage is lost over time due to the deterioration of the timber boards, this has led to an eventual point of collapse.

Perhaps wind assisted, the tile weight can no longer be supported, and many tiles have slipped together, some bound by mortar, pulling other adjacent tiles with them in a cascade effect. Such a failure has generated significant forces and greater damage of the tiles themselves, with many becoming cracked with impact on the masonry eaves parapet.

Photos from December 2024 showing the significant loss of tiles on steeper pitched roof elements. The tiles appear to have been secured directly to the sarking felt and boards, and including 'torching', with mortar bedding at the top edge for enhanced weather protection. This was a method used historically for vertical tiling in Sussex, but does block ventilation of the roof timbers, leading to decay in the boards. In the image we see the sarking boards, swollen and cracked, leading to the loss of mortar, loss of the fixing anchor, and slipping of tiles.

The roof repairs include replacement battens, with new treated timber cut-in to sound timbers and with new tiles fixed using modern galvanised steel nails to BS EN 490 / 491 – less likely to corrode than the historic original (mild steel). The sarking felt, which is completely degraded, will be replaced with a modern breather membrane. The above methods will allow the retention of the original sarking boards and supporting timbers below.

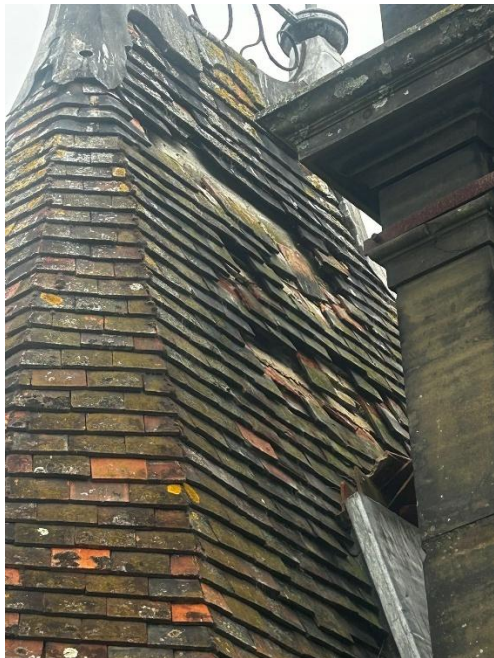
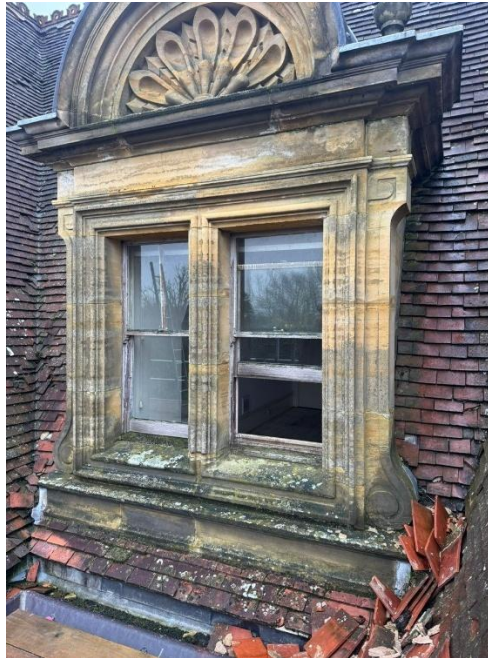
We observe that clay plain tiles have slipped leaving gaps in the weathering finish, allowing rainwater to freely enter the batten space behind. In time, the timber battens have become saturated and rotten. Tile fixings have also corroded within the saturated batten. In time the degree of decay in the batten, and the weight of the clay tile finish has led to tiles losing their fixing anchor and slipping.

Photos show other areas of tile loss. The right-hand image shows the accumulation of numerous individual tiles which have slipped from different locations. These are found on the shallower pitched roof elements and can be locally repaired using salvaged or salvageable tiles.

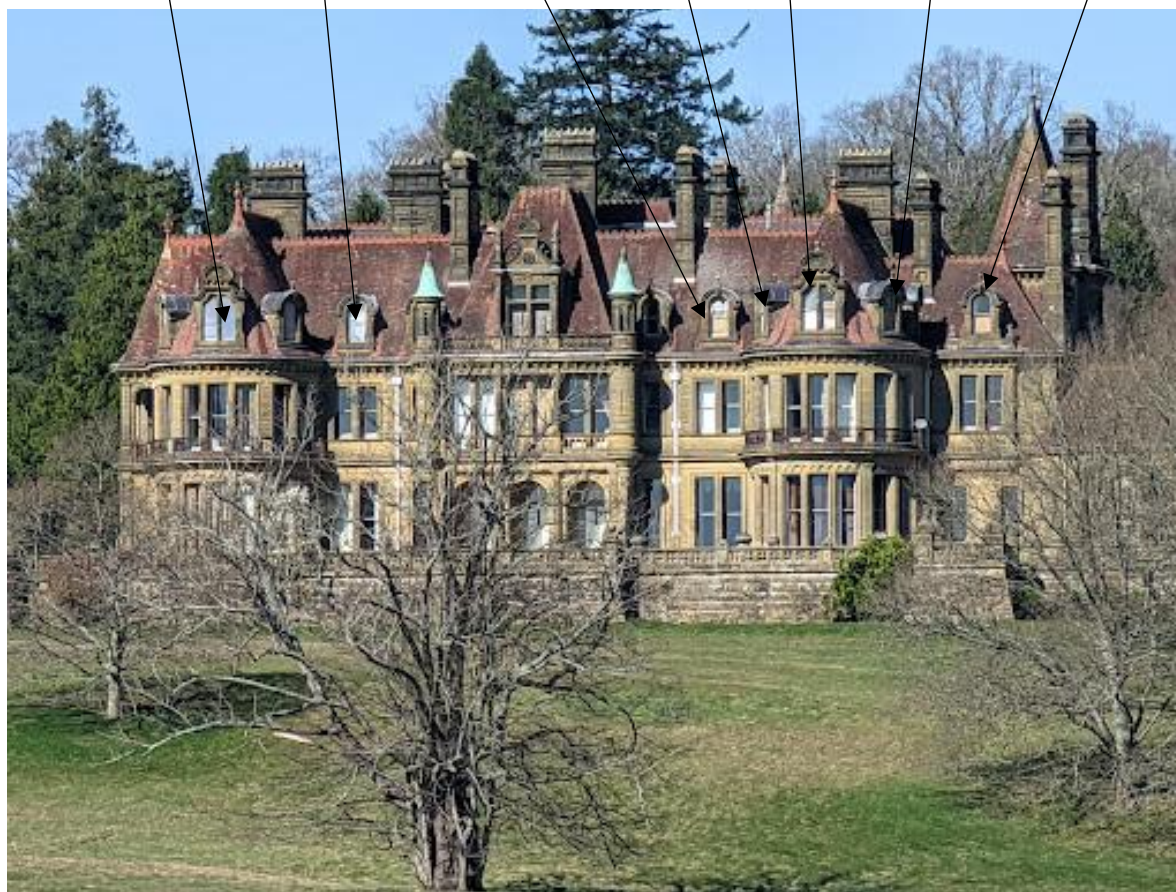
Photo taken from prior to client's acquisition shows the damaged second floor windows generally.

Our client states that in-situ windows were repaired and new windows, crafted to match the originals, were installed where frames were missing. They considered this a necessity for weather protection and noted that the window repairs offered better value than full replacement. Although we do not have historic record of the original windows, we are inclined to accept this explanation, due to the photographic evidence and our client's general philosophy of preservation, as observed in other window repairs and to the original internal door joinery generally.

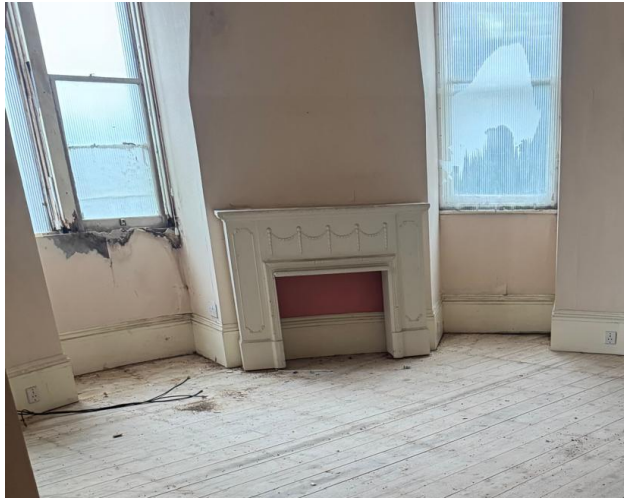
Type 1 - W2.08 with complete loss of original frames, cill, glazing and damage to central mullion

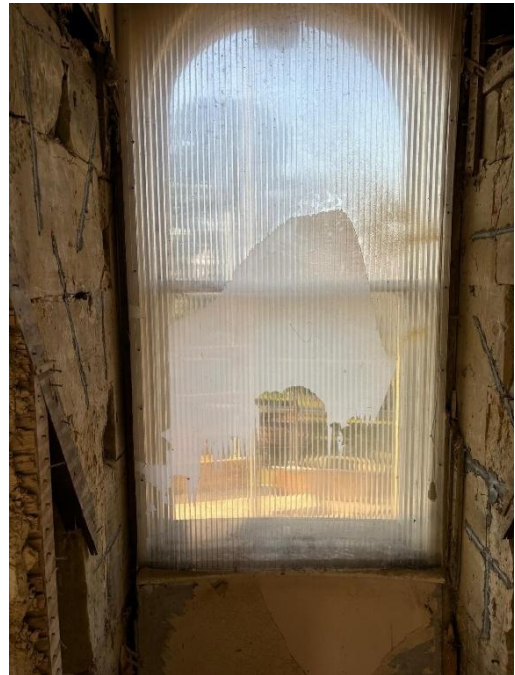
Type 2 - W2.01 with loss of glazing and polycarbonate sheeting both sides

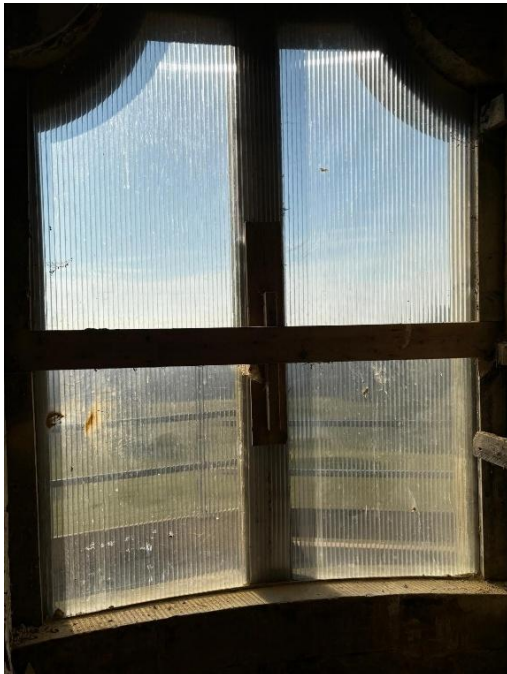
Type 1 – W2.04 with missing frame / glass

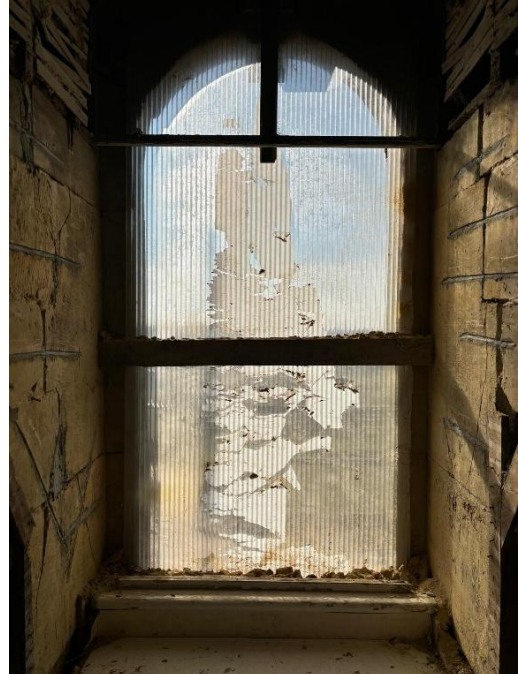
Type 2 – W2.06 with missing frame etc

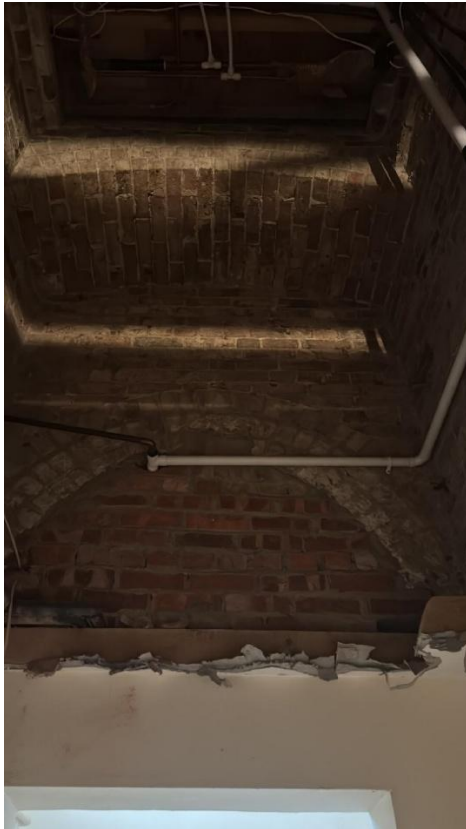
Modern plasterboard ceiling with new pipework run in void above.

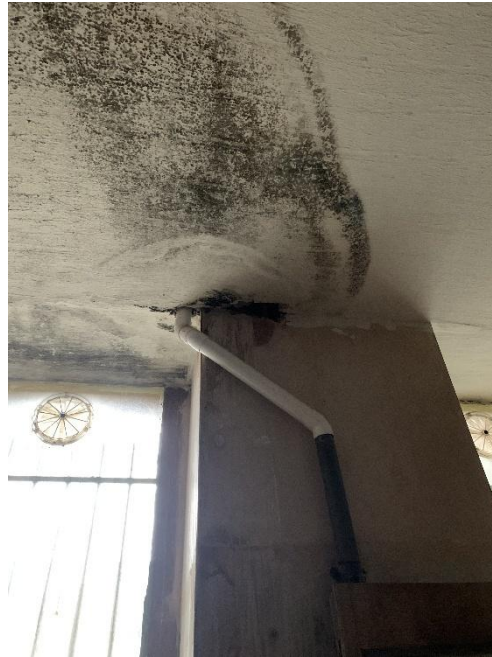
Modern, harmful pipework addition

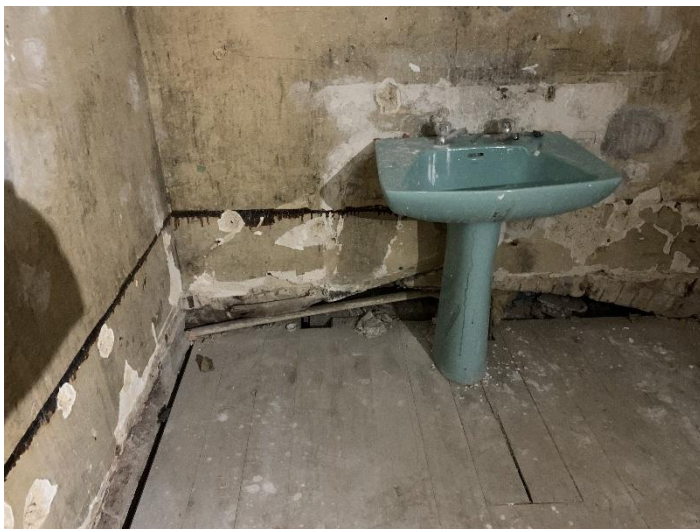
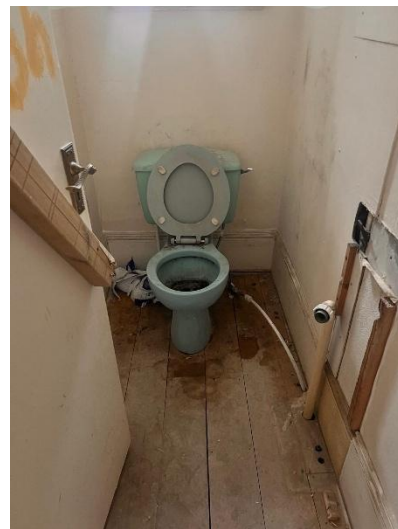
Examples of 70s plumbing additions including supplies and drainage tracking around rooms and penetrations through fabric.

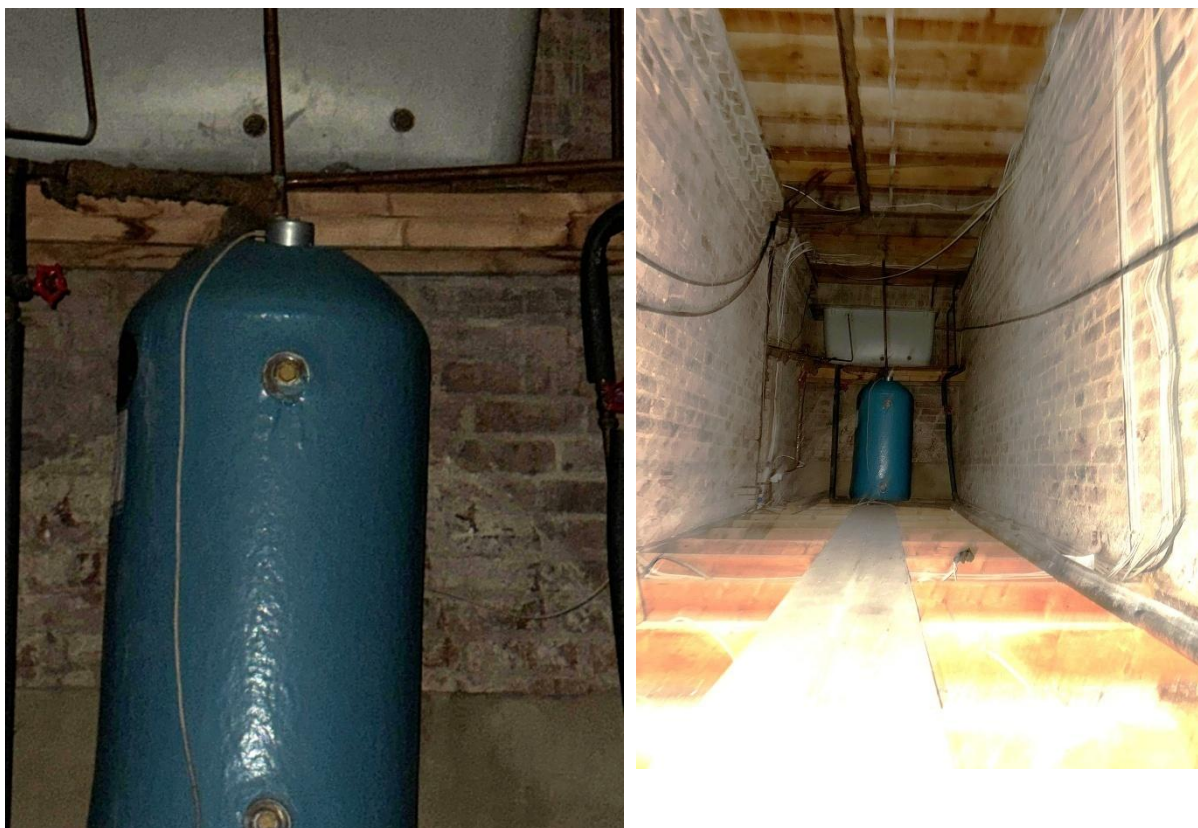
Photographs showing new de-centralised heating systems (tank and cylinder) concealed in newly formed voids, over modern joisted ceilings.

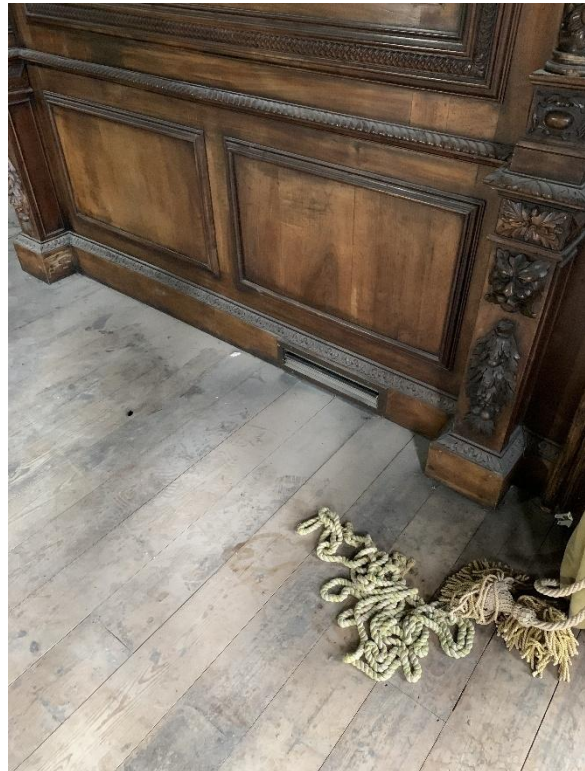
Non-original grille, connected to the duct system

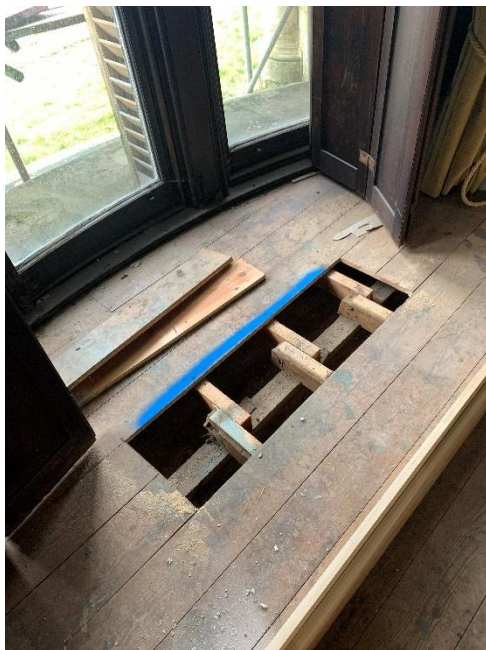
The adjacent photograph shows exploration of the existing dining room floor void, revealing modern timber supports below and a void of sufficient depth to hold the proposed trench heater product. Only the grille being visible, flush to the floor.

The floor joists below will be 'trimmed' locally to provide space for the heater, requiring one joist to be cut-out, with the ends re-supported by perpendicular double timbers, spanning between the remaining joists.

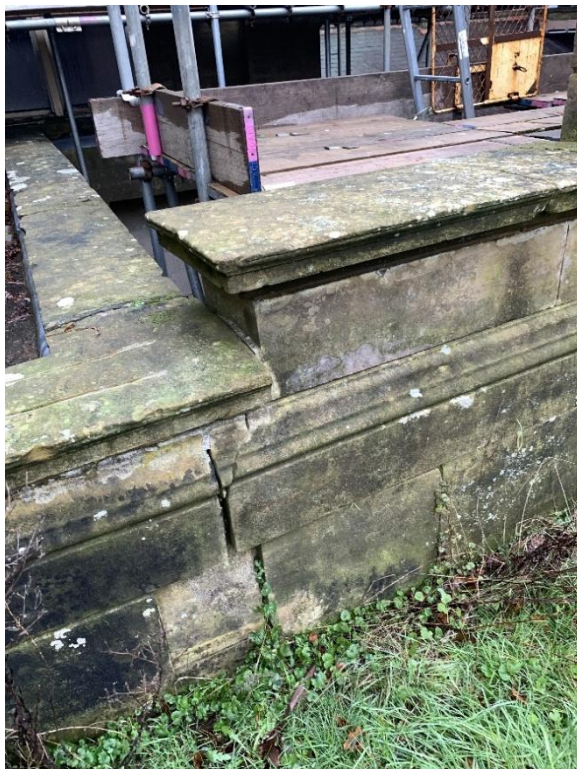
During a recent site visit we have taken further photographs (See images below), which show the reason for the failure of the wall. The wall has not failed due to the historic structural design or workmanship but is instead due to the presence of a tree, immediately adjacent this wall, which has been allowed to grow and push the wall out.

Cracked junction, courtyard wall and house

Should any cracks form, or if individual blocks be damaged, then we would anticipate using the same isolated lime mortar repairs adopted (for the same stone) on the facades of the house, by the same specialised stone masonry company.

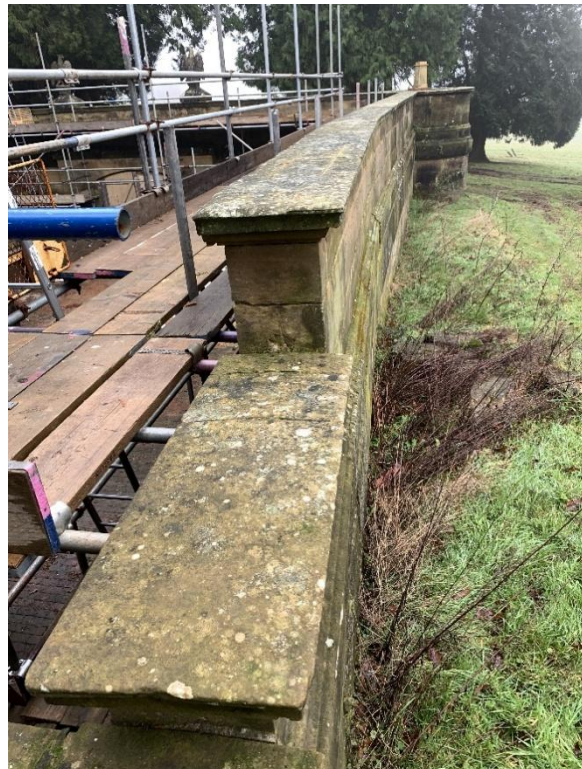
Wall bowed at high-level due to tree growth

In respect of the current proposal, it does not envisage the need to alter the visible appearance of the wall from the courtyard. Also, the stone sections themselves appear to be in good condition but are displaced due to the force of the tree growth behind. Therefore, we are optimistic that the original stones will be able to be successfully positioned in their original locations.

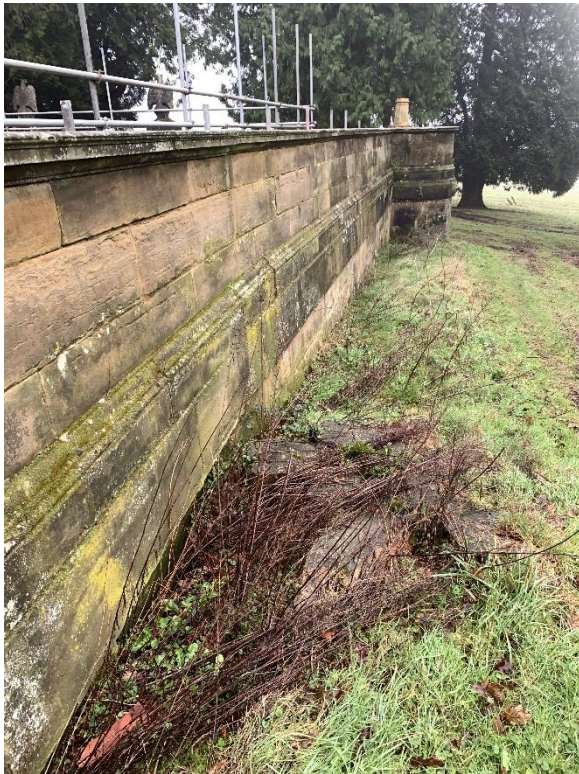
Image below shows the large tree stump. This tree had been allowed to grow immediately adjacent the wall, causing the wall to bow at high level. From within the courtyard behind, the line of the wall remains true at the ground level.
