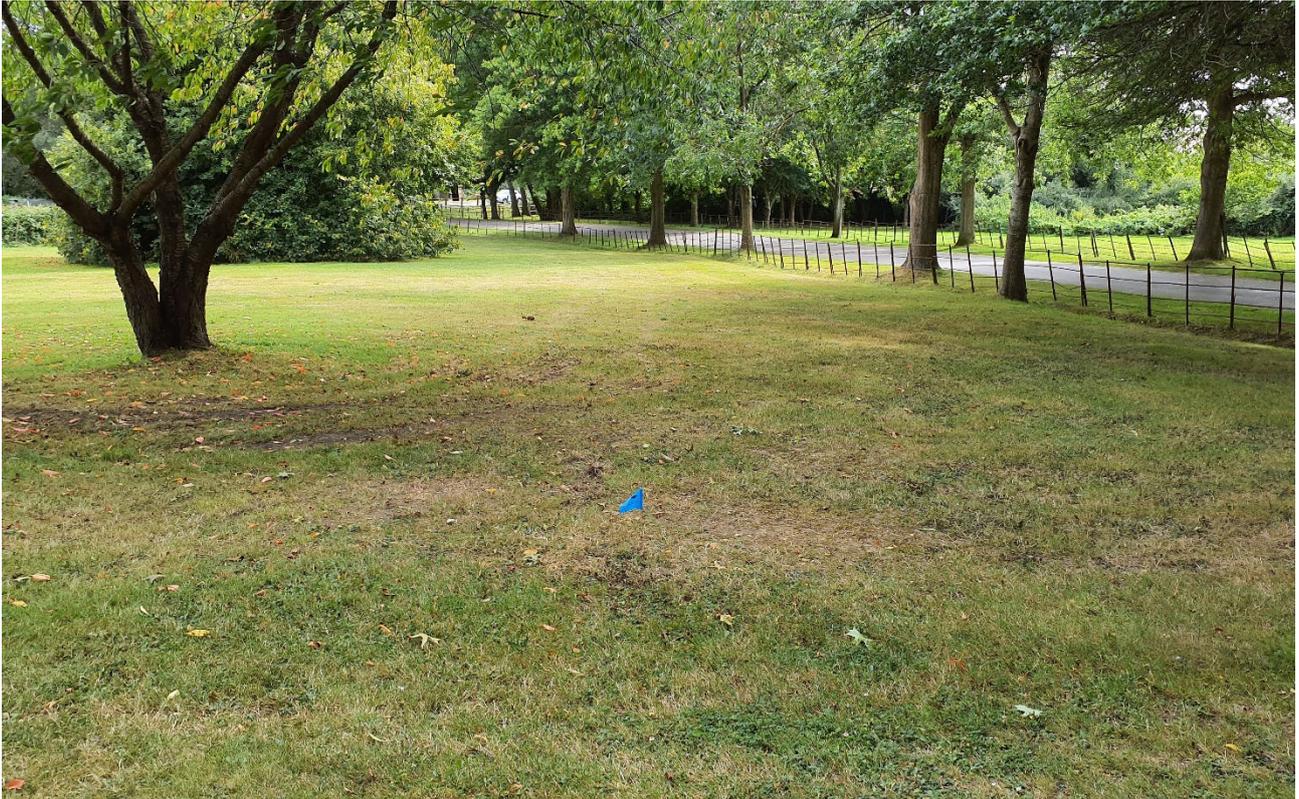
Plate 1: NE field, adjacent to entrance. Looking S towards entrance off B2118 road. WS29 flag in foreground.

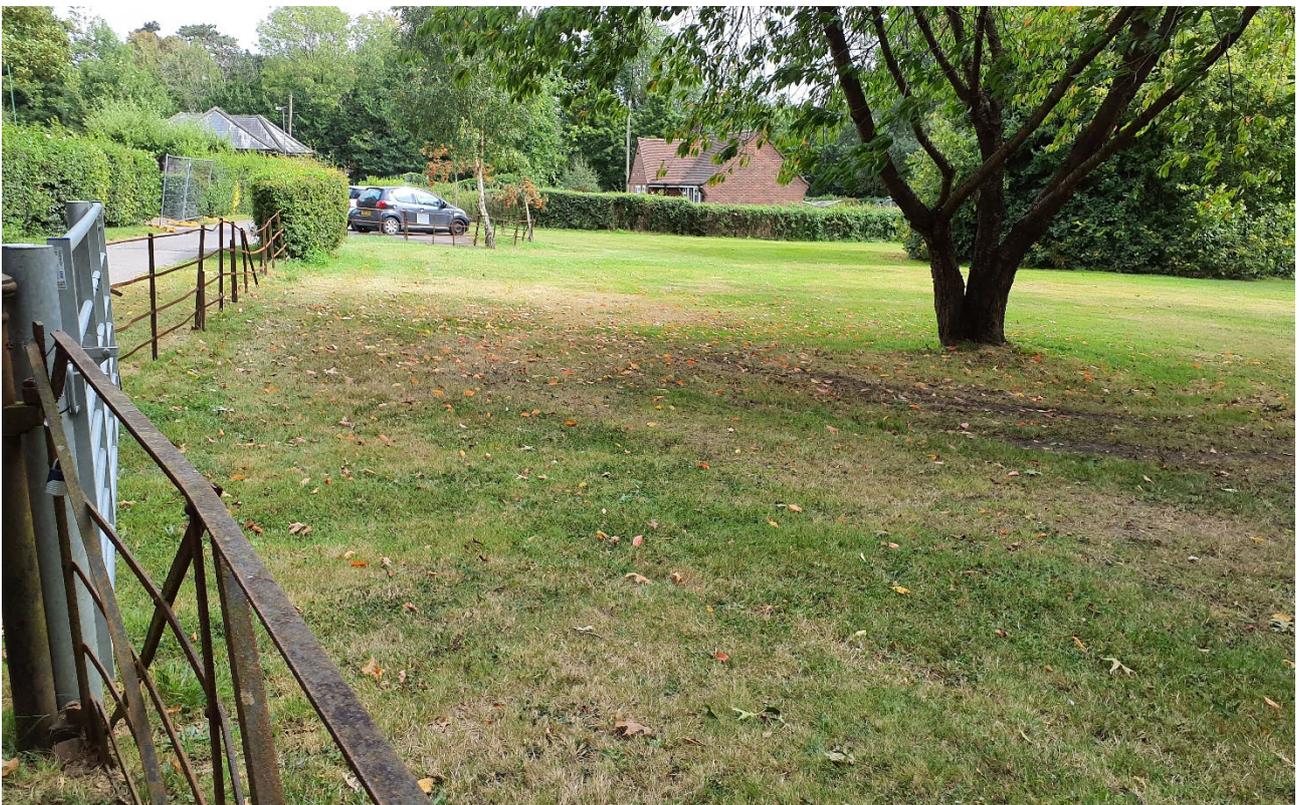
Plate 2: NE field, adjacent to entrance. Looking SE towards adjacent residential property.

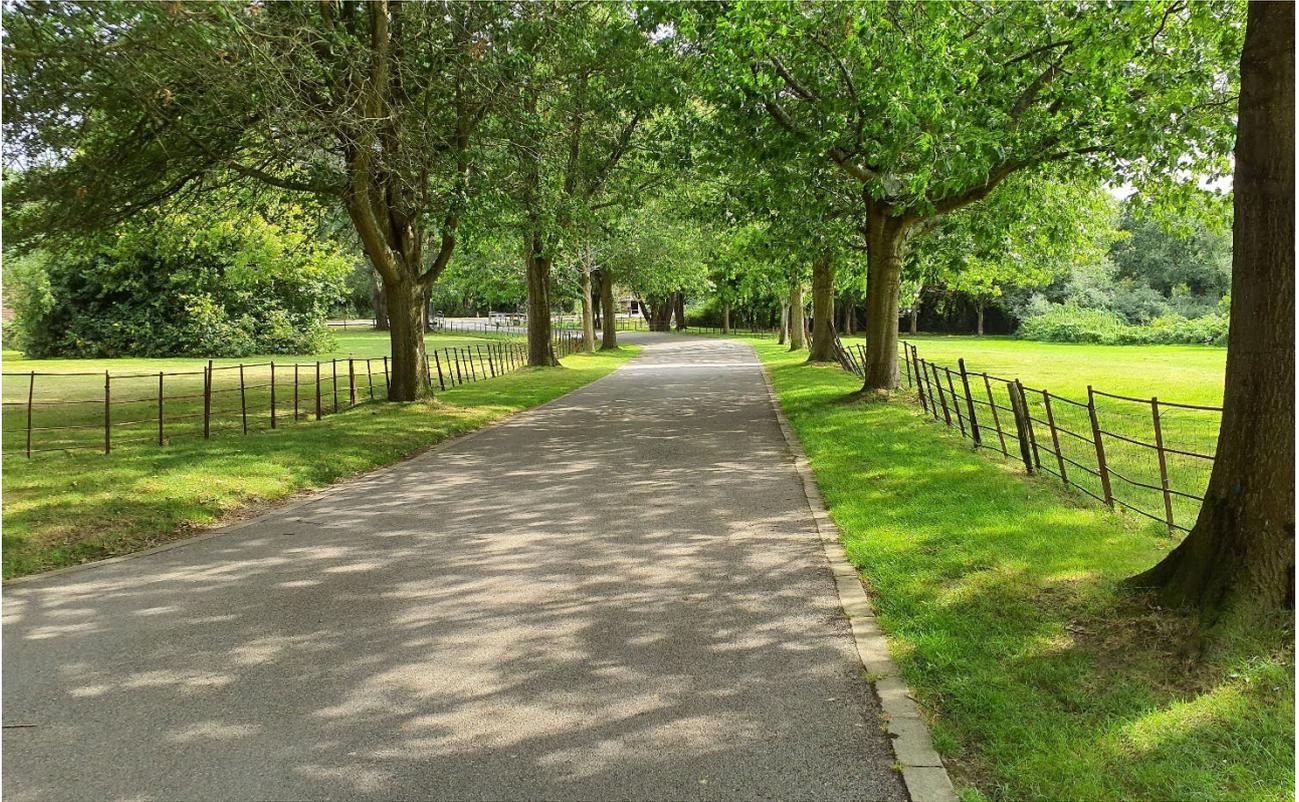
Plate 3: Looking SE along access road, towards entrance. Field adjacent to residential property to the left, eastern field to the right.

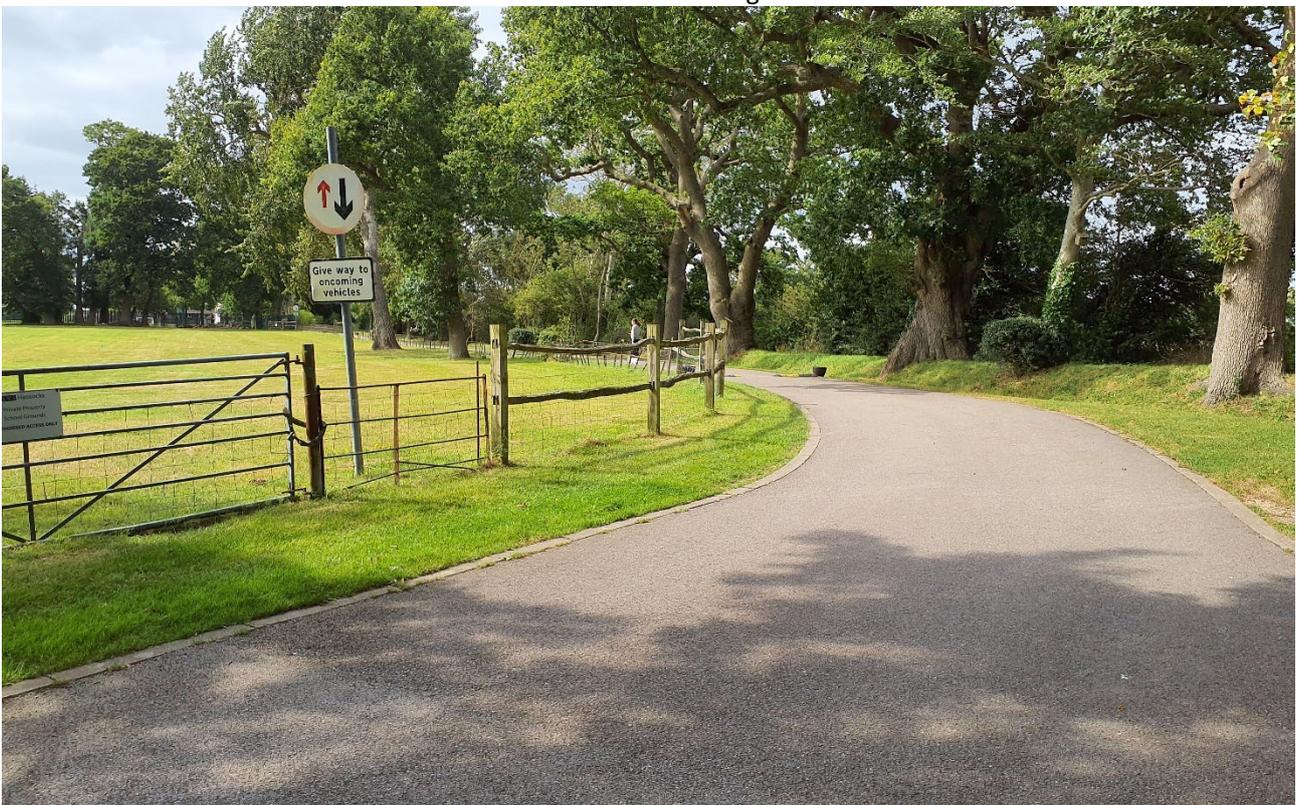
Plate 4: Looking NW along access road.

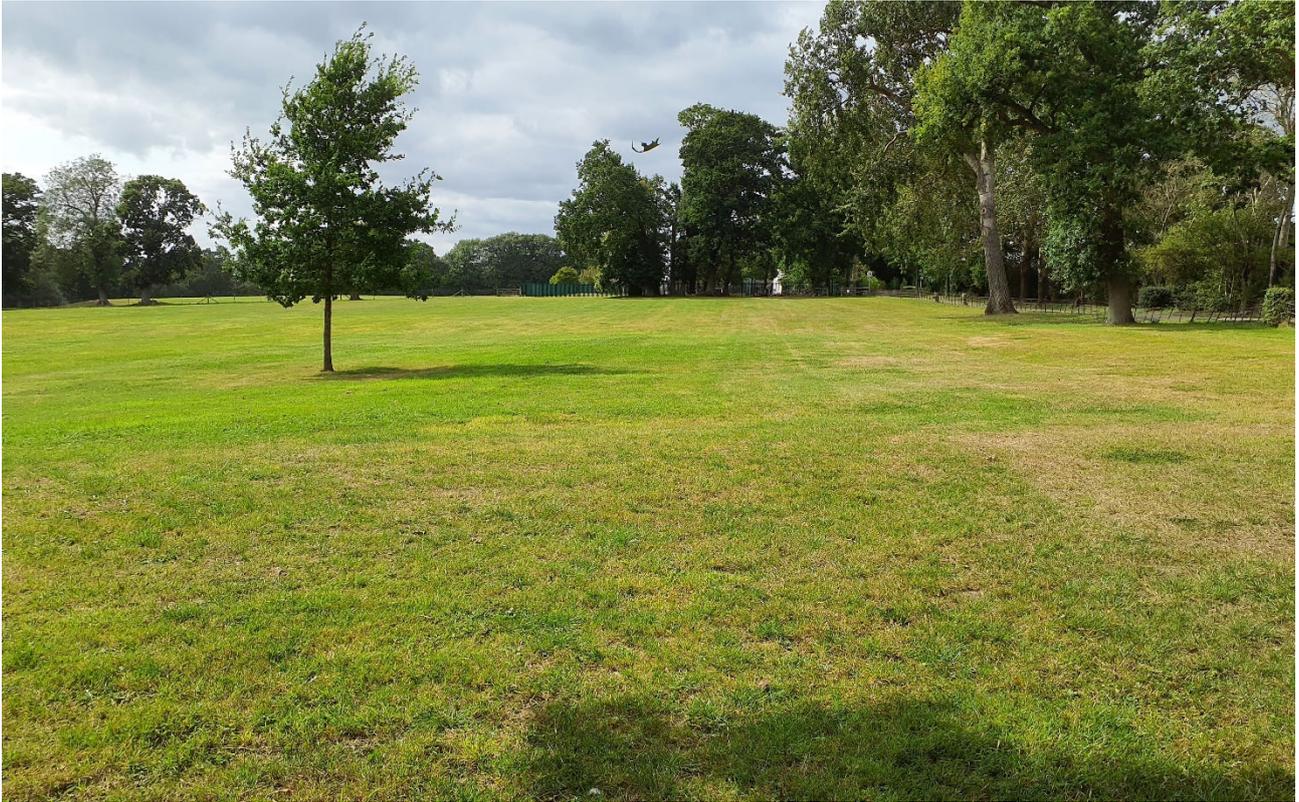
Plate 5: Looking W across eastern field.

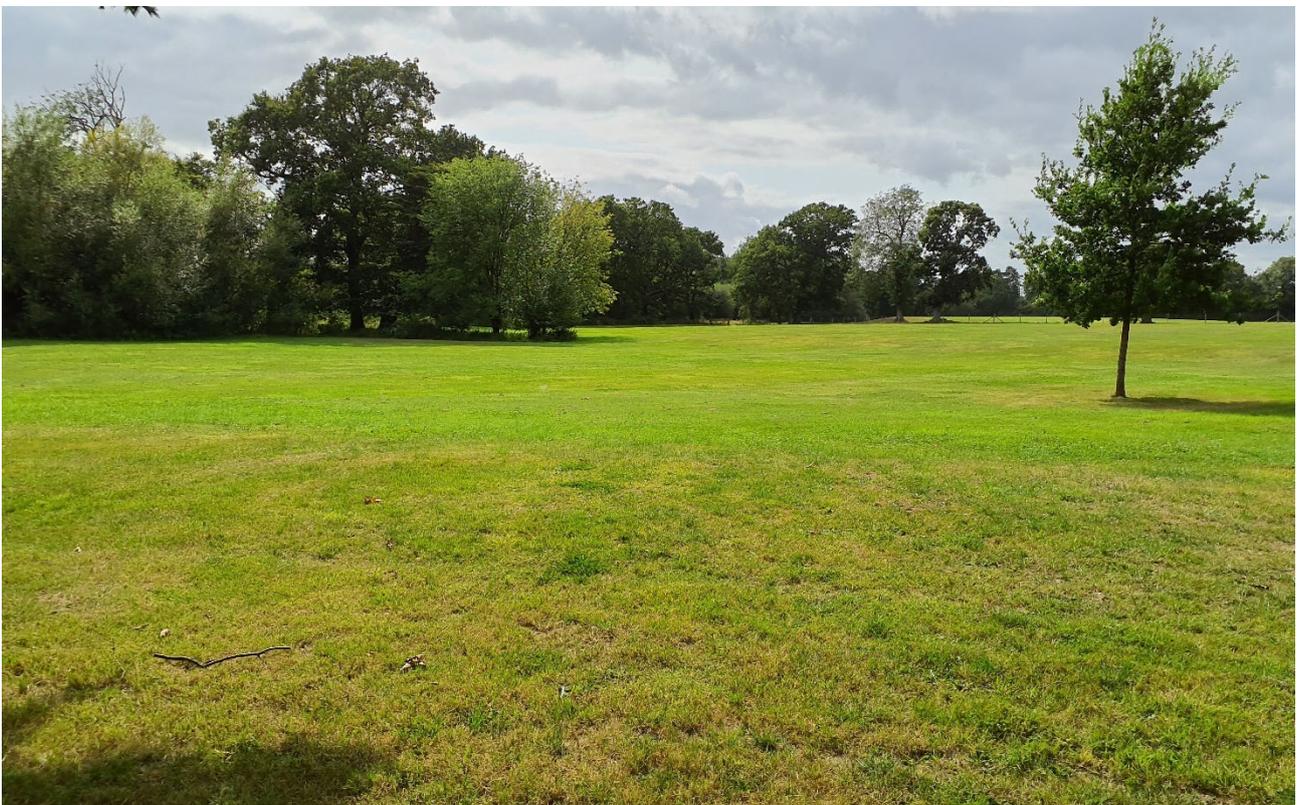
Plate 6: Looking SW across eastern field.

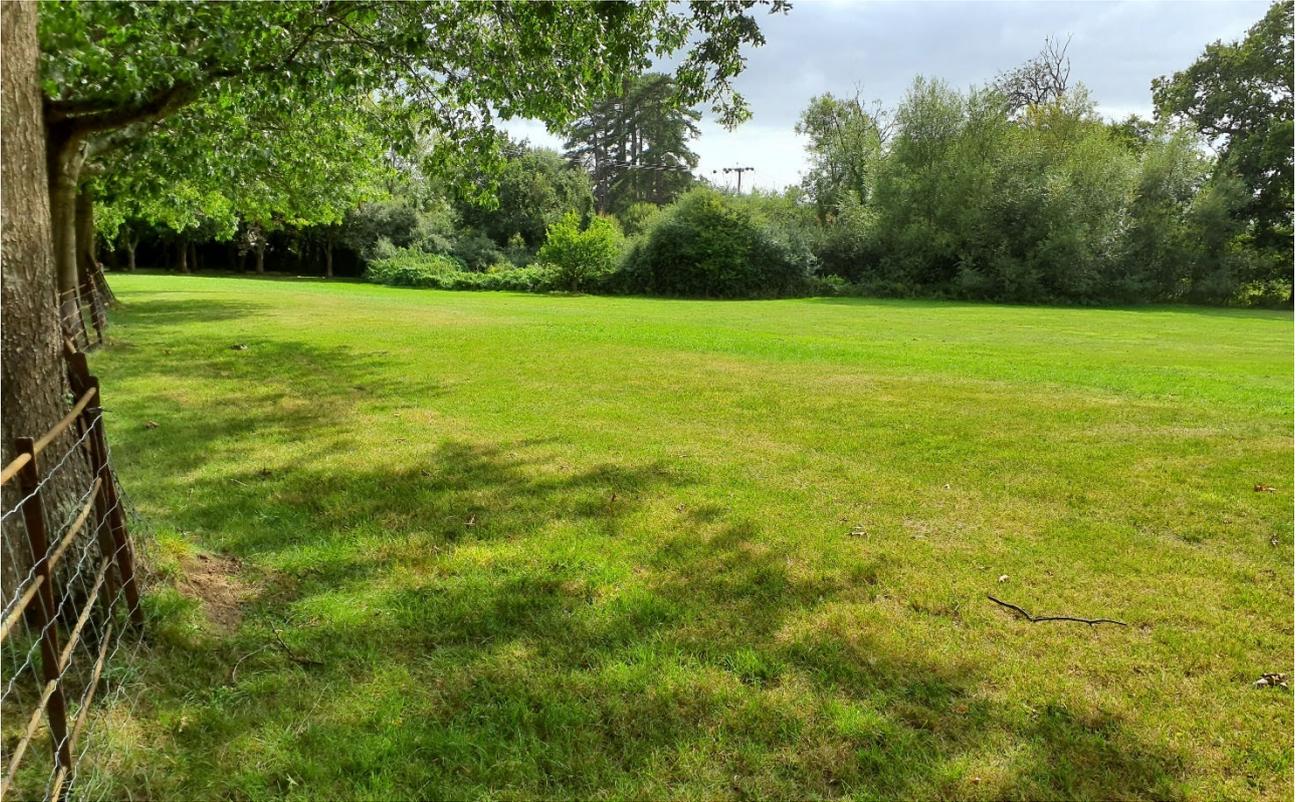
Plate 7: Looking SE along treeline in the NE of the eastern field.

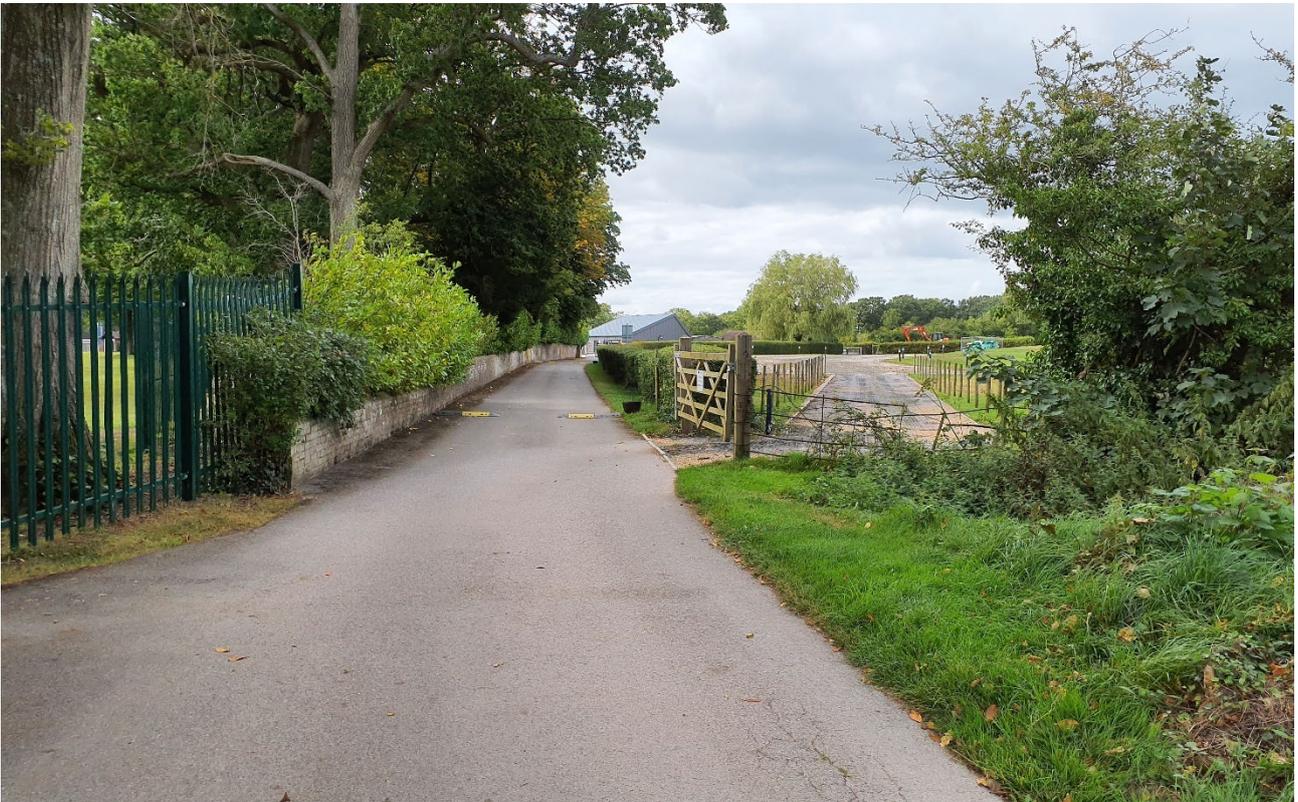
Plate 8: Looking E along access road from centre of site on the bend in the road.

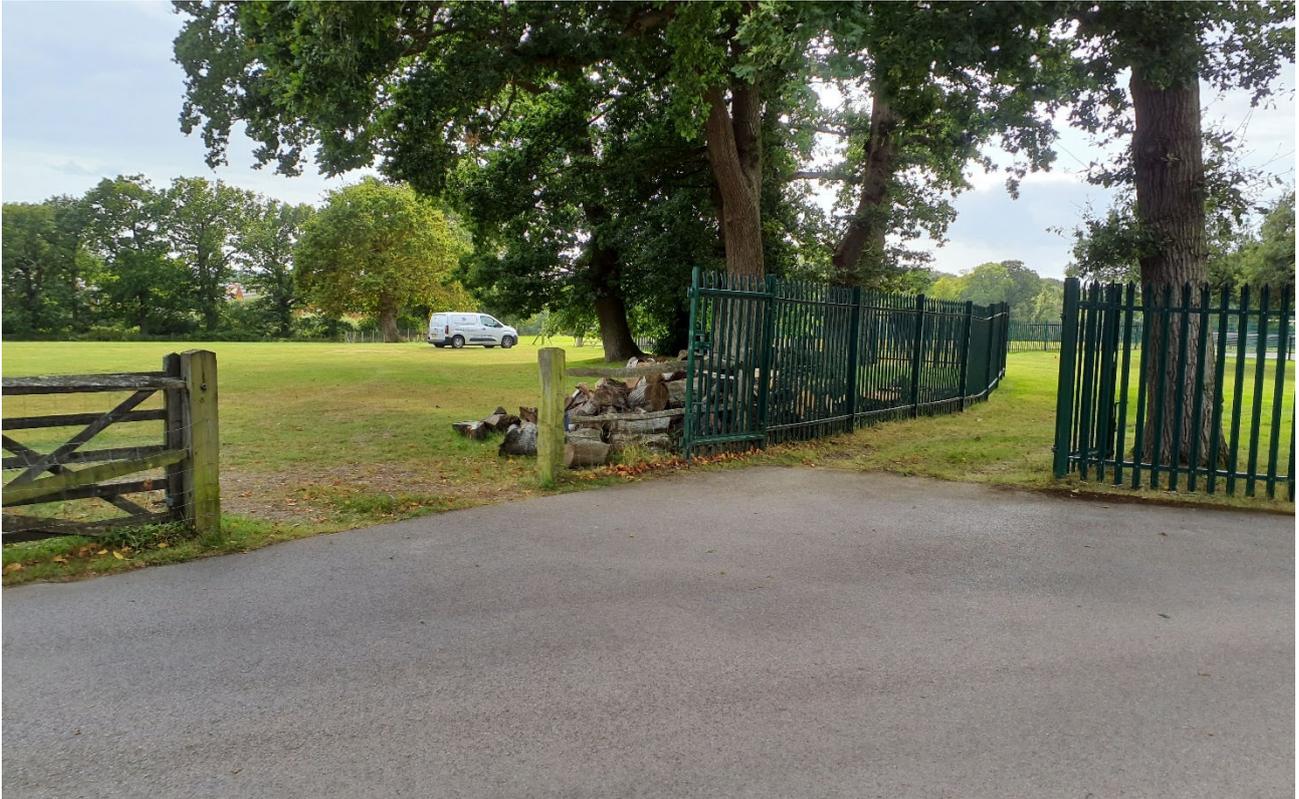
Plate 9: Looking SW into eastern field. Basketball court site beyond metal fencing in the right of the photo.

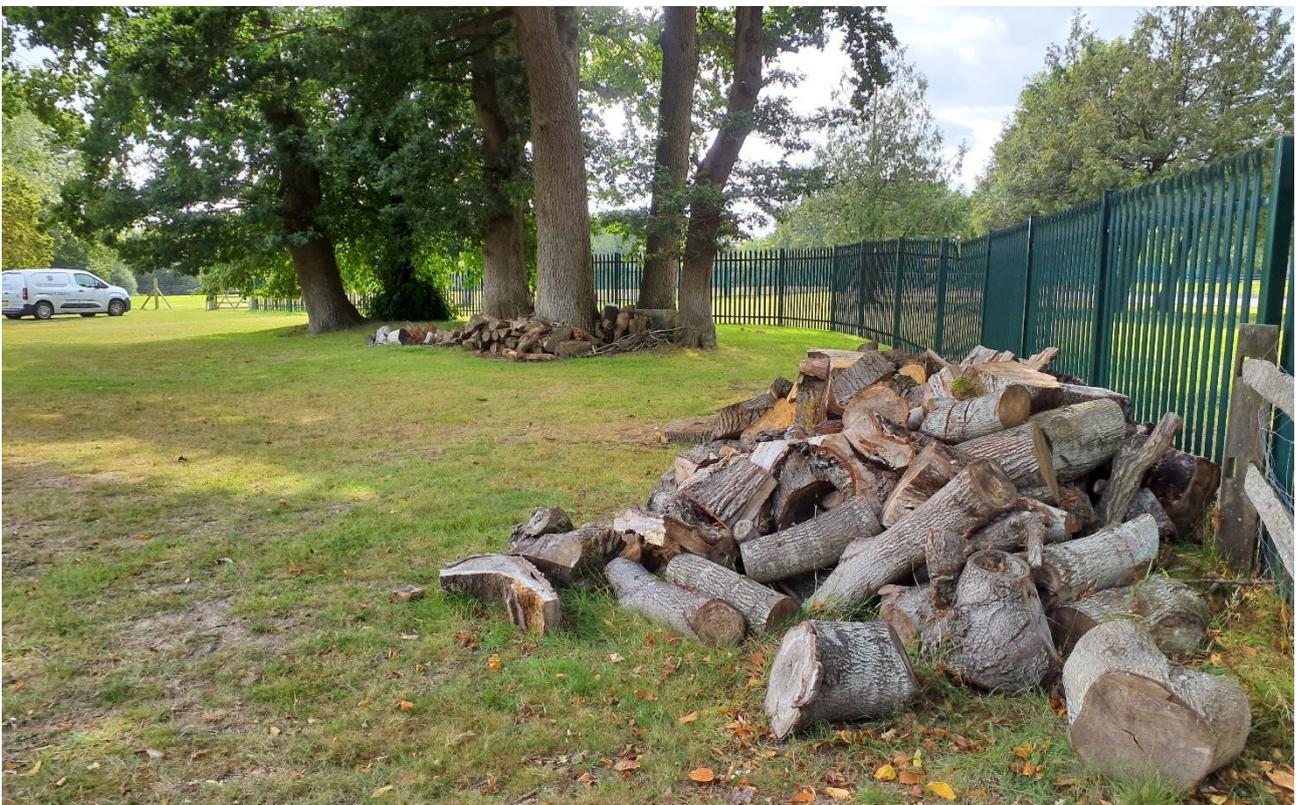
Plate 10: Stockpile of chopped wood in NW corner of eastern field. Looking SW.

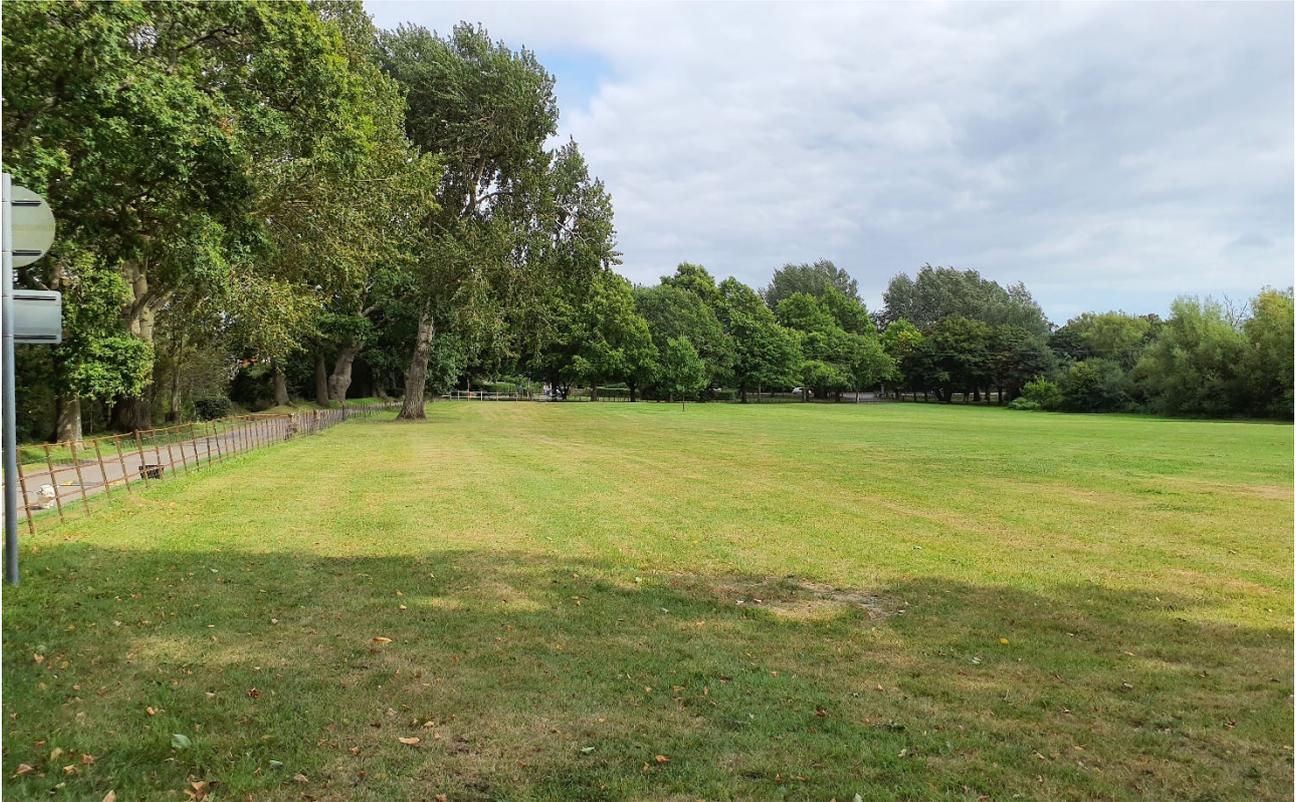
Plate 11: Looking E across eastern field.

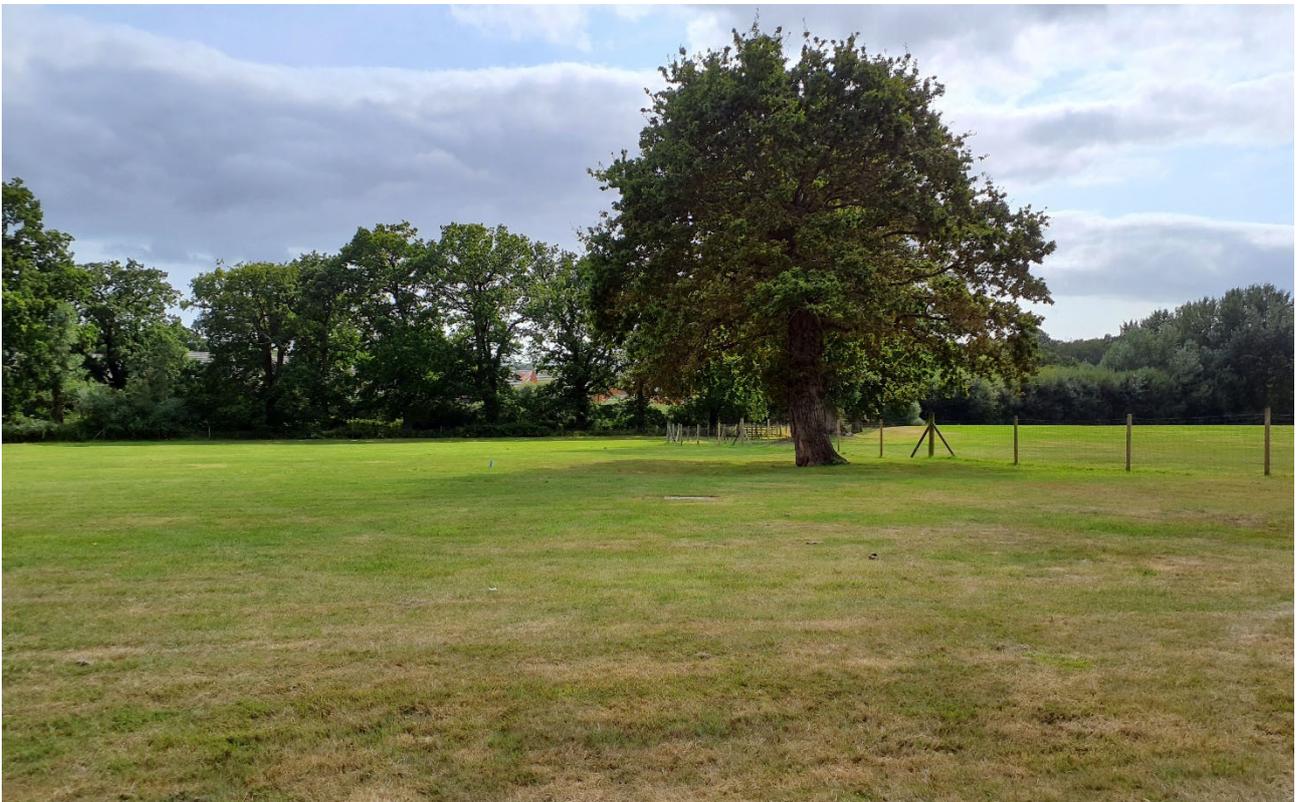
Plate 12: Tree on boundary between eastern field and southern field.

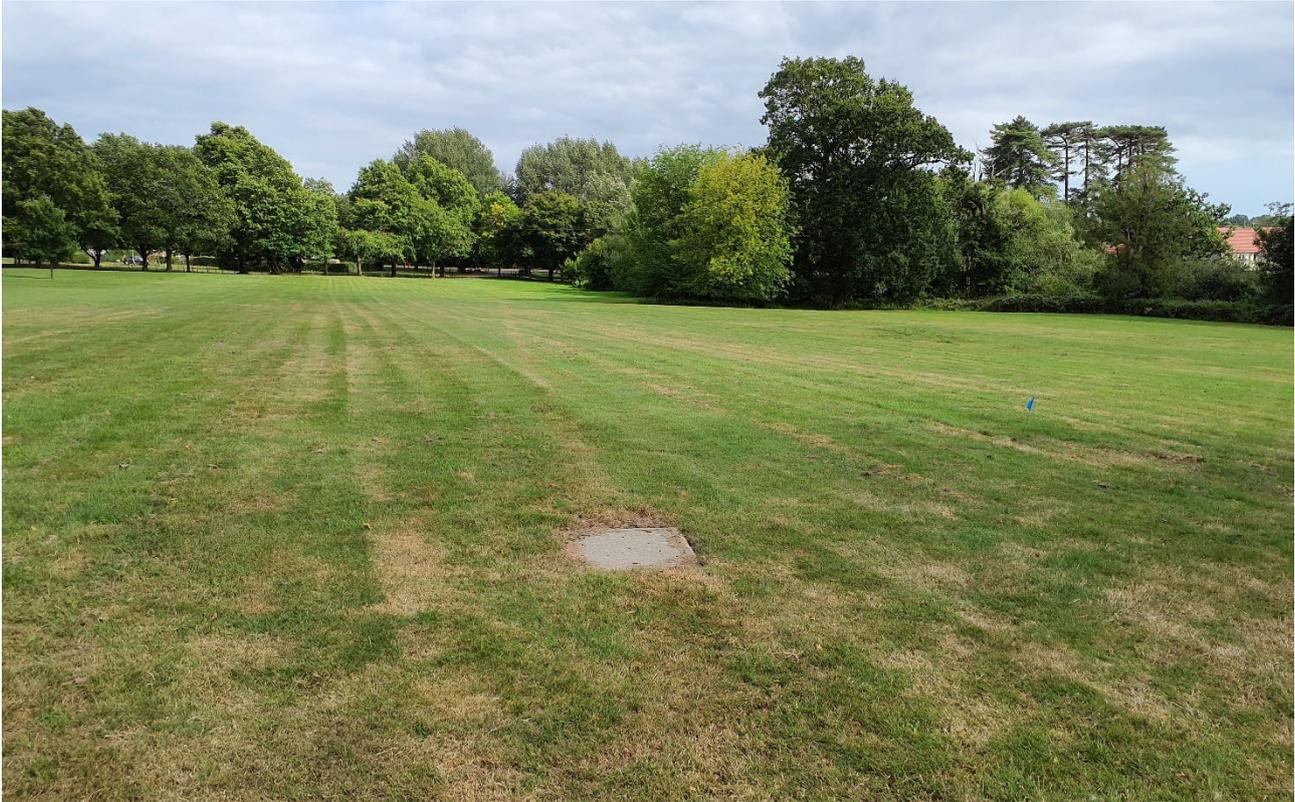
Plate 13: Service cover and faint trace line across eastern field. Looking SW.

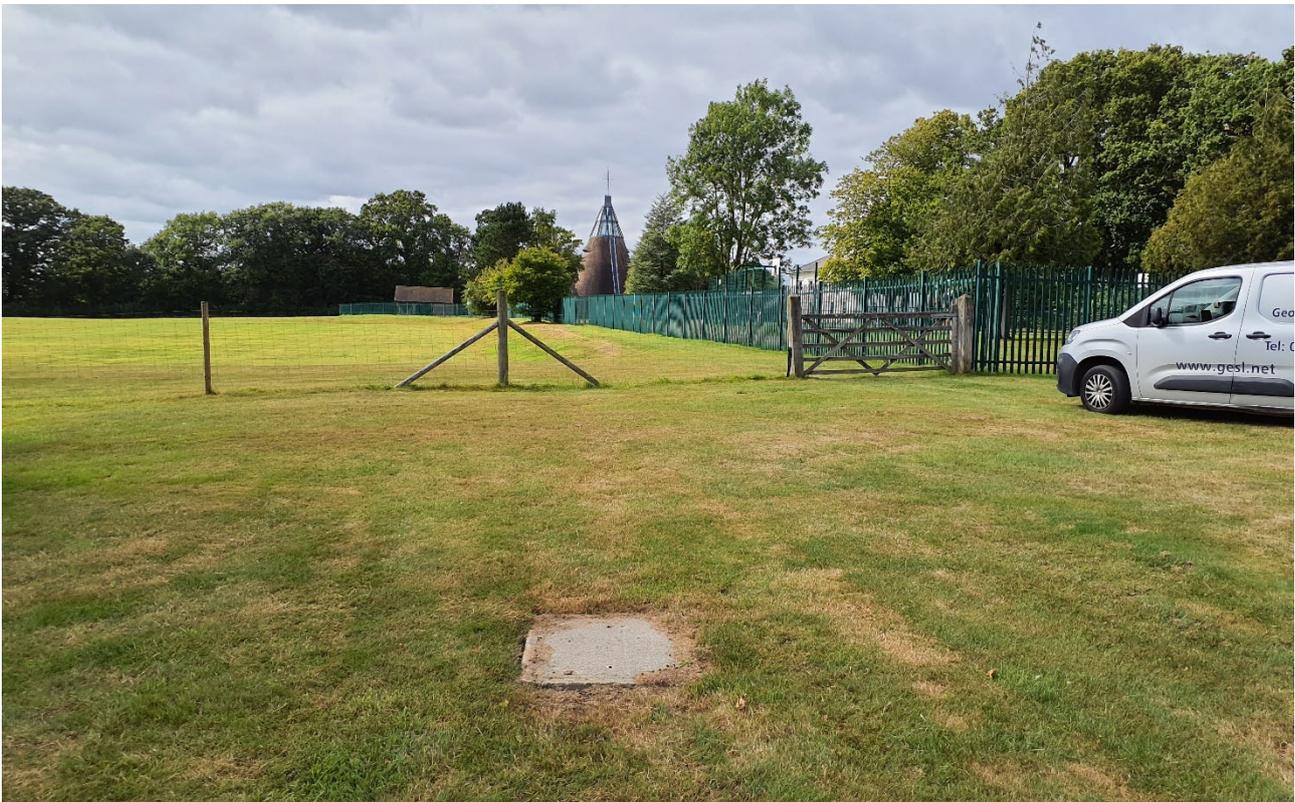
Plate 14: Service cover looking NW. Trace line visible and change in green metal fence line visible where service crosses fence boundary (visible at left of base of cone-shaped church building).

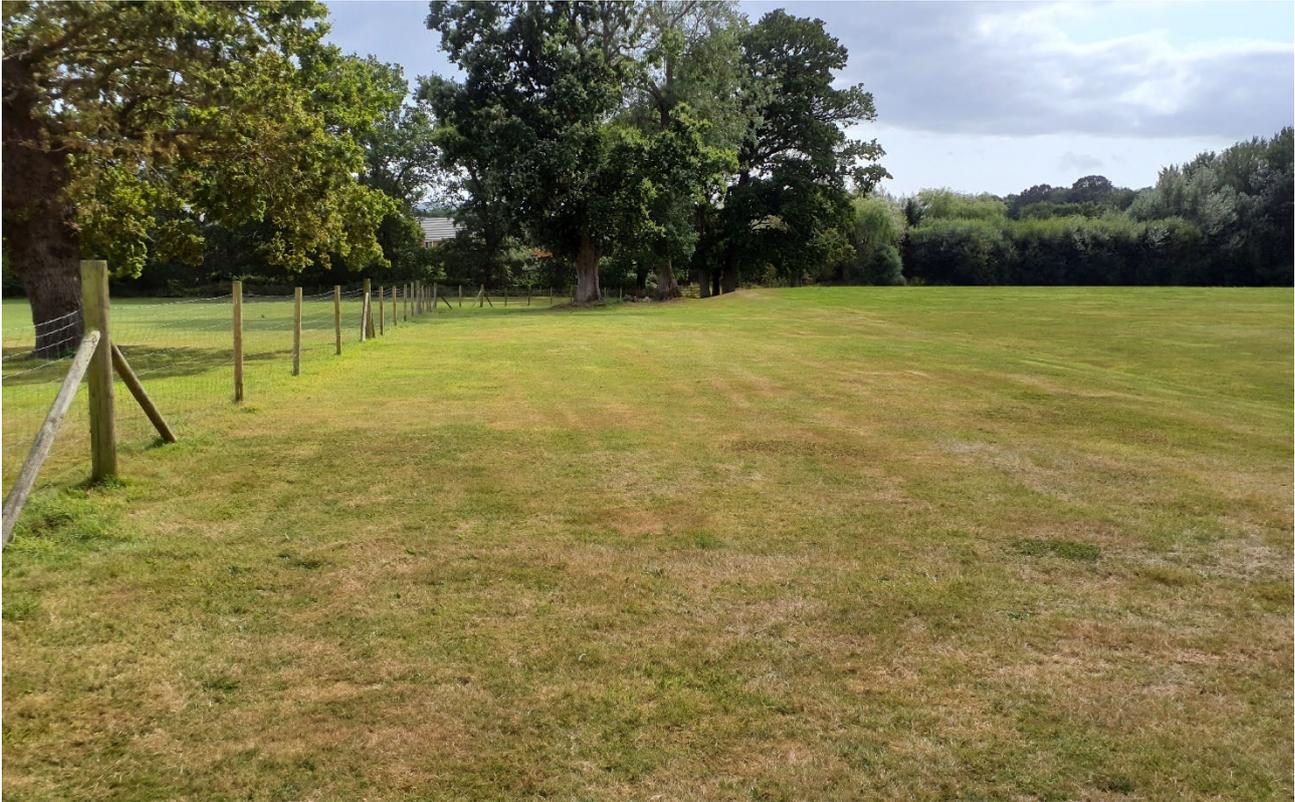
Plate 15: Fenceline between eastern and southern fields. Earthworks fill visible on right side of photo for level playing field.

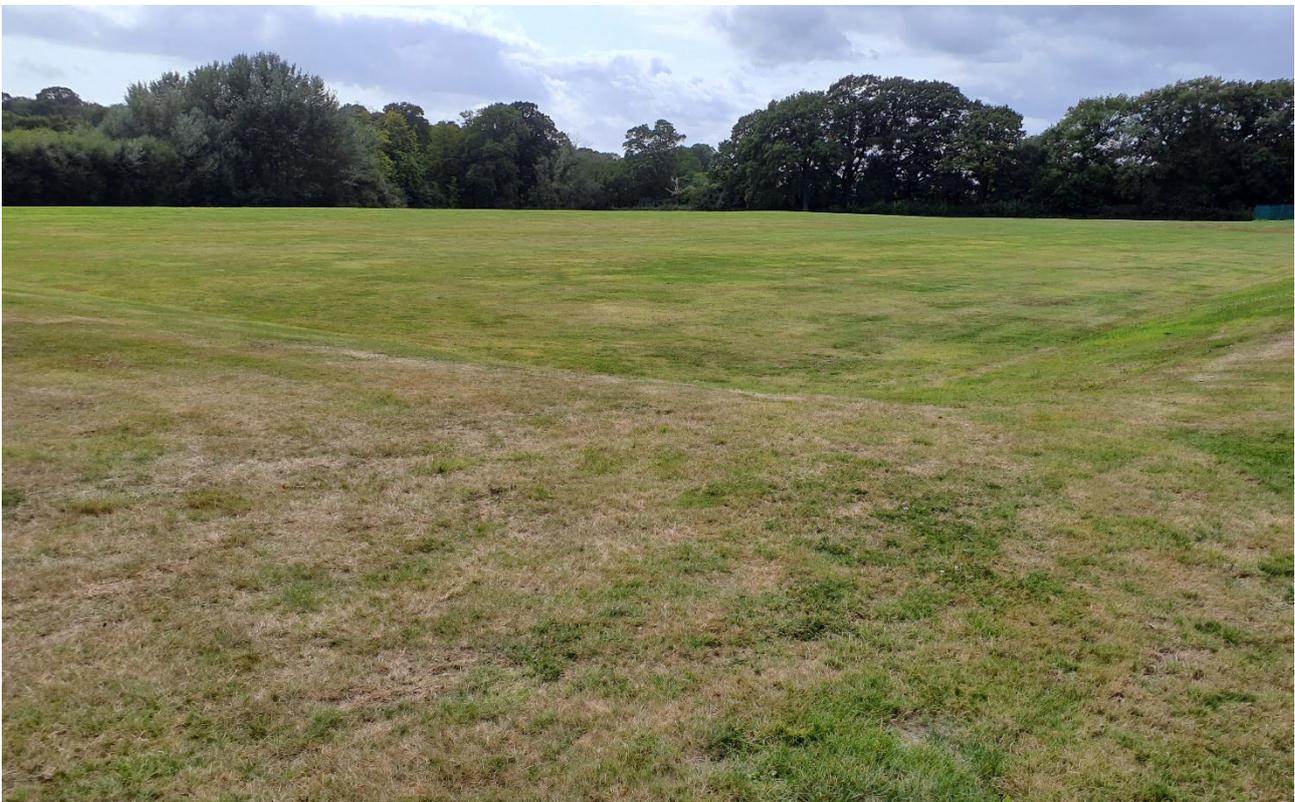
Plate 16: Level playing field in southern field. Earthworks cut and fill visible.
