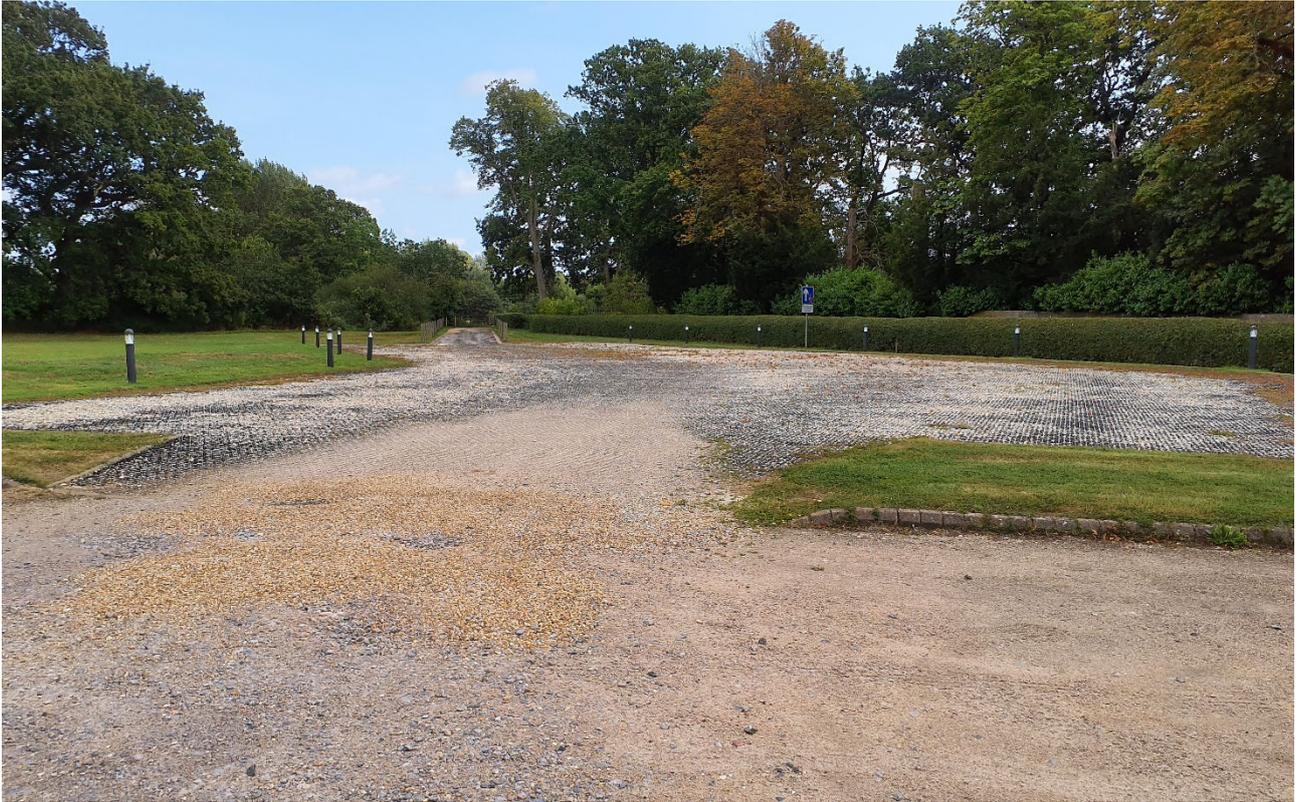
Plate 105: SE area of car park. Geogrid and gravel surface. Looking SE.

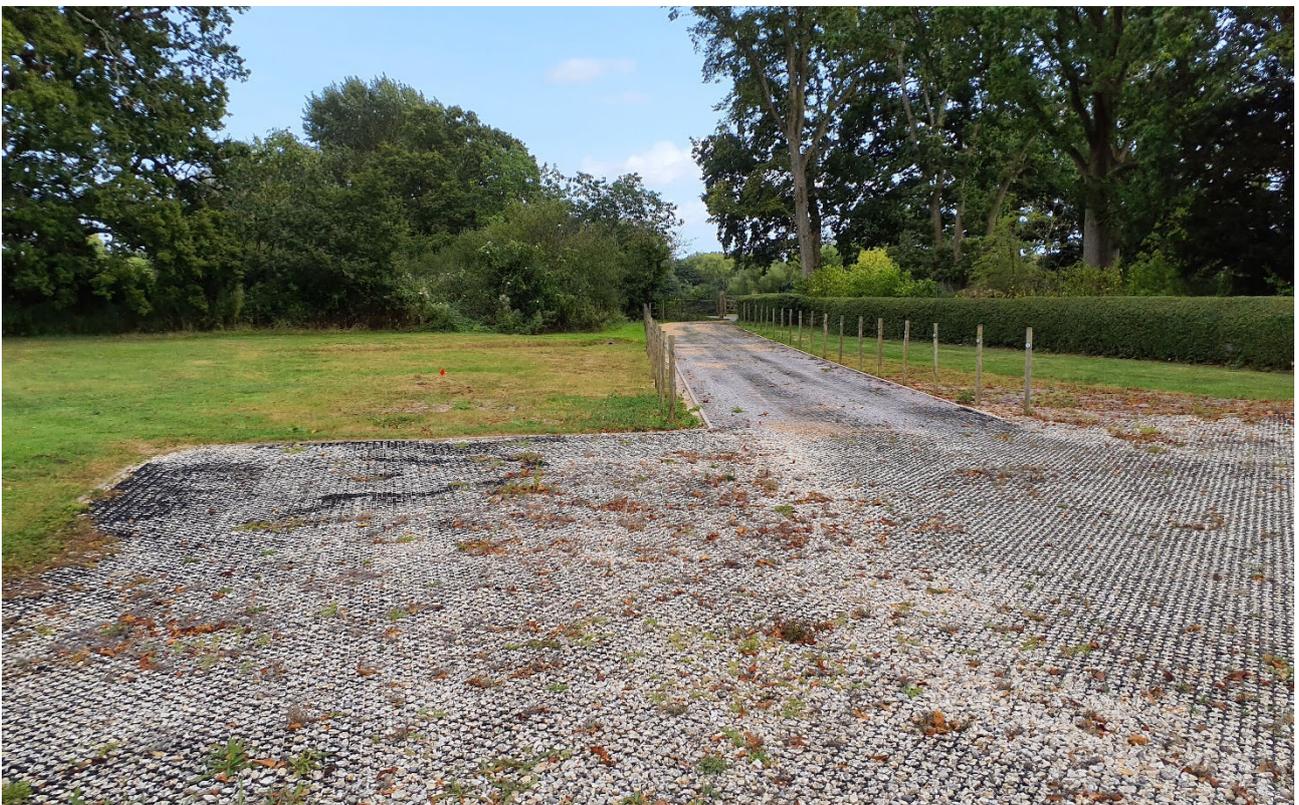
Plate 106: SE area of car park. Geogrid and gravel surface. Looking SE.

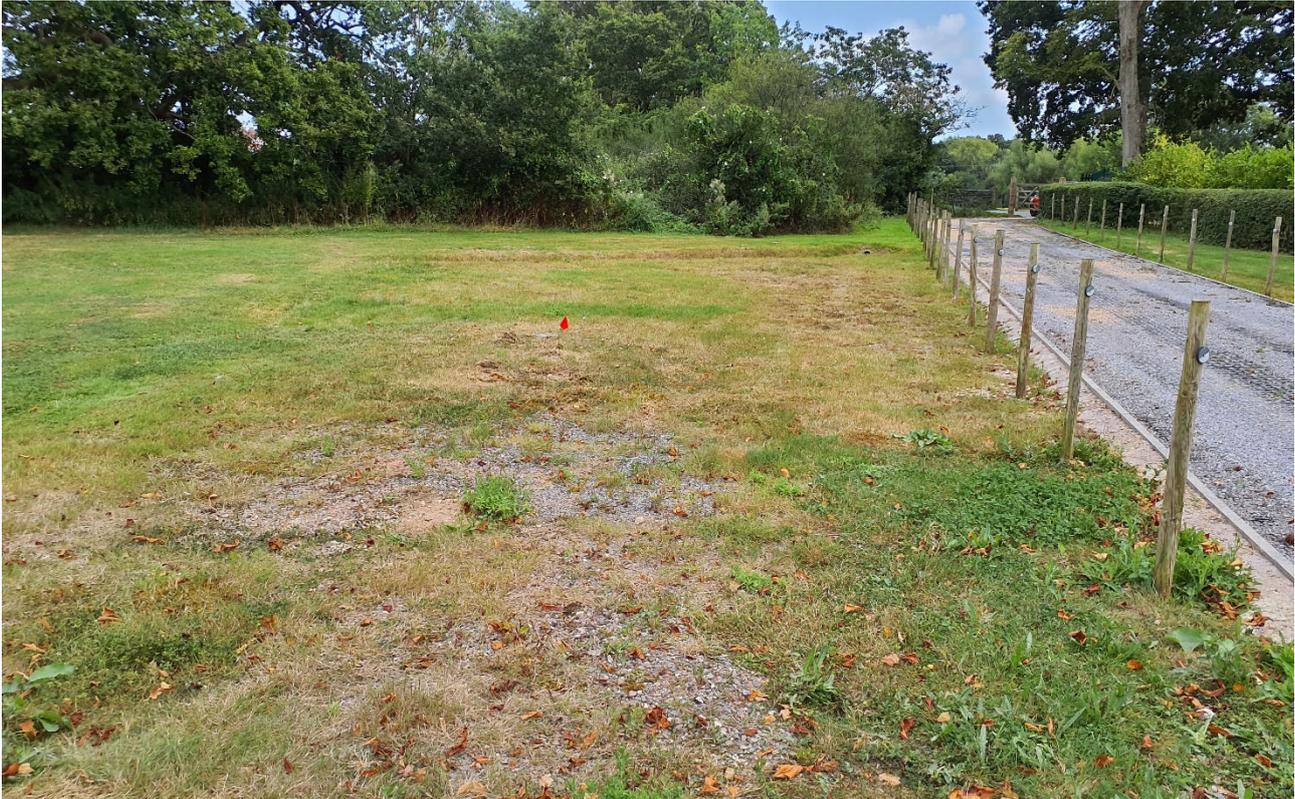
Plate 107: Area of field with some gravel, appeared to be reclaimed from car park. Drain visible in background. Looking E.

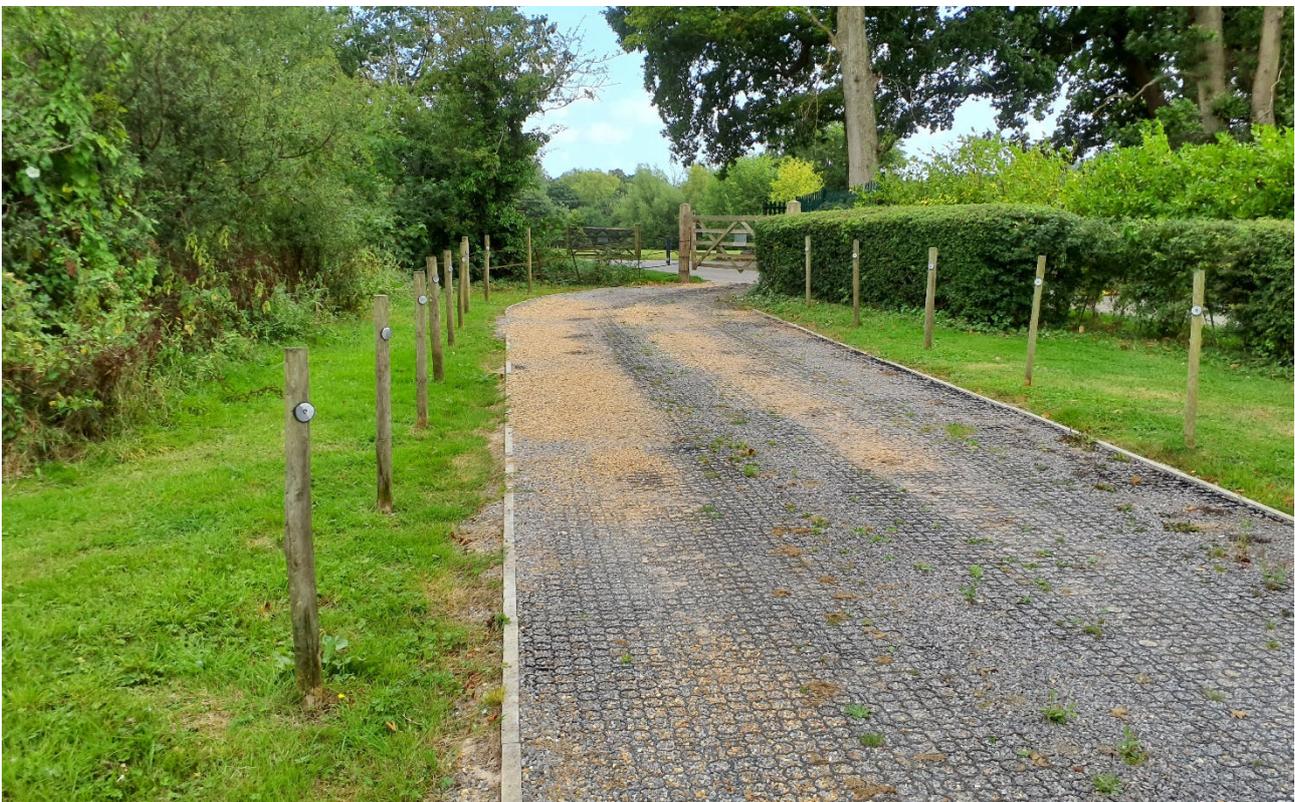
Plate 108: Access driveway from car park to access road. Looking SE.

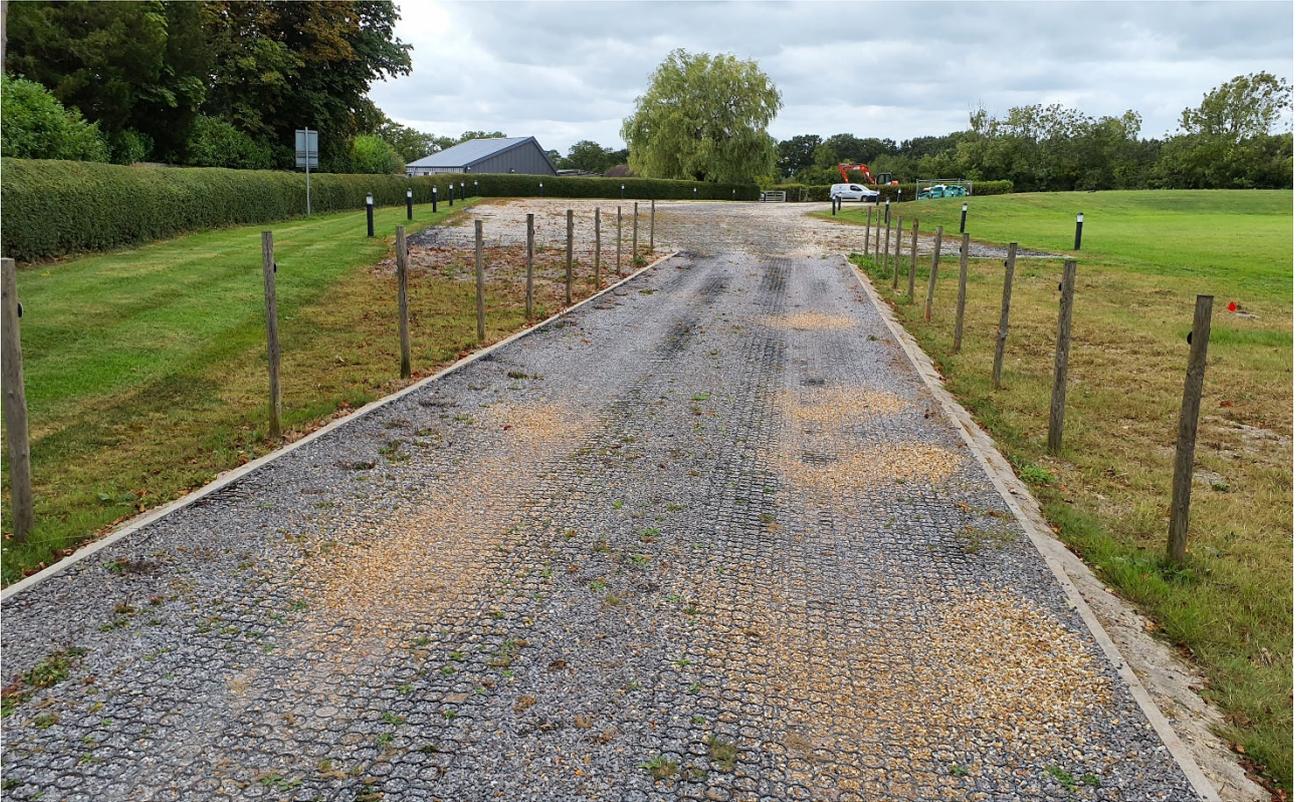
Plate 109: Looking NW across car park.

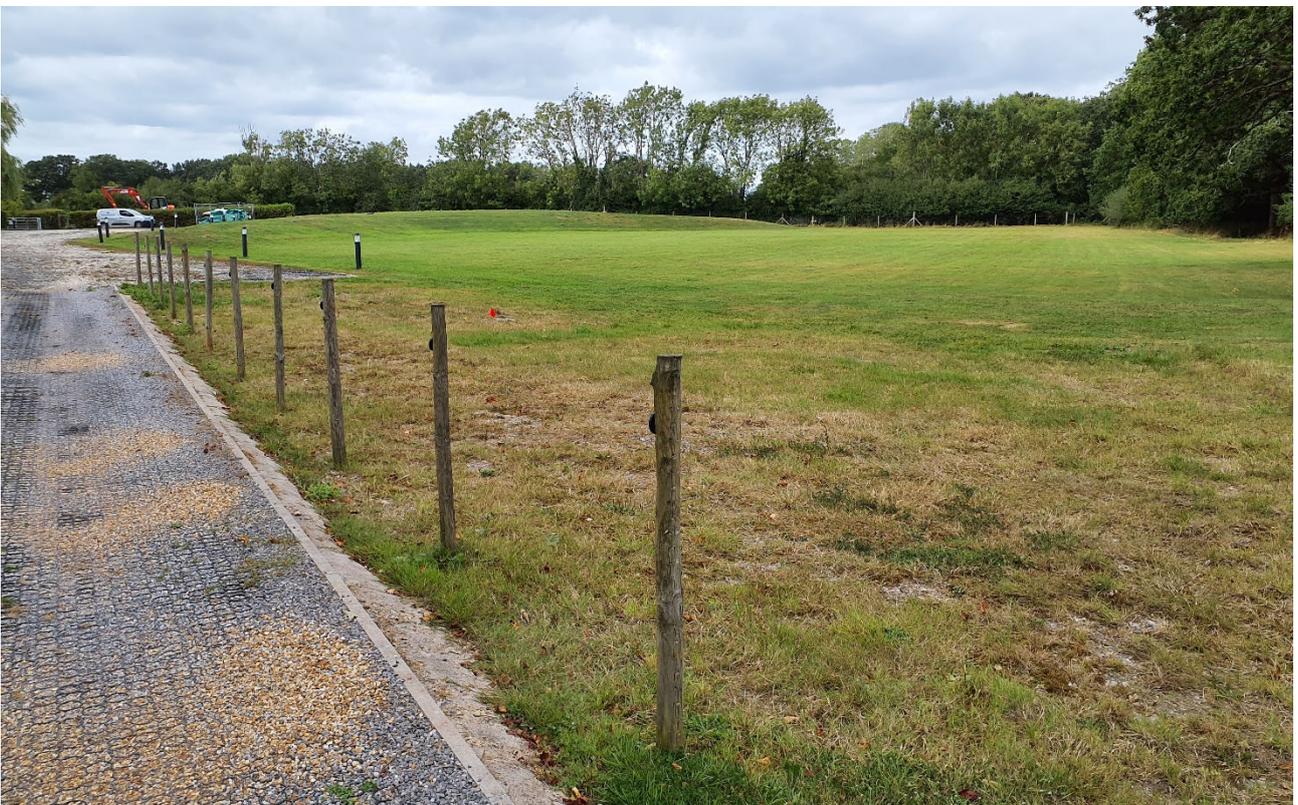
Plate 110: Looking NE across field adjacent to car park. Earthworks bund in NW corner of field.

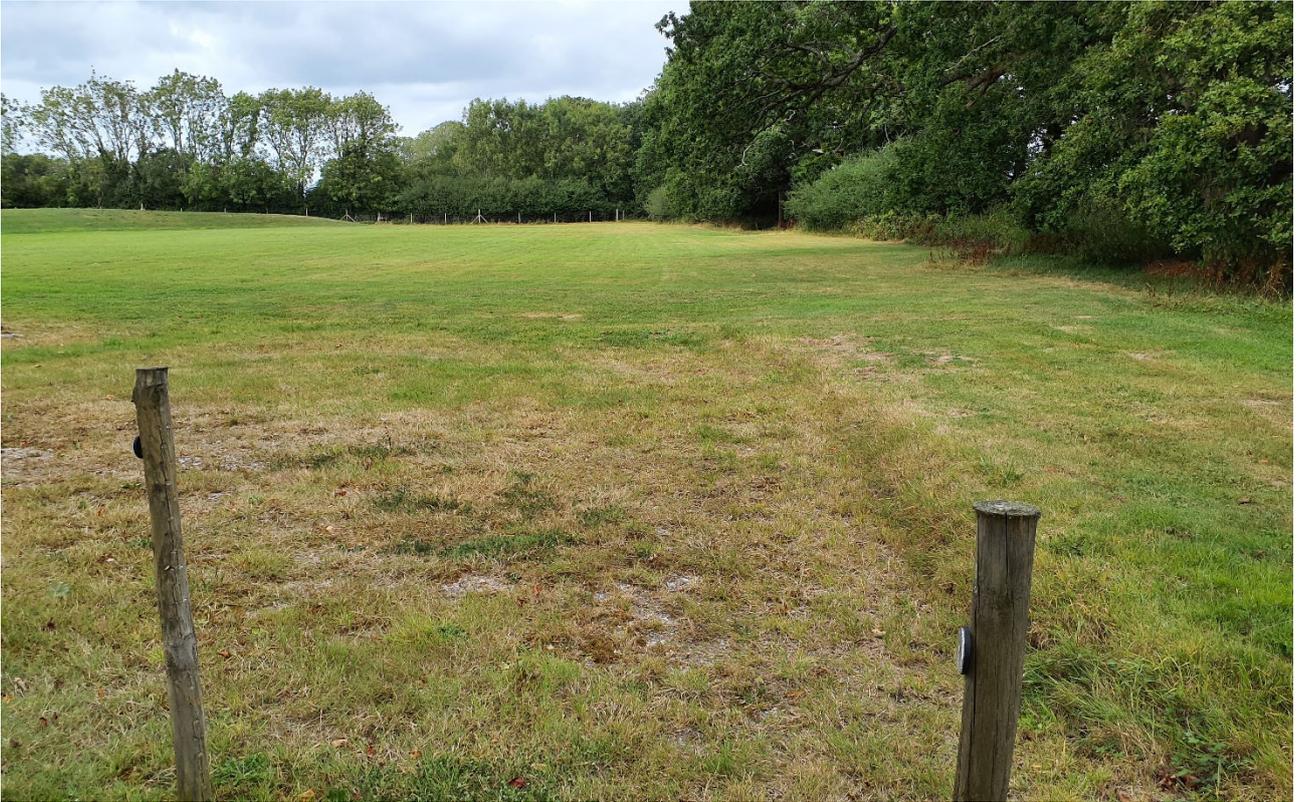
Plate 111: Looking N across field adjacent to car park. Earthworks bund in NW corner of field.

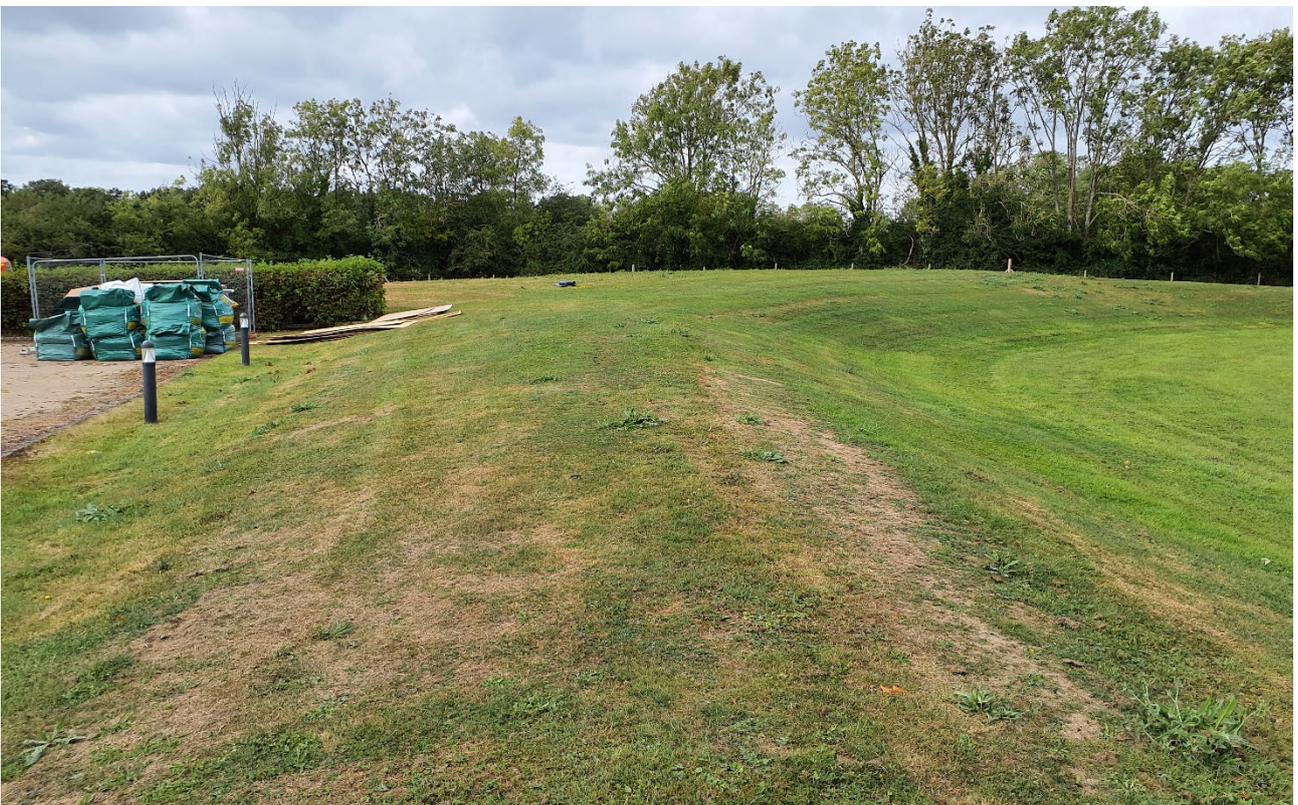
Plate 112: Looking N across NW portion of field adjacent to car park. Earthworks.

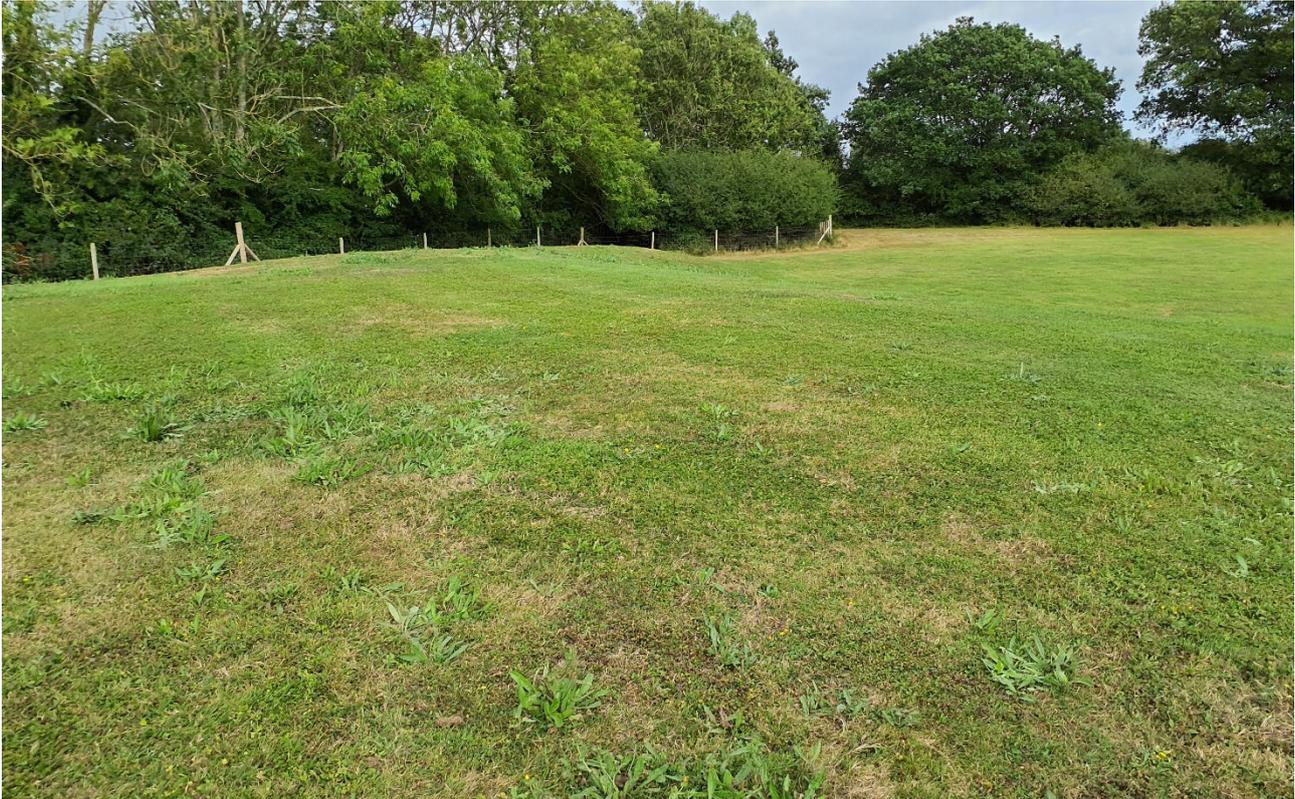
Plate 113: Looking NE from NW portion of field adjacent to car park. Earthworks.

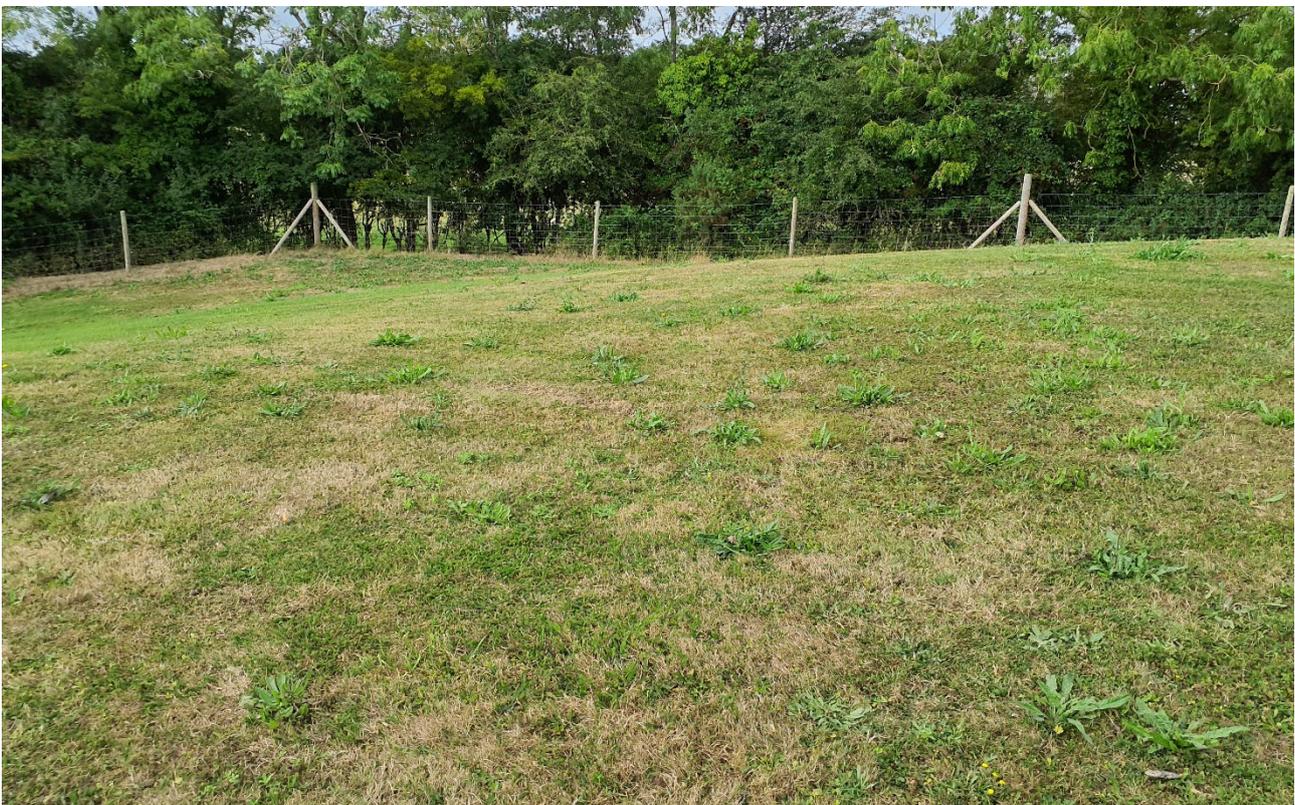
Plate 114: Looking NW from NW portion of field adjacent to car park. Earthworks.

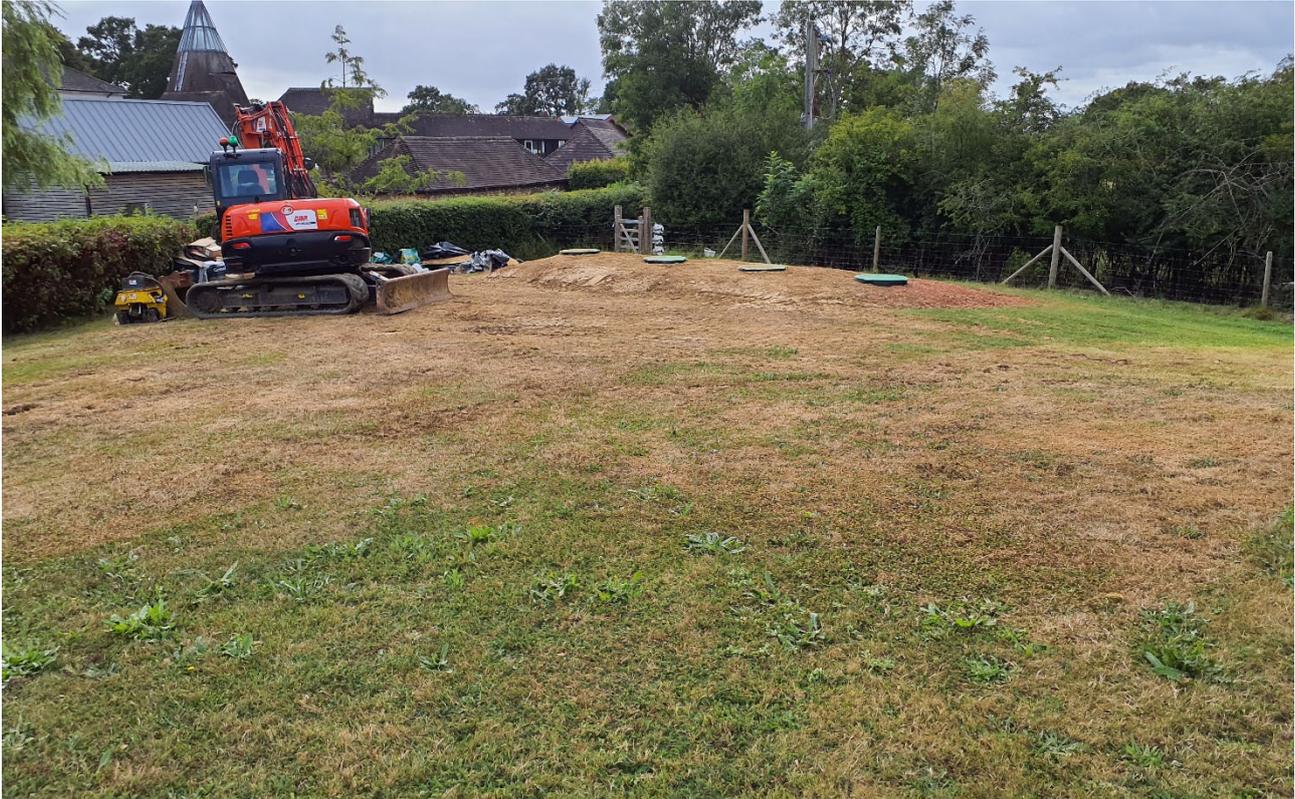
Plate 115: Looking E from NW portion of field adjacent to car park. Gas tank being installed.

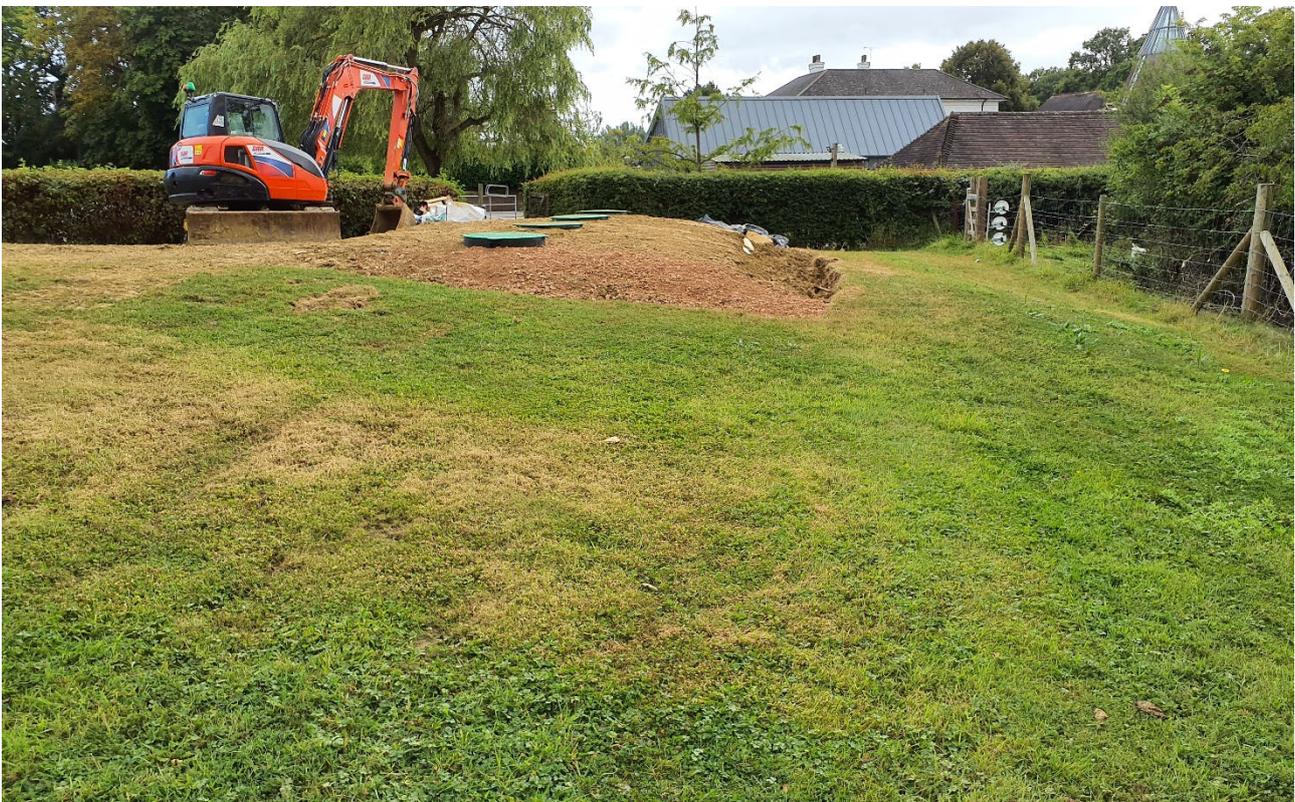
Plate 116: Looking S towards gas tank being installed.

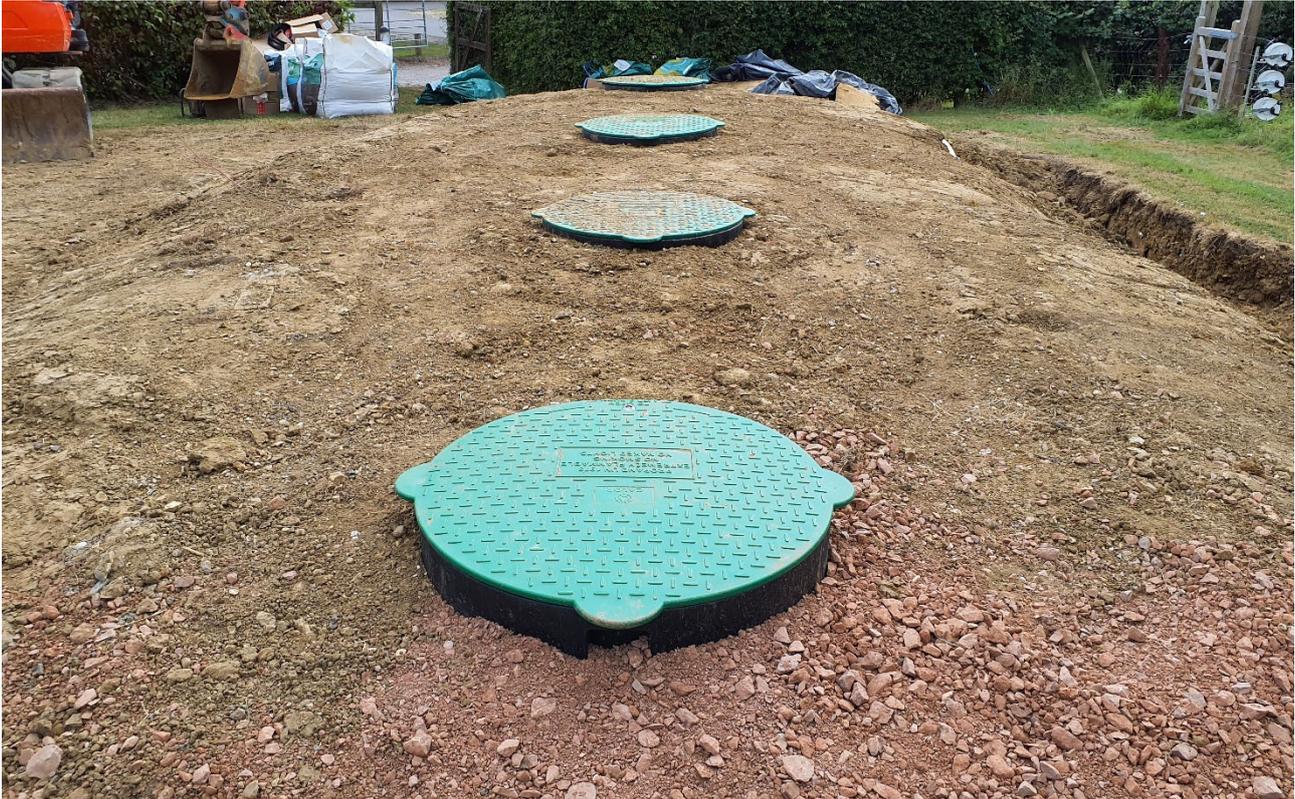
Plate 117: Looking SW. Gas tank being installed.

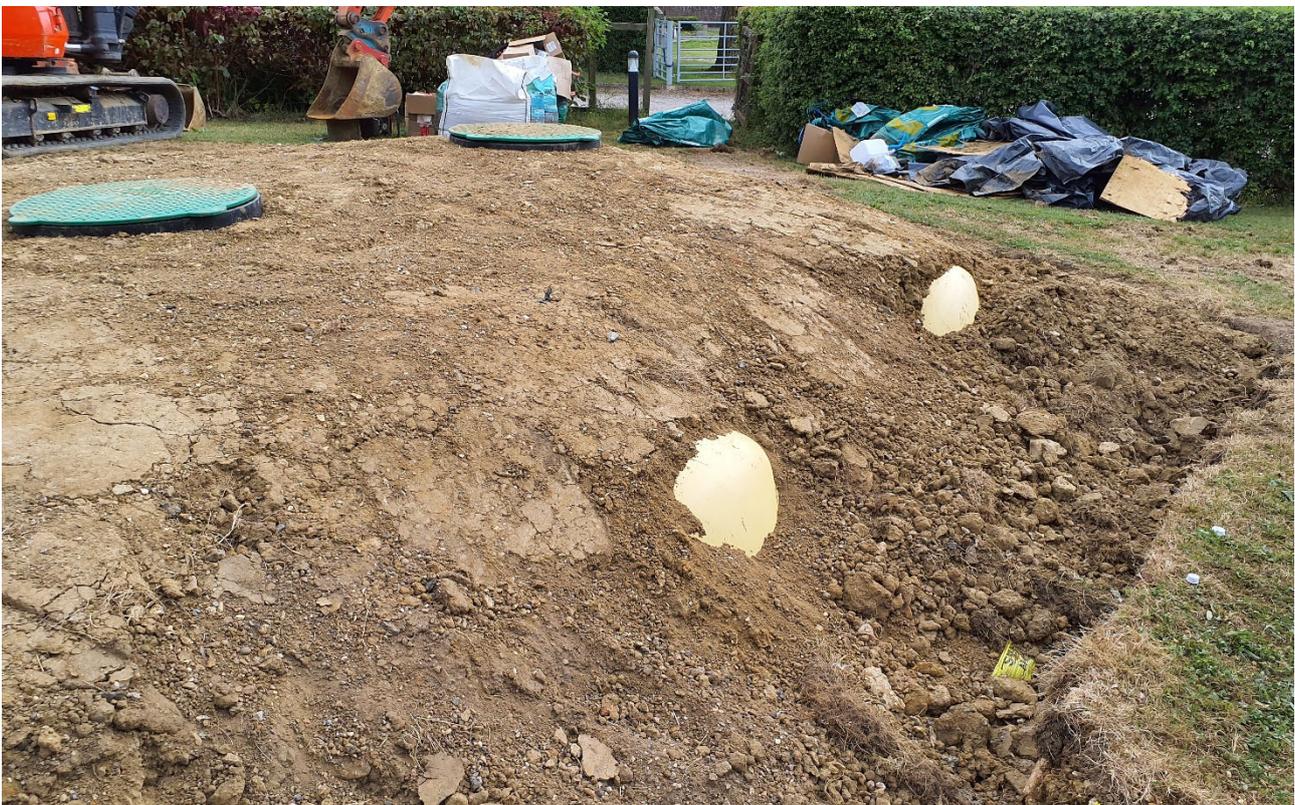
Plate 118: Looking S. Gas tank being installed. Gate to car park beyond.
