## **PHASE 1 SITE INVESTIGATION**

Bullfinch Lane, Hurstpierpoint

Project No. 001SUCOP1

Wesson Environmental

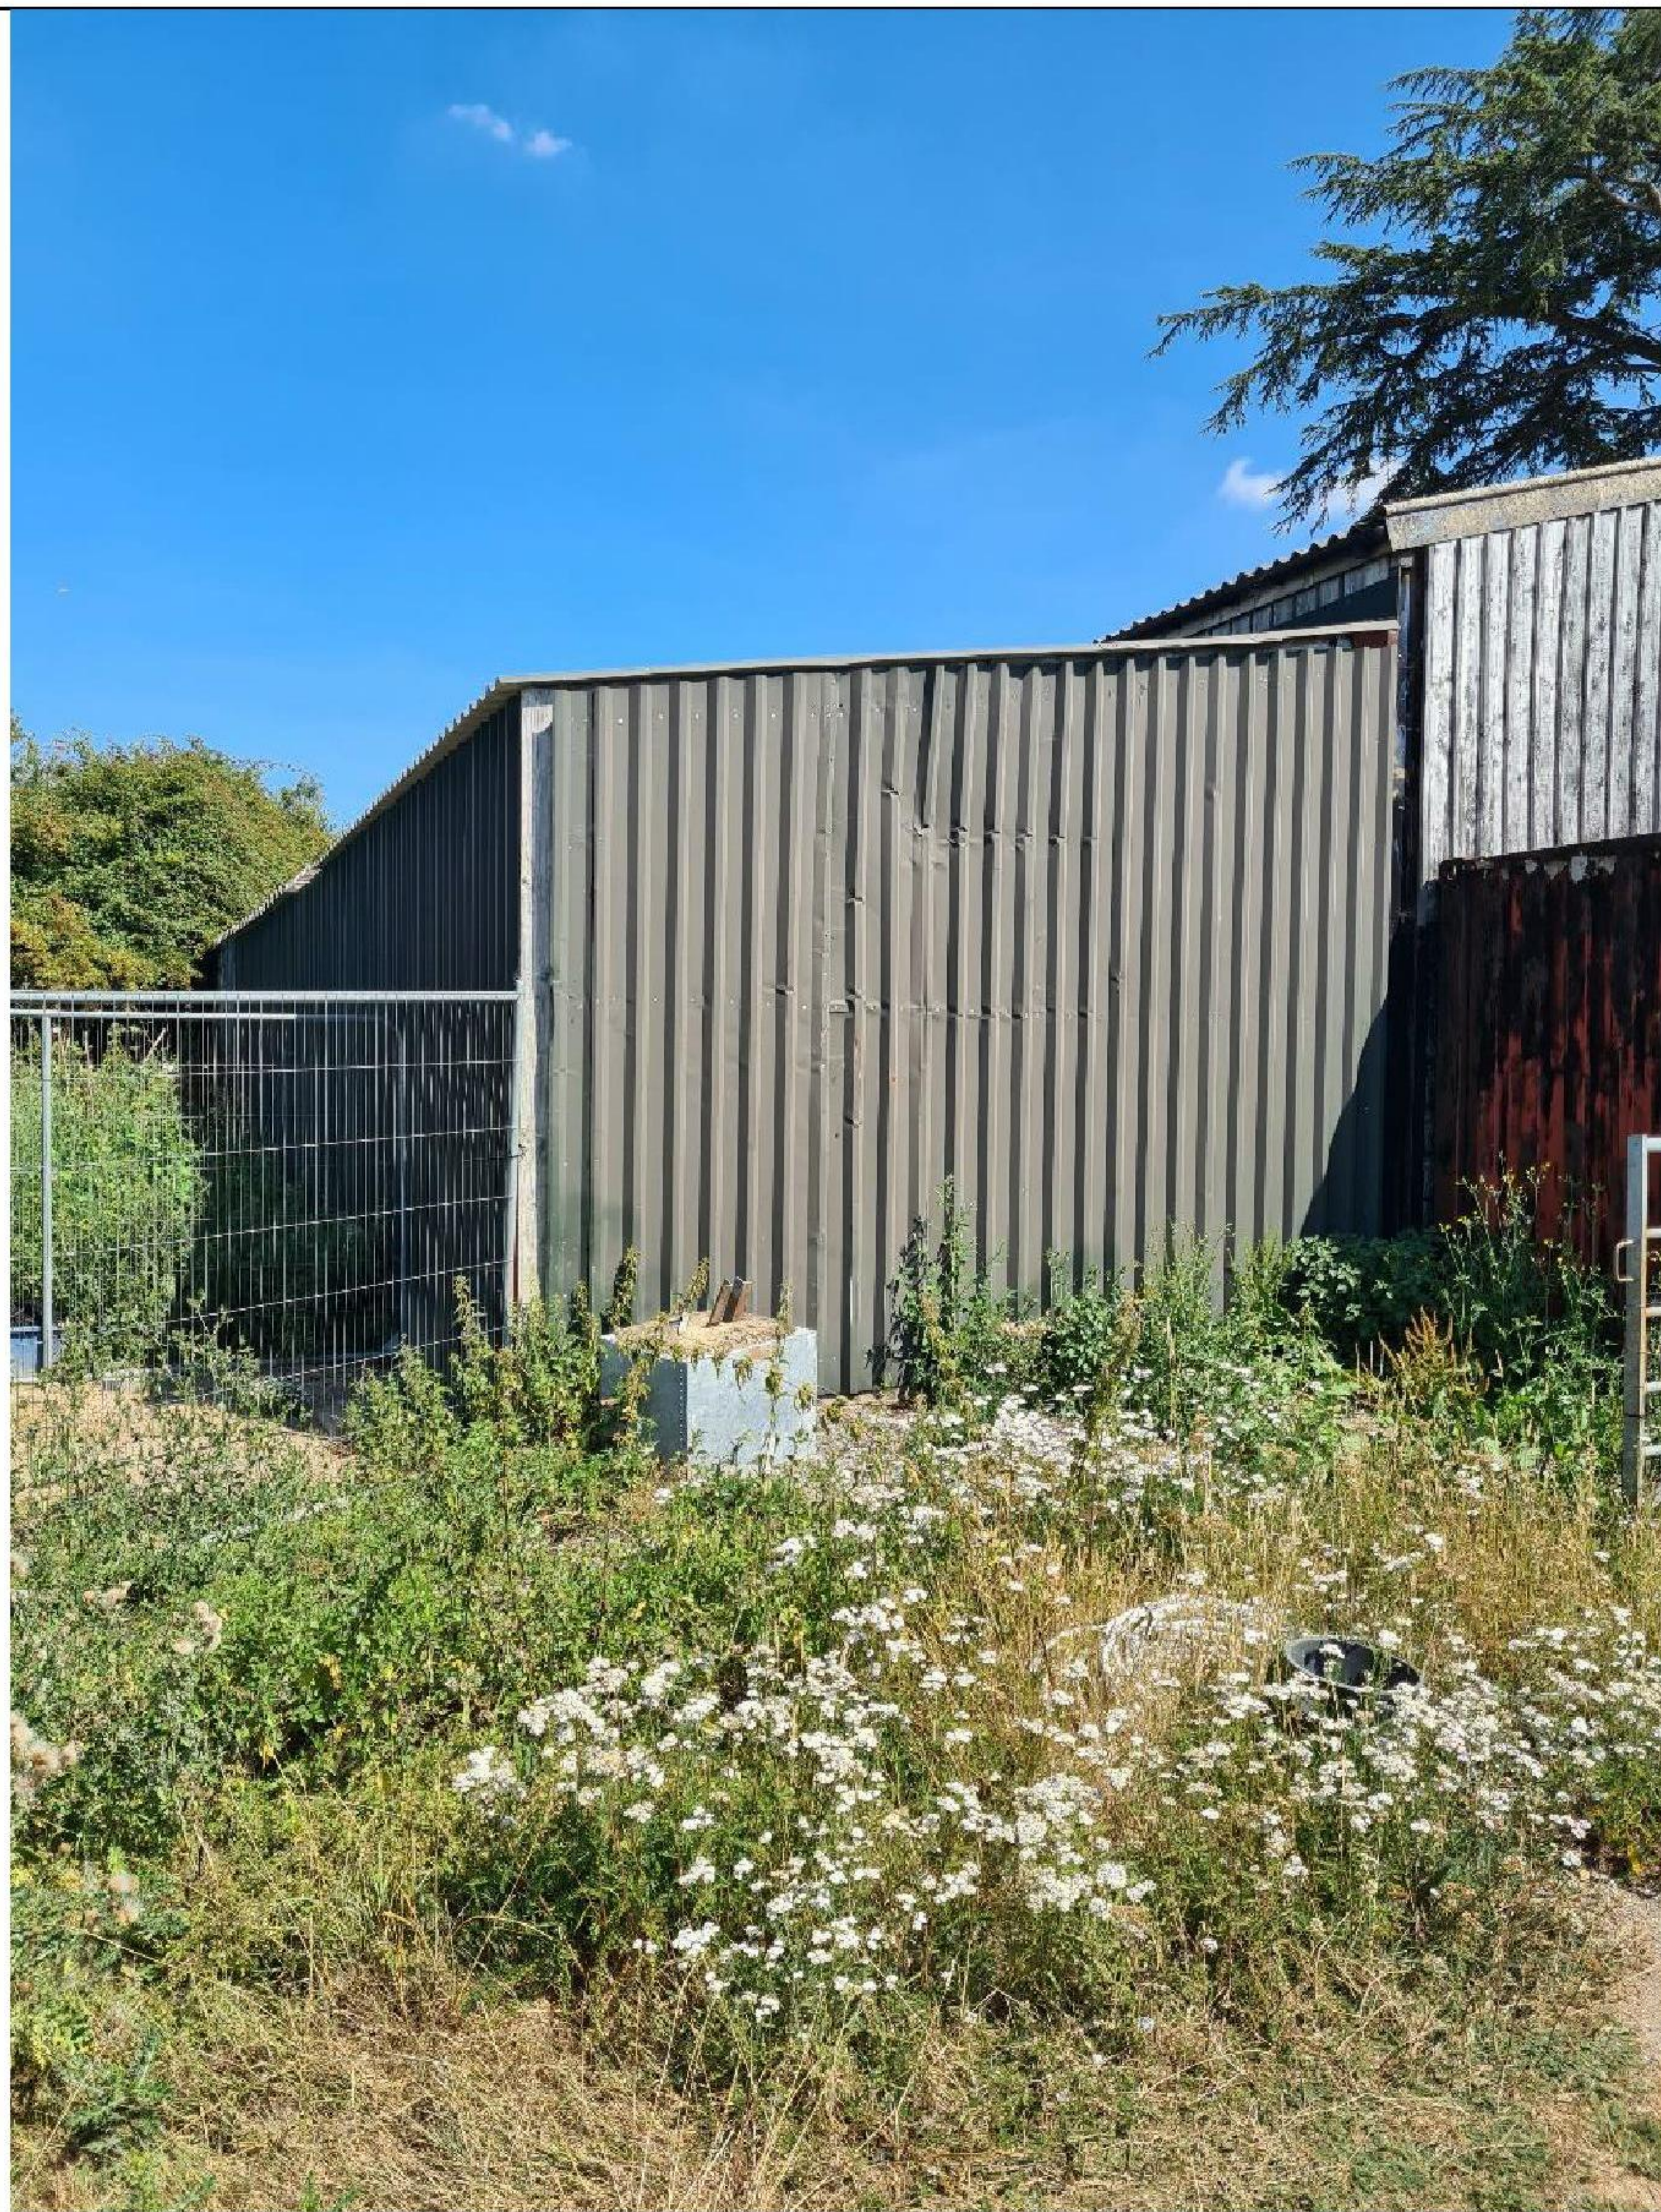
The site was visited on 8<sup>th</sup> August 2022 to allow a visual inspection to take place. The site was observed to comprise agricultural buildings and associated land. The southernmost building was metal framed with brickwork and wood construction. Cement bonded asbestos roofing was observed to be present in good condition with no breakages. It is understood that this had been used for lambing and poultry was present at the time of the visit. A dirt floor was present. The northernmost building was of the same construction but was used to store scaffolding and wood, with occasional machinery such as a lawn mower. To the north of this was an adjoined building which was outside of the planning boundary. This was used to store building material and was of similar construction, with the exception of being separated from the rest by walls constructed of cement bonded asbestos, which it is understood will be removed. The area to the north of this comprised bare ground on which building materials were present. Cement bonded asbestos sheets were stored against the building to the south with some breakage evident. A metal storage container was observed adjacent to the south of the building. The field to the west comprised pasture and was overgrown at the time of the visit. No tanks were observed.

Figure 1: The current building from the south west.

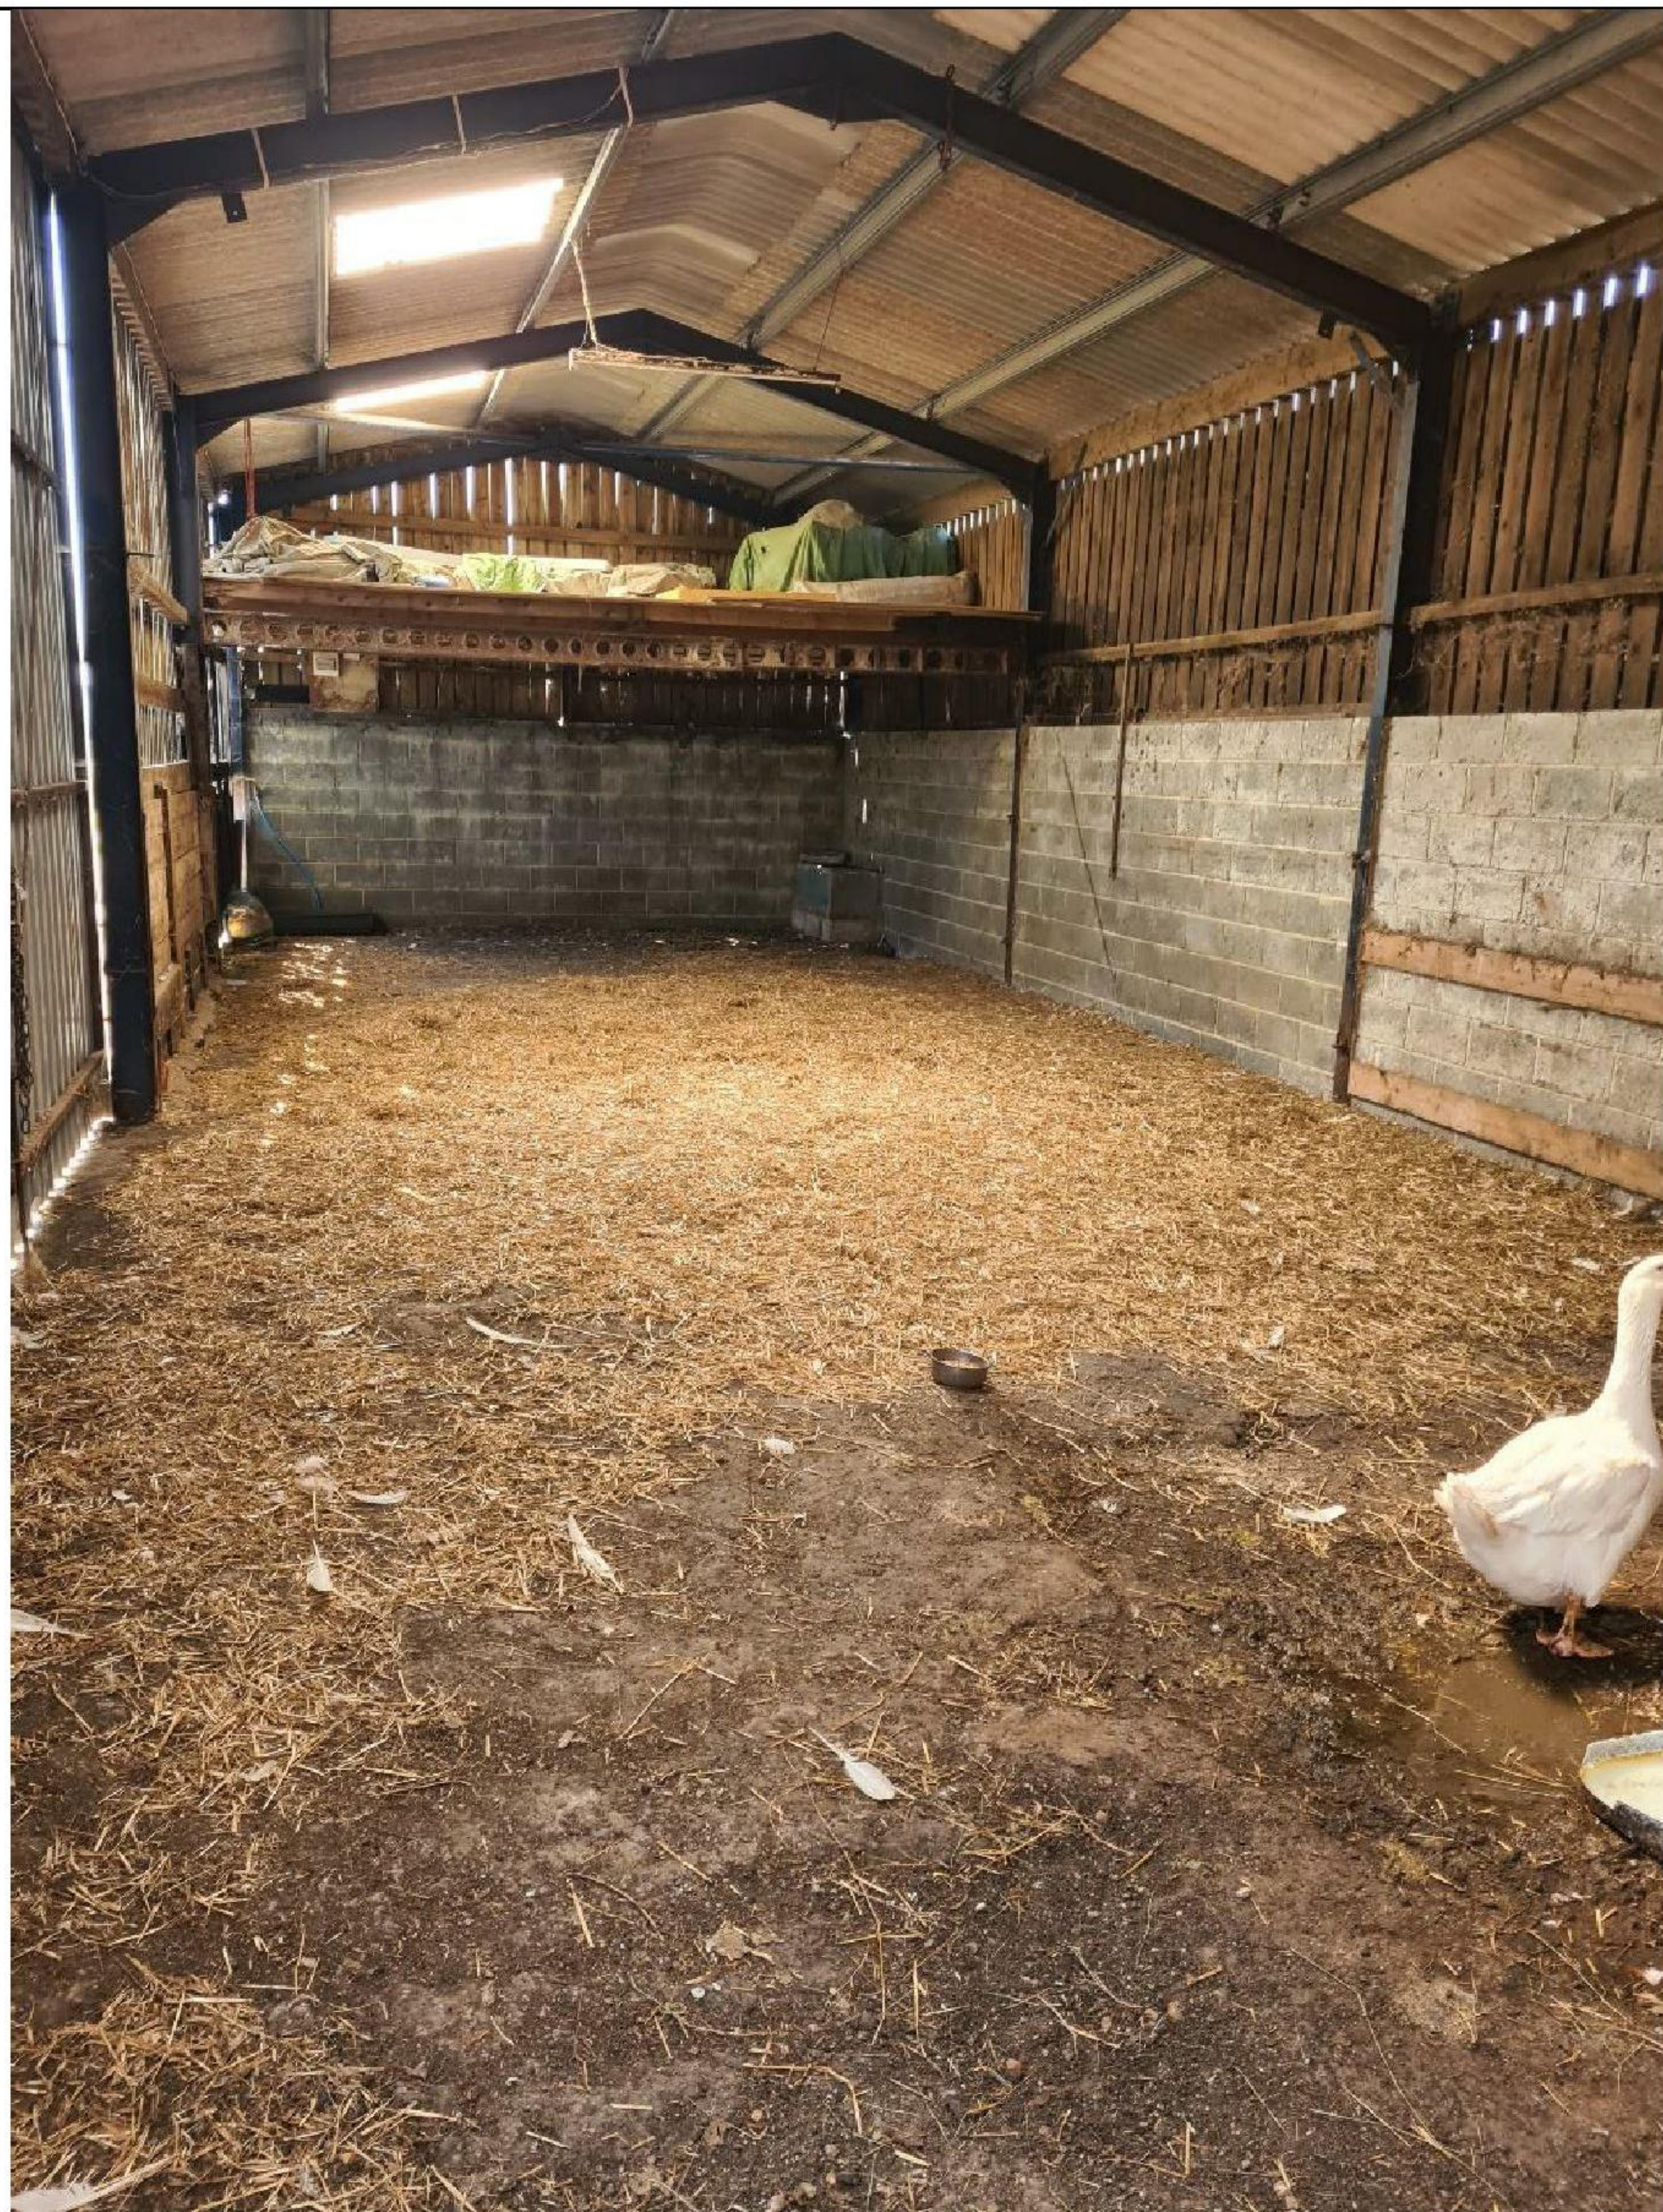
Figure 2. The interior of the southern part of the building.

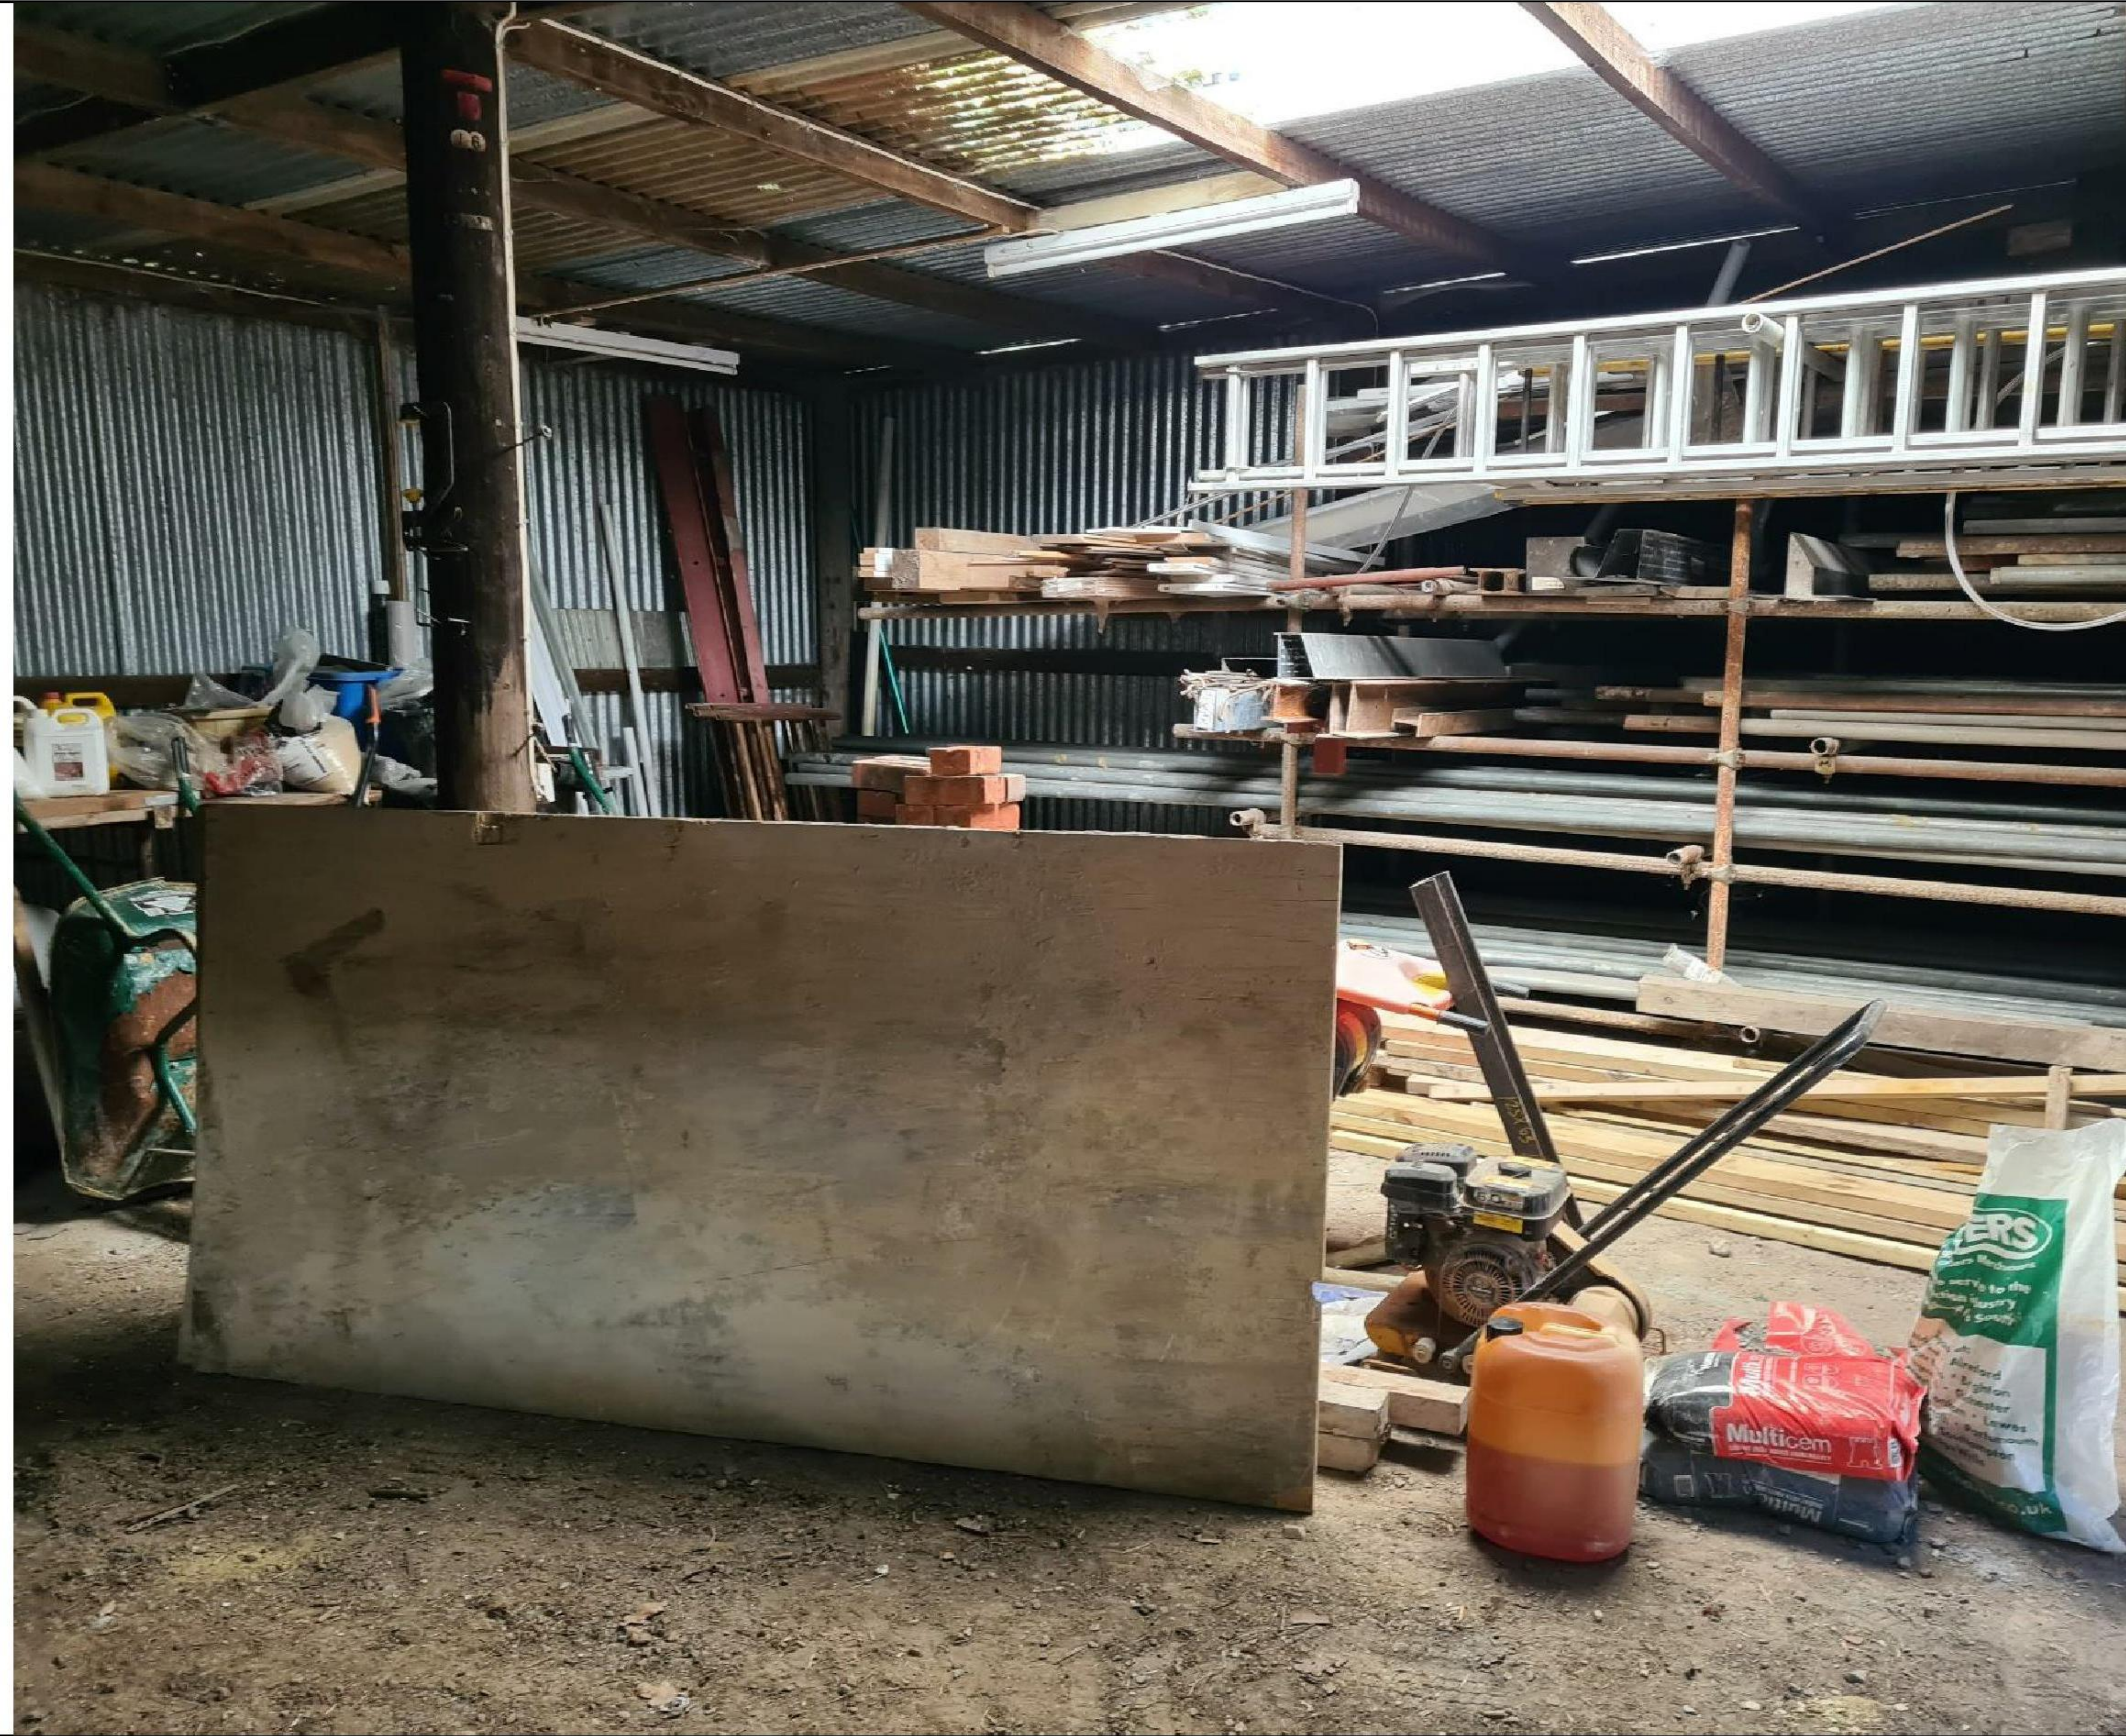
Figure 3. Interior of northern part of building.

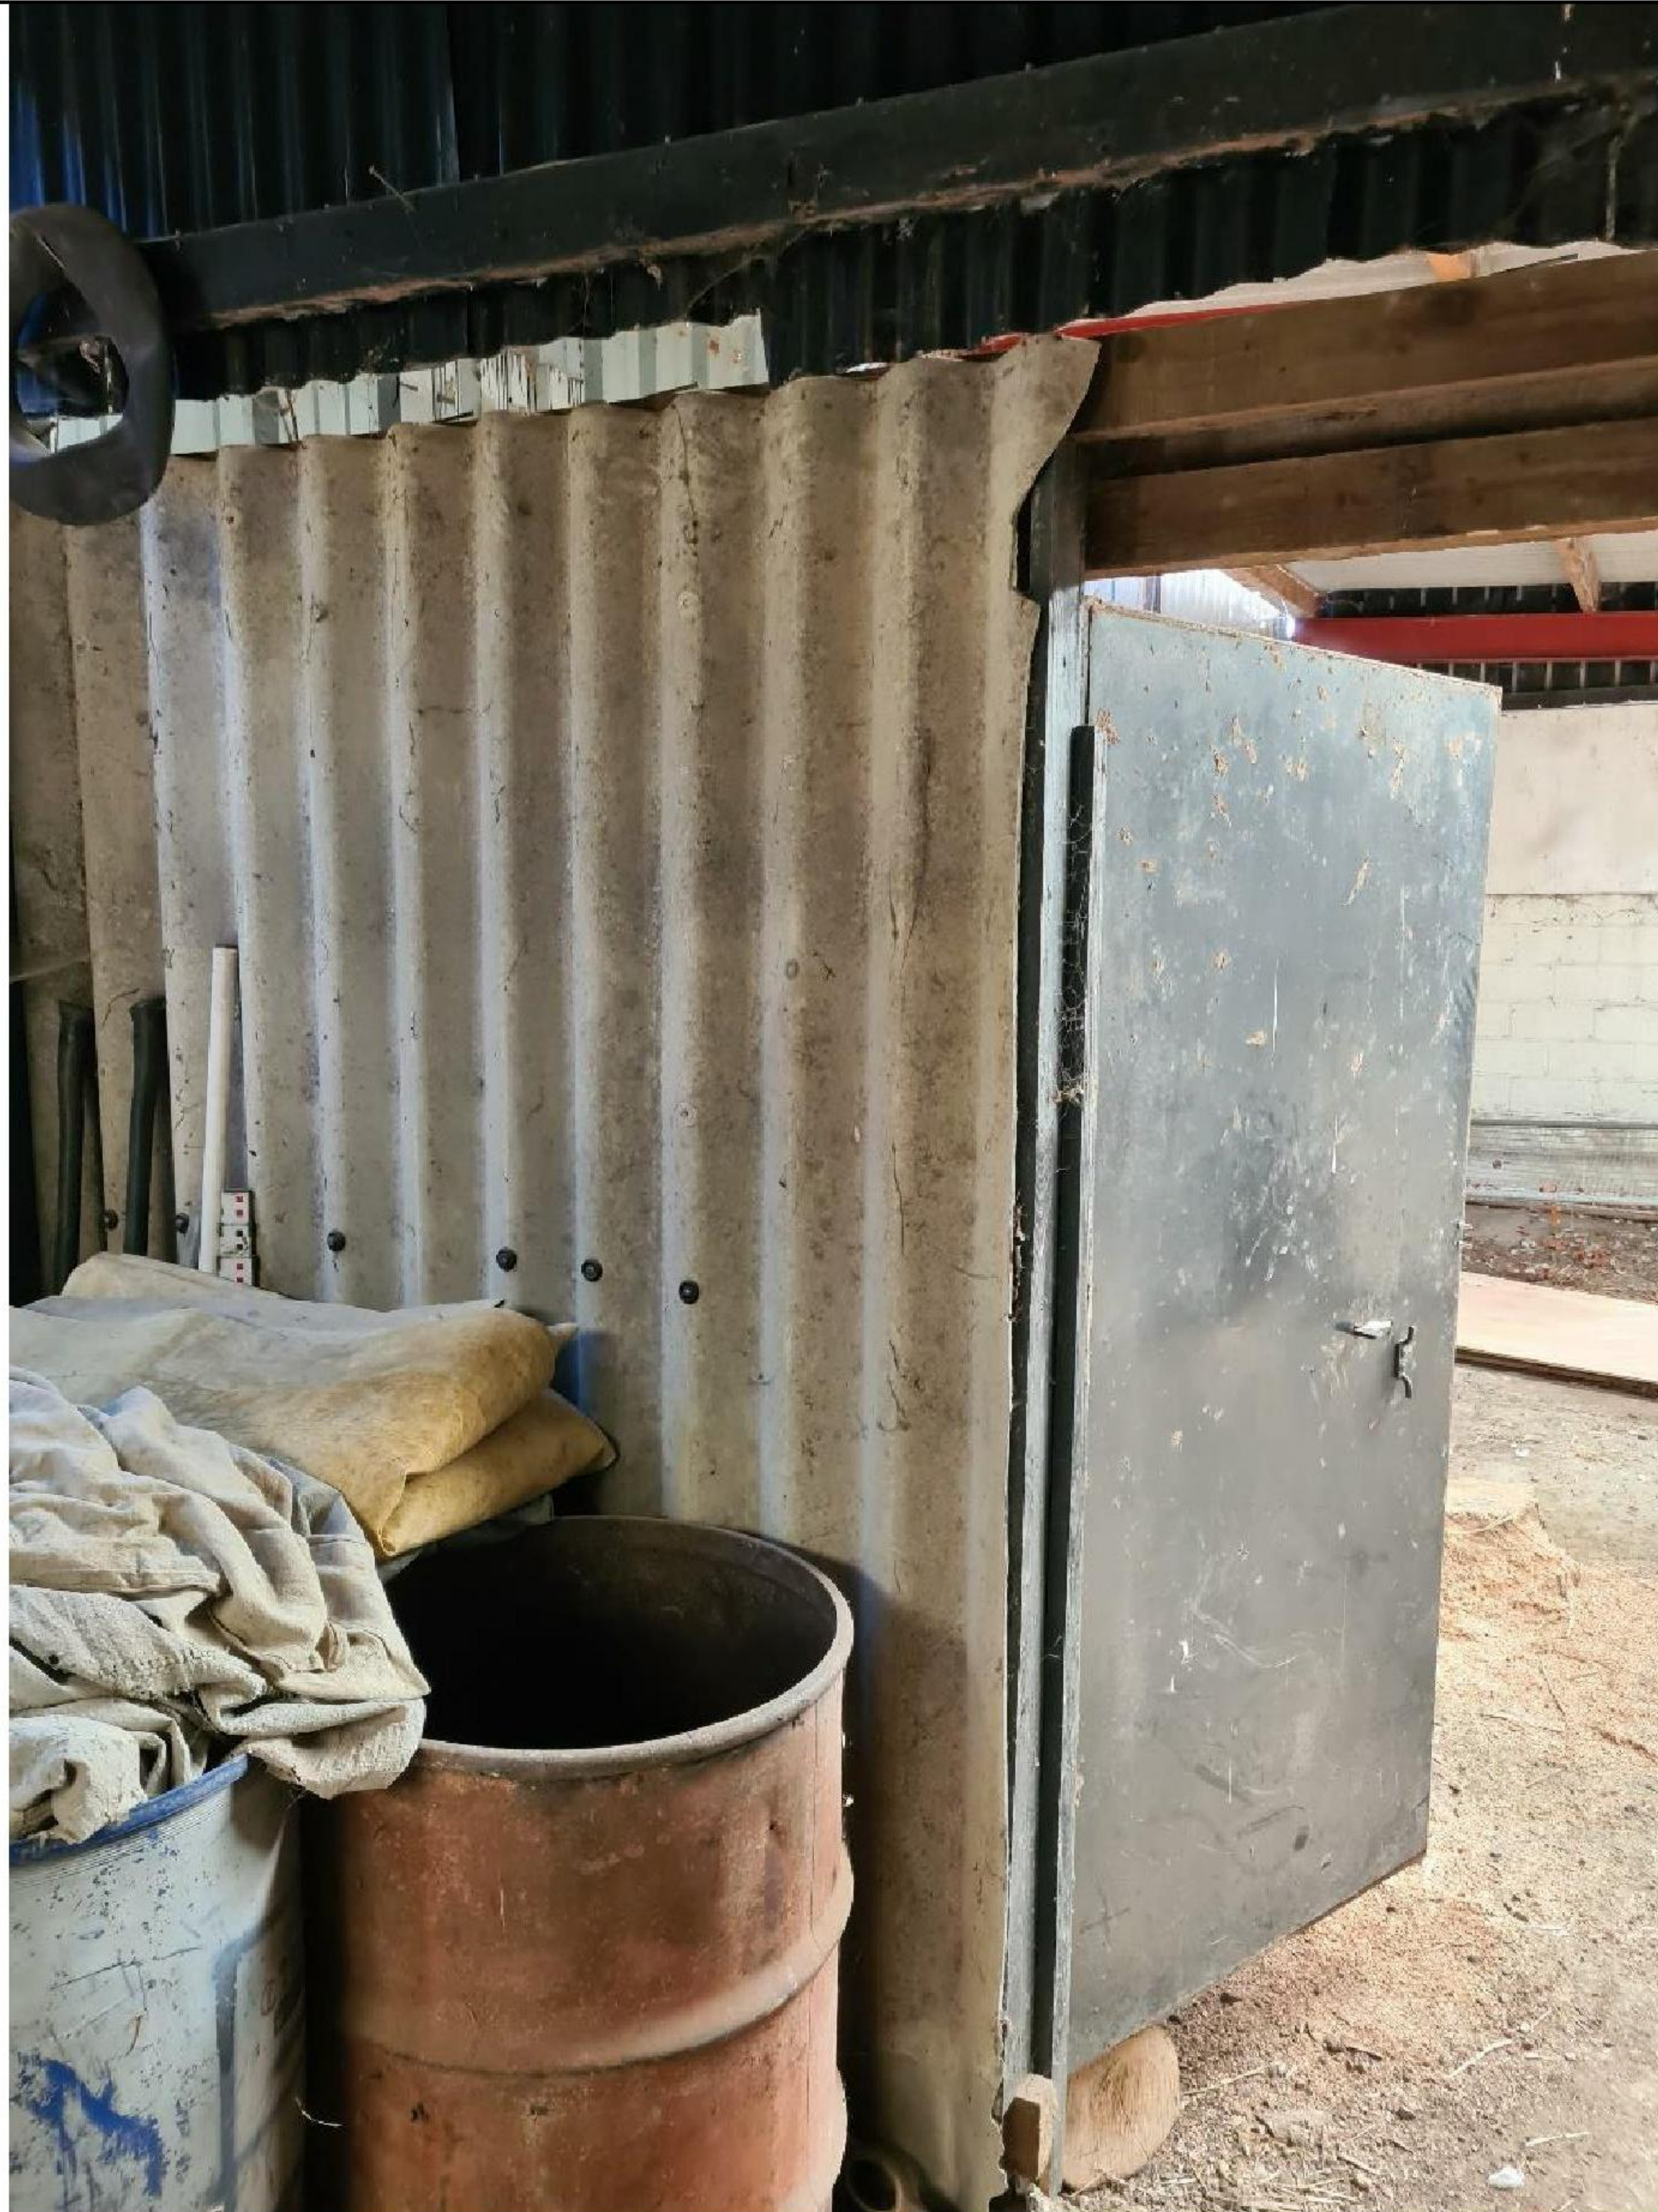
Asbestos in the form of cement bonded corrugated materials were encountered on the site. These mainly formed part of the building structure such as roofing and were in good condition overall. It was also encountered internally as a partition and a small amount of breakage was observed. However, the intention is to remove this material using an asbestos removal company. A small amount of asbestos was observed near to a building to the north of the site with some breakage present. Being offsite some way to the north, this is considered unlikely to have impacted site soils.

**Figure 4. The internal partition.**

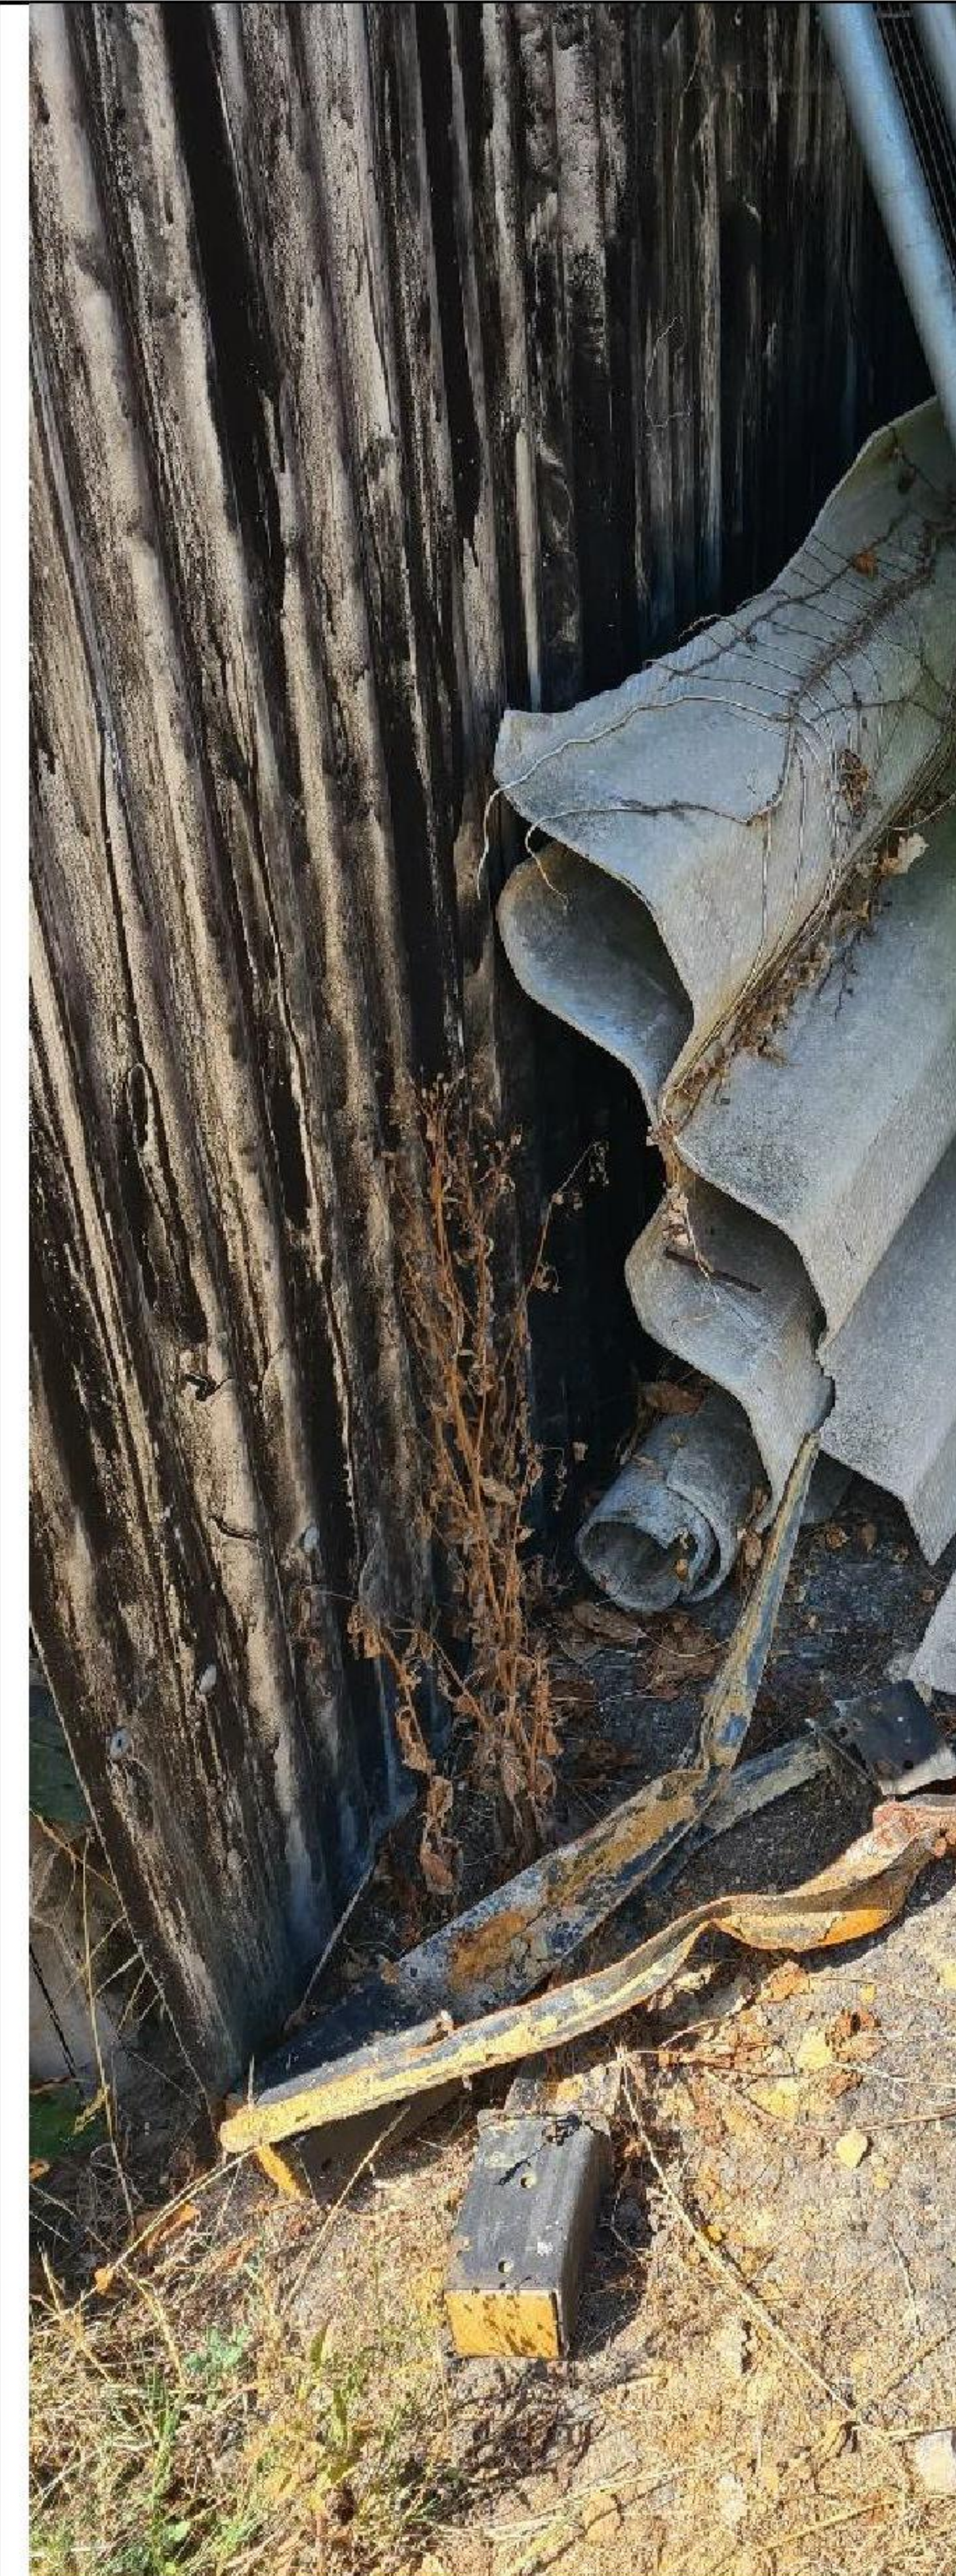
As discussed in the previous section, the potential for impacts on site soils is considered to be unlikely in view of the former uses of the site and surrounding area. In the case of the asbestos observed on the site, the roofing was observed to be in good condition with this and the partitioning etc to be removed. The area where this is located will coincide with building footprint with hardstanding immediately to the east. As only a dust inhalation pathway is relevant in the case of asbestos, even if asbestos fibres were present in these locations, then a pathway will

**Figure 5. The asbestos materials c**
