### The Castle, Hickstead

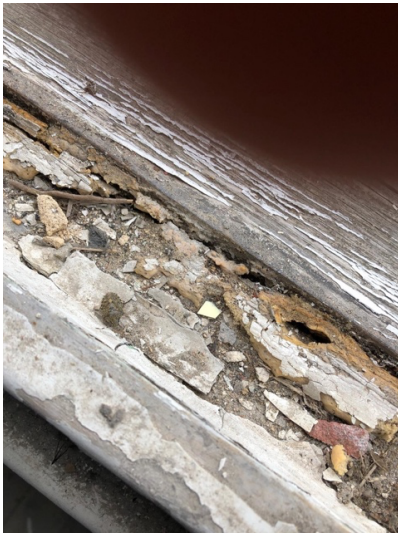
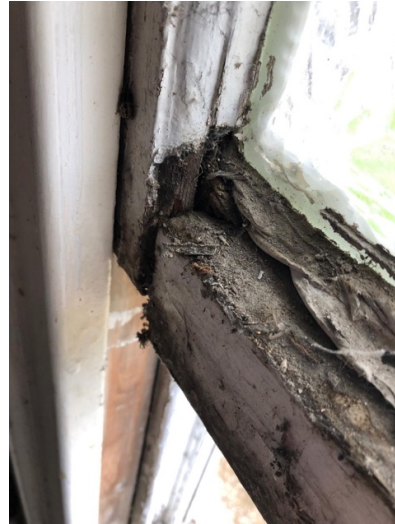
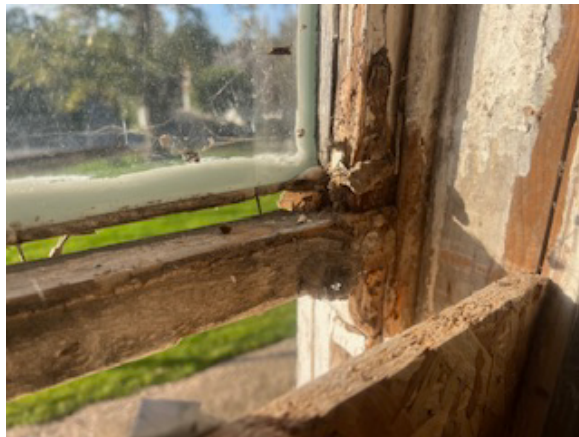
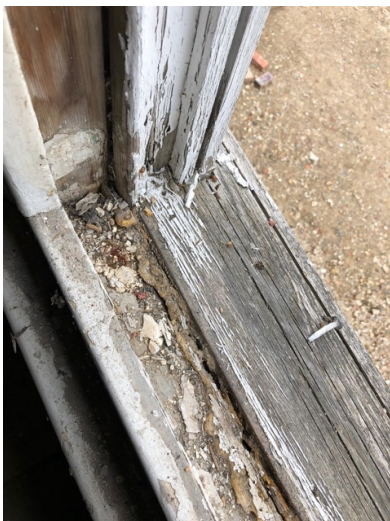
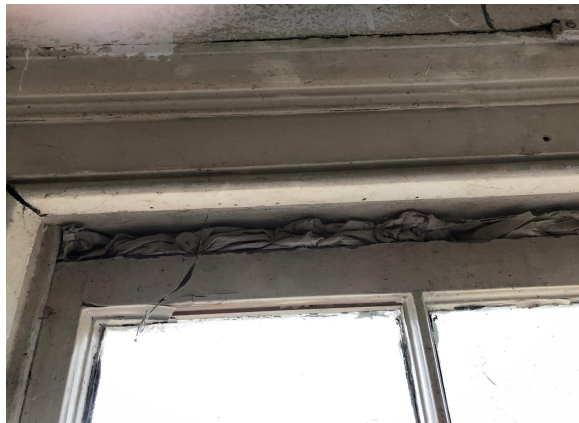
Window FF9 - The cill is covered over with 3 ¼" x 5/8" timber on top and 2 ¾" x 5/8" on face only to improve appearance, it is completely rotten under. Pulley stiles have rot ¼" way up past pulley pocket. Top sash looks short & has been stuffed with paper to stop draughts. Outside lining is rotten but a piece of 4" x 1" has been nailed to face to make it look good. The bottom rail has badly decayed tenons that have come out of the stiles at the bottom.
