**Project Name:** Cuckfield Rd - Ansty  
**Project Description:** CCTV Survey, Trace & Plot  
**Project Status:** Complete  
**Project Date:** 04/06/2026  
**Inspection Standard:** MSCC5 Sewers & Drainage GB (SRM5 Scoring)

# **EYES ON DRAINAGE**

## **CCTV-Trace-Plot-Map-Repair**

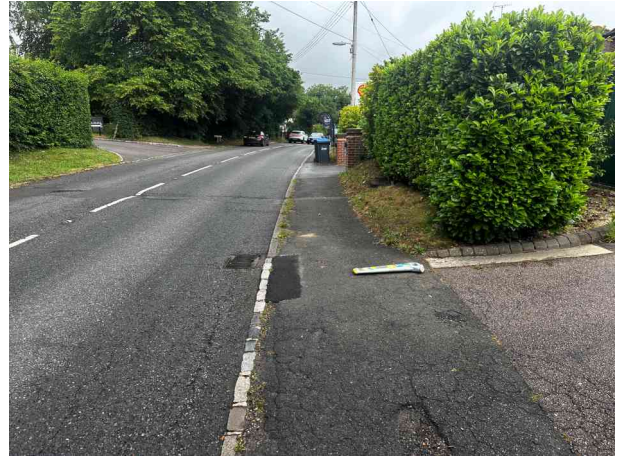
Location of hard stop, assumed buried CP1

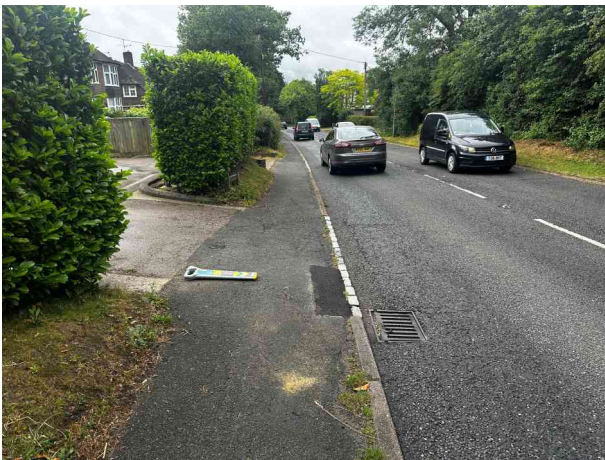
Location of hard stop, assumed buried CP1

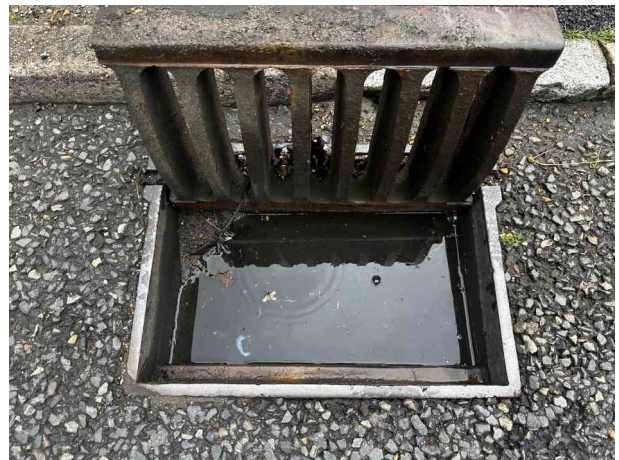
RG adjacent to hard stop, high water level

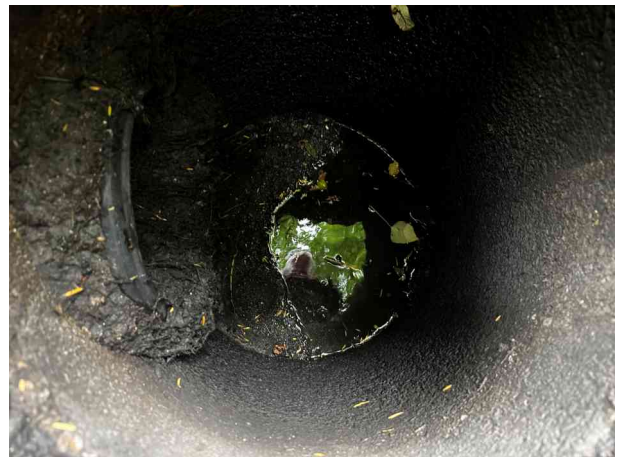
RG4 (new 225mm outlet higher than inlet)

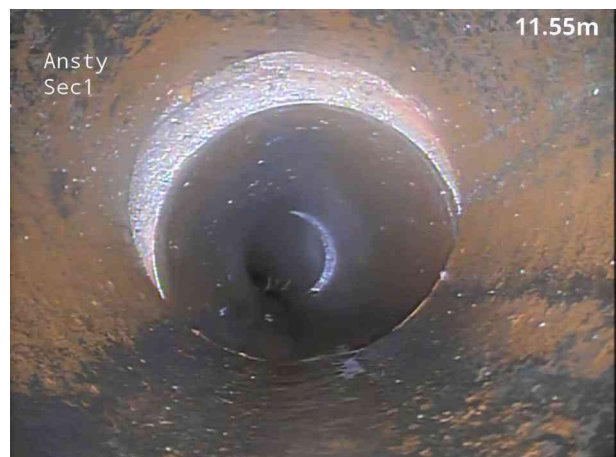
6, 00:00:52, 0.10 m  
Joint displaced, medium, start

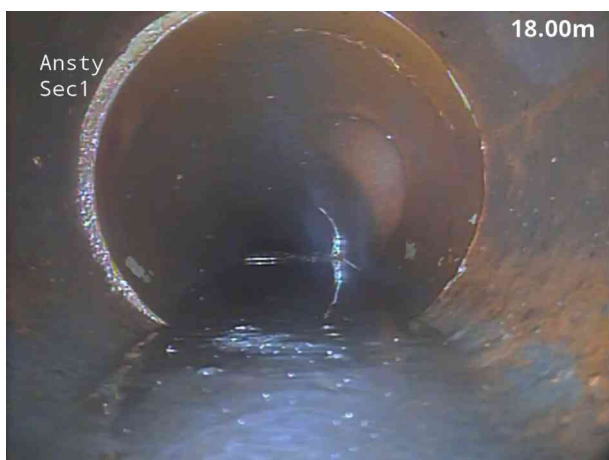
9, 00:02:06, 18.20 m  
Water level, 10% of the vertical dimension

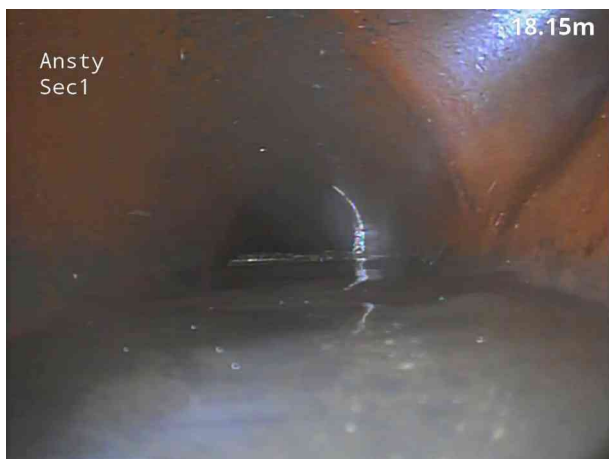
11, 00:02:09, 18.40 m  
Water level, 20% of the vertical dimension

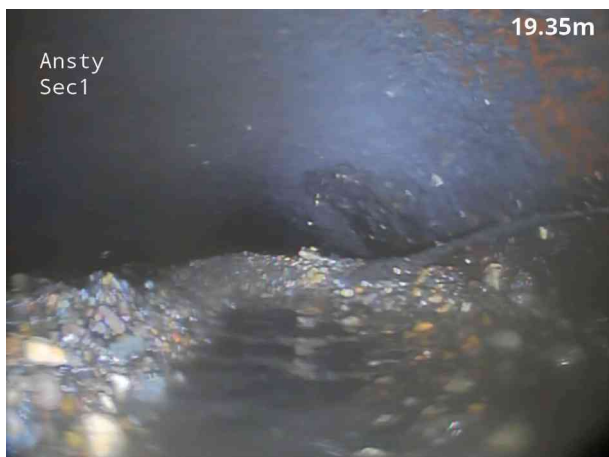
| Section | PLR | Grade | Description |
|---|---|---|---|
| 1 | RG1X | 4 | Settled deposits, coarse, 60% cross-sectional area loss, finish |

13, 00:02:27, 19.30 m  
Settled deposits, coarse, 60% cross-sectional area loss, start

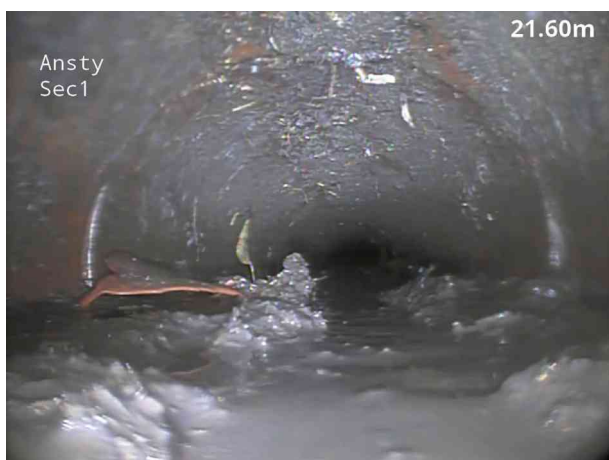
15, 00:02:56, 21.60 m  
Settled deposits, coarse, 50% cross-sectional area loss, change

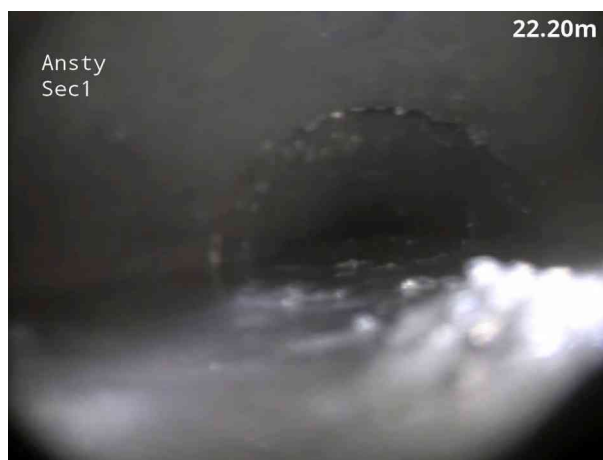
16, 00:03:42, 22.20 m  
Settled deposits, coarse, 60% cross-sectional area loss, change

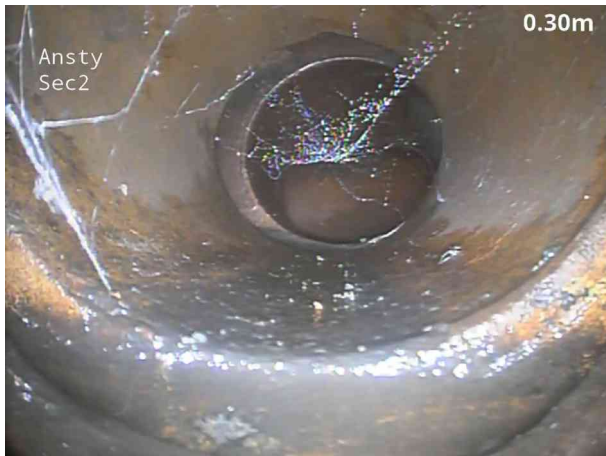
3, 00:00:13, 0.30 m  
Joint displaced, medium, start

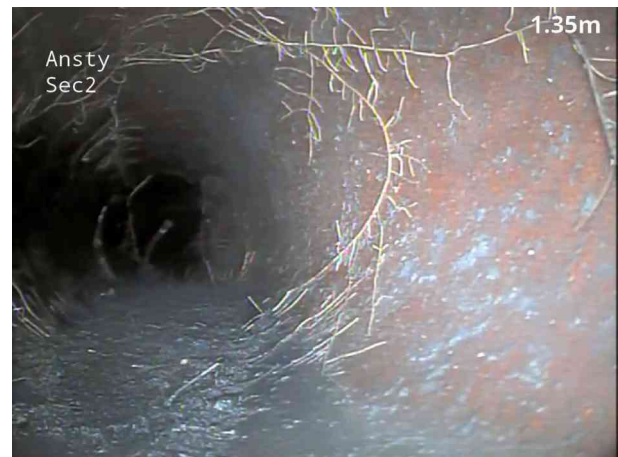
6, 00:00:34, 1.30 m  
Roots, fine, start

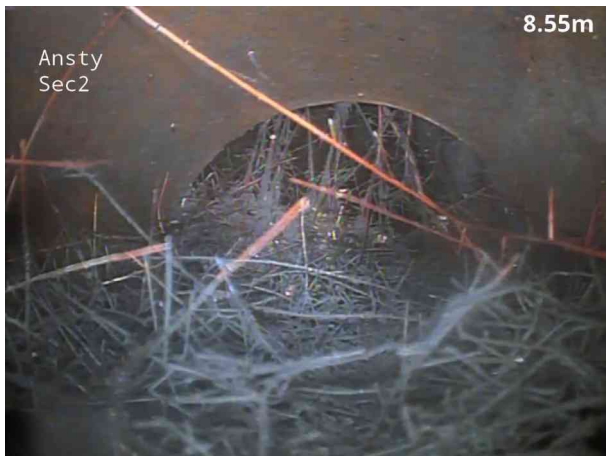
13, 00:01:35, 8.70 m  
Roots, mass, 70% cross-sectional area loss

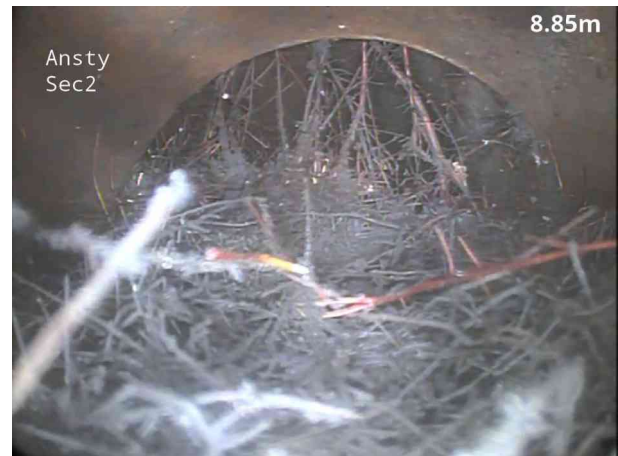
14, 00:01:35, 8.70 m  
Roots, mass, 70% cross-sectional area loss

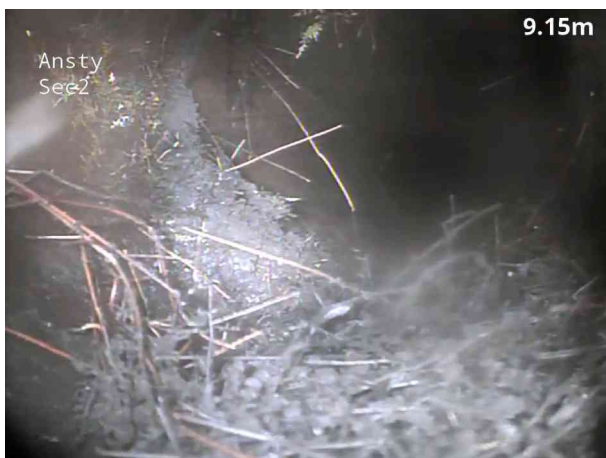
15, 00:01:52, 9.20 m  
Roots, mass, 10% cross-sectional area loss, change

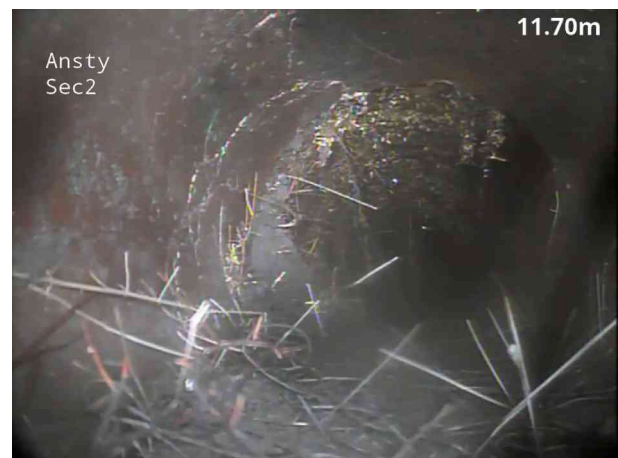
16, 00:02:01, 11.80 m  
Roots, mass, 20% cross-sectional area loss, change

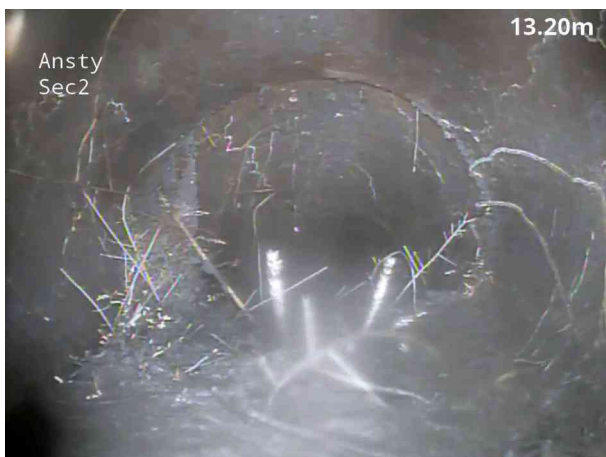
17, 00:02:07, 13.30 m  
Roots, mass, 30% cross-sectional area loss, change

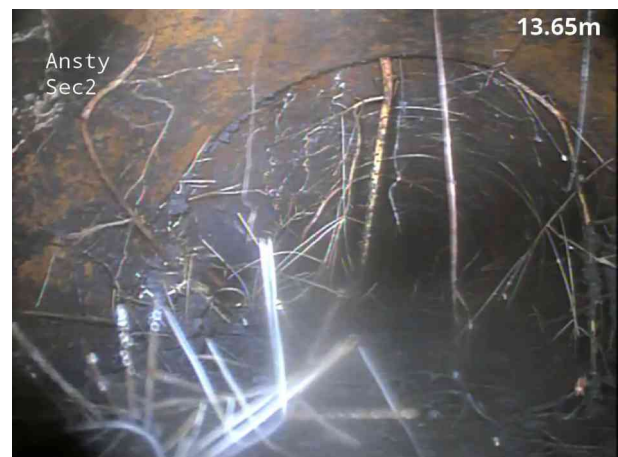
18, 00:02:12, 13.80 m  
Roots, mass, 40% cross-sectional area loss, change

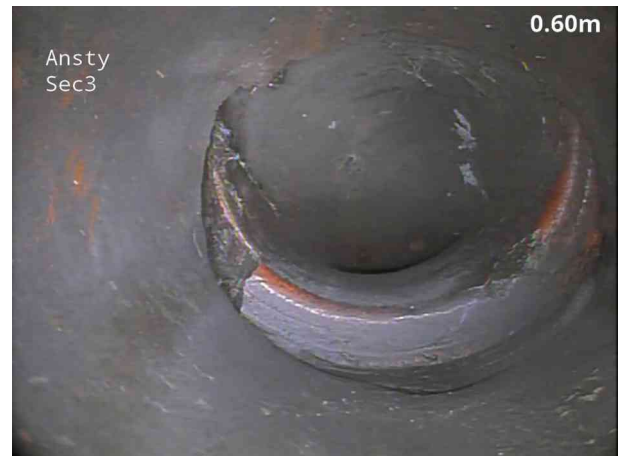
2, 00:00:20, 0.70 m  
Joint displaced, large

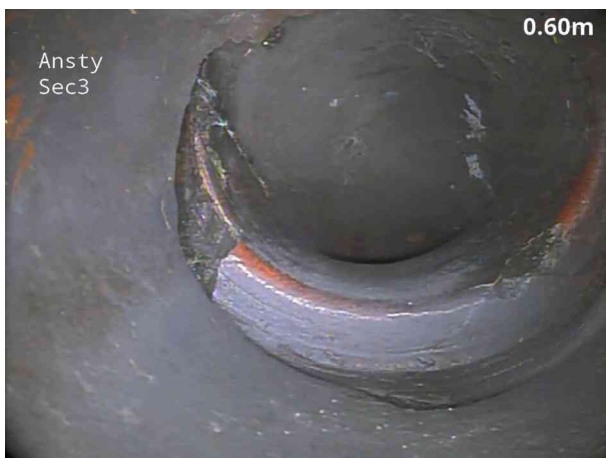
3, 00:00:20, 0.70 m  
Joint displaced, large

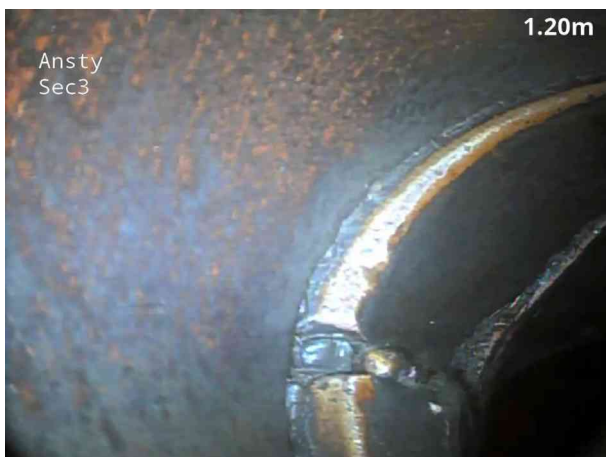
| Section | PLR | Grade | Description |
|---|---|---|---|
| 3 | RG3X | 4 | Broken pipe at joint from 6 o'clock to 12 o'clock |

5, 00:00:39, 1.30 m  
Broken pipe at joint from 6 o'clock to 12 o'clock

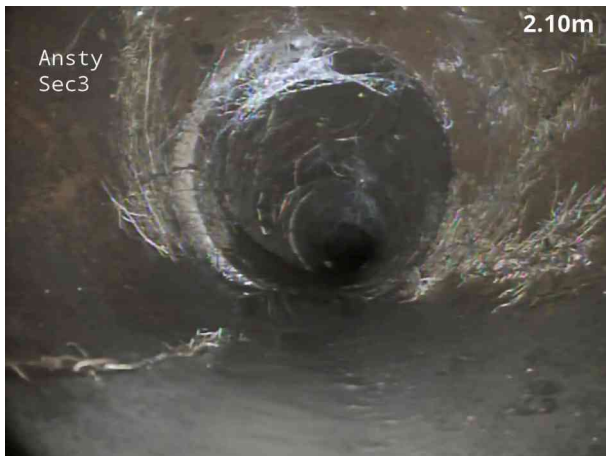
7, 00:00:55, 2.00 m  
Roots, fine, start

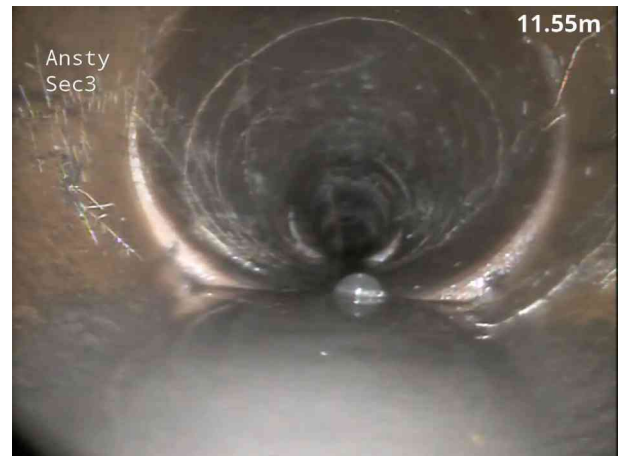
8, 00:01:38, 11.80 m  
Fracture, circumferential at joint from 12 o'clock to 12 o'clock

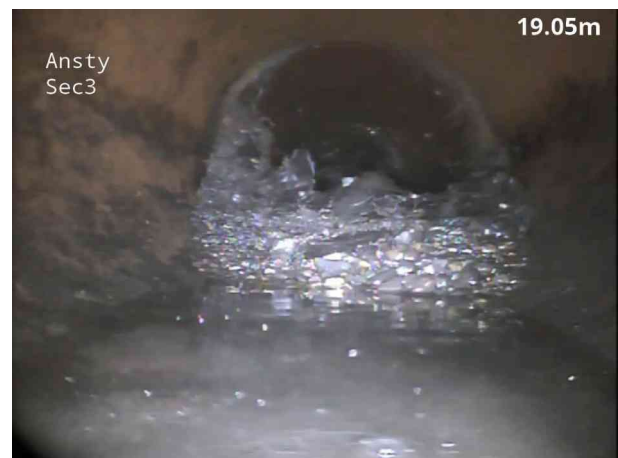
10, 00:02:11, 19.30 m  
Settled deposits, coarse, 60% cross-sectional area loss

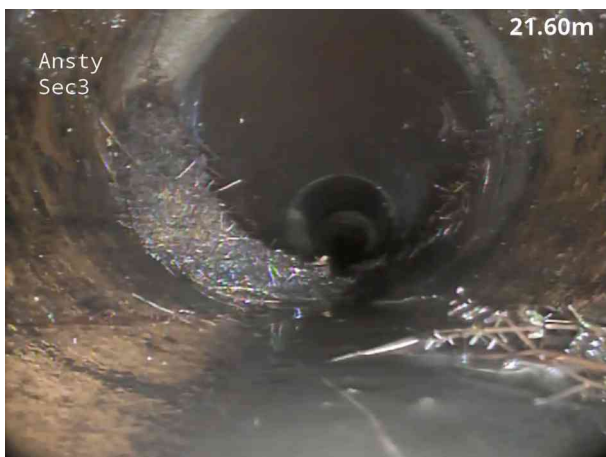
11, 00:02:30, 21.80 m  
Roots, mass at joint, 15% cross-sectional area loss

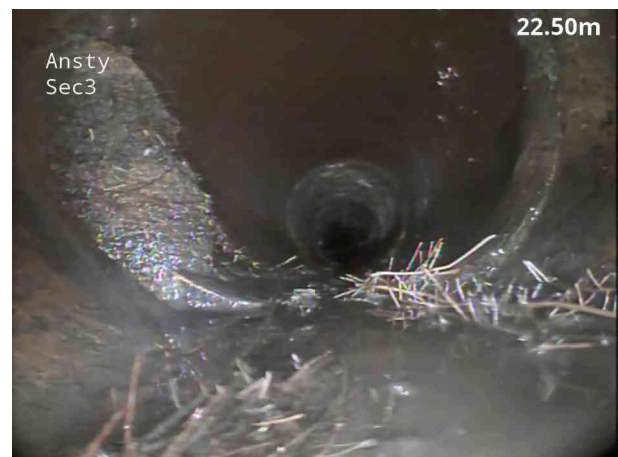
12, 00:02:33, 22.70 m  
Roots, mass at joint, 10% cross-sectional area loss

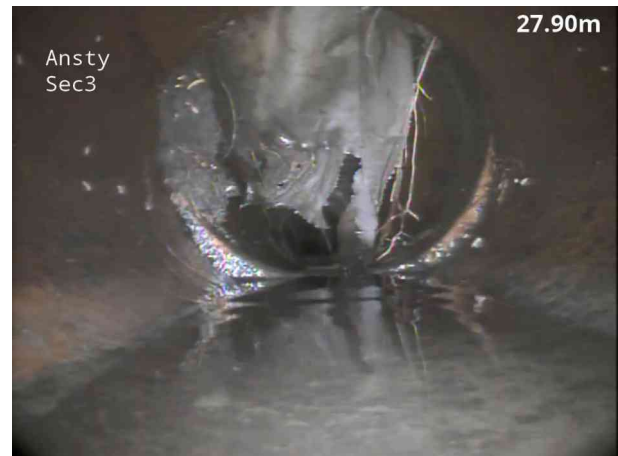
| Section | PLR | Grade | Description |
|---|---|---|---|
| 3 | RG3X | 5 | Other obstacles at joint from 8 o'clock to 2 o'clock, 60% cross-sectional area loss |

14, 00:02:50, 28.20 m  
Other obstacles at joint from 8 o'clock to 2 o'clock, 60%  
cross-sectional area loss, Upvc sheet

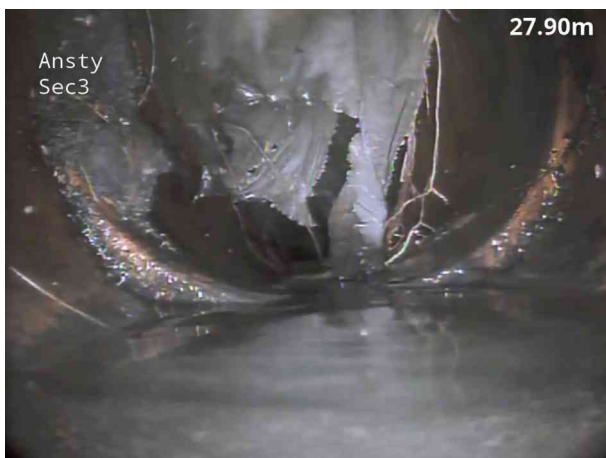
15, 00:02:50, 28.20 m  
Other obstacles at joint from 8 o'clock to 2 o'clock, 60%  
cross-sectional area loss, Upvc sheet

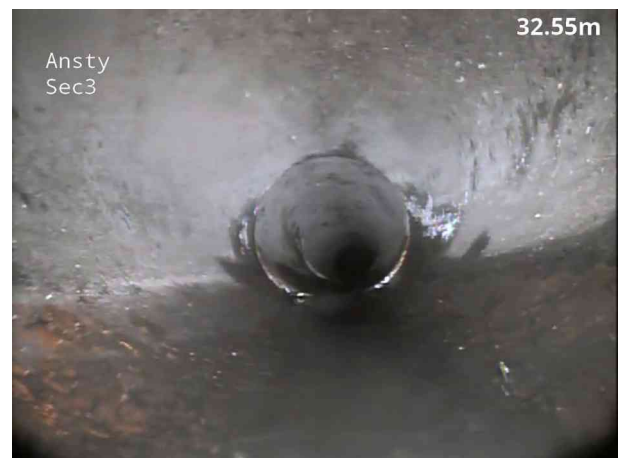
16, 00:03:16, 32.50 m  
Roots, fine, finish

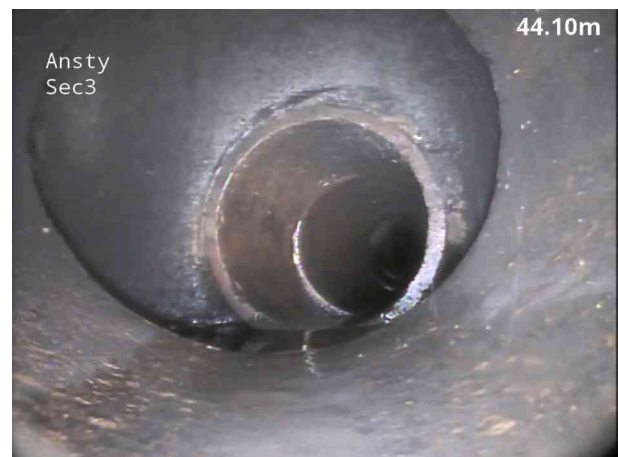
18, 00:04:07, 44.40 m  
Finish node, catchpit, reference: CP3, Buried
