**ARBORICULTURAL REPORT**  
**at**  
**Birchwood**  
**Birchwood Grove Road**  
**Burgess Hill**  
**West Sussex**  
**RH15 0DL**

19635/ChC

- 1.1.1 This arboricultural report is required by our client as part of an investigation into the ongoing subsidence issues at:

**Birchwood, Birchwood Grove Road, Burgess Hill, West Sussex, RH15 0DL.**

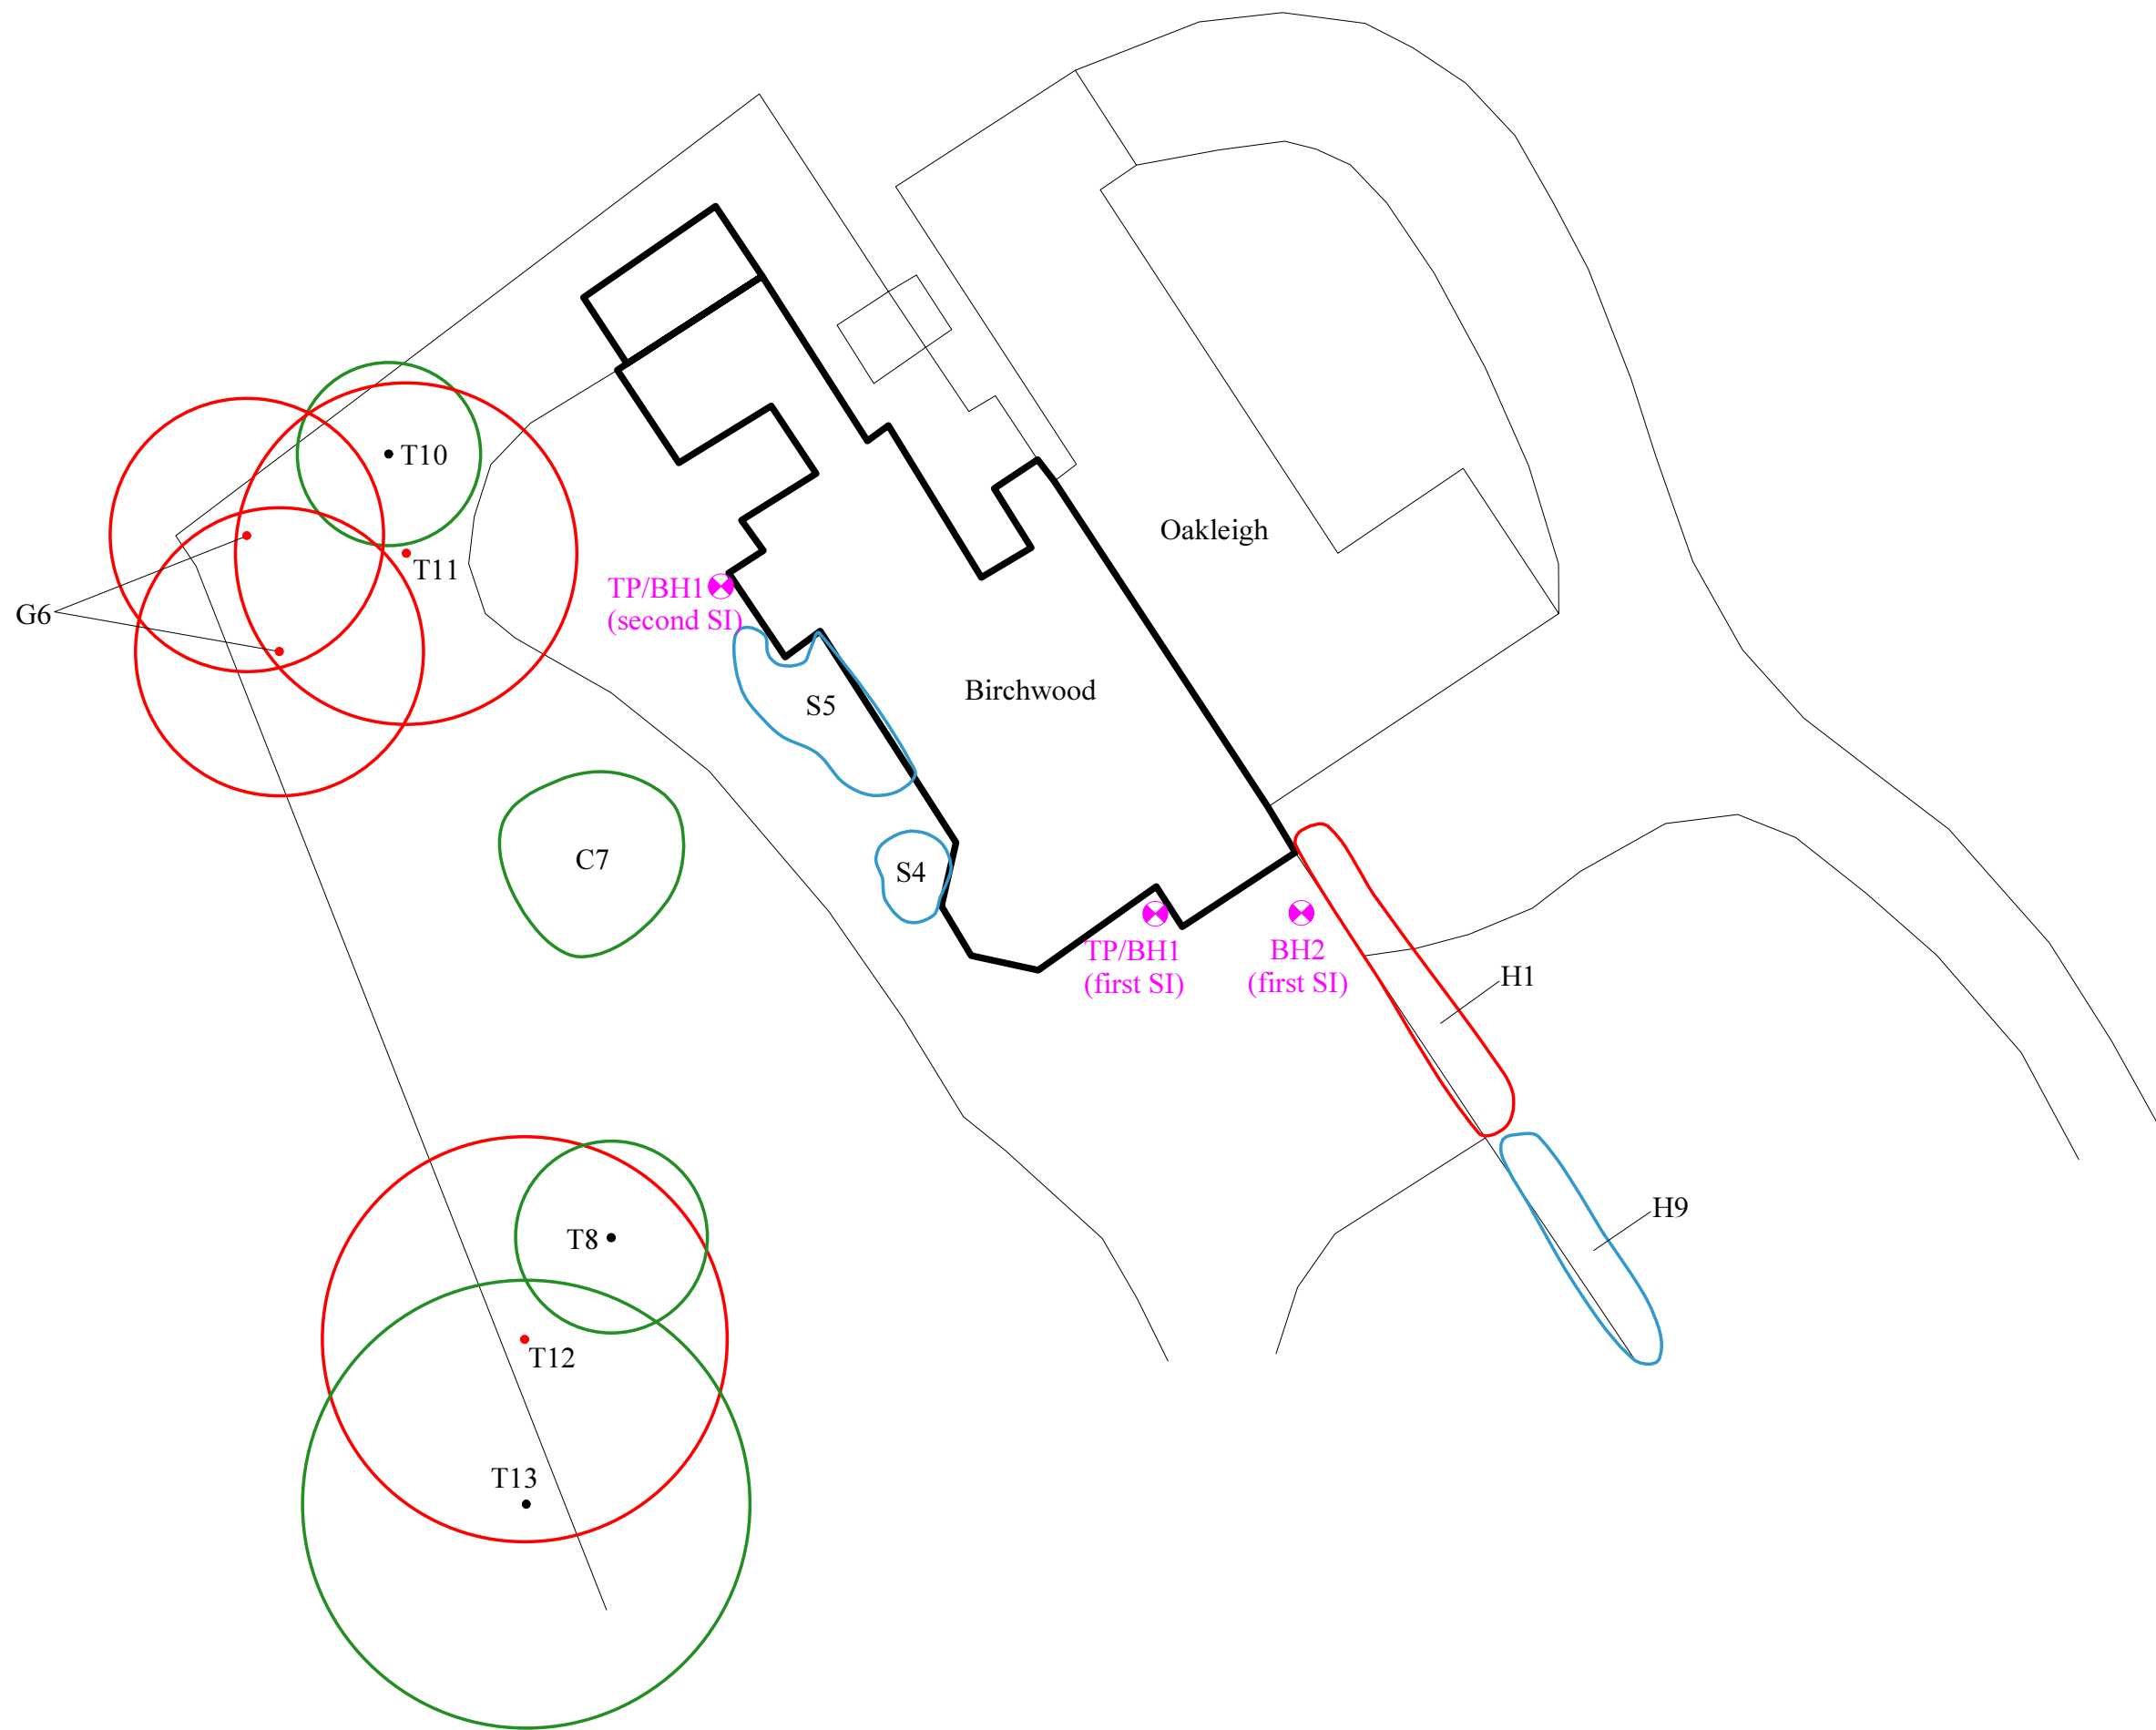
## Appendix 2: Site Plan

- 5.1 Descriptions of the surveyed vegetation and all recommended work are detailed in the tables at **Appendix 1**.
- 5.2 Please refer to the site plan at **Appendix 2** for the locations of the vegetation surveyed and all the relevant site features.

- 6.3 We consider the vegetation identified as **H1**, **G6**, **T11** and **T12** to be contributing to the damage observed at the subject property. We have therefore recommended that these items of vegetation be removed to ground level, and that the stumps of the Oak trees are treated to prevent regrowth. Please note we consider **H1** and **T12** to be contributing towards the damage at the front, which forms part of the initial/a separate claim.

- 6.4 We consider the vegetation identified as **S4**, **S5** and **H9** to be of possible future concern to the subject property, if left unmanaged. We have therefore recommended that these items of vegetation be maintained at their current size over the forthcoming years. These works are only recommended as a precaution and are not considered a priority to resolve the damage observed at the subject property.
