| HAVELOCK FARM EXISTING DRAINAGE (SURFACE WATER) REMEDIAL LIST | | | | | | | |

| <b>HAVELOCK FARM, WAKEHURST</b> | | | | |
| DRAWING TITLE:<br><b>EXISTING DRAINAGE<br/>CONDITION SURVEY (FEBRUARY 2024)<br/>AND PROPOSED REPAIRS</b> | | | | |
| 24079-SFK-09-ZZ-DR-C-9002 | | | | T1 |

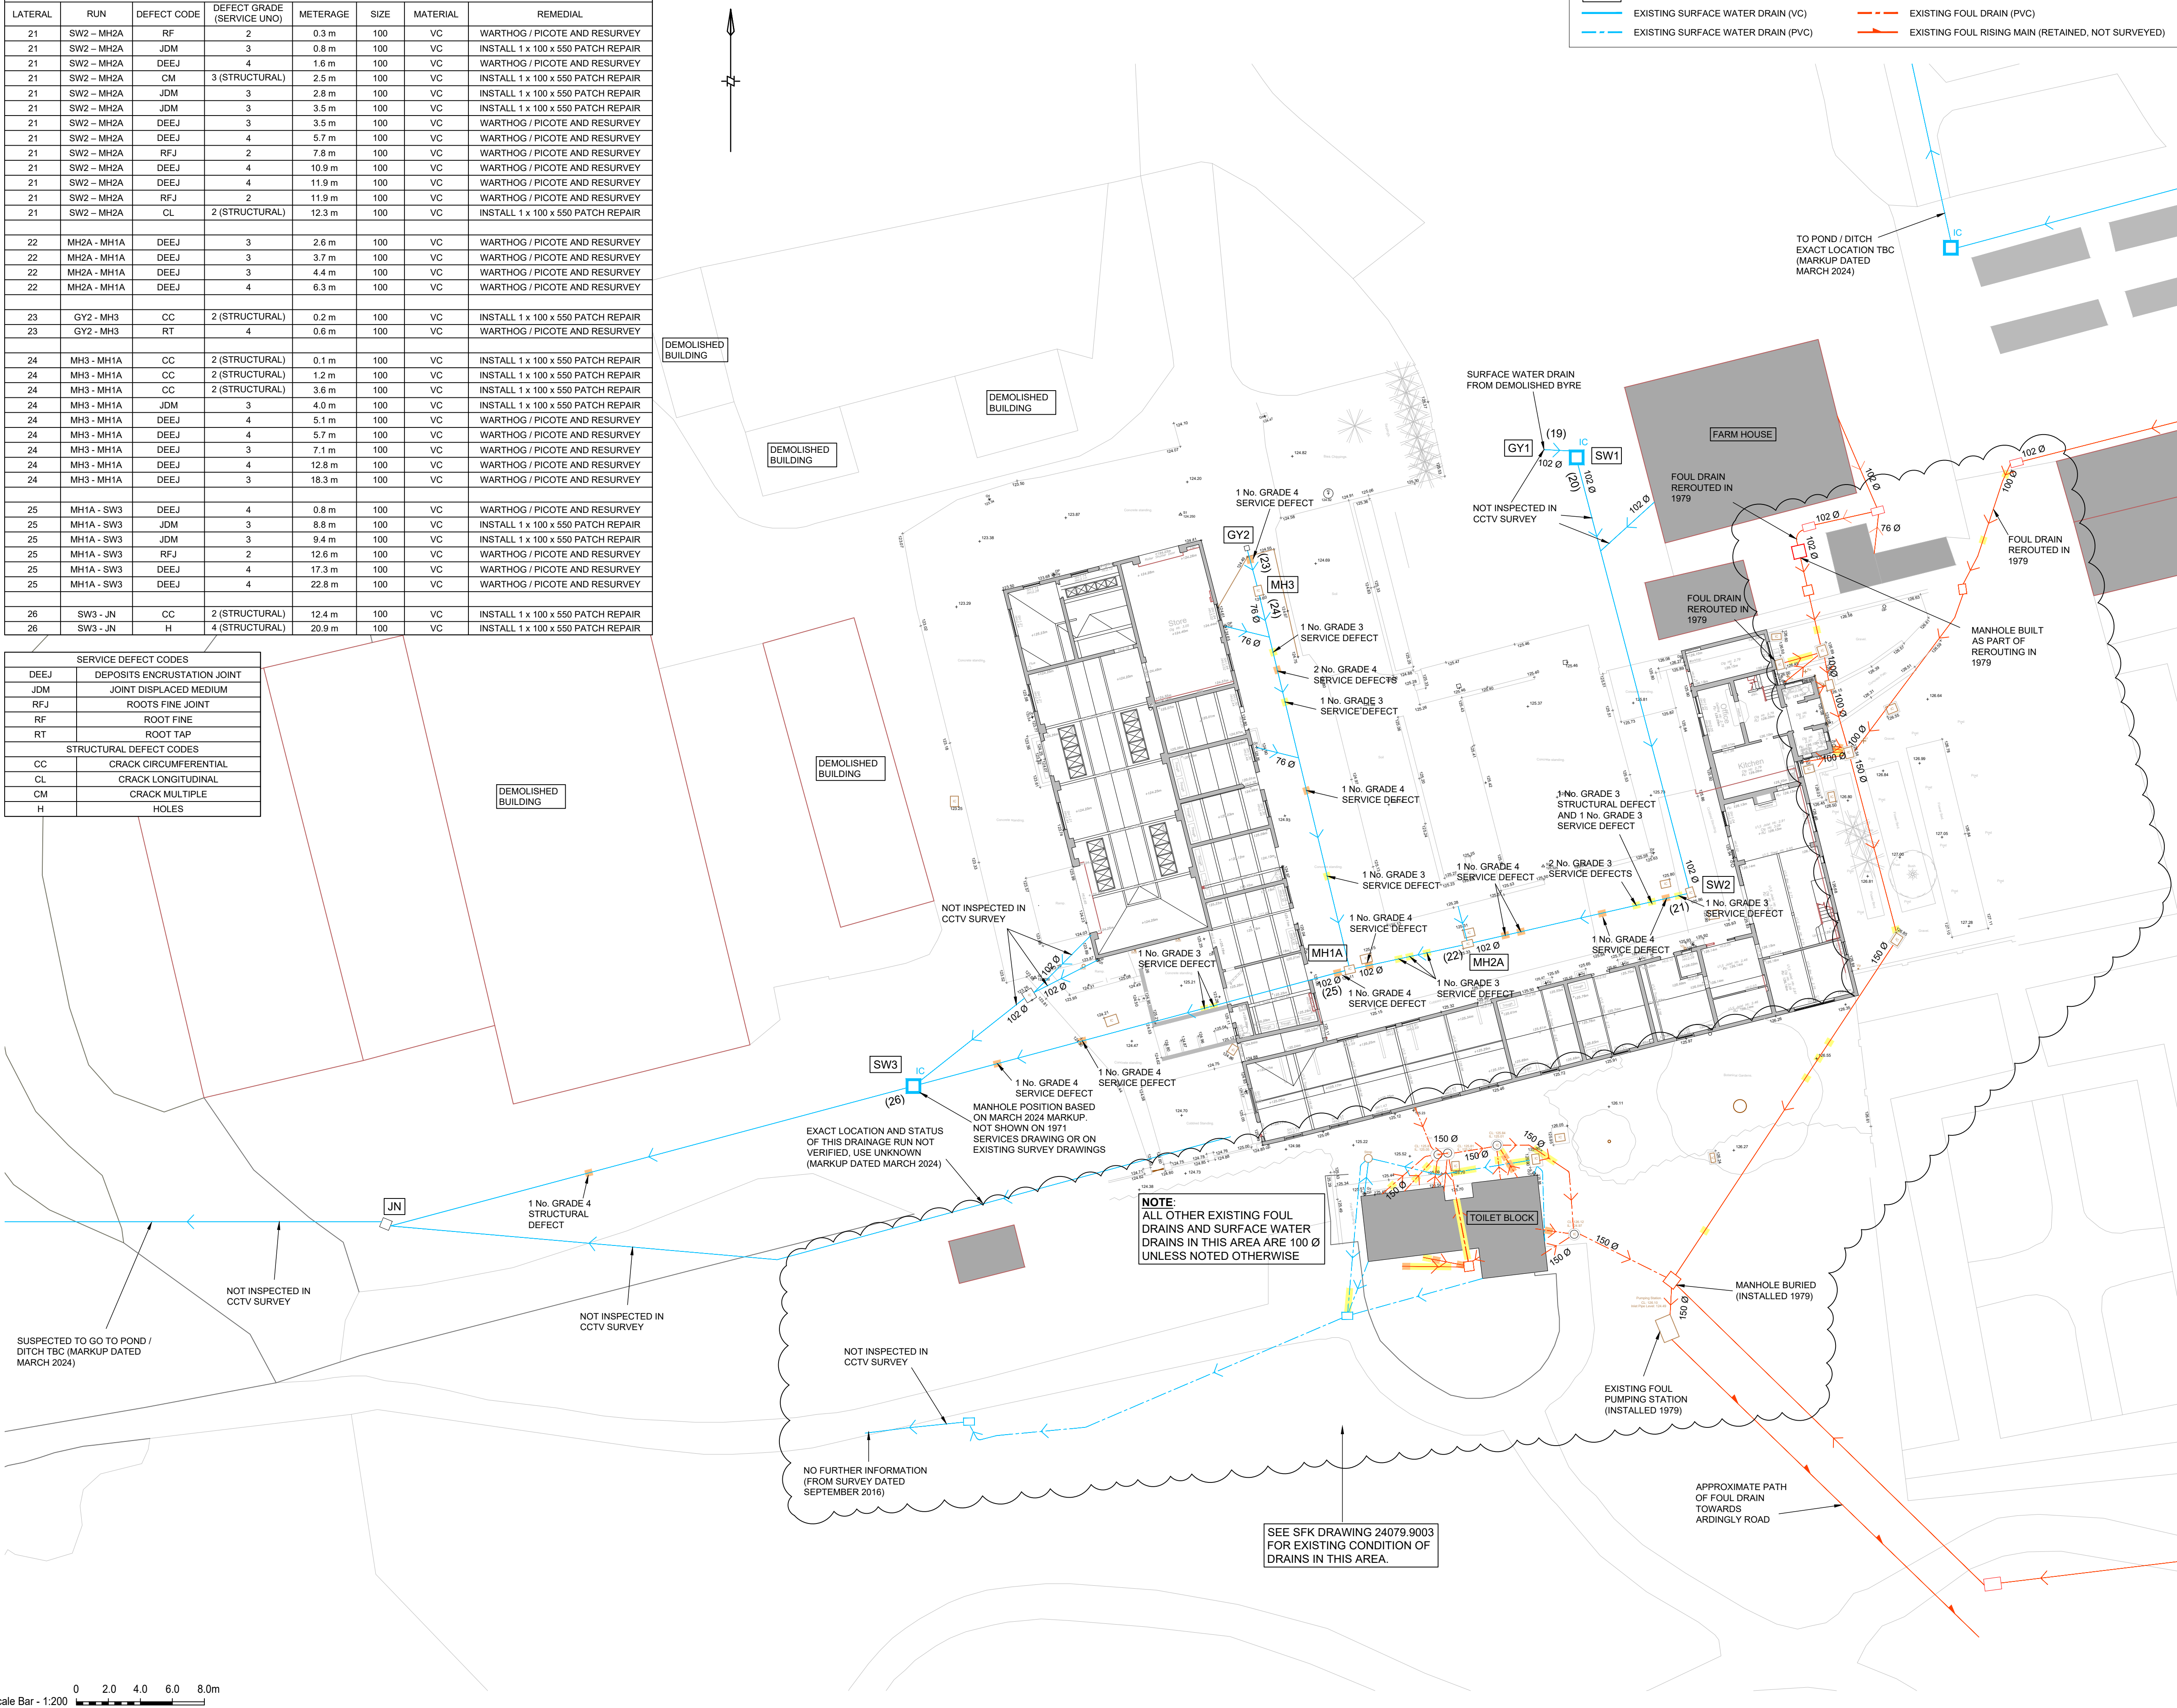
DRAINAGE OBSERVATIONS BASED ON CCTV SURVEY BY HAPPY DRAINS DATED FEBRUARY 2024 (REF: C1010599/001).

SEVERAL DRAINAGE PIPES SUFFER FROM SETTLED DEPOSITS THEREFORE HIGH PRESSURE JETTING IS RECOMMENDED FOLLOWING RECOMMENDED REPAIRS.

THERE ARE SEPARATE SURFACE AND FOUL WATER PIPED NETWORKS. THE SURFACE WATER NETWORK IS SHOWN TO DISCHARGE INTO THE ON-SITE POND. HOWEVER, THIS HAS NOT BEEN VERIFIED (NOT SURVEYED).

FOR SCOPE OF RECOMMENDED REPAIRS REFER TO HAVELOCK FARM EXISTING DRAINAGE (SURFACE WATER) REMEDIAL LIST BY SFK CONSULTING.
