| | drawn | ML | | RIBA STAGE 4 ISSUE. ISSUED FOR TENDER |

HAVELOCK FARM,  
WAKEHURST

# EXISTING DRAINAGE CONDITION SURVEY (JULY 2025) AND PROPOSED REPAIRS

24079 - C - 9003

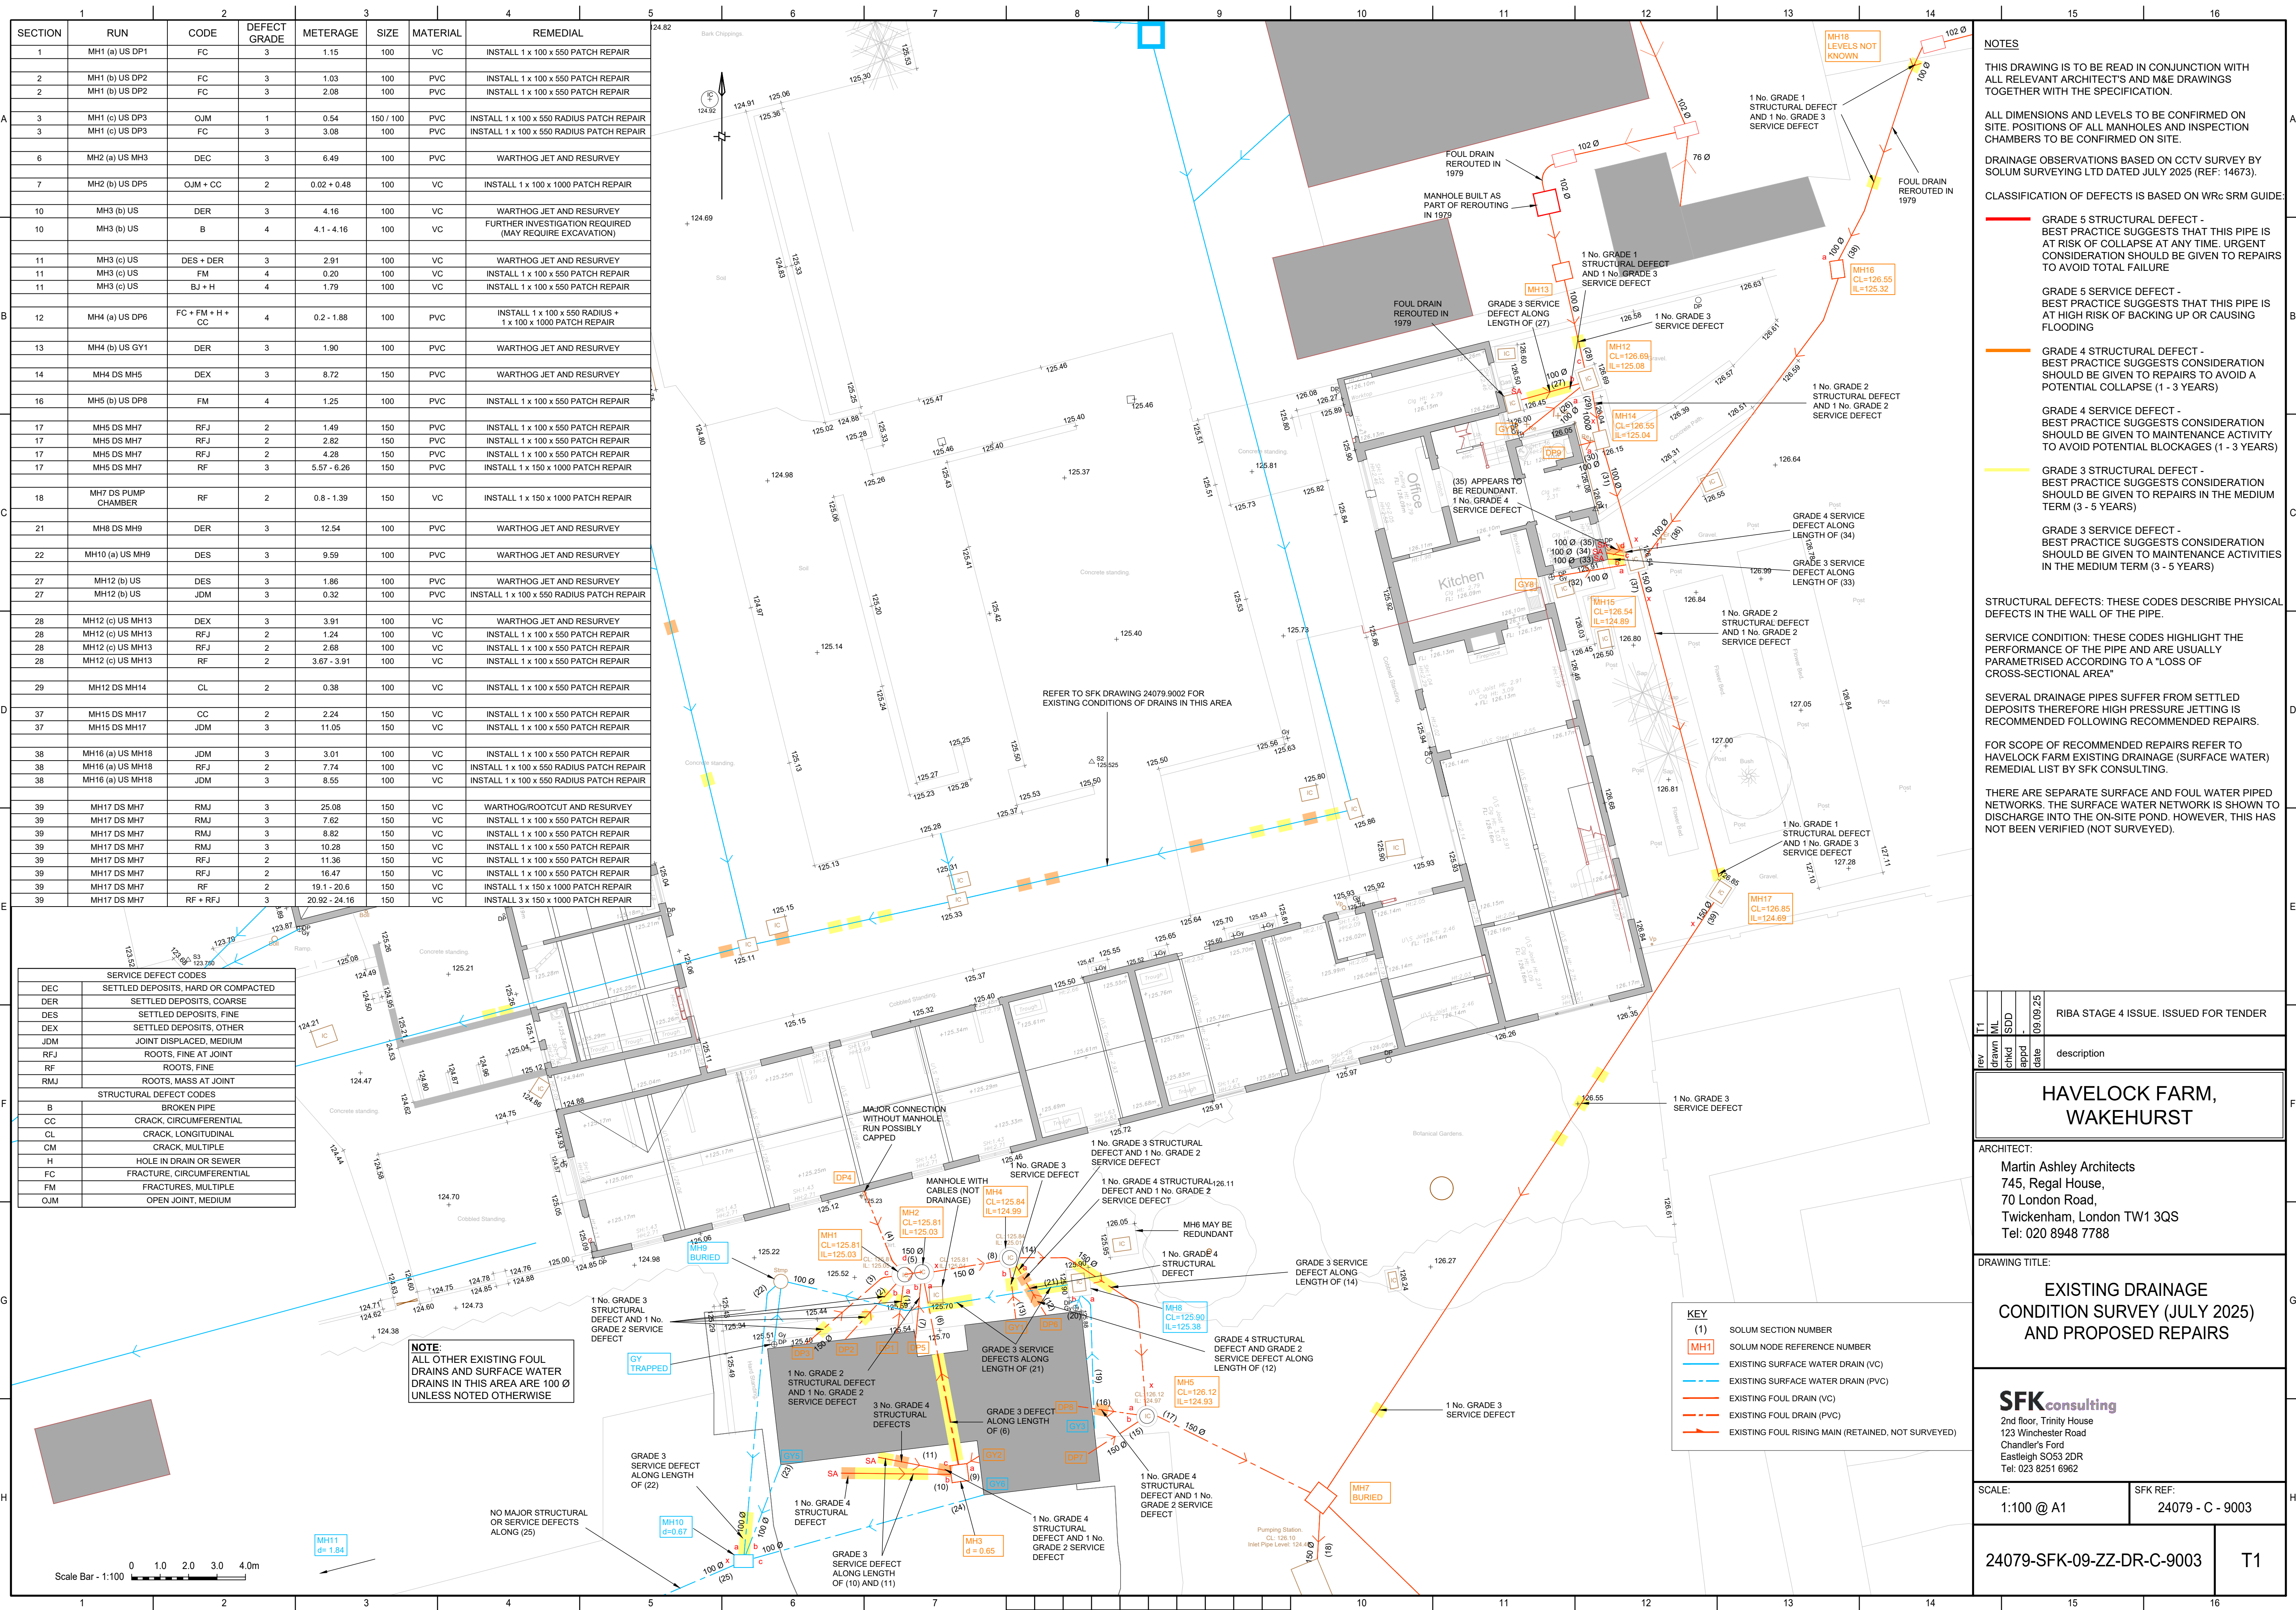
NO MAJOR STRUCTURAL  
OR SERVICE DEFECTS  
ALONG (25)

DRAINAGE OBSERVATIONS BASED ON CCTV SURVEY BY  
SOLUM SURVEYING LTD DATED JULY 2025 (REF: 14673).

SEVERAL DRAINAGE PIPES SUFFER FROM SETTLED DEPOSITS THEREFORE HIGH PRESSURE JETTING IS RECOMMENDED FOLLOWING RECOMMENDED REPAIRS.

THERE ARE SEPARATE SURFACE AND FOUL WATER PIPED NETWORKS. THE SURFACE WATER NETWORK IS SHOWN TO DISCHARGE INTO THE ON-SITE POND. HOWEVER, THIS HAS NOT BEEN VERIFIED (NOT SURVEYED).

FOR SCOPE OF RECOMMENDED REPAIRS REFER TO  
HAVELOCK FARM EXISTING DRAINAGE (SURFACE WATER)  
REMEDIAL LIST BY SFK CONSULTING.
