Project Shepherds Farm, Crawley Down, RH10 4HQ.

Drawing Emergency Works to Damaged Chimneys.  
Existing Roof Plan and East Facing Elevation.  
Issued for Planning

Date Jan 2025 Scale As Noted @ A1 Dwg 0491 EX 37A

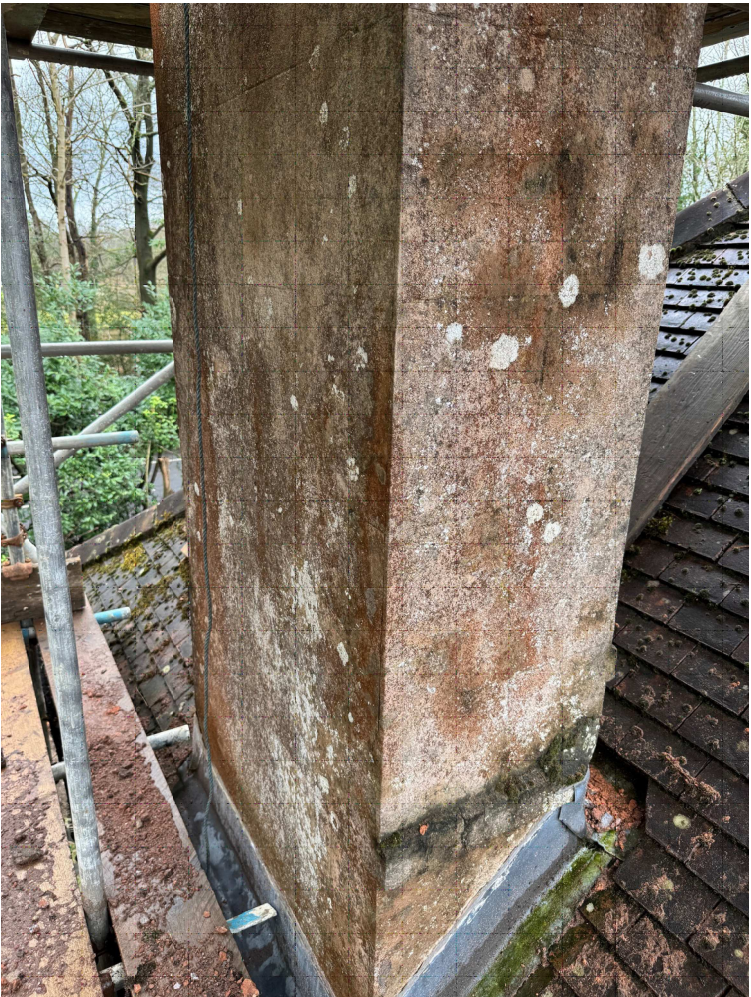
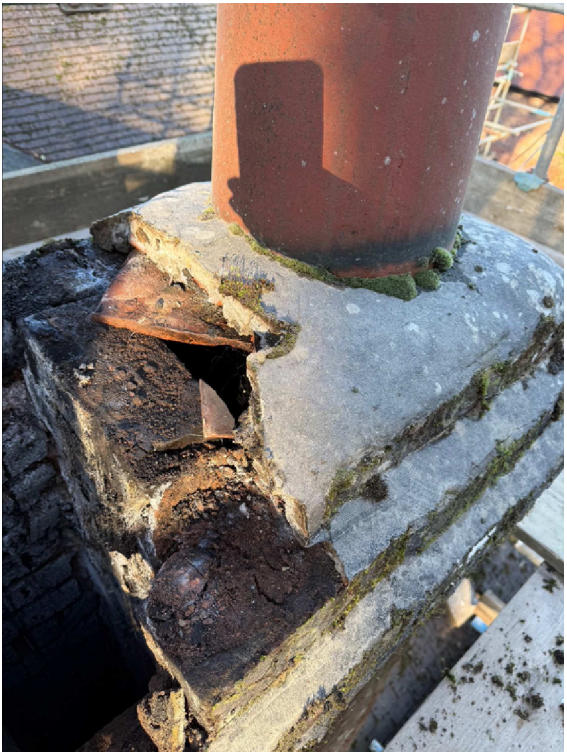
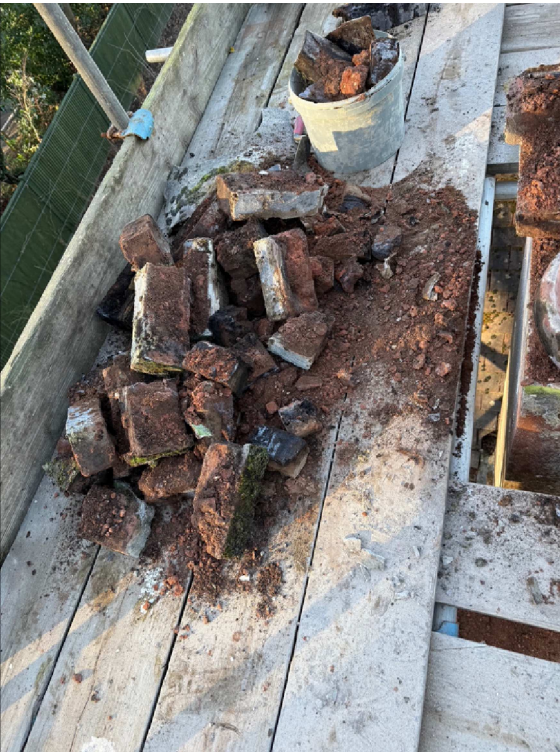
Poor quality of the masonry as removed.

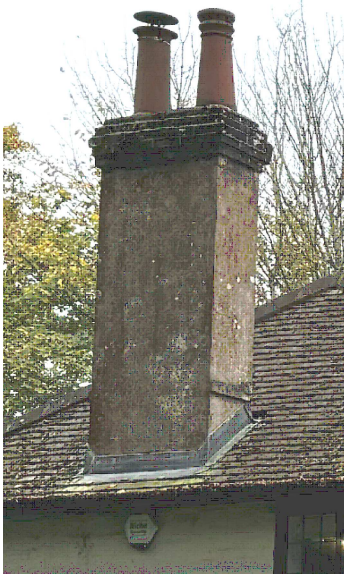
### Chimney 04 (South)

- This was deemed as damaged and structurally unstable.
- On inspection it was found that the upper section of the chimney was resting on a piece of slate.
- The stack has been finished in render which is in poor condition and there is concern as to what the render is hiding.
- The top 6ft has therefore been removed as there was a major concern of the chimney collapsing and causing avoidable damage to the existing property below.
- Scaffolding has been placed on the 4sides which has stabilised the remaining stack.

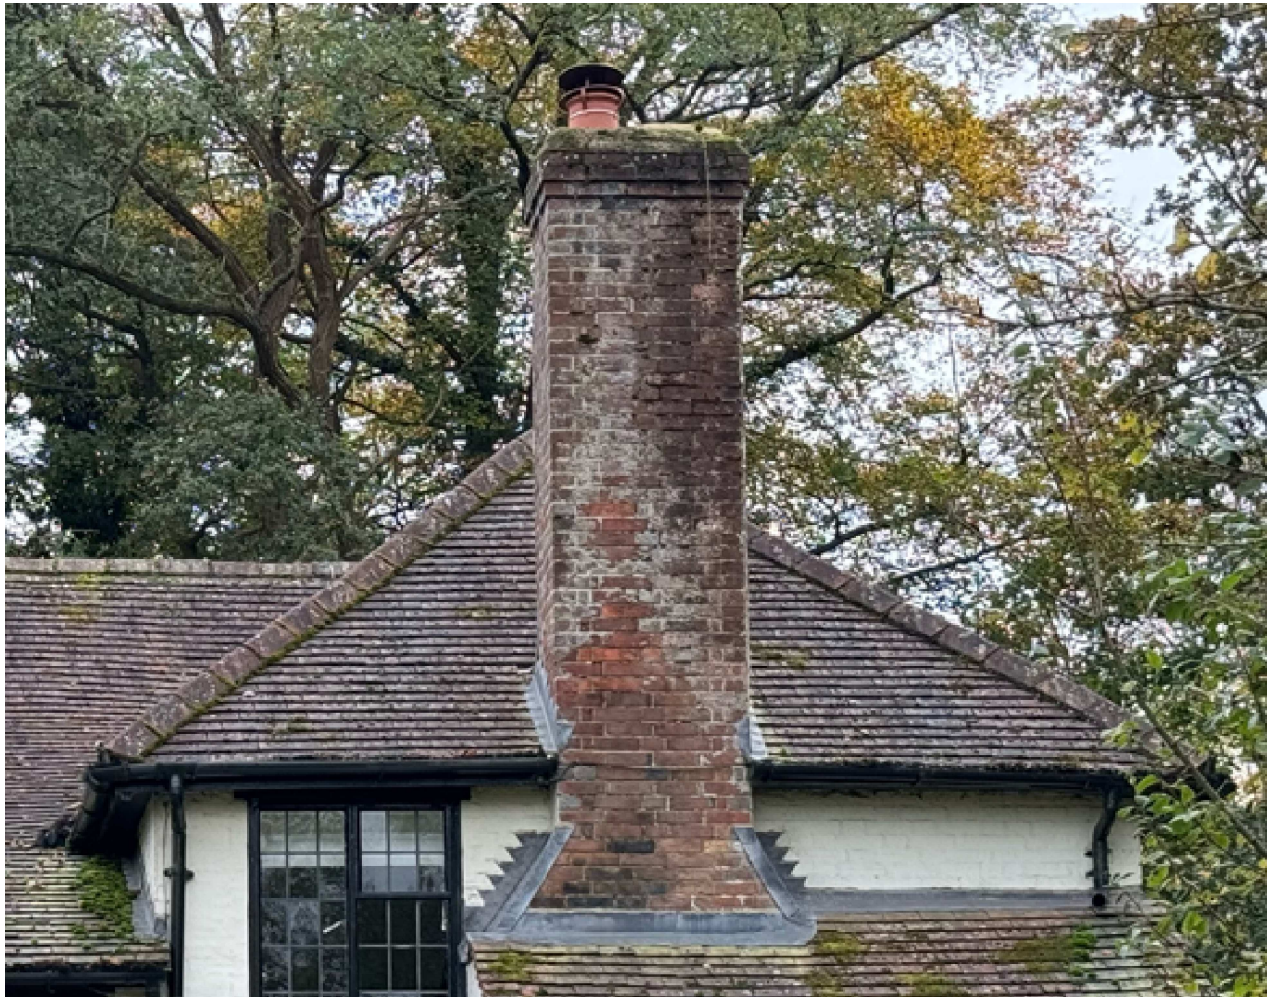
### Chimney 01 (North)

- This stack leaned towards the house and was unstable and it rock slightly when pushed.
- The top section of the chimney has been removed to a level where the structure is stable.
- It is then to be re-built to a height, and with details, that match the existing.
- As with Chimney 4 there was a concern of it collapsing should there be further gales and bad weather.
- Photo above is of the chimney prior to the removal of the top section.

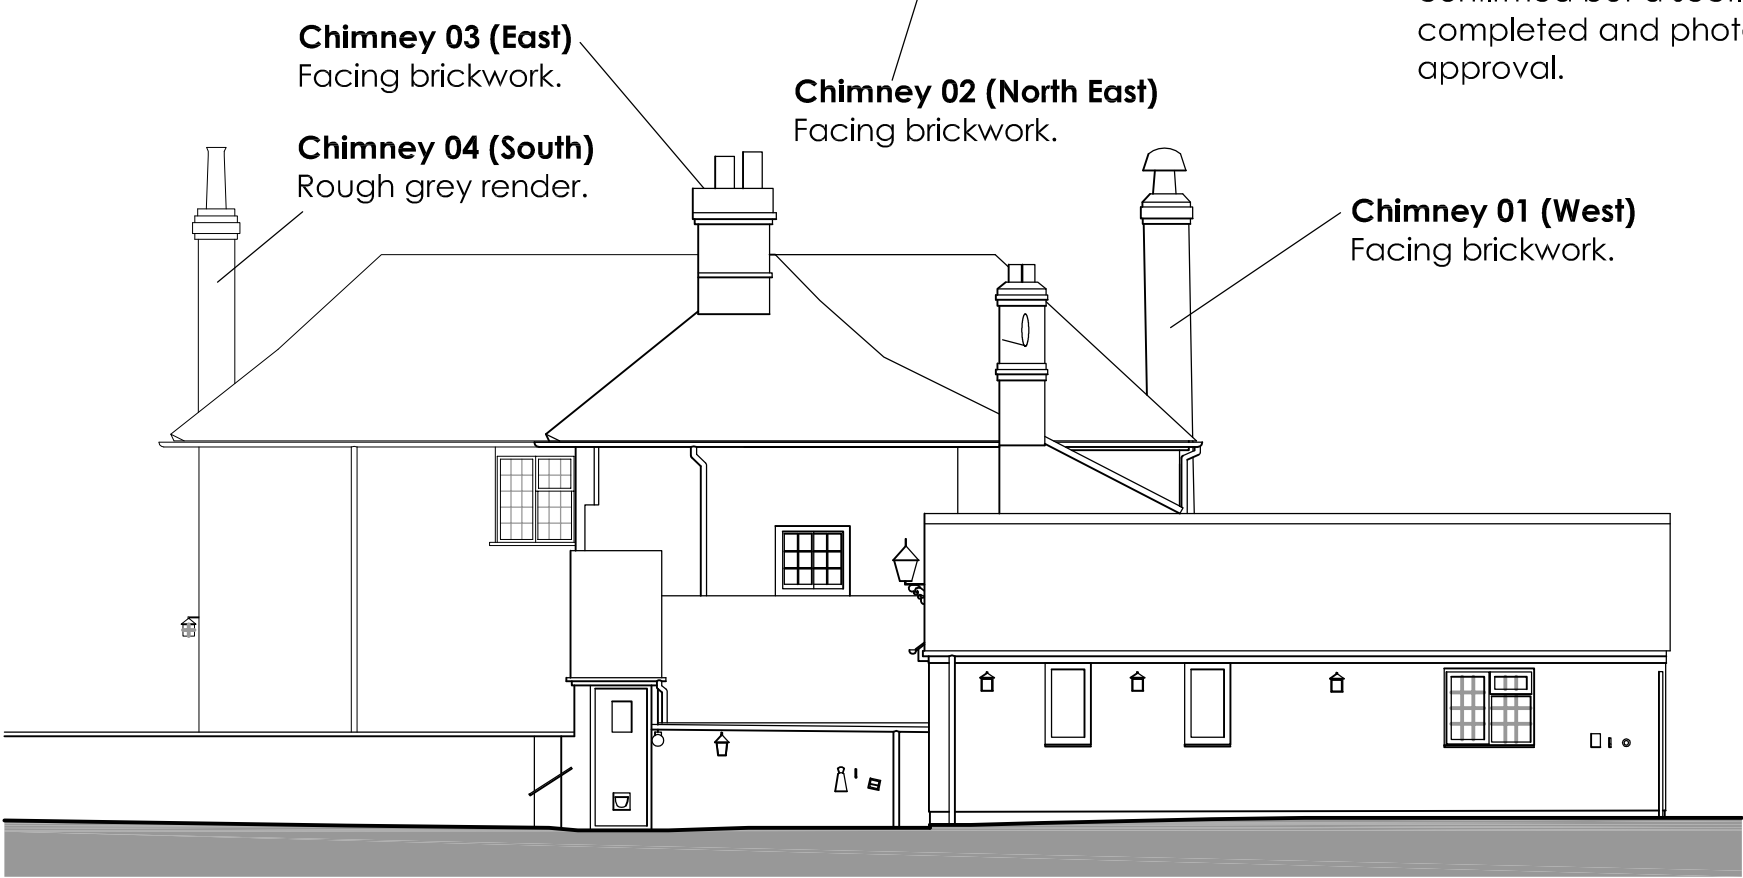
Existing East Facing Elevation SCALE 1:100

- This stack has chimney caps because the two flues are not in use. The caps as installed have been deemed as too small and there is water ingress - the caps need replacing.
- This chimney, whilst structurally stable, does need to be re-pointed.
- The mortar and pointing are to be confirmed but a section could be completed and photographed for approval.

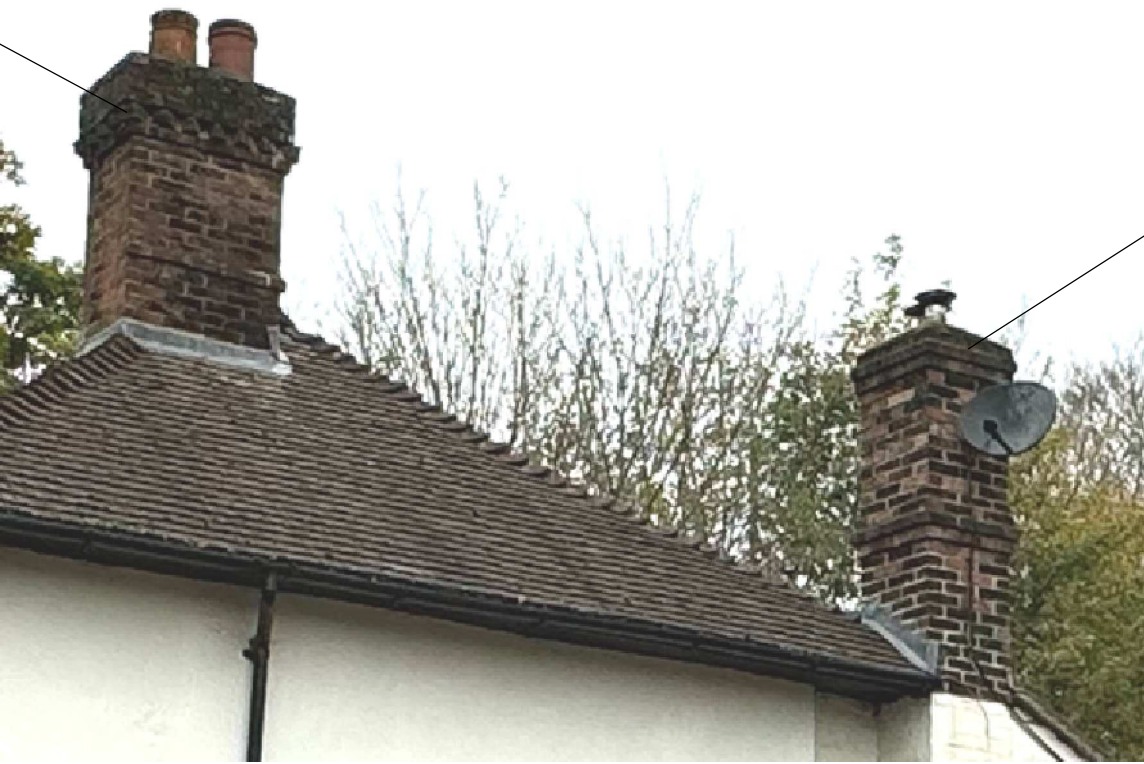
### Chimney 02 (North East)

- From ground level this chimney looks to be in good condition and visually it looks stable.
- There is no scaffolding around this one at present.
- No works are needed to this chimney.
