MS07801/DS

**Structural Appraisal of Proposed Conversion of Barn & out-buildings at Birchgrove Farm, Horsted Keynes**

Showing the  
Existing Plans and Sections  
Showing Structural Site  
Notes

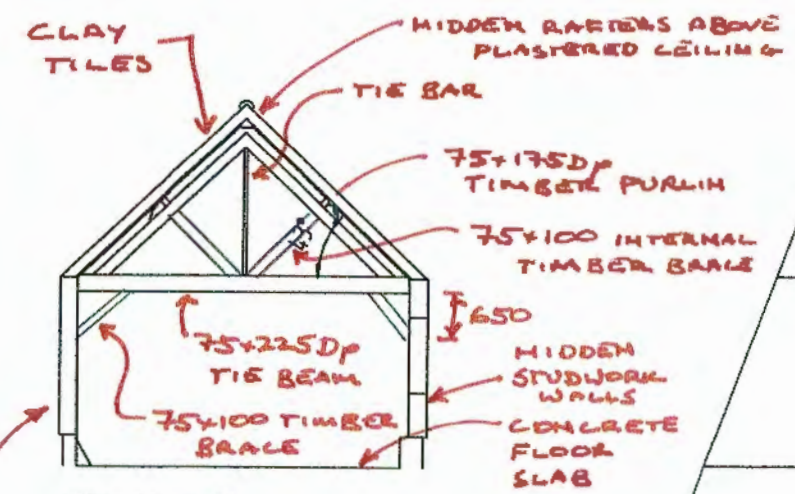
Section B

ORIGINAL DOOR TIMBER LINTEL ROTTING & CRACK NOTED IN STONEWORK

SLIGHT CRACKS TO WINDOW REVEALS & REAR WALL SLIGHTLY LEANING OUT INDICATING EAVES THRUST

NOTE - RAFTERS GENERALLY BOWED

The walls to all areas of the barn complex are generally in a very good condition, some areas will require localised masonry crack repairs and repointing and lintels will need to be replaced where they have rotted.

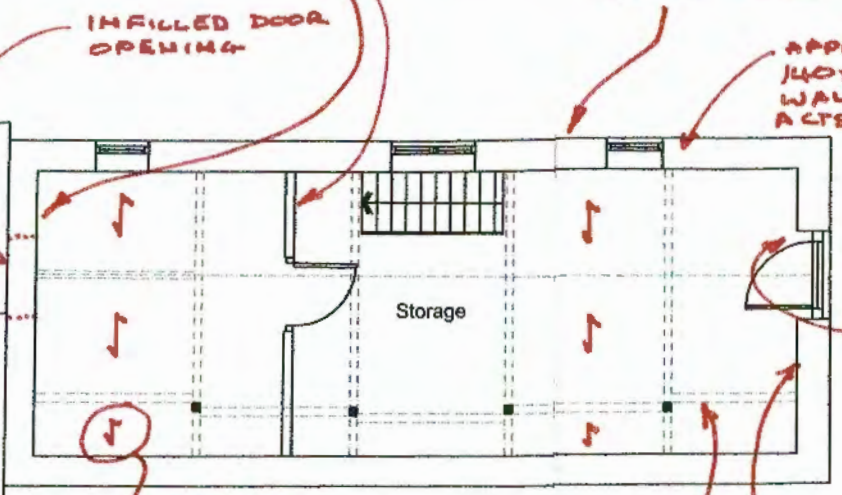
First Floor Plan

REPLACED SORTWOOD RAFTERS TO THIS BAY.

SOME SORTWOOD 50x100 TIMBERS ALONGSIDE & REPLACING ORIGINAL 80x100 OAK JOISTS IN THIS BAY ONLY.

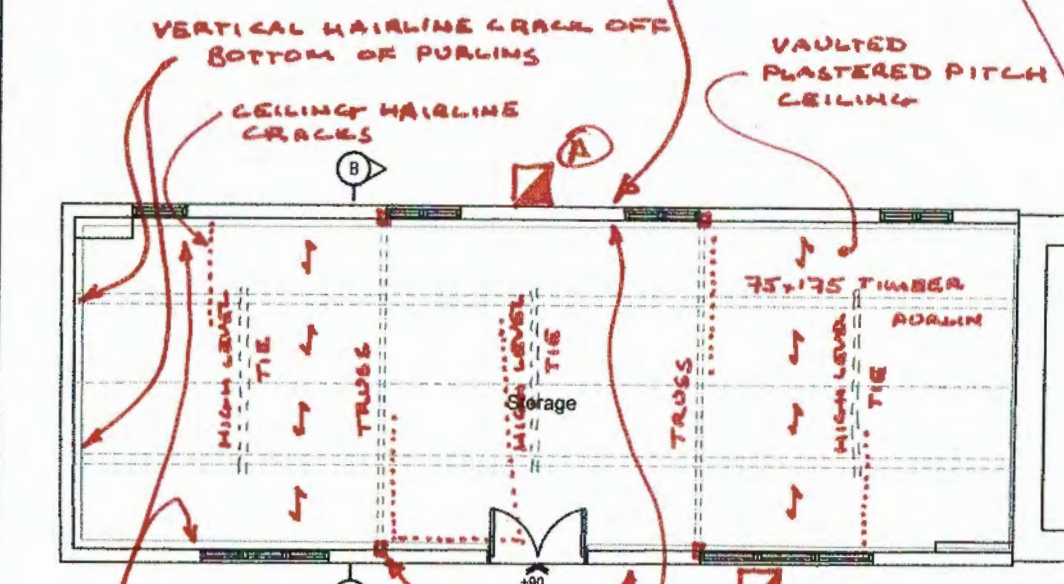
Ground Floor Plan

OAK FLOOR BEAM WITH 50x100 TIMBERS FIXED TO SIDE TO AID SUPPORT OF FLOOR JOISTS OVER

CORBEL BRICKS SUPPORTING FIRST FLOOR TIMBER BEAMS

STONE SETTS TO GROUND FLOOR

350 WIDE x 160 Dp INSITU CONCRETE LINTEL

BRICKWORK PIER UNDER FLOOR BEAM WITH SPLIT AT END OF BEAM.

STONE OUTER LEAF LINTEL & TIMBER LINTEL TO INNER FACE

As the ground floor to the main stone barn was stone setts, these will probably need to be lifted and replaced with a concrete or limecrete floor slab bearing onto the sandstone subsoil to allow for suitable insulation. The timber frame barn concrete floor slab appears to be a ground bearing insitu concrete slabs, this can be retained were the levels perimeter.

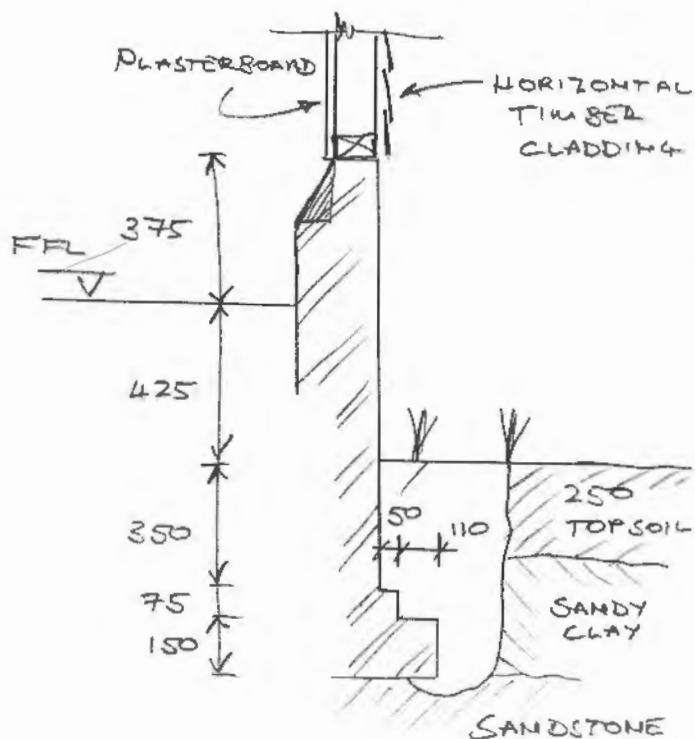
SECTION A-A

Two trial holes were undertaken around the main barn building to showed the existing foundations. The trial holes along the front and rear of the building showed the wall was

supported on corbelled out sandstone masonry over sandstone subsoil extending approximately 400mm deep.

The subsoil was sandstone as per the trial hole findings, so the existing foundations should not require any extensive underpinning.

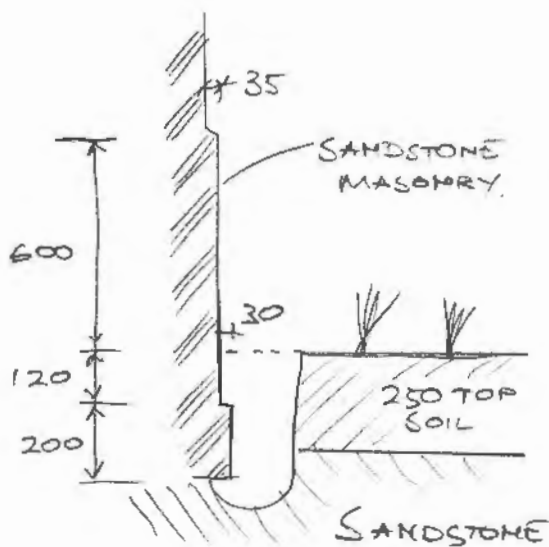
SECTION C-C

A trial holes were undertaken on the front and rear elevations; the rear hole showed a corbelled brickwork footing approximately 550mm deep from ground level and projecting out around 150mm. The front hole was approximately 400mm deep to underside, but did not corbel out. Both footings were bearing onto sandstone subsoil.
